Brownfields Cleanup Action

**Joseph Guy Community Center
Kwethluk, Alaska**

**FINAL
June 2013**

ERM Project # 0172736

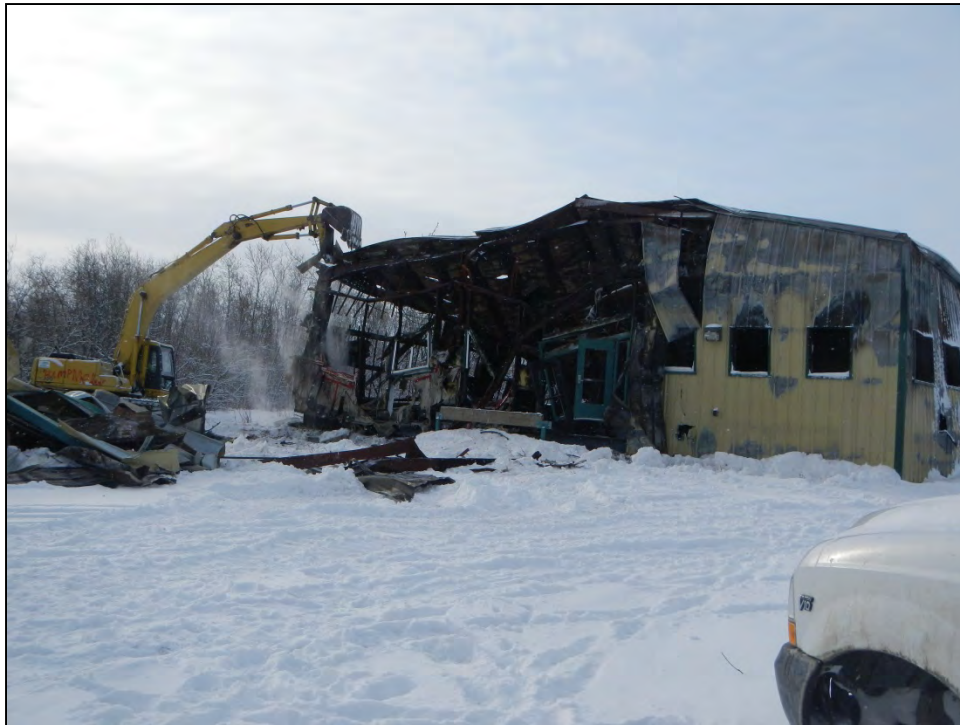
PHOTOGRAPH 1: DISMANTLING THE FRAME AND STRUCTURE OF THE JGCC BUILDING (LOOKING SOUTH).

The metal shell and frame of the building were dismantled on April 5, 2012. The metal was then crushed and staged for hauling to Bethel for recycling and disposal. Thirteen truckloads of metal were transported to the Bethel Landfill in April 2012. The building had been supported by twelve steel pilings and cross beams. The cross beams were staged onsite for use by village residents. The piles were cut below grade and removed with the metal building materials. Approximately 30 cubic yards of non-hazardous small debris/soil was scraped up during the building demolition and transferred to the Kwethluk dump.

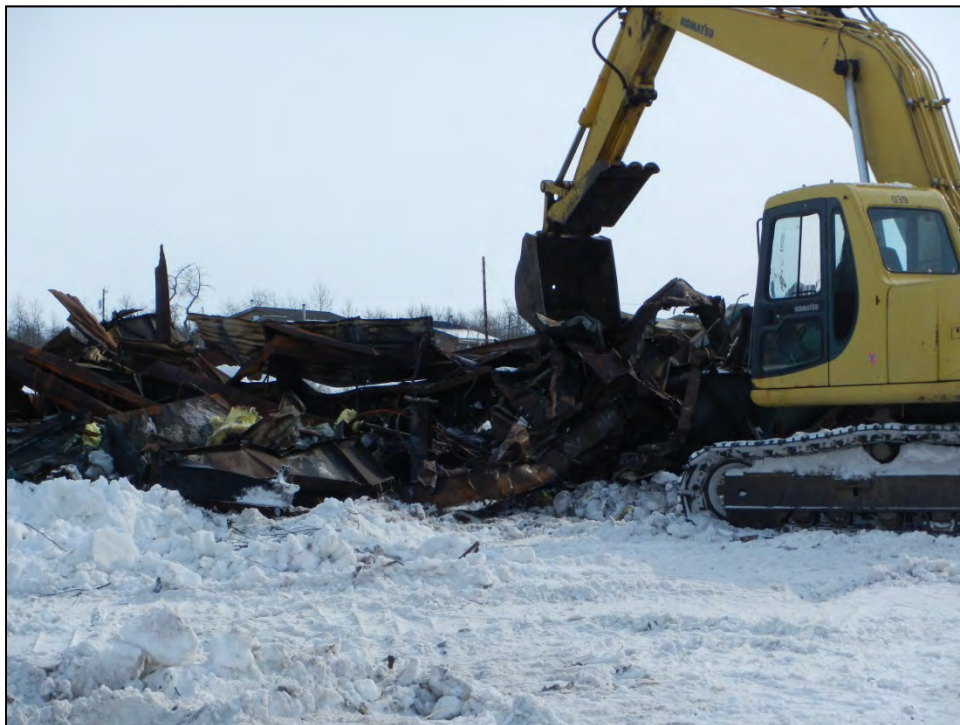
PHOTOGRAPH 2: STAGING AND CRUSHING METAL DEBRIS FOR TRANSPORT TO BETHEL LANDFILL (LOOKING SOUTHEAST).

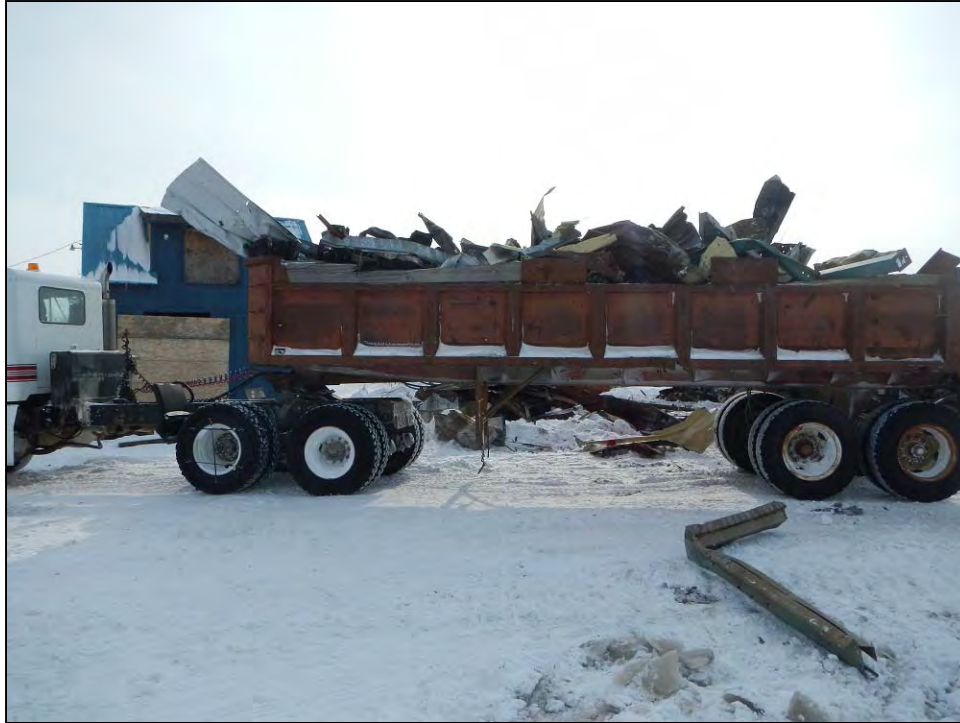
PHOTOGRAPH 3: DUMP TRUCK LOADED AND READY TO HAUL ACROSS ICE ROAD TO BETHEL LANDFILL (LOOKING EAST)

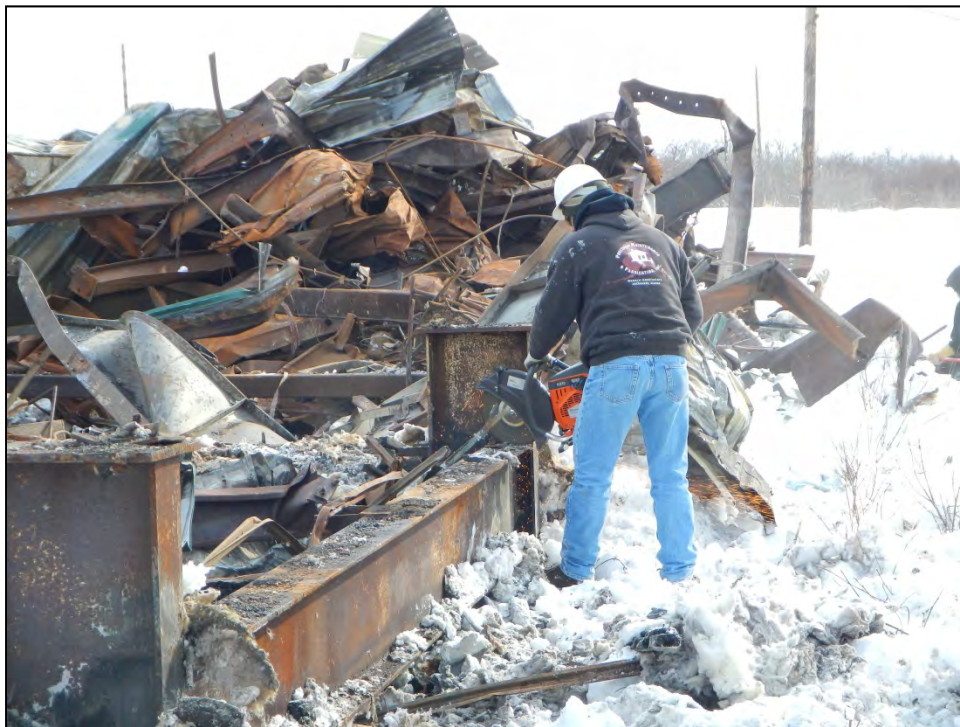
PHOTOGRAPH 4: CUTTING BEAMS AWAY FROM STEEL PILES (LOOKING SOUTH).

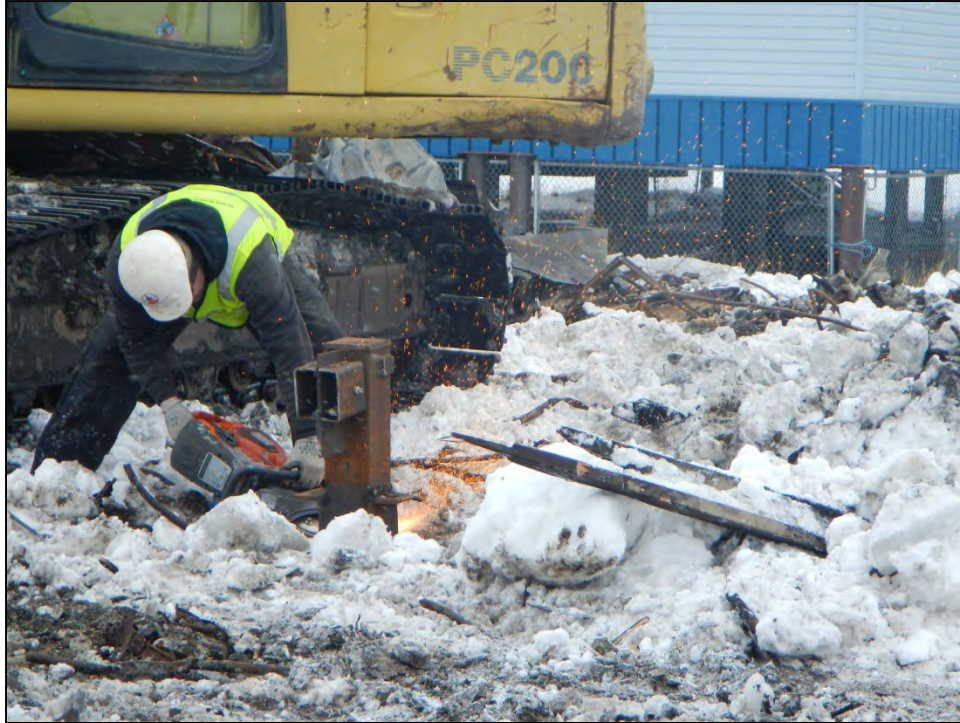
PHOTOGRAPH 5: CUTTING VERTICAL PILES BELOW GRADE (LOOKING WEST)

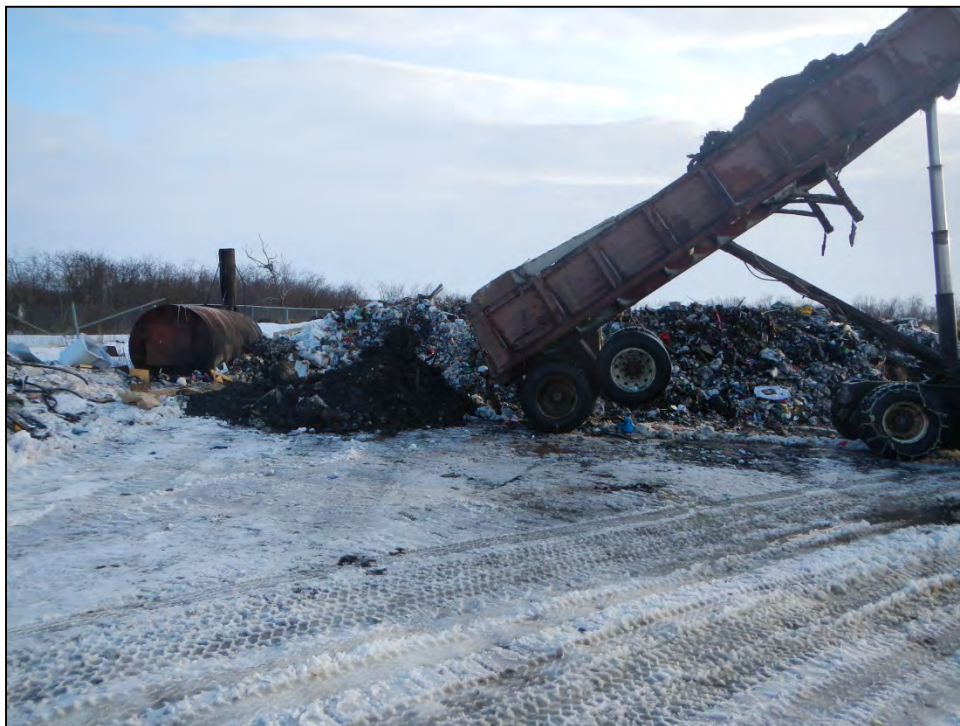
PHOTOGRAPH 6: DUMPING DEBRIS/SOIL AT KWETHLUK DUMP (LOOKING SOUTH).

BSI then scraped the surface debris/soil within the building footprint to approximately 1 foot below grade or to the polystyrene foam board, whichever was shallower. March 2012 TCLP metal results suggested that the soil beneath the building footprint could be treated as polluted soil, rather than hazardous waste. Approximately 30 cubic yards (cy) of debris/soil was transported by dump truck to the Kwethluk dump (Photograph 6) with approval of the DEC Solid Waste Program.

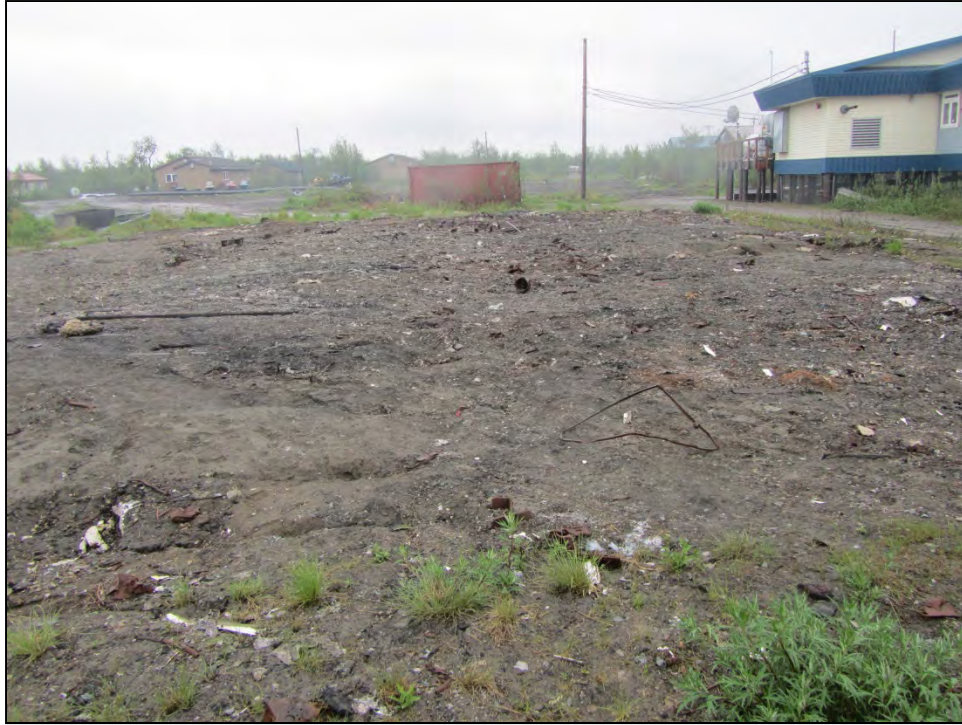
PHOTOGRAPH 7: BUILDING FOOTPRINT AFTER SPRING FLOODING AND BEFORE DEBRIS CLEANUP (LOOKING SOUTH).

Upon arrival at the site, ERM personnel observed significant amounts of metal debris located on and around the footprint. In May 2012, the Kuskokwim and Kwethluk Rivers had breached their banks and flooded the village of Kwethluk, including the Community Center site. The flooding likely re-distributed subsurface debris, not removed during the April field effort. Additional cleanup of the site was deemed necessary and ERM oversaw cleanup of debris large enough to be picked up by hand and transferred to the Kwethluk dump. Photographs 7 and 8 show the site before and after debris cleanup.

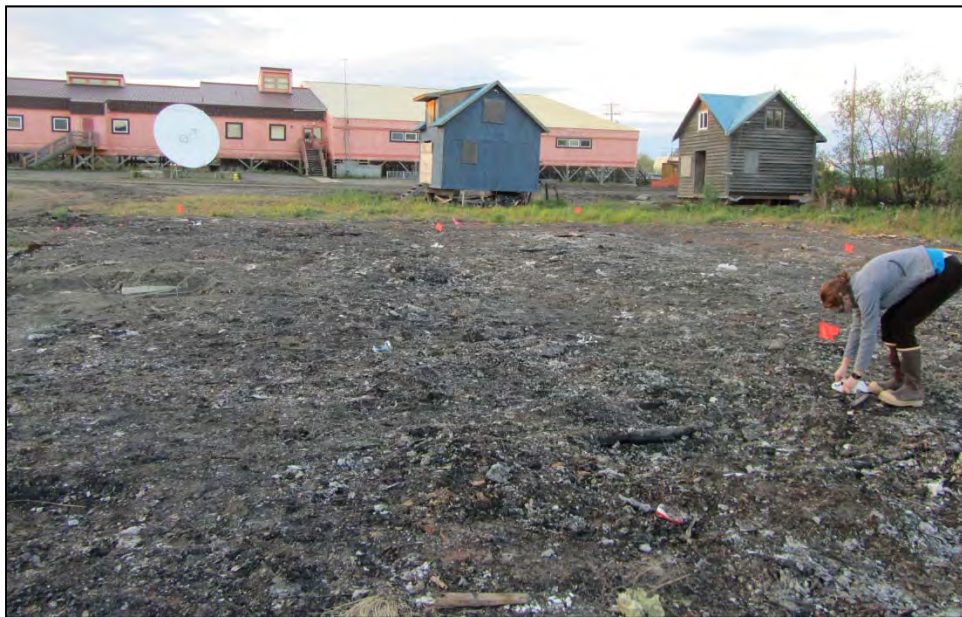
PHOTOGRAPH 8: BUILDING FOOTPRINT AFTER METAL CLEANUP (LOOKING NORTH).

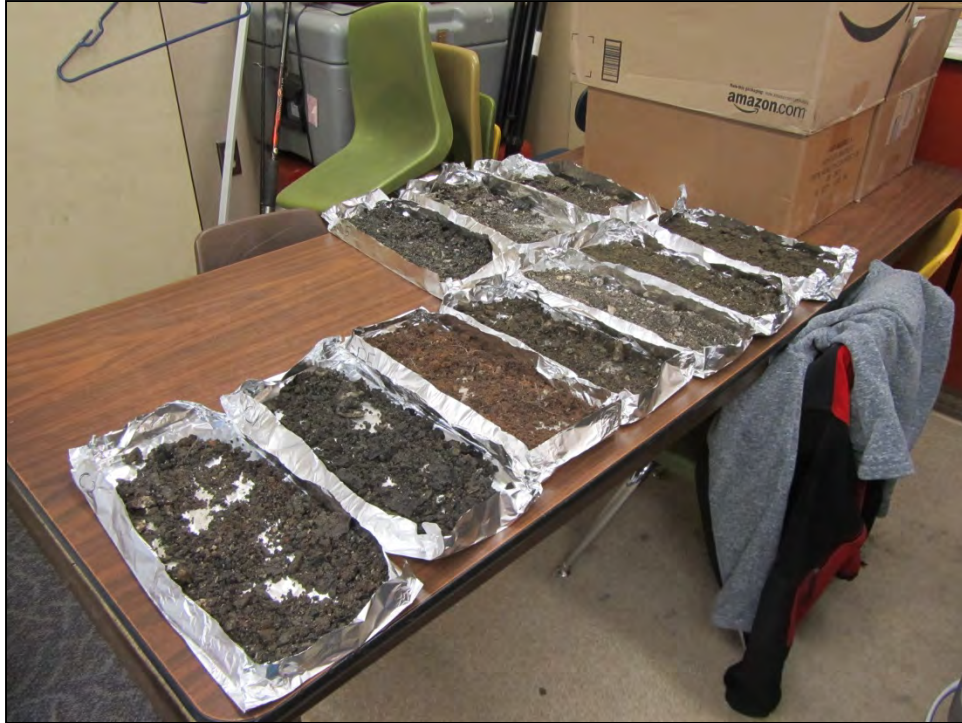
PHOTOGRAPH 9: DRYING SOIL FOR XRF ANALYSIS.

Each bag of soil was dried overnight (Photograph 9) then placed in a toaster oven for approximately 15 minute at 350°F to remove any remaining moisture. Screening samples were sieved to 60-mesh (Photograph 10), and placed into a sample cup provided as part of the soil kit for the XRF. The XRF analyzer was set to soil mode and all three element ranges were used (main, low, and high). A measurement time of 60 seconds on each range, totaling three minutes per location was used. Results were recorded by the analyzer for all detectable metals. ERM also recorded the concentrations of antimony, arsenic, chromium, cobalt, copper and nickel in the field notebook. The results are presented in Table 2 and Figure 3.

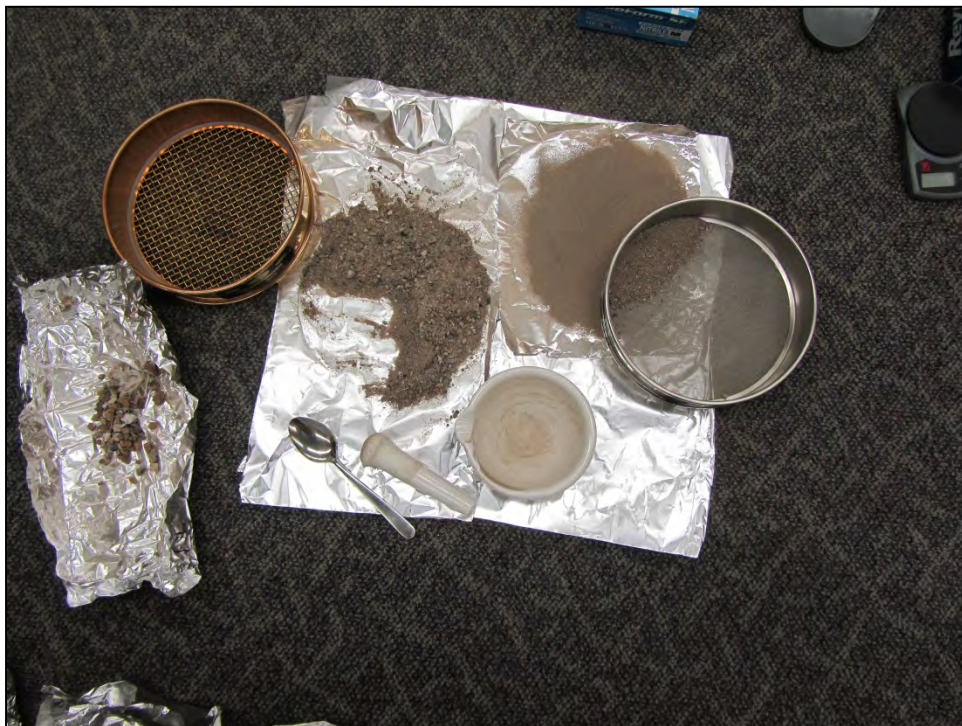
PHOTOGRAPH 10: SIEVED AND SAMPLED SOIL FOR XRF ANALYSIS.

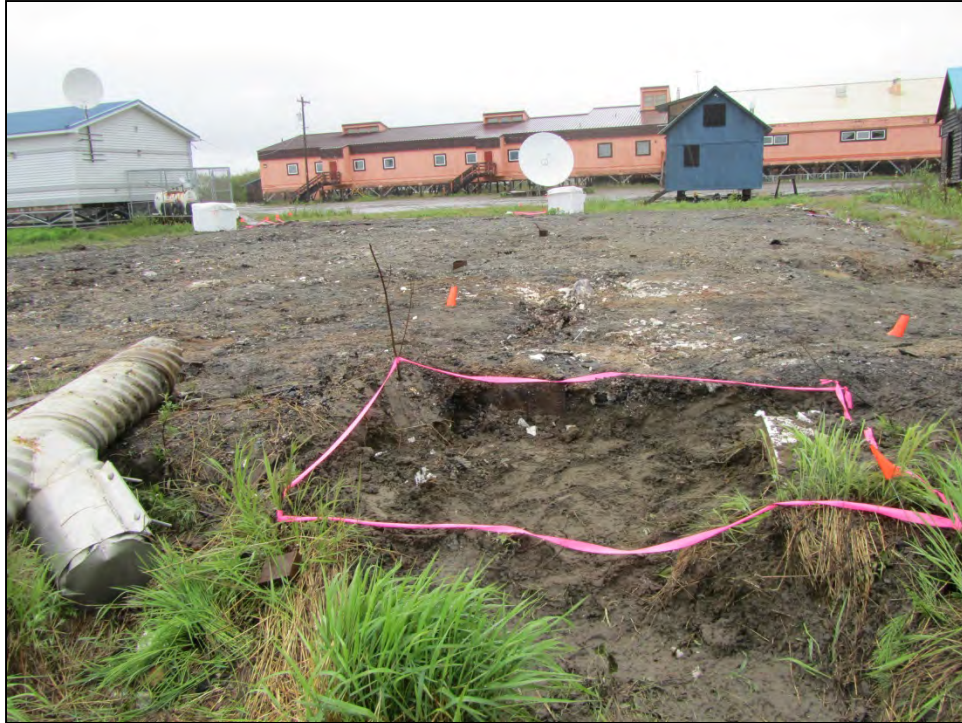
PHOTOGRAPH 11: EXCAVATION AREA 1 - JUNE 2012 (LOOKING NORTH)

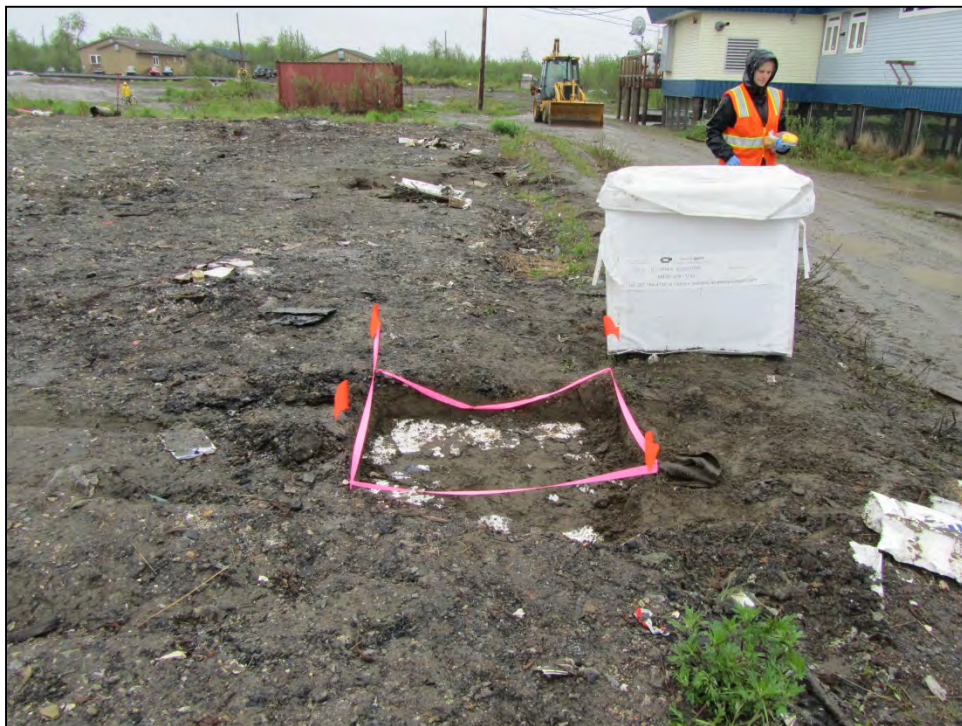
PHOTOGRAPH 12: EXCAVATION AREA 2 WITH BULK SACK - JUNE 2012 (LOOKING SOUTH).

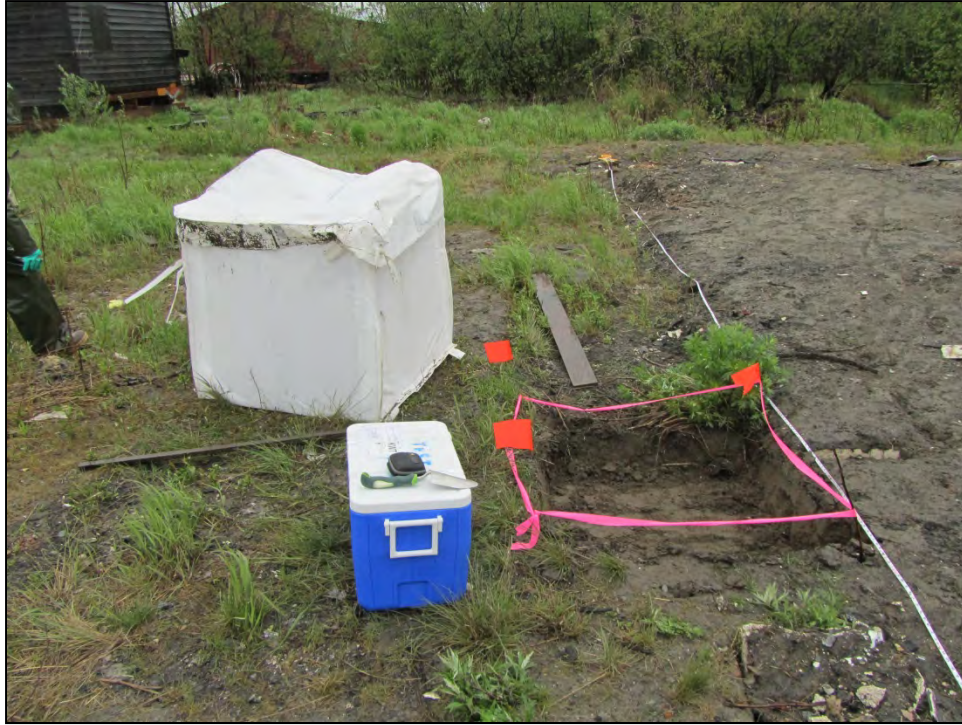
PHOTOGRAPH 13: EXCAVATION AREA 3 WITH BULK SACK (LOOKING EAST).

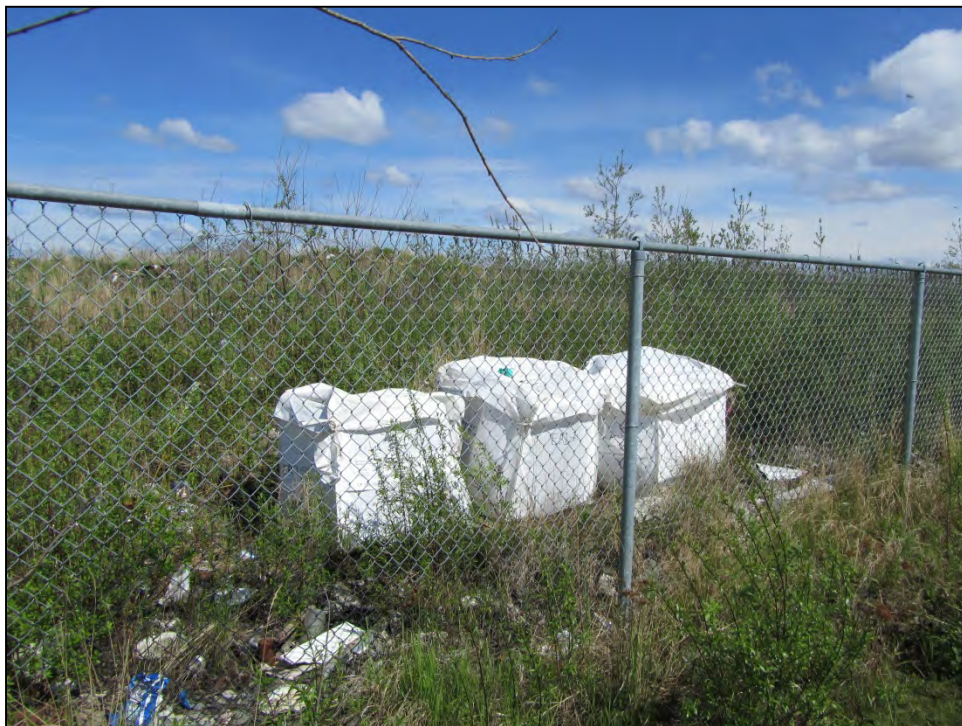
PHOTOGRAPH 14: JUNE 2012 BULK SACKS STORED INSIDE SOUTH FENCE LINE OF KWETHLUK DUMP (LOOKING NORTHEAST).

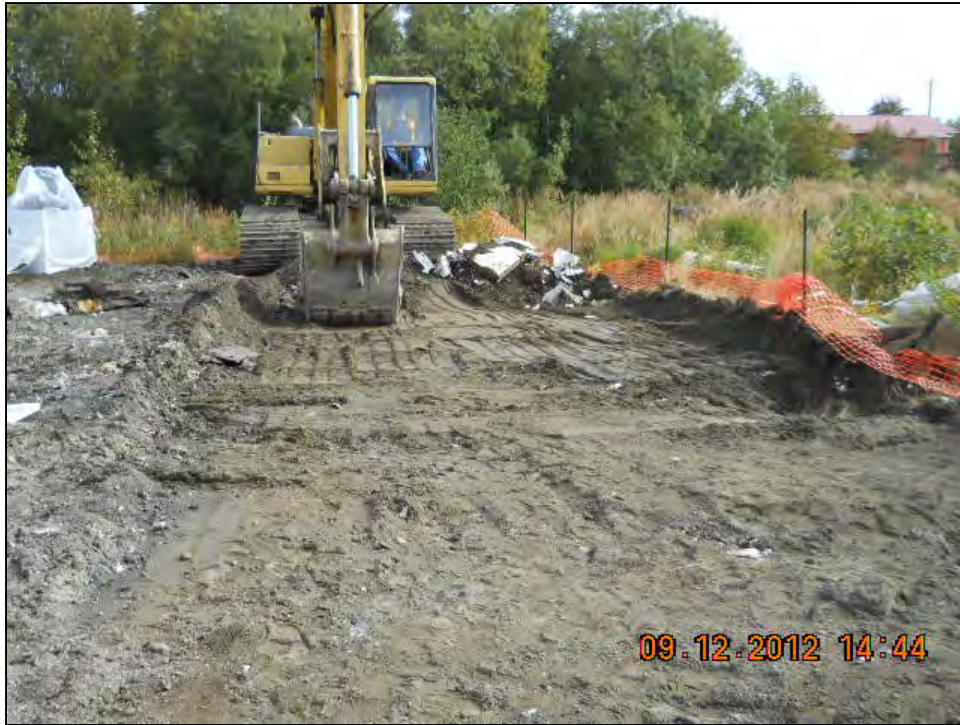
PHOTOGRAPH 15: SEPTEMBER 2012 EXCAVATION AROUND LOCATIONS A5, B5, AND C5 (LOOKING EAST).

During the September 2012 field event, the field crew screened the area to be excavated using an XRF. They then removed 13 cy of debris/soil, 2 cy of polystyrene foam, and two H-piles attached to treated timbers that were used as the building foundation.

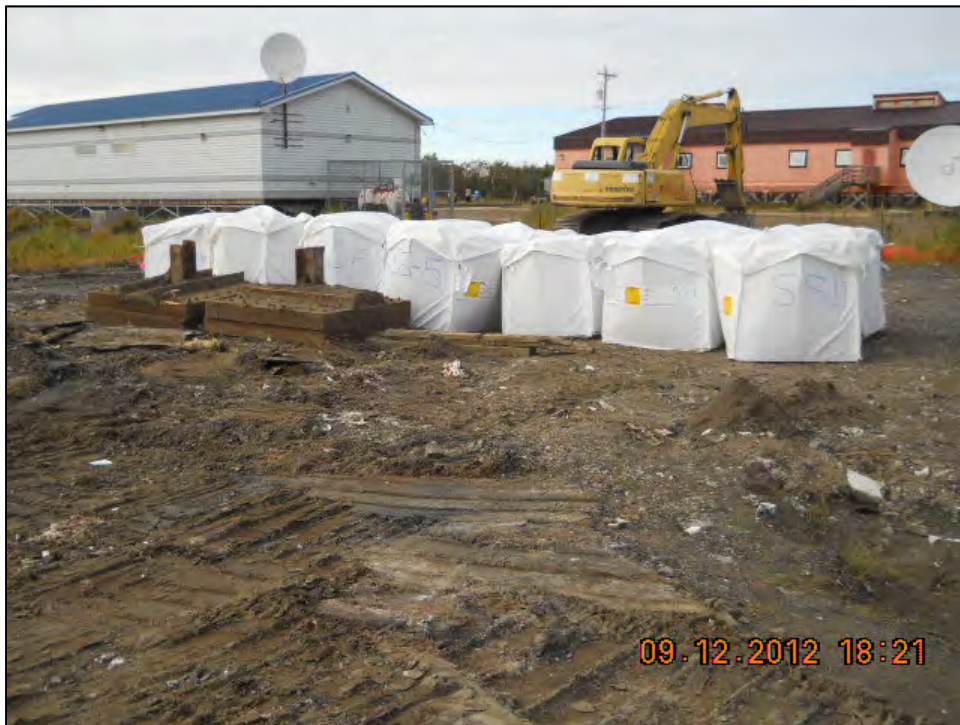
PHOTOGRAPH 16: STAGING LOCATION FOR BULK SACKS AND PILING PENDING ANALYTICAL RESULTS (LOOKING SOUTHWEST).

The crew encountered wood cribbing foundation blocks with attached pilings as they excavated the debris. Per the request of the OVK, the piles and wood cribbing were removed and temporarily staged next to the bulk sacks. The temporary staging location of the sacks and pilings are shown in Photograph 16.

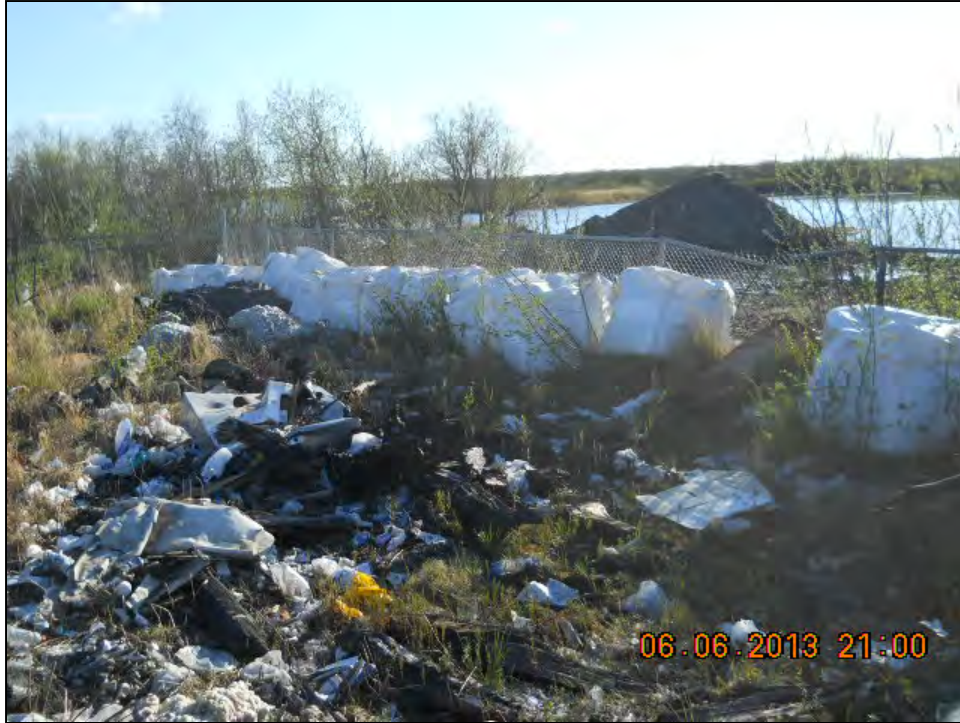
PHOTOGRAPH 17: 1-CY BULK SACKS PLACED INSIDE THE WEST FENCE LINE OF THE KWETHLUK DUMP (LOOKING SOUTHWEST).

ERM returned to the site in September 2012 to remove the material suspected to be hazardous based on the calculated TCLP results. Soil and debris surrounding the three sample locations noted above were excavated and placed into 1-cubic-yard (cy) bulk sacks. The action produced 13 cy of small debris/soil, 2 cy of polystyrene foam, and two steel pilings with attached treated wooden cribbing footers. The sacks were sampled for TCLP arsenic and chromium, the only two COPC metals regulated by RCRA. TCLP sample results were well below the RCRA TCLP limits for these two metals, supporting the use of direct contact rather than MTG cleanup levels for metals contamination. With approval from the DEC Solid Waste Program, the bulk sacks were transferred to the Kwethluk dump in June 2013.
