Property Assessment and Cleanup Plan

Selawik Area-Wide

Selawik, Alaska

By:
Shannon & Wilson, Inc.
5430 Fairbanks Street, Suite 3
Anchorage, Alaska 99518

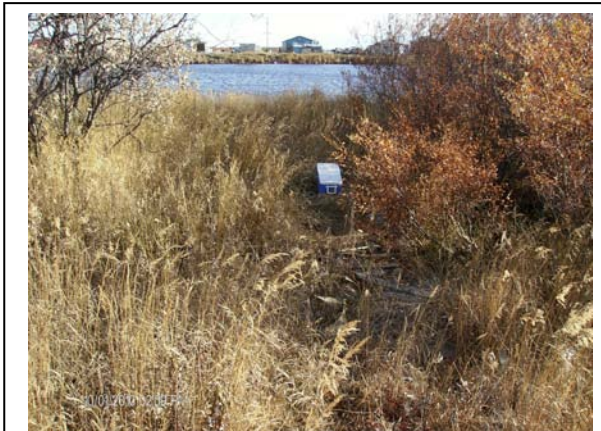
Photograph 4.2-3: Looking east to the Test Pit I8 location, the eastern channel of the Selawik River, and the Selawik airport. (10/1/2010)

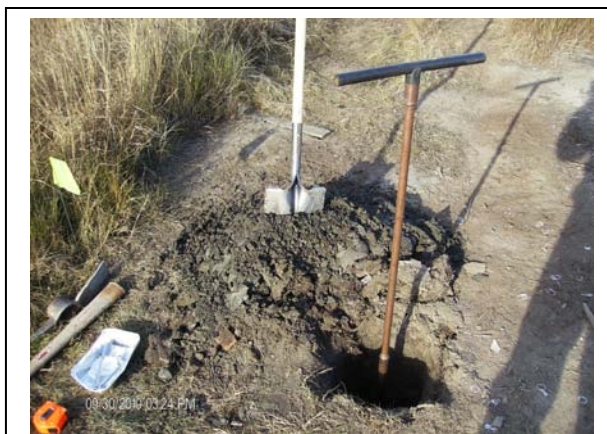
Ten test pits were advanced by shovel and hand auger at the IRA Fuel Project Former Tank Farm. A representative test pit is shown in Photo 4.2-4. Test Pit I1 was placed at the location of the visible surface stain near the access bridge. Test Pits I2, I3, I4, and I6 were

Photograph 4.2-4: Looking down at Test Pit I1 advanced by hand using a shovel and hand auger at the IRA Fuel Project Former Tank Farm. Stained soil associated with the former dispenser shed visible to left. (9/30/2010)

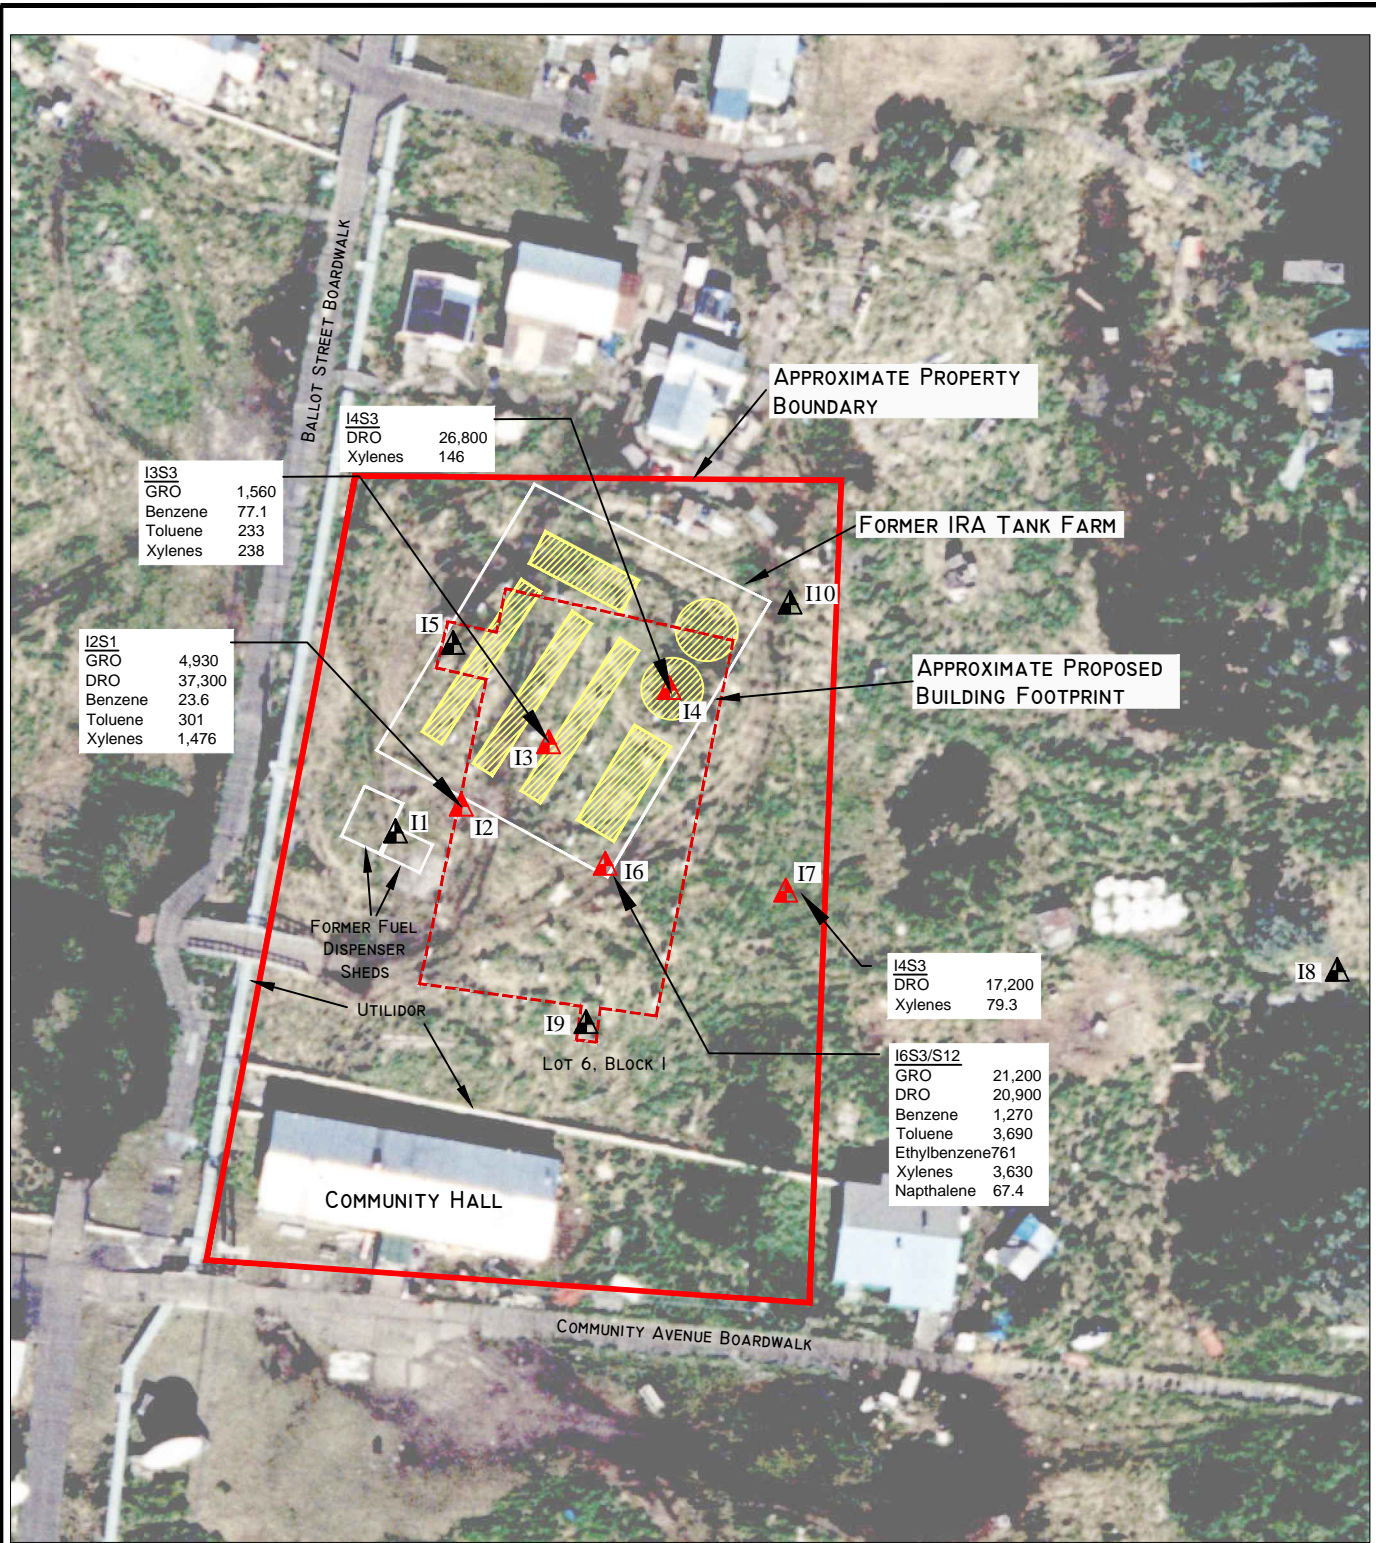
- ▲ I2 Approximate location of Test Pit I2 by Shannon & Wilson, Inc., 2010, with sample results greater than the ADEC cleanup levels. Concentrations of analytes with exceedences shown in mg/kg. For other analytes see Table 4.2-2.
- ▲ I1 Approximate location of Test Pit I1 by Shannon & Wilson, Inc., 2010, with sample results less than the ADEC cleanup level, or not analyzed (I8).

Inhalation, dermal contact, and ingestion are potentially complete exposure pathways for the IRA Fuel Project Former Tank Farm. Concentrations of GRO and DRO in excess of the DEC Method Two maximum allowable concentration were measured in the near-surface soil. BTEX and naphthalene concentrations exceed the Method Two outdoor inhalation standards, and benzene concentrations also exceed the direct contact standards. The presence of volatile compounds near the ground surface suggests a potential inhalation exposure for humans or animals that spend significant periods of time on the site. The extent of soil contamination and the possibility of surface water contamination have not been fully investigated.

Remedial actions will likely be required for the site due to the presence of GRO and DRO in excess of the DEC maximum allow concentrations. Proper assessment of remedial alternatives is not practicable given the remaining data gaps.

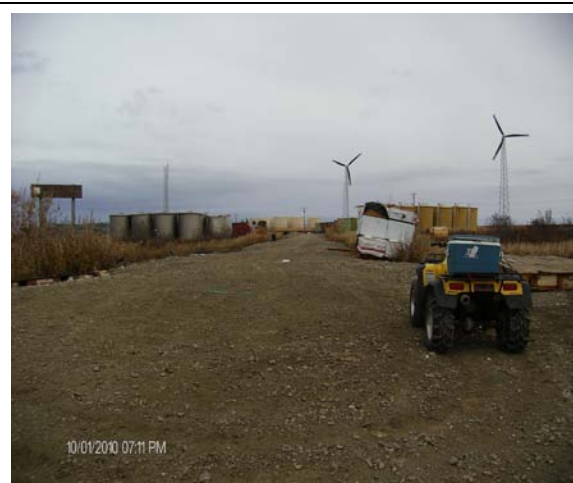
Photograph 5.2-1: Looking south-southeast up ramp from Selawik River to Barge Landing storage area. (10/1/2010)

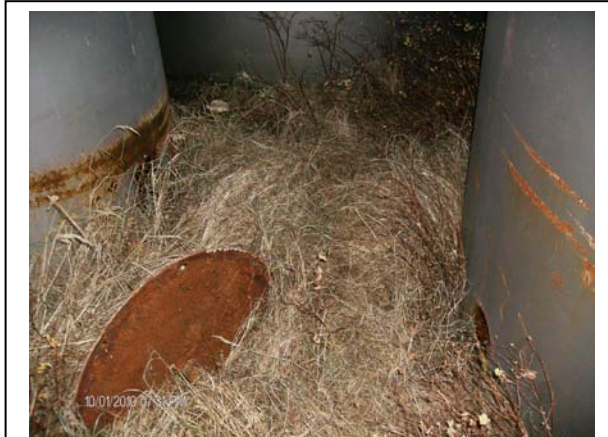
The decommissioned aboveground storage tanks (ASTs), stored vertically in two groups, are the most obvious feature of the area. Fourteen tanks are stored at the northern end of the gravel pad. Ten of these tanks are painted a yellow color that appears to match the color of tanks

Photograph 5.2-2: ASTs stored at the Barge Landing Area, showing holes cut in tanks and a removed cover. These tanks are thought to be from the Former AVEC Facility. (10/1/2010)

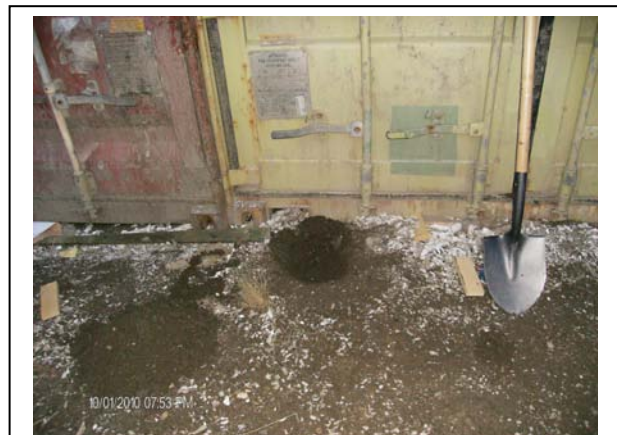
Photograph 5.2-3: Looking north at broken fluorescent bulbs and the Sample BLS2 location at the base of shipping containers on the Barge Landing storage pad. (10/1/2010)

unidentified steel items. It also included plastic bins with bagged aluminum cans, one lead-acid battery contained in a plastic tote, fluorescent light bulbs, a partially burned refrigerator, a chest freezer, and 5-gallon plastic buckets labeled as latex paint. The majority of the florescent bulbs had been pulled out and broken against the south faces of the northern row of shipping containers as shown in Photo 5.2-3. The paint buckets were not in secondary containers, and one of the buckets had spilled at the northwestern edge of the gravel pad, as shown in Photo 5.2-4. A stain in the soil from the spilled paint bucket extended 6 to 8 feet down the gravel embankment toward the western swale.

Stained soil was observed at the marine header, broken florescent lighting tubes and spilled paint were observed on the gravel storage pad, and burned debris and welding rods were observed in the drainage swale. Limited sampling and laboratory analyses suggest that the staining at the marine header is confined to the soil surface. The limited sampling and analyses also suggest that potential mercury in the florescent tubes or RCRA metals in the welding rods had not leached into the subsurface soil. There is potential for contaminants to be released from materials stored on site. Proper handling and disposal of the existing and future scrap, recyclables, and solid waste is recommended.

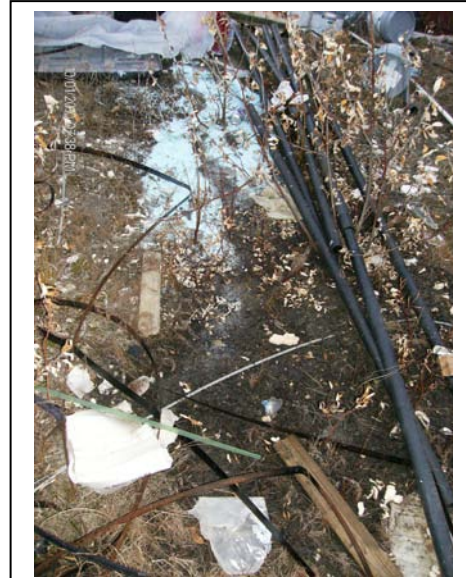
Photograph 5.2-4: Soil staining from spilled paint and debris observed at Barge Landing storage pad, looking east. (10/1/2010)

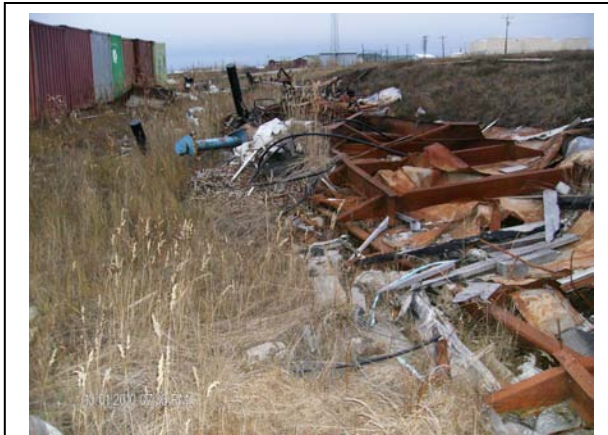
- Burned construction trailers and other debris, including welding rods, were observed in a wet swale along the southwestern side of the gravel storage pad. Results from a soil sample collected beneath the welding rods did not suggest elevated levels of eight metals.
- Broken florescent light tubes were observed on the ground surface. A sample from 6 inches below the ground surface suggests that mercury has not leached into the soil at this location;
- Paint buckets stored outside, including one which had spilled what appeared to be latex paint on the ground surface;
- One horizontal above ground storage tank that did not appear to be cut and cleaned; and
- A surface soil stain at the marine header for a fuel pipeline. The results for a soil sample collected 1 foot beneath the stain suggest that a large fuel release had not occurred at the location of the stain.

Photograph 5.2-5: Looking southeast up the swale on the west side of the Barge Landing storage pad at a burned trailer, debris, and discarded welding rods. (10/1/2010)

We have recommended that additional characterization be performed to investigate the possibility of surface water contamination from the burned debris. We have also recommended more secure storage of materials staged for transportation and removal of the debris located within the swale.

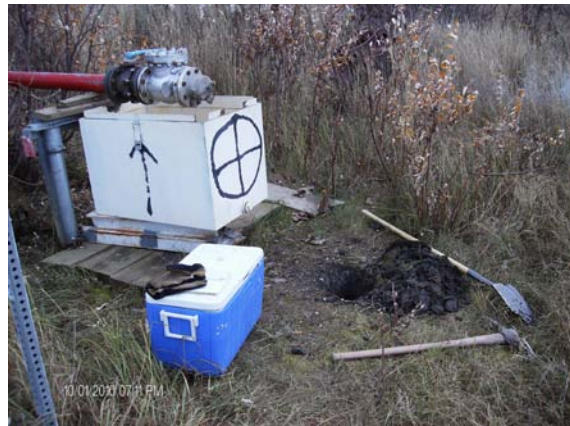
The steel pipeline connected to the marine header appeared to be solid and in good condition. A drip-catch tub beneath the header fittings was missing its lid. The tub contained frozen water and sorbent pads, and had a slight diesel odor. A potentially oily stain roughly 1.5-foot diameter was in soil beyond the north end of the tub. The marine header, drip-catch tub, and stained soil at the end of the tub are shown in Photo 5.2-6.

Photograph 5.2-6: Looking northwest toward the marine header, drip tub, and Sample BLS1 location. (10/1/2010)

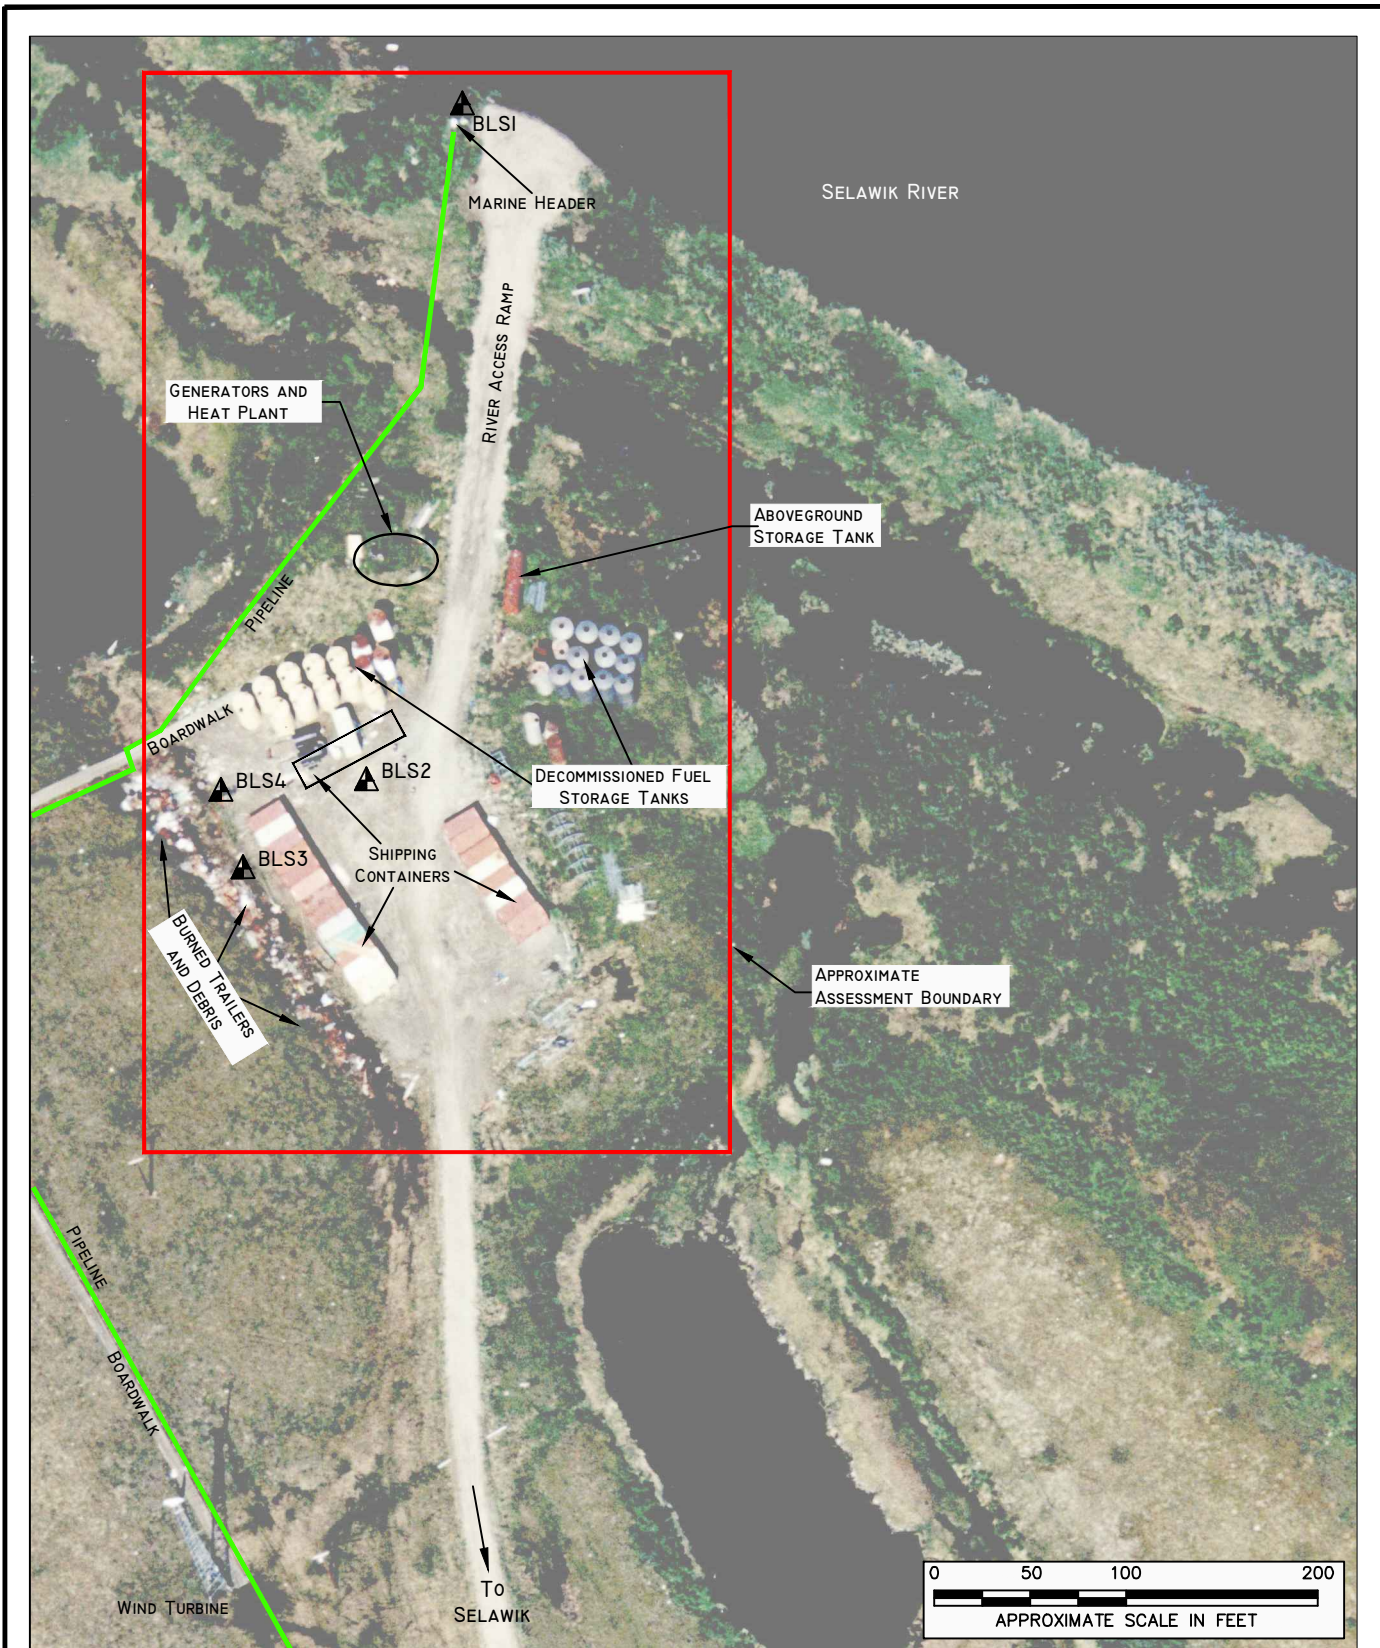
- ▲ BLS1 Approximate location of near-surface Soil Sample BLS1 by Shannon & Wilson, Inc., 2010, with sample results less than the ADEC cleanup levels, or not analyzed (BLS4).

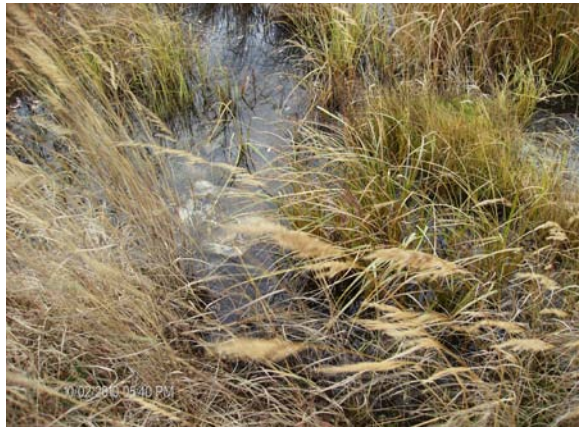
Photograph 6.2-1: Wetland near Sample AVS2 at the Former AVEC Facility. (10/2/2010)

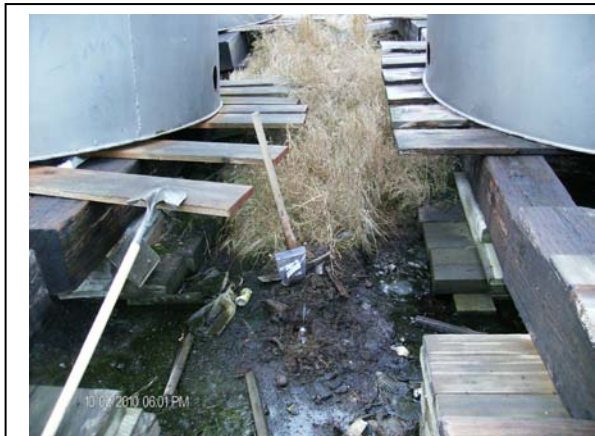
Photograph 6.2-2: Decommissioned ASTs remaining at the Former AVEC Facility, and stained soil at the Sample AVS4 location, looking north. (10/2/2010)

site eight vertically-oriented ASTs remain within a weathered secondary containment area. Staining was observed in the material around the eight ASTs, as shown in Photo 6.2-2. A steel pipe led from the tanks into the ground just south of the existing containment area at the time of our site visit. There appeared to be light staining of the dark peat exposed where the pipe entered the ground. While an additional 14 above ground fuel storage tanks are visible in the 2000 aerial photograph, included as Figure D-11 in Appendix D, little evidence of the northern

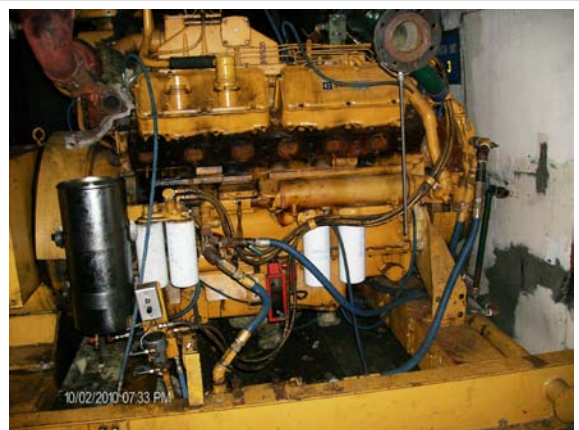
Photograph 6.2-3: One of two diesel engines for electrical generation in the Butler building at the Former AVEC Facility, looking south. (10/2/2010)

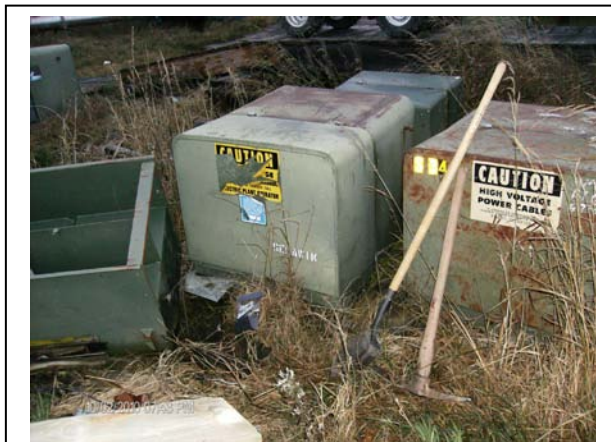
- Five electrical boxes, three which may have been electrical transformers, remain on site and in contact with the ground surface, and potential transformers remain on platforms;

Photograph 6.2-5: Electrical boxes near the southeast corner of the Former AVEC Facility, and the Sample AVS8 location next to the upturned box, looking west-southwest. (10/2/10)

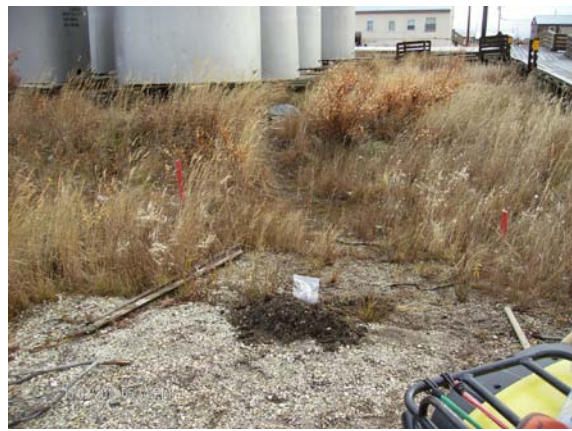
Photograph 6.2-6: Looking south from the Sample AVS1 location, past the remaining decommissioned ASTs, with Tundra Street along the left side of the picture.

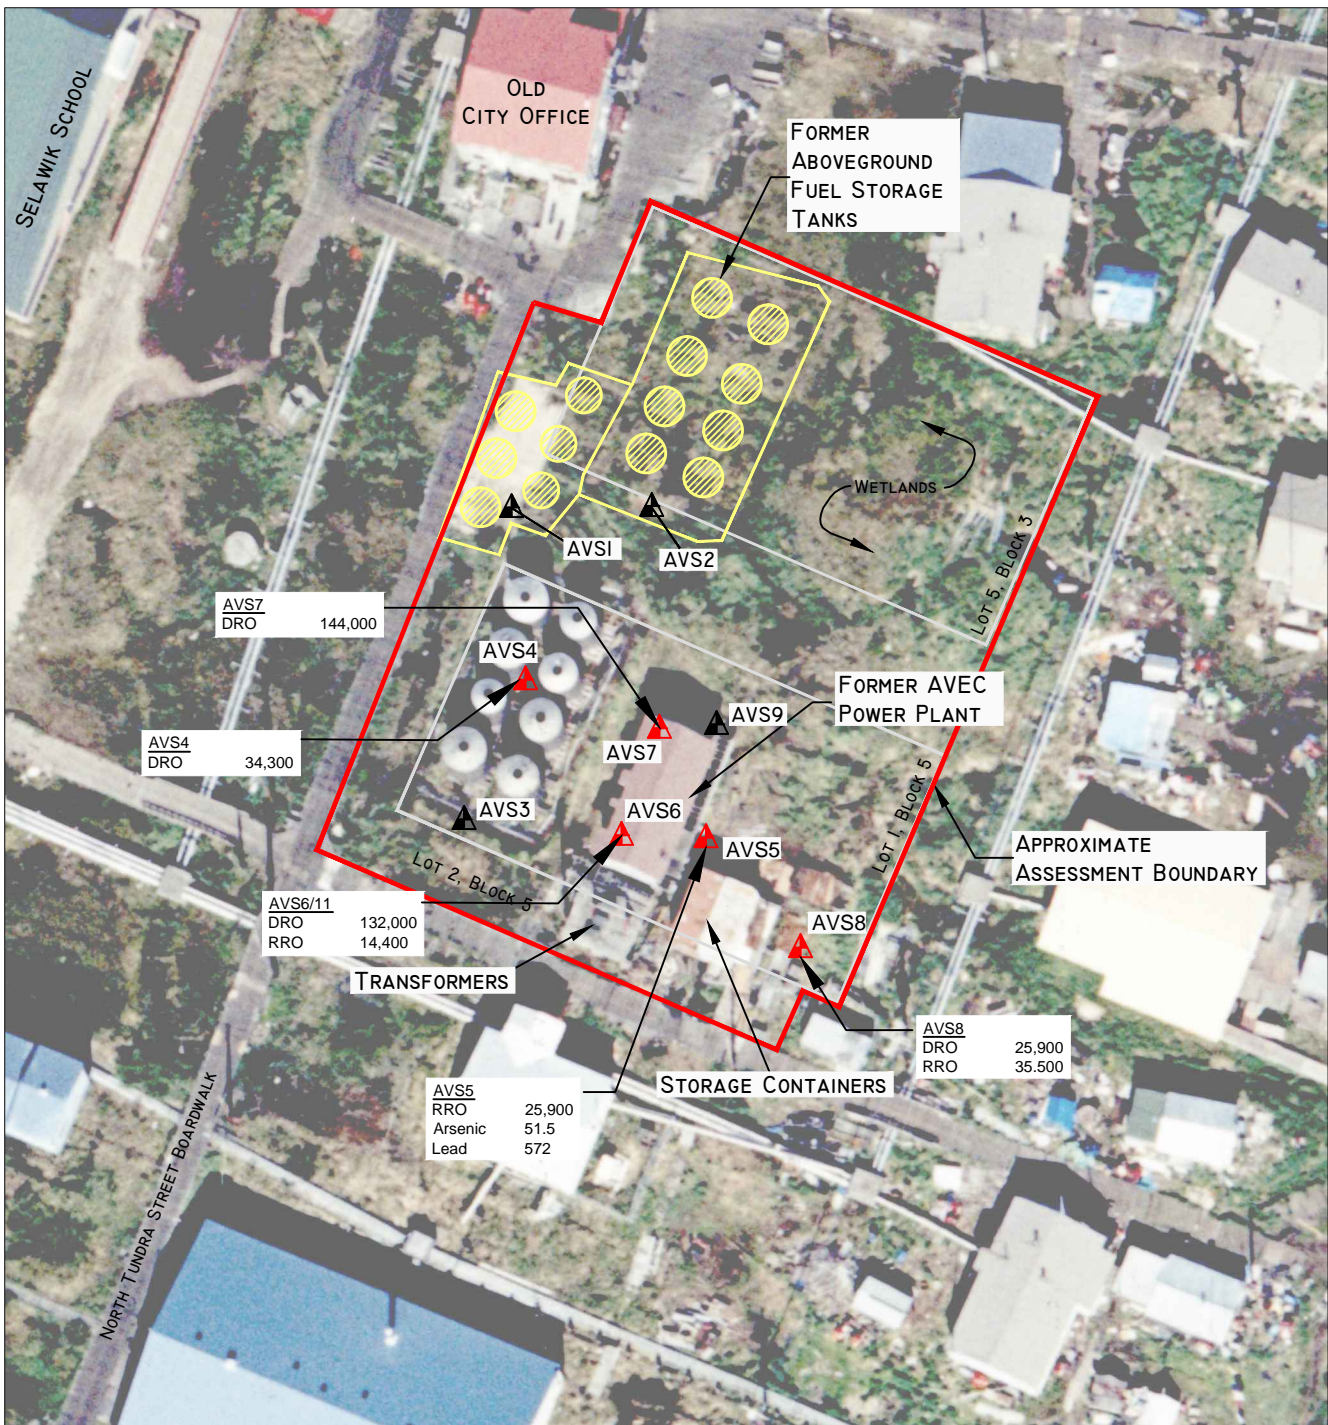
AVS4 Approximate location of near-surface Soil Sample AVS4 by Shannon & Wilson, Inc., 2010, with sample results greater than the ADEC cleanup levels. Concentrations of analytes with exceedences shown in mg/kg. For other analytes see Table 6.2-2

and samples collected at 0.1 feet bgs suggest that exposed soil is contaminated. Organic compounds such as DRO and RRO tend to adsorb tightly to organic soils such as the peat encountered at this site, decreasing the mobility of the contaminants. However, because the soil encountered in the test pits was at or near saturation with water, and standing water was observed within 50 feet of the test pit locations, the contaminants may migrate in pore water and surface water to the on-site wetlands. Fluids remaining in transformers and generator engines have the potential to be released to the environment. Creosote-treated wood has the potential to leach contaminants into the wet soil.

Remedial actions will likely be required for the site due to the presence of DRO and RRO in excess of the DEC maximum allow concentrations. Proper assessment of remedial alternatives is not practicable given the remaining data gaps.

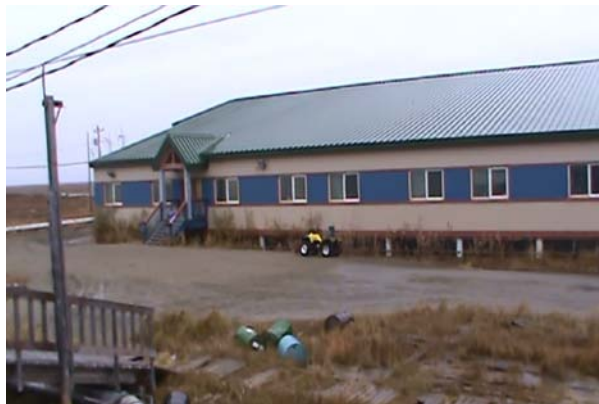
Little surficial evidence remains of the Former School Tank Farm. The Davis-Ramoth School partially overlaps the northern boundary of the former tank farm. The new school is built on steel pilings. A gravel road that links the barge landing road to the rest of town runs over the approximate center of the former tank farm, as shown in Photo 7.2-1. The gravel fill comprising

Photograph 7.2-1: The southwest portion of the Davis-Ramoth School, and the gravel pad/road over the location of the Former School Tank Farm, looking north-northwest from the water treatment plant. The 4-wheeler is near the location of Test Pit SF1. (10/2/2010)

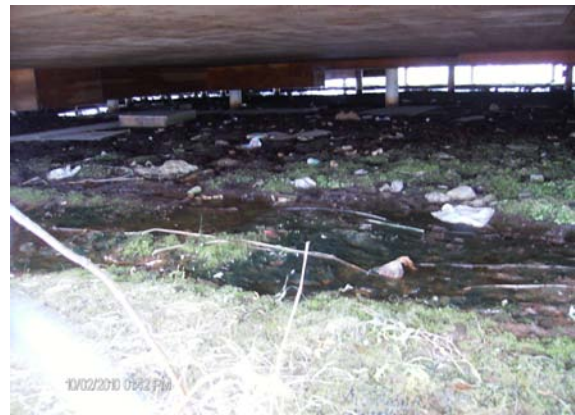
Photograph 7.2-2: Looking northwest beneath the Davis-Ramoth School. Ice and water is visible on the ground surface, which appears to be wet peat with residual tundra vegetation. (10/2/2010)

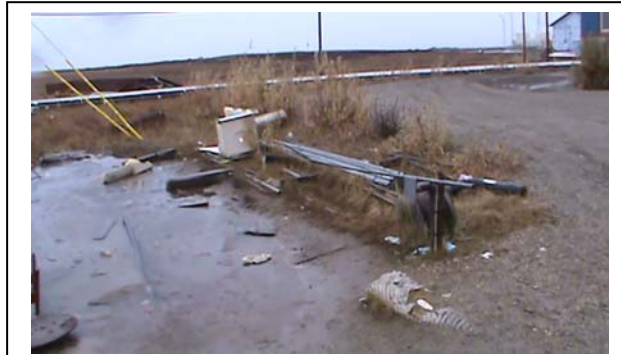
Photograph 7.2-3: Area of ponded water and ice with petroleum sheen and steel piping at location of former AST south of the Former School Tank Farm, looking northwest. The old clinic and the southwest corner of the Davis-Ramoth School are visible in the upper right corner of the photo. (10/2/2010)

We have recommended that additional characterization be performed to investigate to surface water exposure pathway.

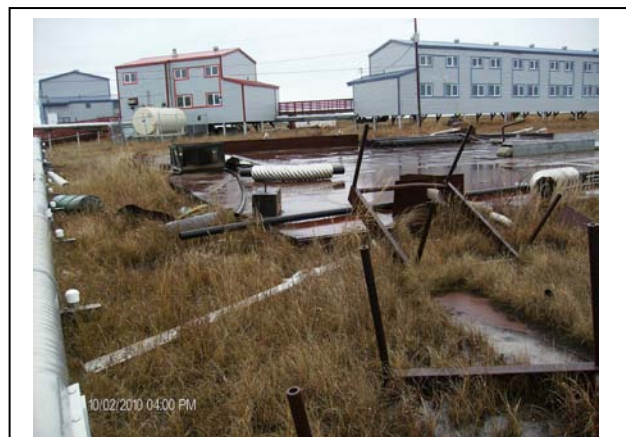
The sheet steel surface of the Storage Pad was mostly unoccupied, with some piping, construction debris and scrap stored on it, as shown in Photo 7.2-4. A variety of items were on the tundra around the edges of the pad, including a partially disassembled 4-wheeler, plastic pipe, and plywood, as shown in Photo 7.2-5. Five 55-gallon drums were in the wetland off the edge of the pad. The drums were frozen in place, making it difficult to determine if they contained fluids. One drum had an intact label for Vantherm; VanWaters &

Photograph 7.2-4: Looking south-southwest across the Storage Pad, with piping, construction debris, a drum, and scrap visible. (10/2/2010)

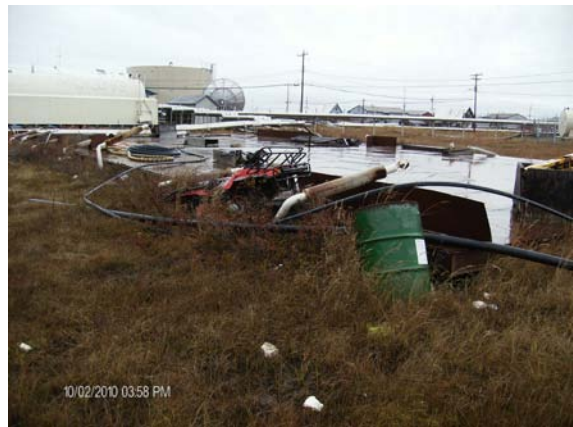
Photograph 7.2-5: Looking southeast at the steel Storage Pad with cooling risers, drum and 4-wheeler in foreground and a fuel tank and water tank in background. (10/2/2010)

Field observations at the steel Storage Pad platform suggest that there is potential for contaminants to have been release from the pad. Significant areas of distressed vegetation were not observed in the surrounding wetland. Neither soil, sediment, nor water sampling were performed during this investigation.

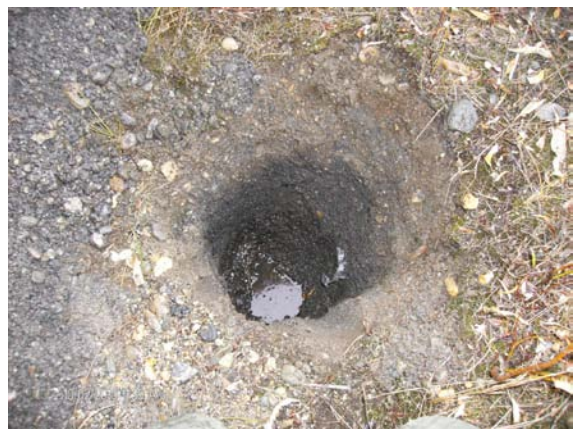
- Test Pit SF2 was located west of Test Pit SF1. Water began entering the test pit at approximately 0.7 feet bgs and clear polyethylene sheeting was encountered at approximately 1.4 feet bgs. The plastic was not perforated, and the fuel odor was noted

Photograph 7.2-6: Former School Tank Farm Test Pit SF1 with staining, oily water entry at the base, and polyethylene sheeting visible in the right hand side of the test pit. (10/2/2010)

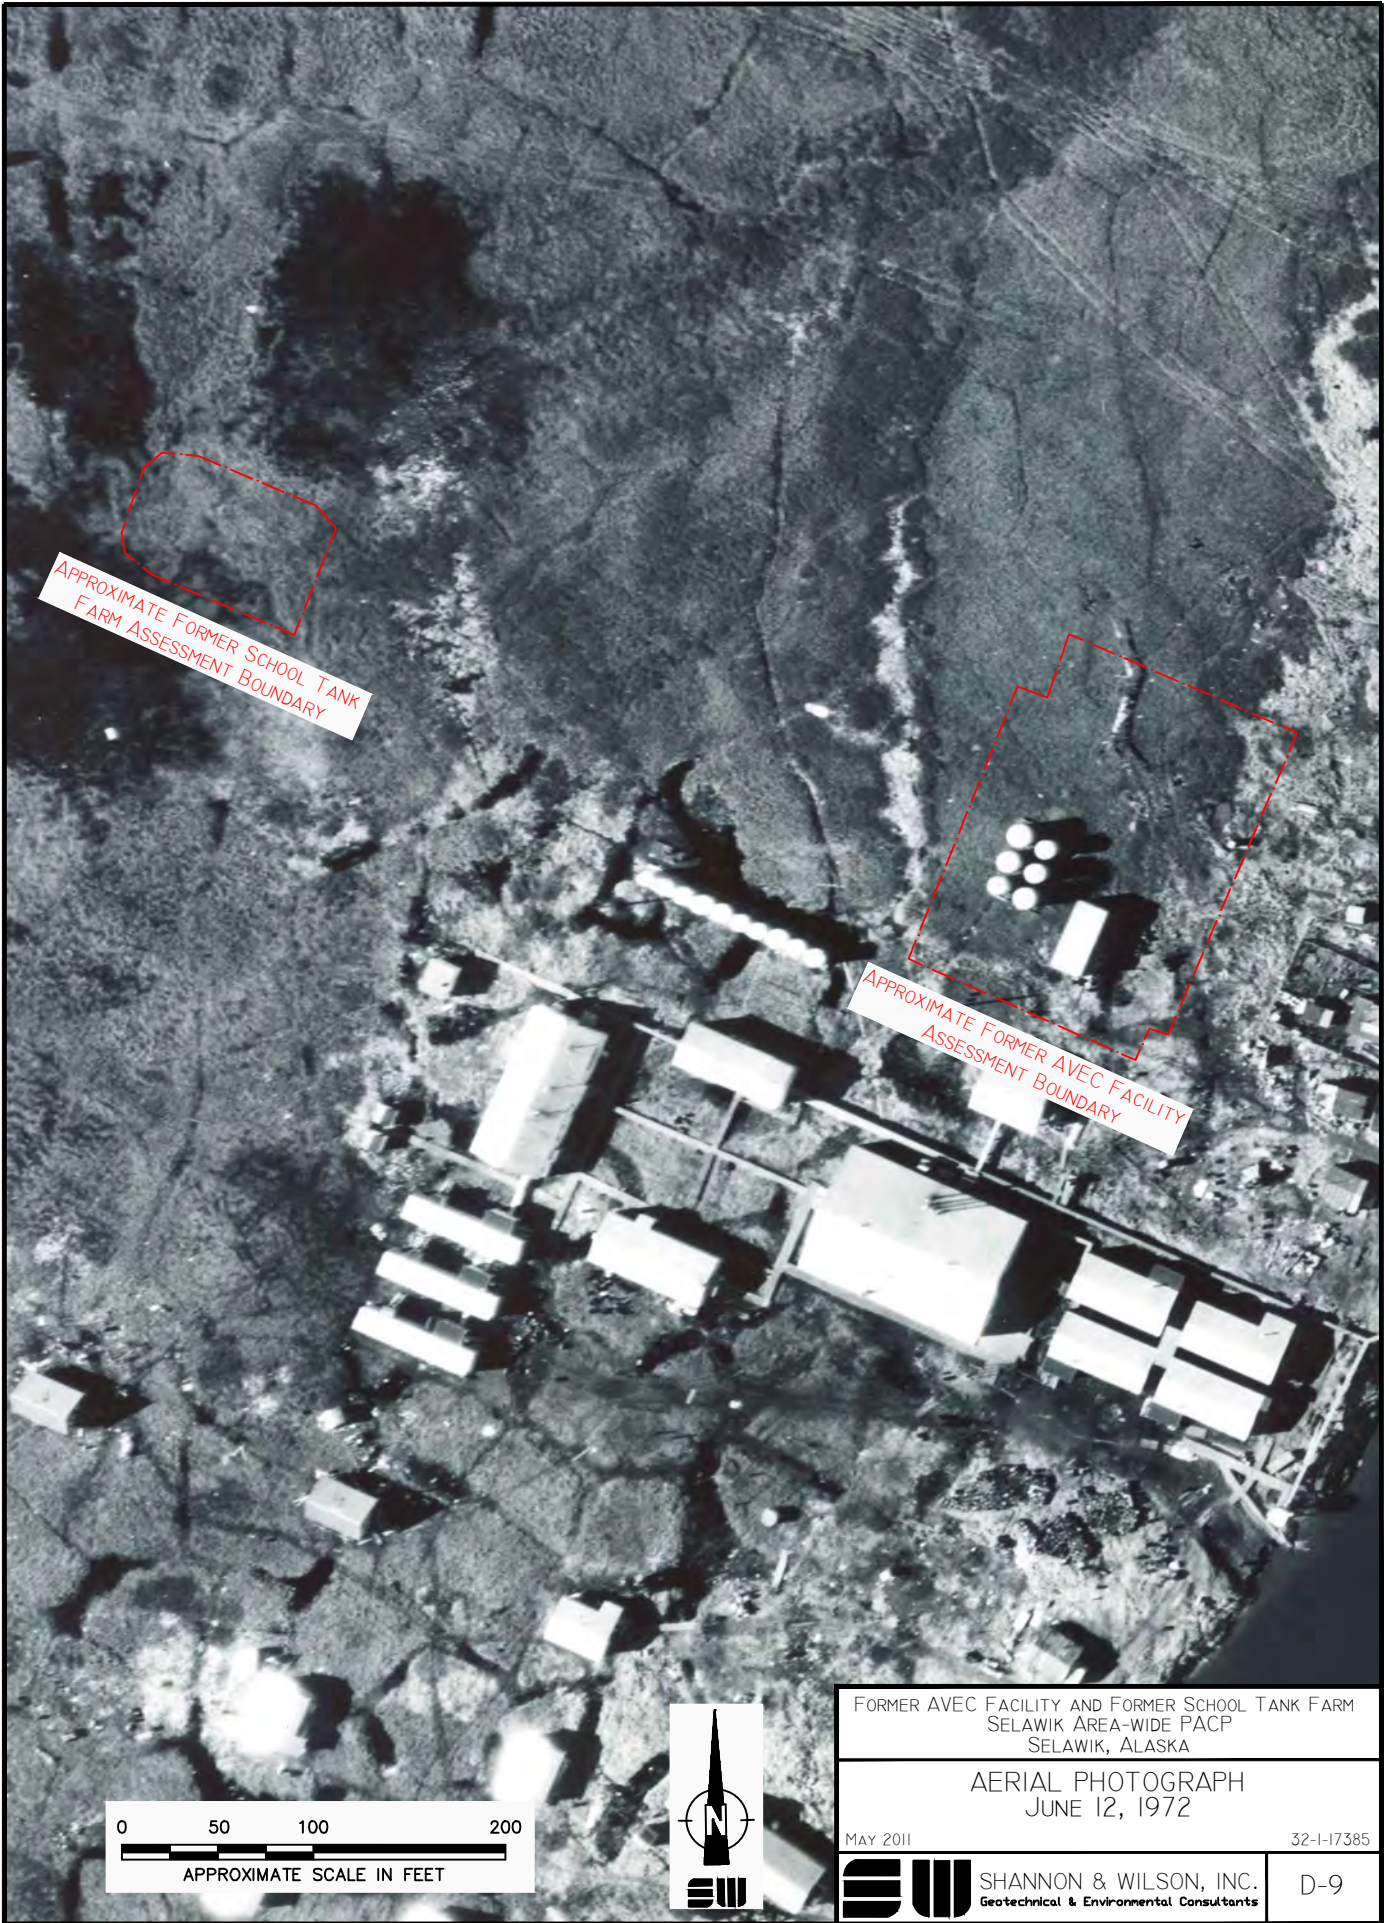
FORMER AVEC FACILITY AND FORMER SCHOOL TANK FARM
SELAWIK AREA-WIDE PACP
SELAWIK, ALASKA
AERIAL PHOTOGRAPH
JUNE 12, 1972
MAY 2011 32-I-17385
SHANNON & WILSON, INC.
Geotechnical & Environmental Consultants D-9

APPROXIMATE FORMER SCHOOL TANK
FARM ASSESSMENT BOUNDARY

APPROXIMATE FORMER AVEC FACILITY
ASSESSMENT BOUNDARY

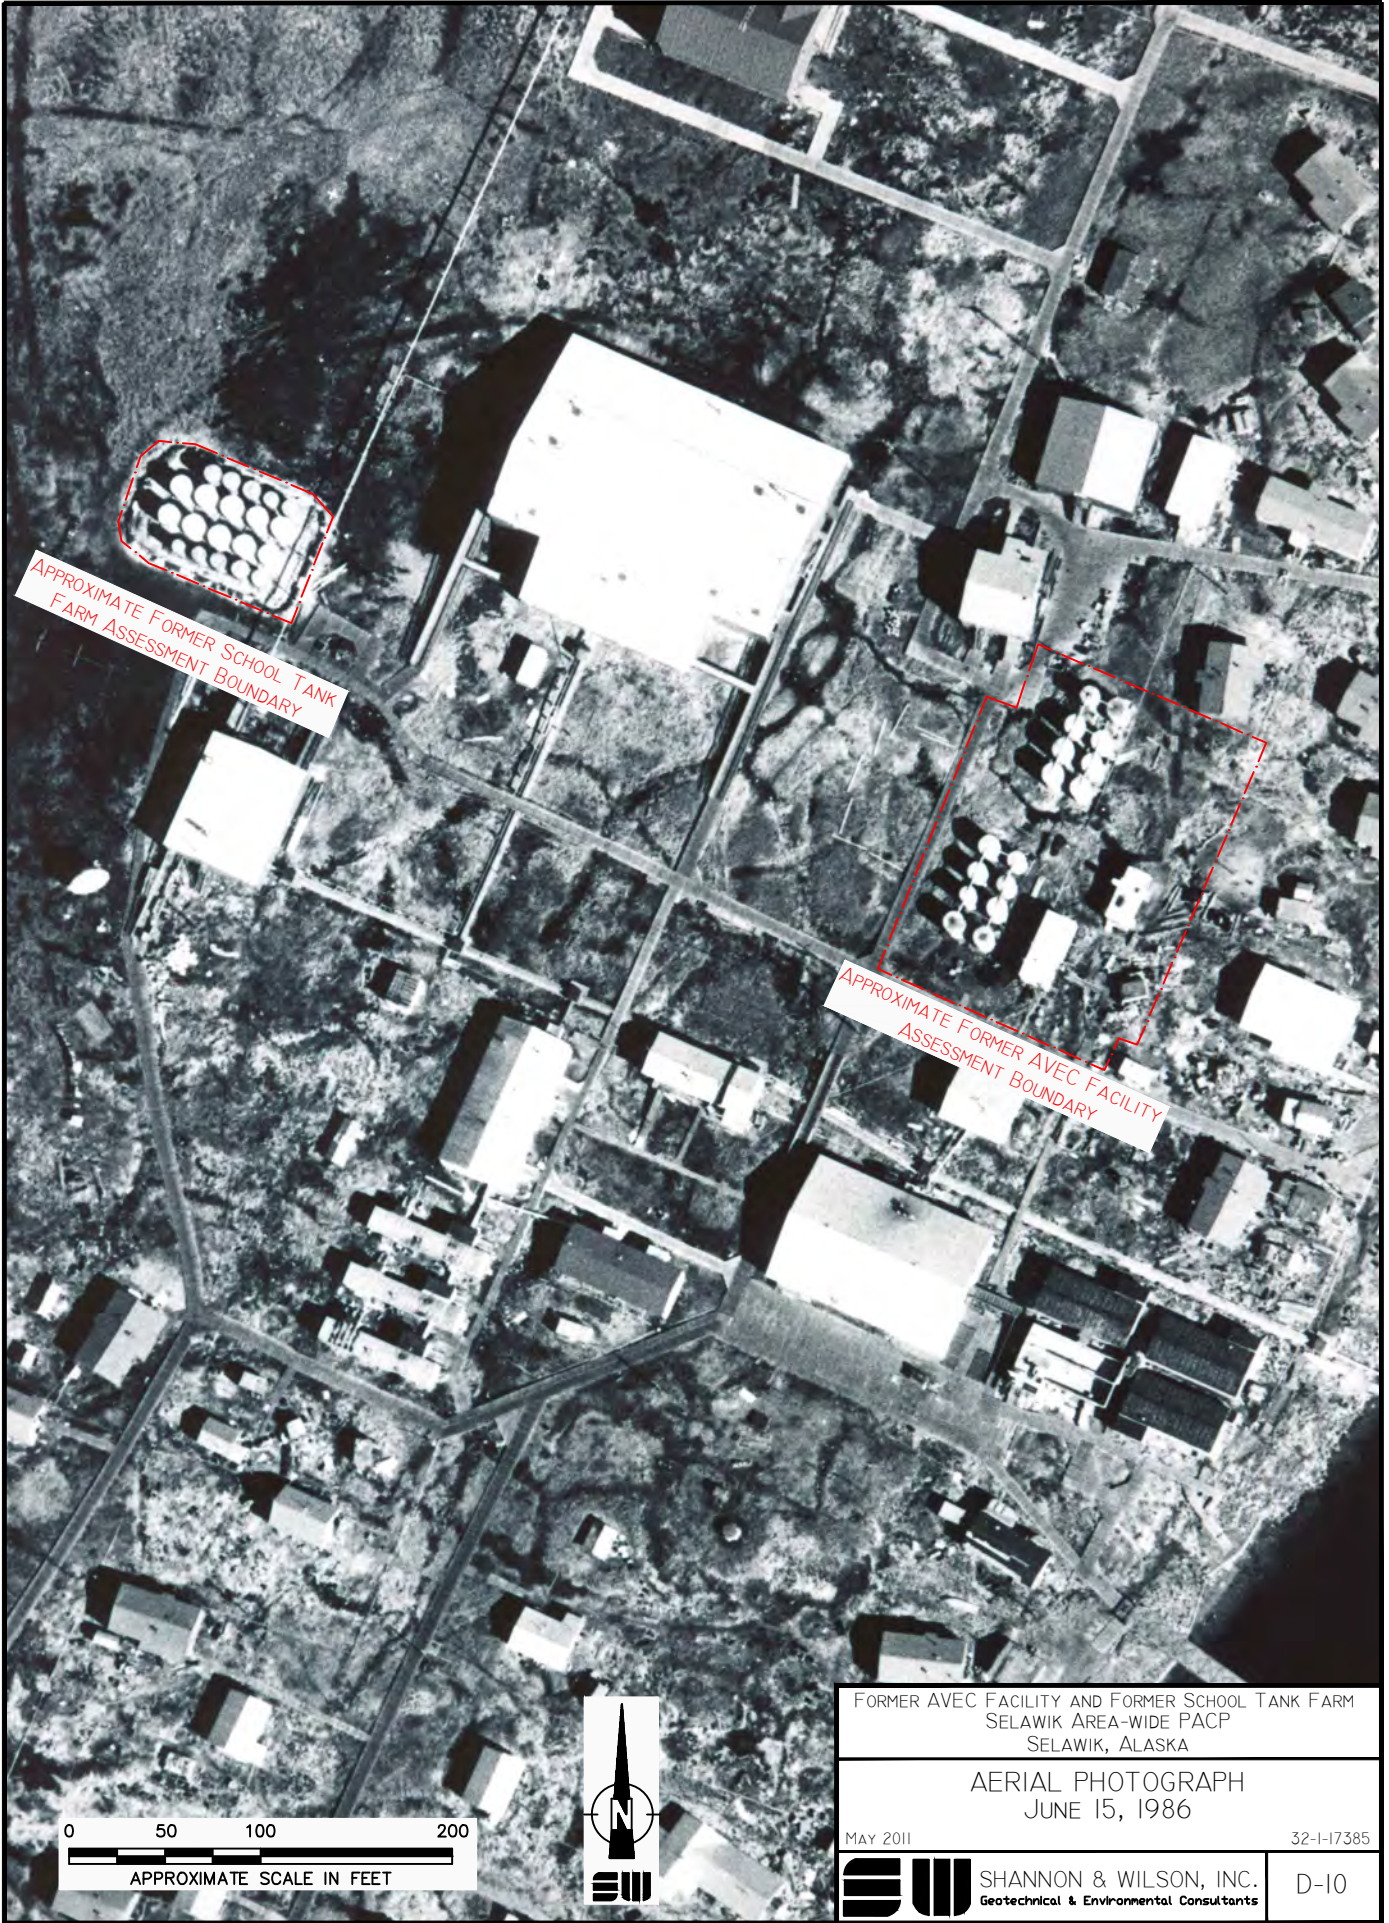
FORMER AVEC FACILITY AND FORMER SCHOOL TANK FARM
SELAWIK AREA-WIDE PACP
SELAWIK, ALASKA
AERIAL PHOTOGRAPH
JUNE 15, 1986
MAY 2011 32-I-17385
SW SHANNON & WILSON, INC.
Geotechnical & Environmental Consultants D-10

APPROXIMATE FORMER SCHOOL TANK
FARM ASSESSMENT BOUNDARY

APPROXIMATE FORMER AVEC FACILITY
ASSESSMENT BOUNDARY
