State of Alaska &gt; DEC &gt; SPAR &gt; CSP &gt; Site Summaries

SALT CHUCK MINE, MILL AREA

Description

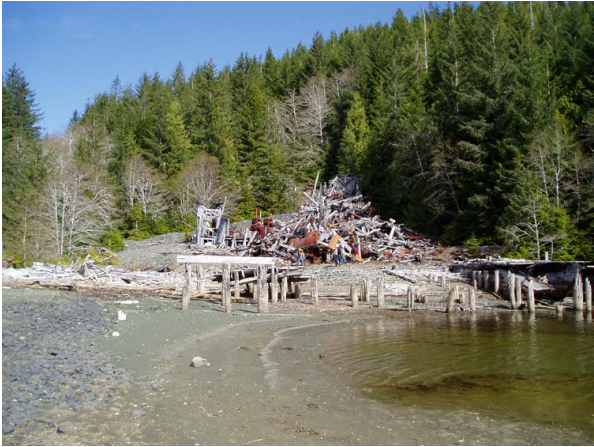
The mill area is shown in May 2009 (above). The mine openings are about a half mile uphill from the mill area. The contaminants from the Salt Chuck Mine include polychlorinated biphenyls (PCBs), copper, lead, mercury, selenium, vanadium, nickel, arsenic, petroleum and polycyclic aromatic hydrocarbons. (DEC photo)

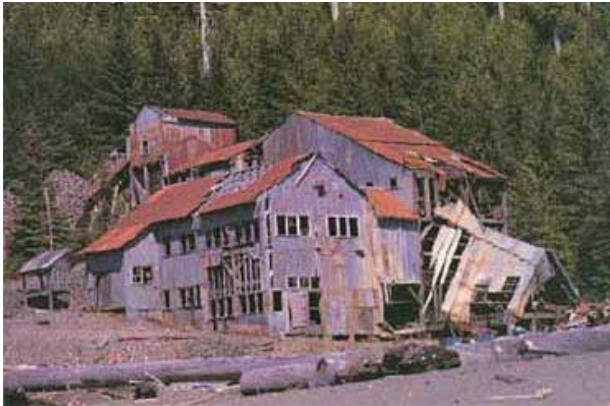
The mill at the Salt Chuck Mine is shown in a photo taken in the mid-1970s (above). (Photo by Patricia Roppel, courtesy of the U.S. Forest Service)

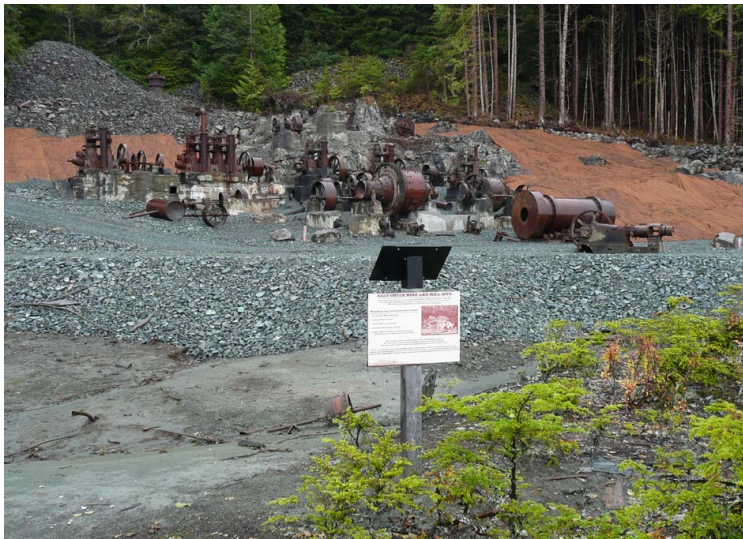
The site's historical mining equipment is now collected in one area, as shown in this October 2011 photo (above). (Photo courtesy of the U.S. Forest Service)

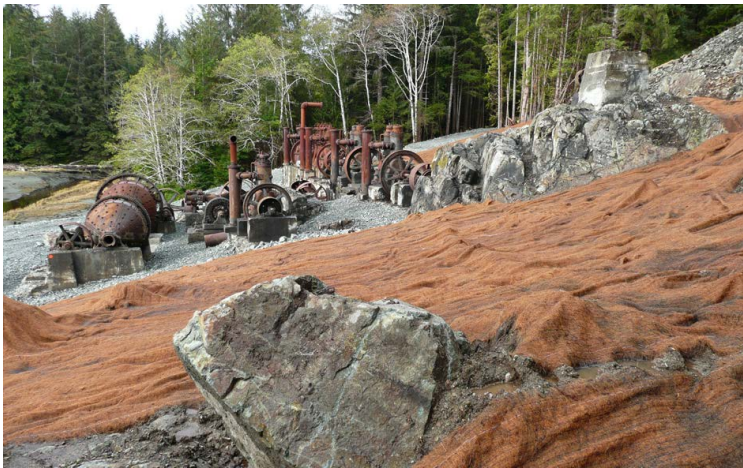
The U.S. Forest Service built a short road to provide access to the site in 2011, removed building debris, drums and tanks, excavated roughly 5,400 cubic yards of petroleum-contaminated soil and metals-contaminated tailings – 8,400 tons of contaminated material, which filled 300 containers averaging 28 tons per load. The material will go to a permitted landfill out of state. The agency set aside the site's historical mining equipment during the excavation, then grouped it in one area, as shown in the photos taken in October 2011 photos (top and bottom). (Photos courtesy of the U.S. Forest Service)

In 2011, the Forest Service used funding from the American Recovery and Reinvestment Act, along with additional funding, to conduct a non-time critical removal action on the uplands. The Forest Service built a short road to provide access to the site, removed building debris, drums and tanks, excavated roughly 5,400 cubic yards of petroleum-contaminated soil and metals-contaminated tailings, and disposed of the excavated material in a permitted landfill out of state. The EPA collected soil, sediment, water and biota samples at the site in 2011 and 2012. Those samples will be used in the Remedial Investigation Report and Risk Assessment Report.

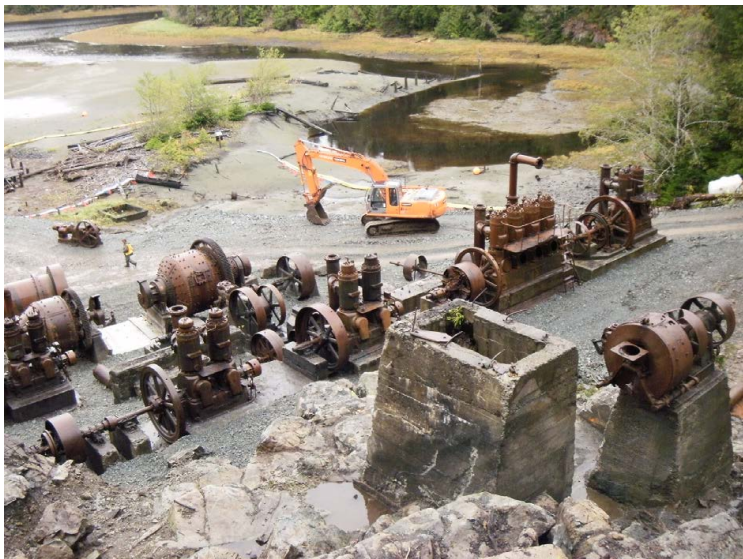
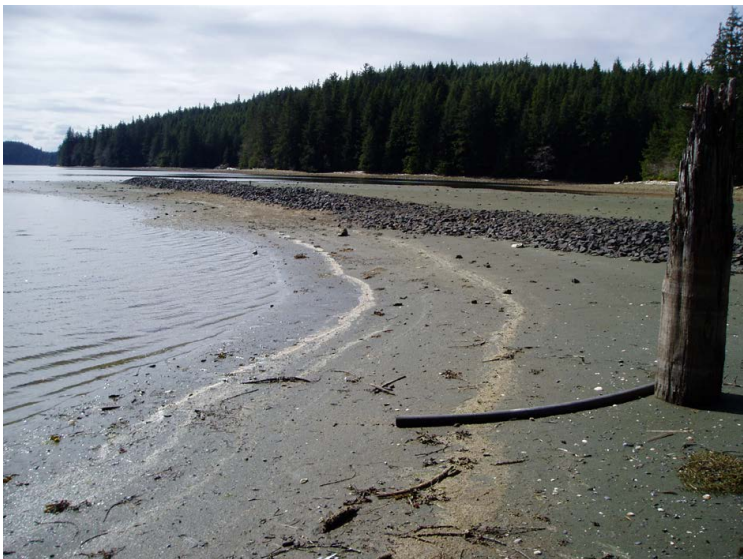
The line of brown rocks and all the sediment on the nearby beach (above ) are metals-contaminated tailings. The beach is near the mill area, on Salt Chuck Bay, and the photo was taken in May 2009. The main contaminants of concern in the intertidal area are copper, arsenic and vanadium. (DEC photo)

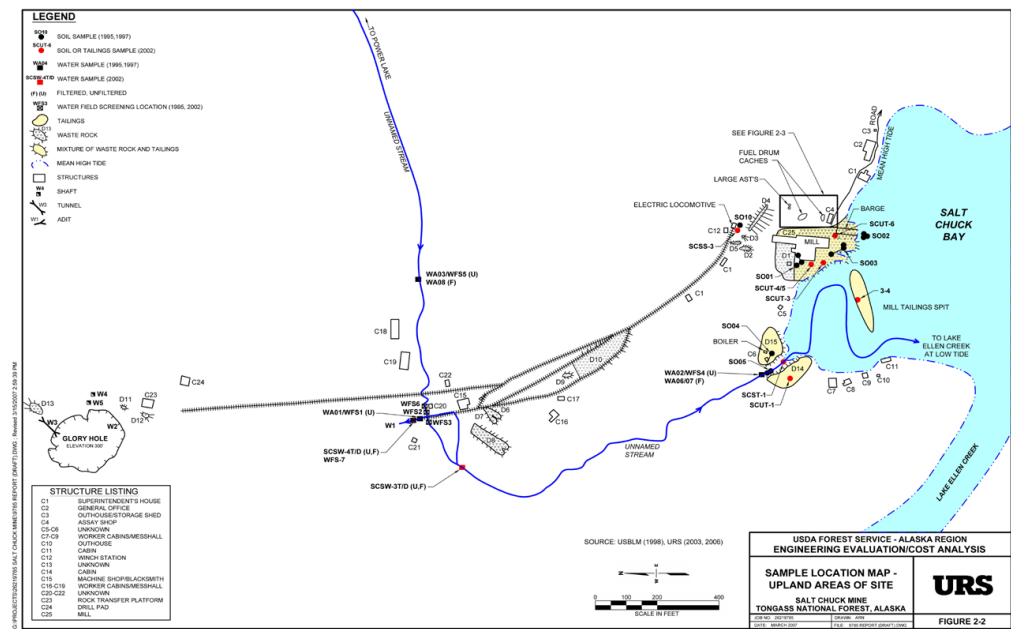
The layout of the Salt Chuck Mine is shown on this March 2007 map. (Map courtesy of the U.S. Forest Service)

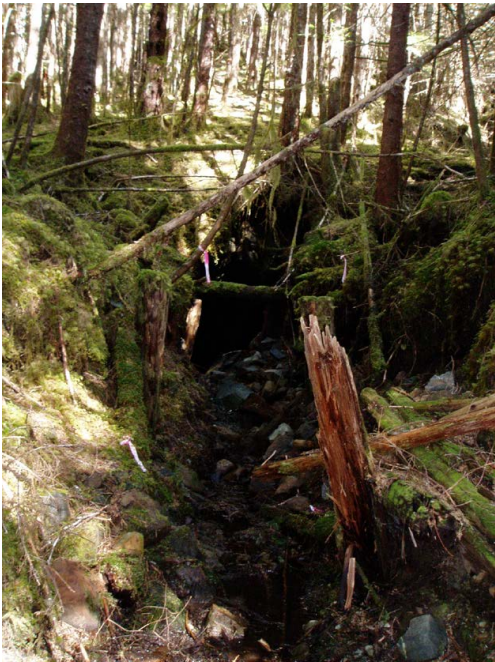
One of the main adits to the mine is shown in this May 2009 photo (above); the adit looked similar in the summer of 2011. An adit is a nearly horizontal passage from the surface to a mine. (DEC photo)
