**Subject: North Pole Gravel Pond and Slough Sampling
(NTP 18400211038)**

The purpose of this report is to document the results of sulfolane surface water, groundwater and sediment sampling performed in June 2013 at several water bodies located within or near the sulfolane-affected area in North Pole, Alaska. All of the sample locations are within the Fairbanks North Star Borough (FNSB).

GRAVEL PITS & BADGER SLOUGH
 GRAVEL PITS SURFACE WATER AND GRAVEL
 SAMPLING REPORT
 North Pole, Alaska

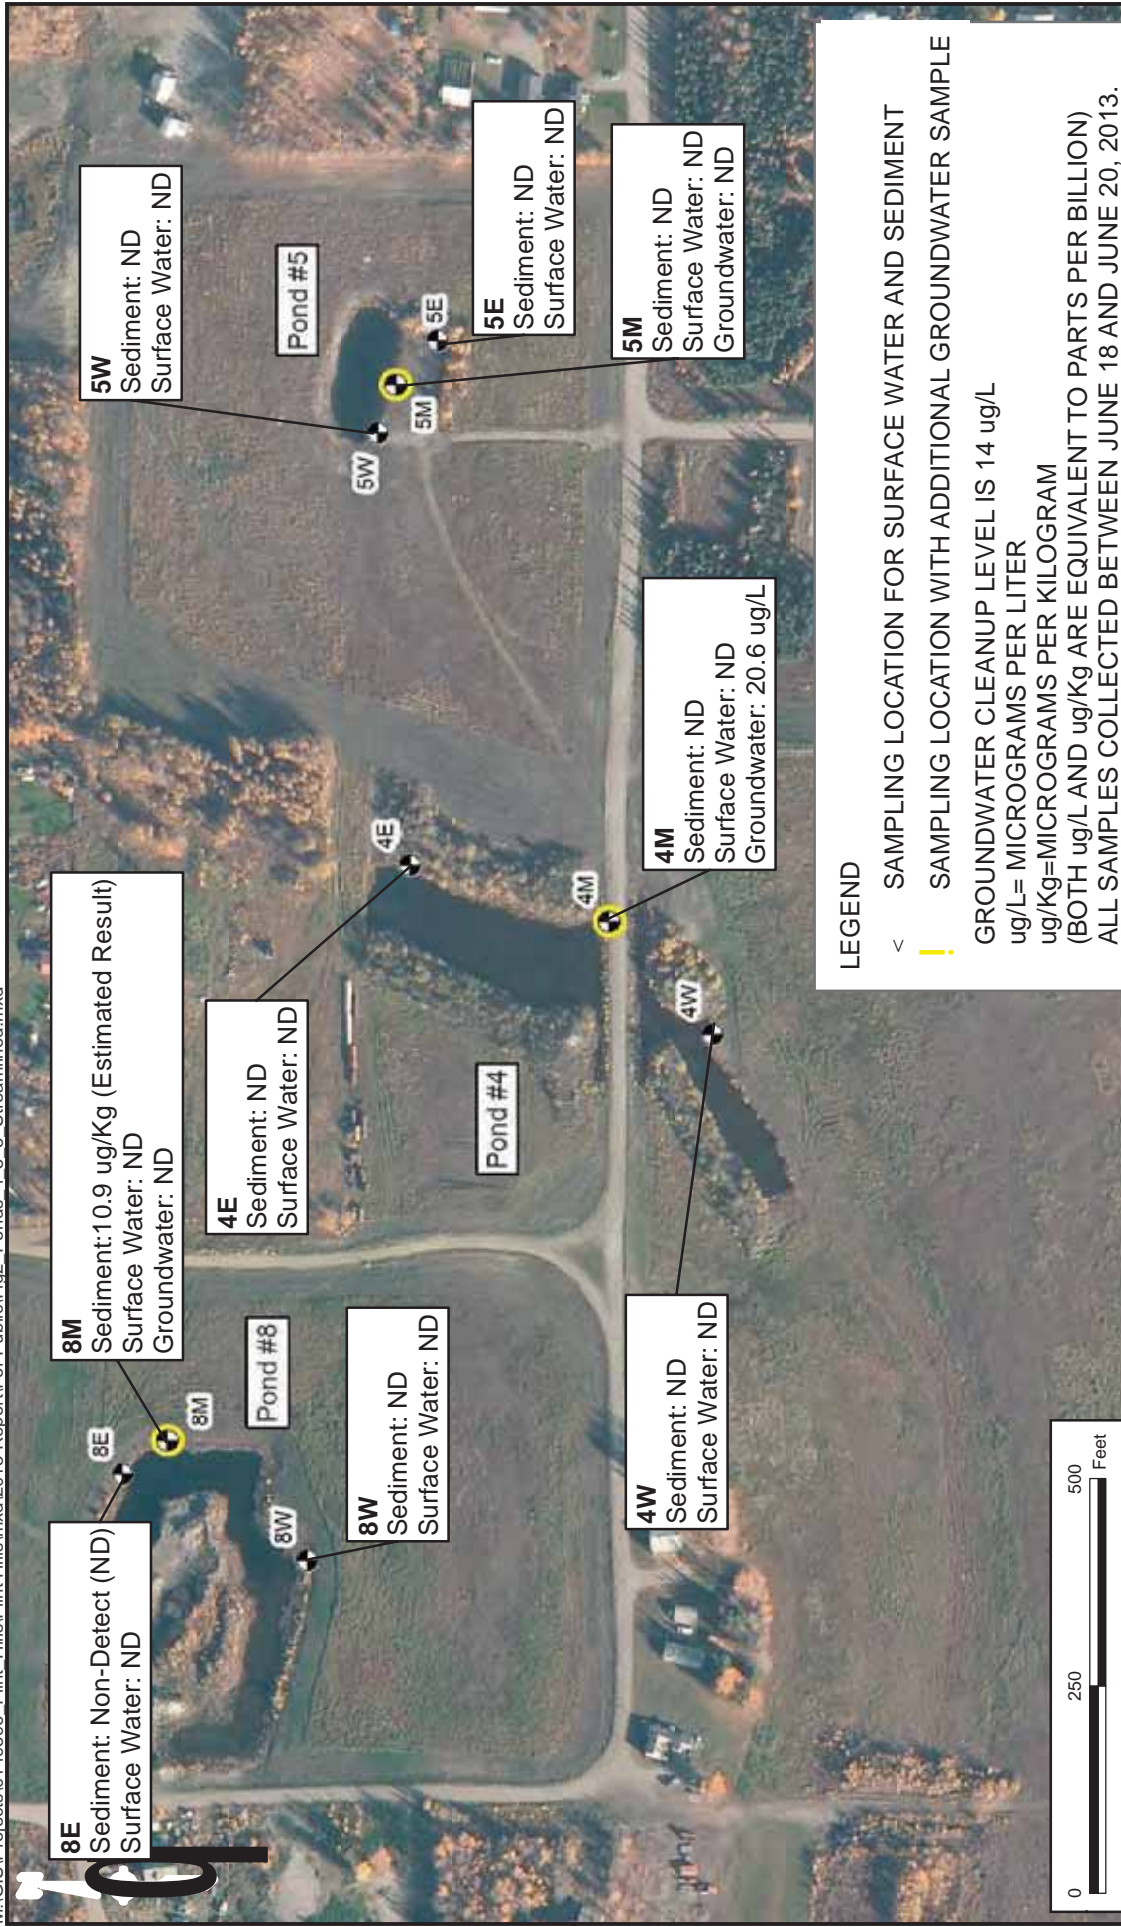
DATE: SEP. 2013 CHKD: J.P. DRWN: W.C.K. PROJ. No.: 0149896 825 W. 8th Ave., Anchorage, AK 99501, (907) 258-4880	PONDS #4, #5, AND #8 GRAVEL PITS & BADGER SLOUGH REPORT FOR THE ALASKA DEPARTMENT OF ENVIRONMENTAL CONSERVATION North Pole, Alaska	FIGURE 2
---	--	--	------------------------

At each pond, surface water and sediment samples were collected from three locations (typically east, middle and west) along the shoreline closest to the refinery. However, at Pond #10, only one surface water and sediment sample were collected, because this pond is located outside of the mapped sulfolane plume (Figure 1). One groundwater sample was collected at the middle location of each pond. Individual pond sampling locations are shown in Figures 2 through 6.

The 2013 data suggest that high groundwater sulfolane concentrations are not indicative of high sulfolane concentrations in nearby surface water bodies. Ponds #4, #5 and #8 are located in an area of known suprapermafrost sulfolane groundwater concentrations between 200 µg/L and 300 µg/L (based on MW-161A/B), as well as elevated sulfolane concentrations in FHR's previous piezometer sampling (Table 1). However, the June 2013 samples showed only a single groundwater detection of 20.6 µg/L from a shallow pit adjacent to Pond #4 and no surface water detections in these ponds. In comparison, July 2013 sulfolane concentrations in groundwater from MW-161A and B were 226 µg/L and 263 µg/L, respectively. The reason that the June 2013 sulfolane concentrations in surface water and adjacent shallow groundwater samples are significantly lower than sulfolane concentrations in nearby monitoring wells, such as MW-161, is not known and

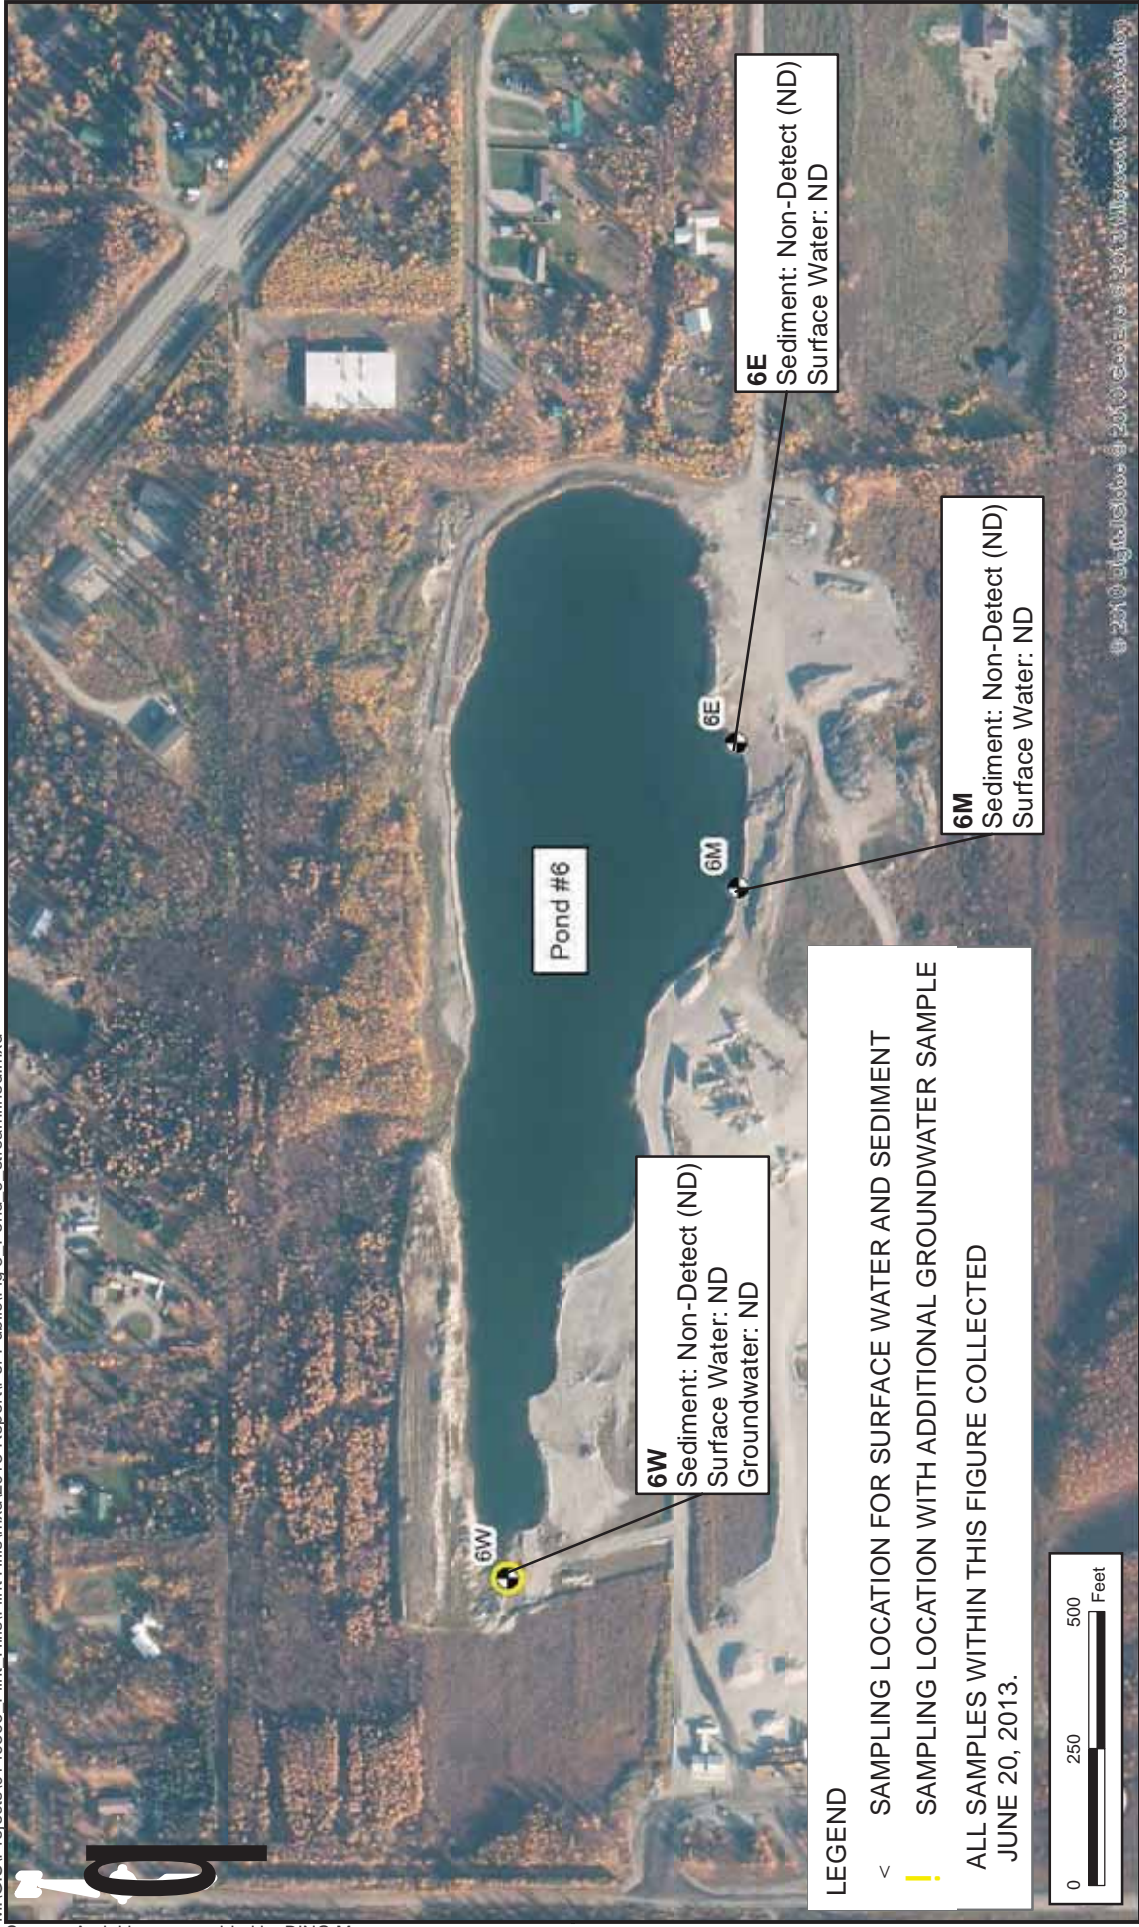
<p>DATE: SEP. 2013 CHKD: J.P. DRWN: W.C.K. PROJ. No.: 0149896 825 W. 8th Ave., Anchorage, AK 99501, (907) 258-4880</p>	<p>POND #6</p> <p>GRAVEL PITS REPORT FOR THE ALASKA DEPARTMENT OF ENVIRONMENTAL CONSERVATION North Pole, Alaska</p>	<p>FIGURE 3</p>
---	--	--	----------------------------

The surface water, groundwater and sediment results do not indicate that active gravel mining operations are impacted by sulfolane. The only pond sampled that is in active use as a gravel pit is Pond #6, and there were no sulfolane detections in any samples from Pond #6. In addition, sulfolane was not detected in previous piezometer and soil sampling performed by FHR at this location (Table 1). The single sulfolane detection in sediment was from Pond #8; which, along with Ponds #4 and #5, has not been used for gravel mining in many years, and there is no intent to resume gravel mining operations in these areas (verbal communication with the property owner).

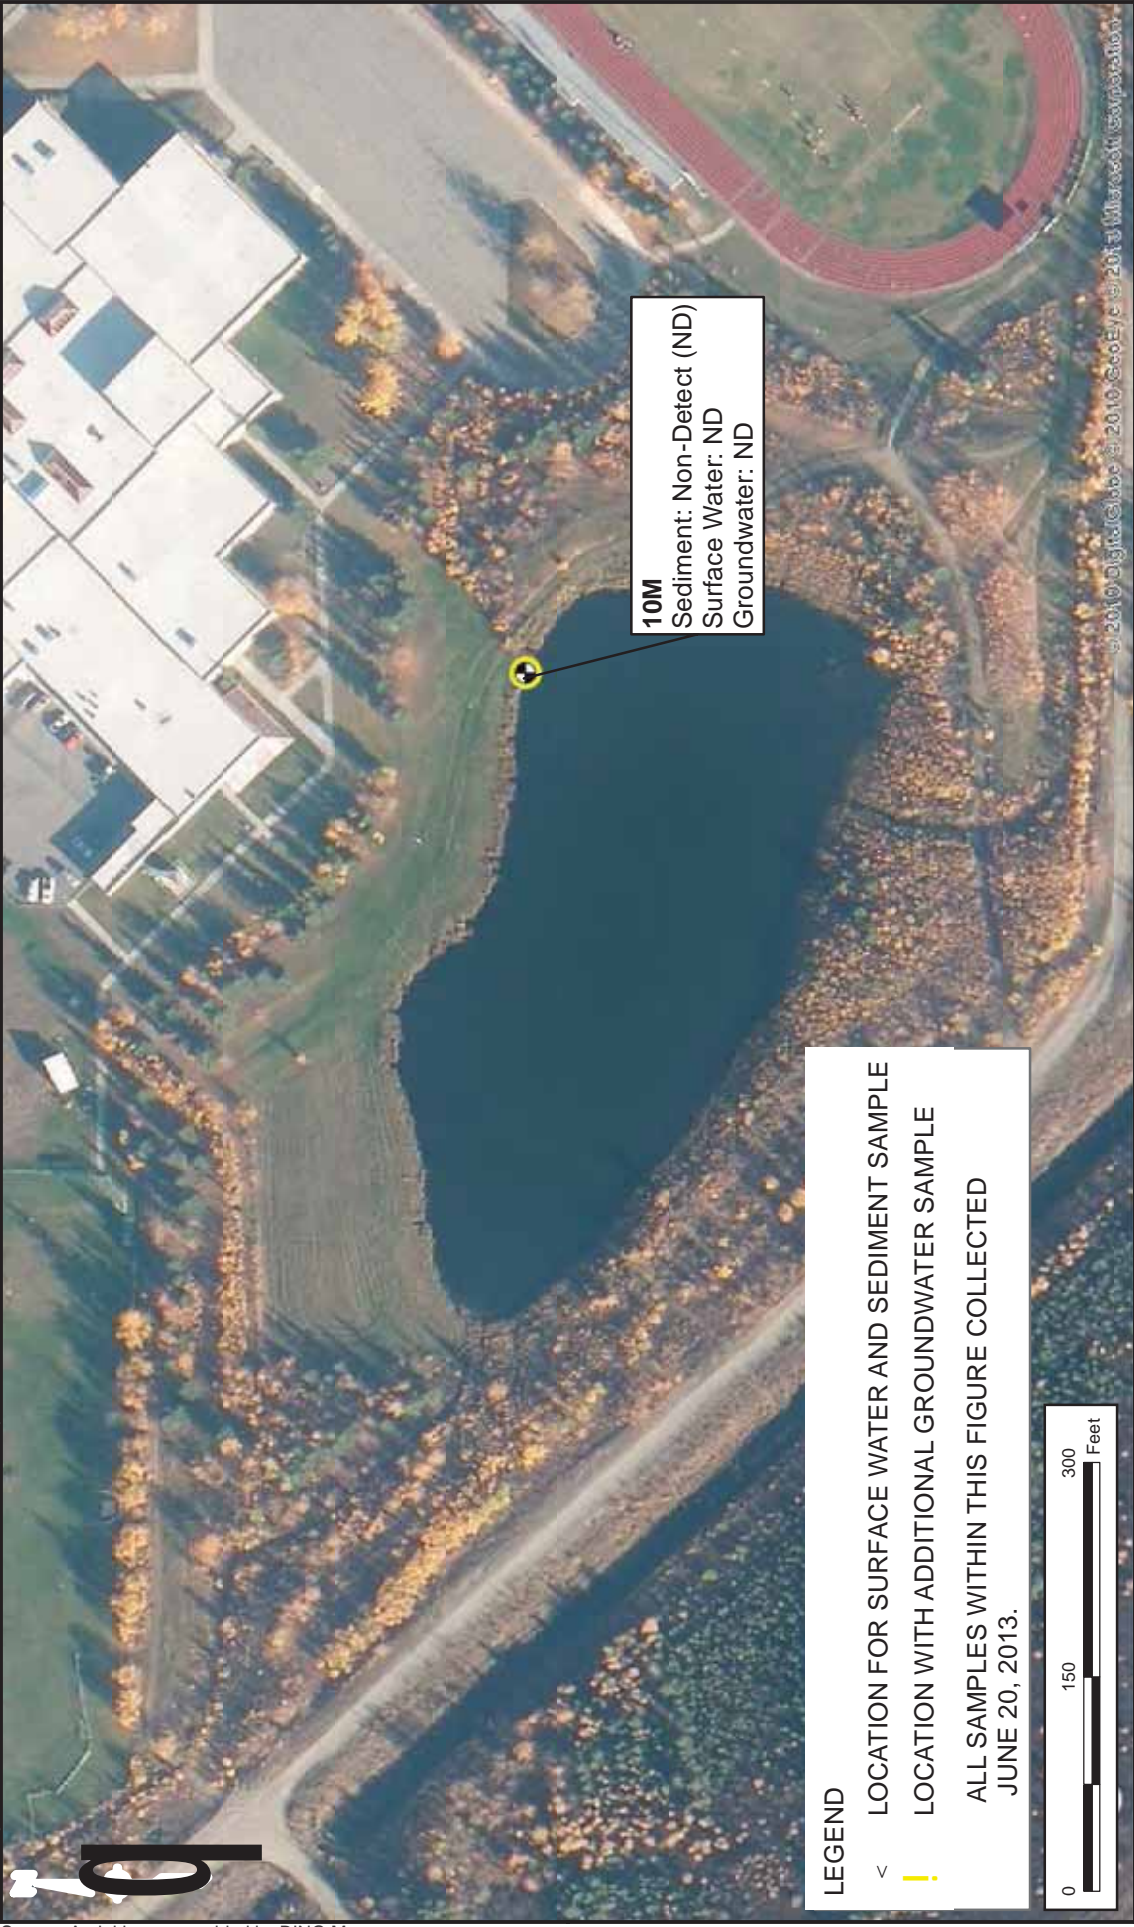
JUNE 2013 SULFOLANE SAMPLE RESULTS
 GRAVEL PITS
 REPORT FOR THE ALASKA DEPARTMENT OF ENVIRONMENTAL CONSERVATION
 North Pole, Alaska

10M
 Sediment: Non-Detect (ND)
 Surface Water: ND
 Groundwater: ND

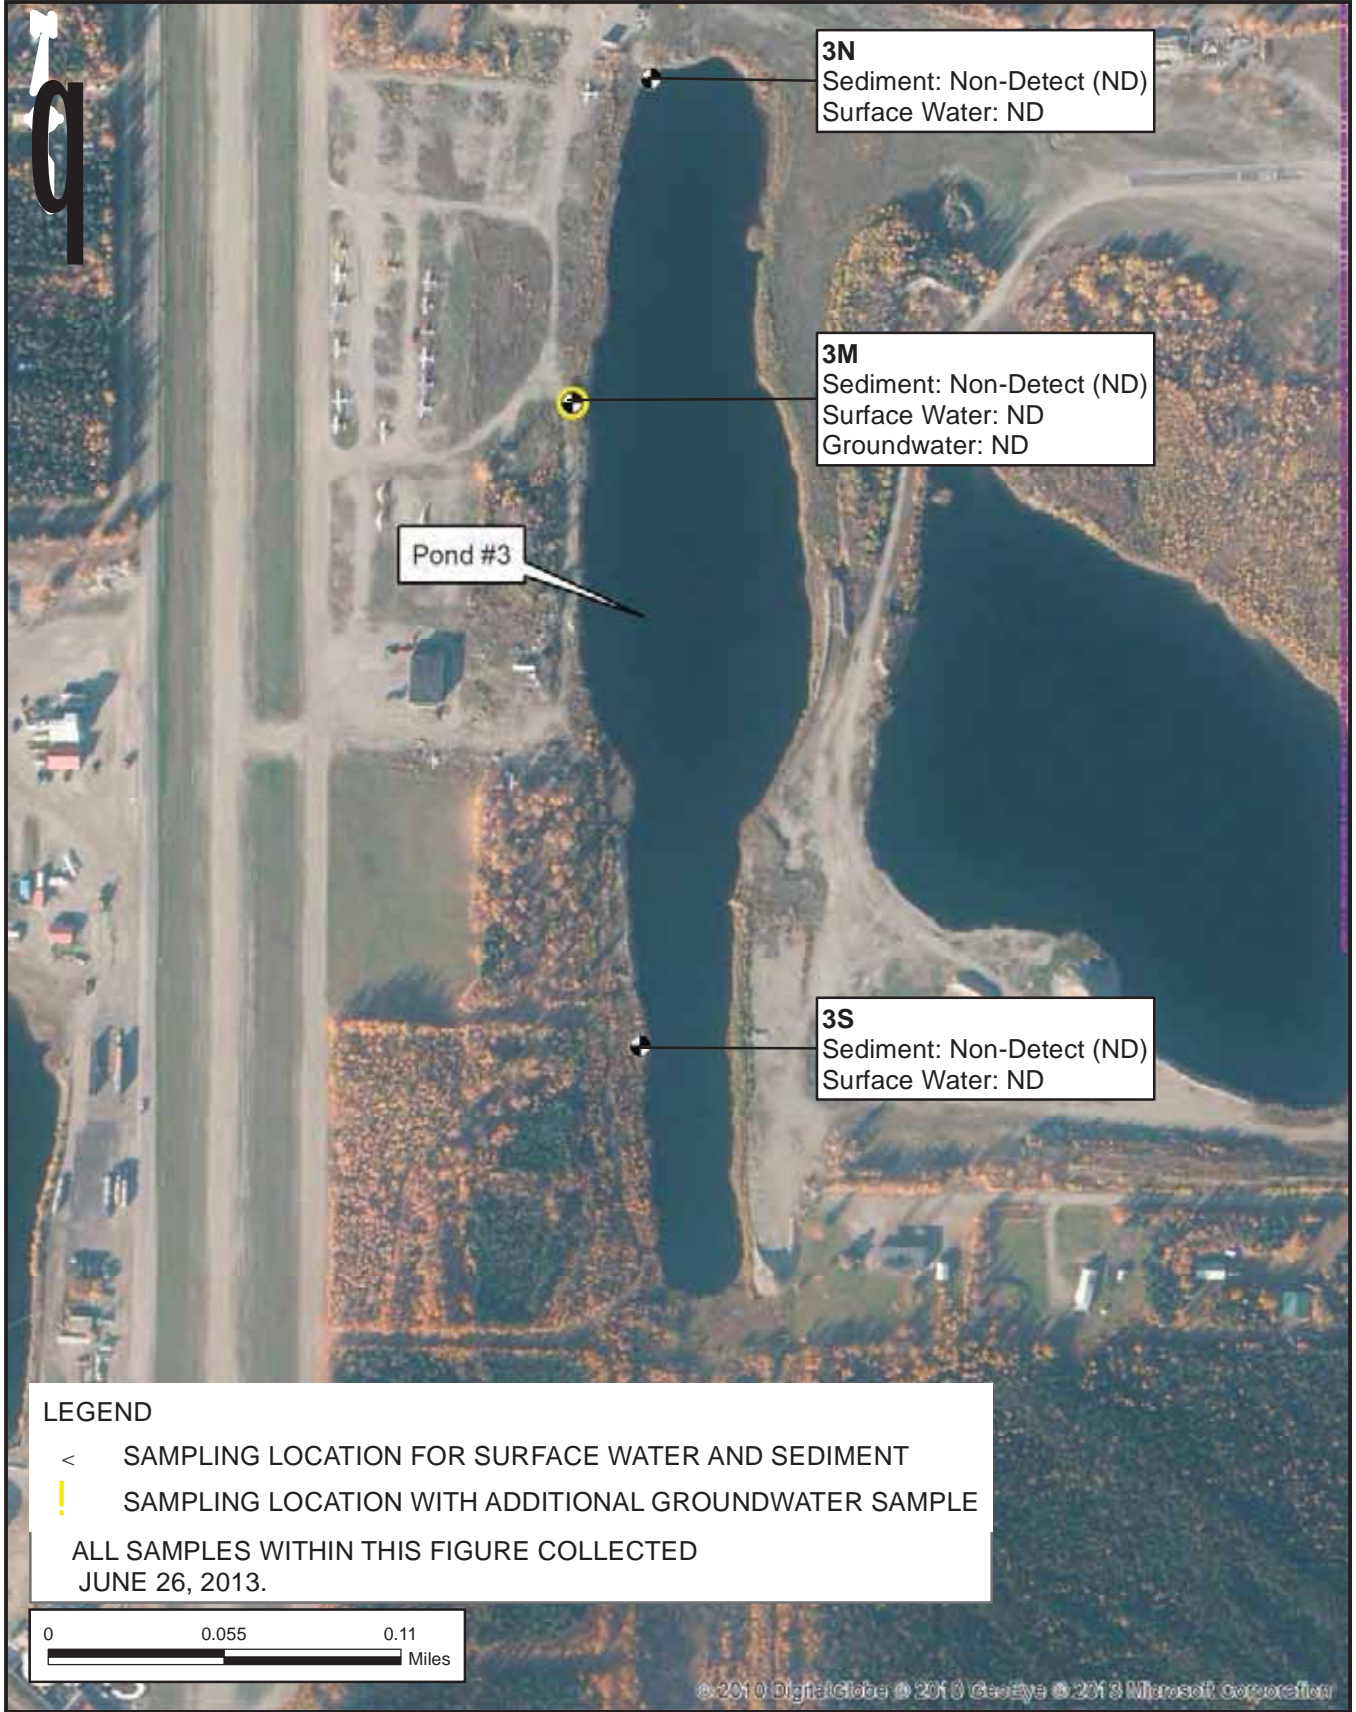
5

POND #3

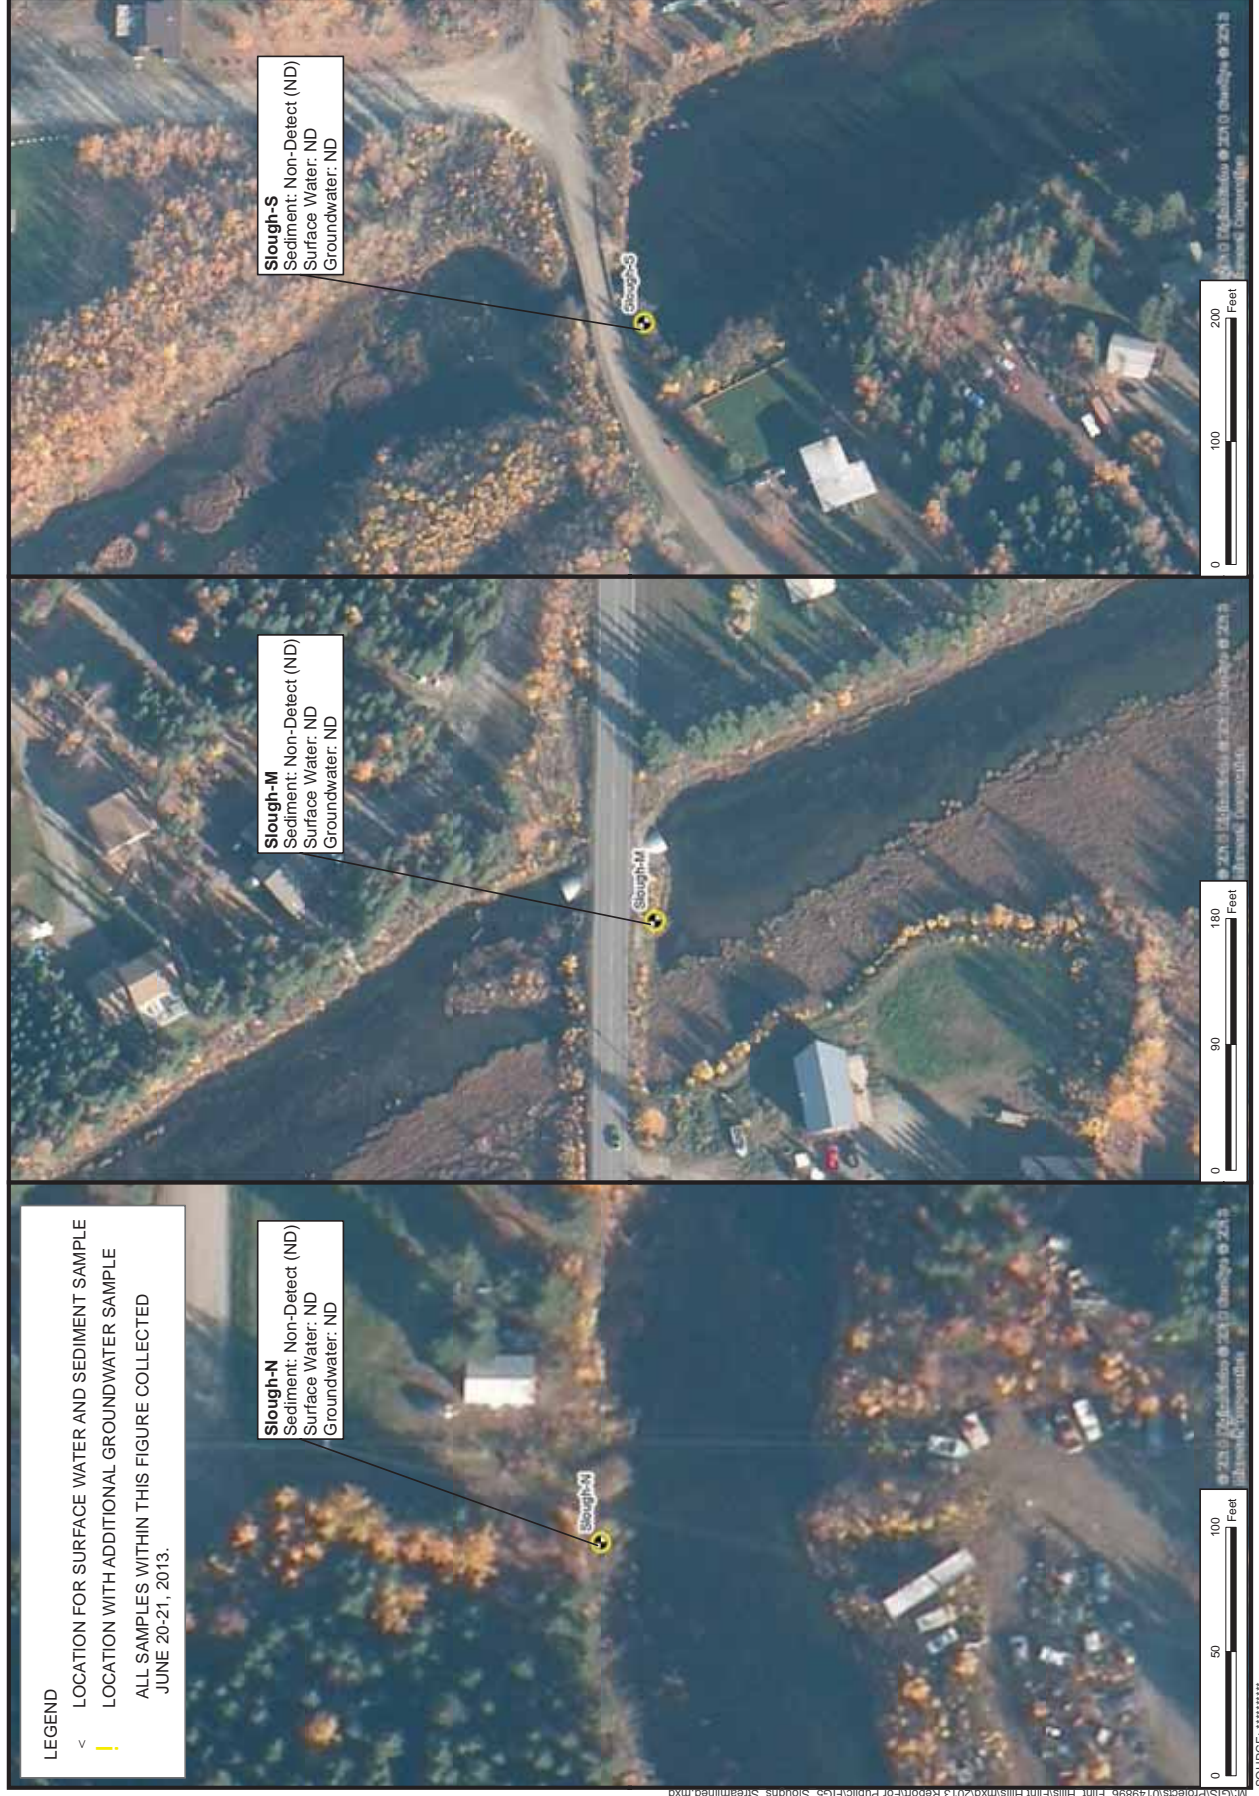
SLOUGHS N, M, AND S

Three locations along the Badger Slough were sampled: a north, middle and south location. One surface water, sediment and groundwater sample was collected at each slough location. An additional surface water sample was collected from each location for stable isotope analysis to support ongoing work by the University of Alaska, Fairbanks (UAF). This work is not discussed in this report.

The samples from Badger Slough show no indication of sulfolane impact to the slough surface water or sediment, nor to shallow groundwater adjacent to the slough.
