# How to conduct a site inspection and review a technical report

Erin Gleason, ADEC Contaminated Sites Program

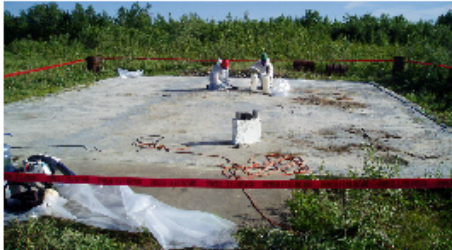
*Lead paint is removed from concrete prior to demolition at a site in King Salmon, Alaska*

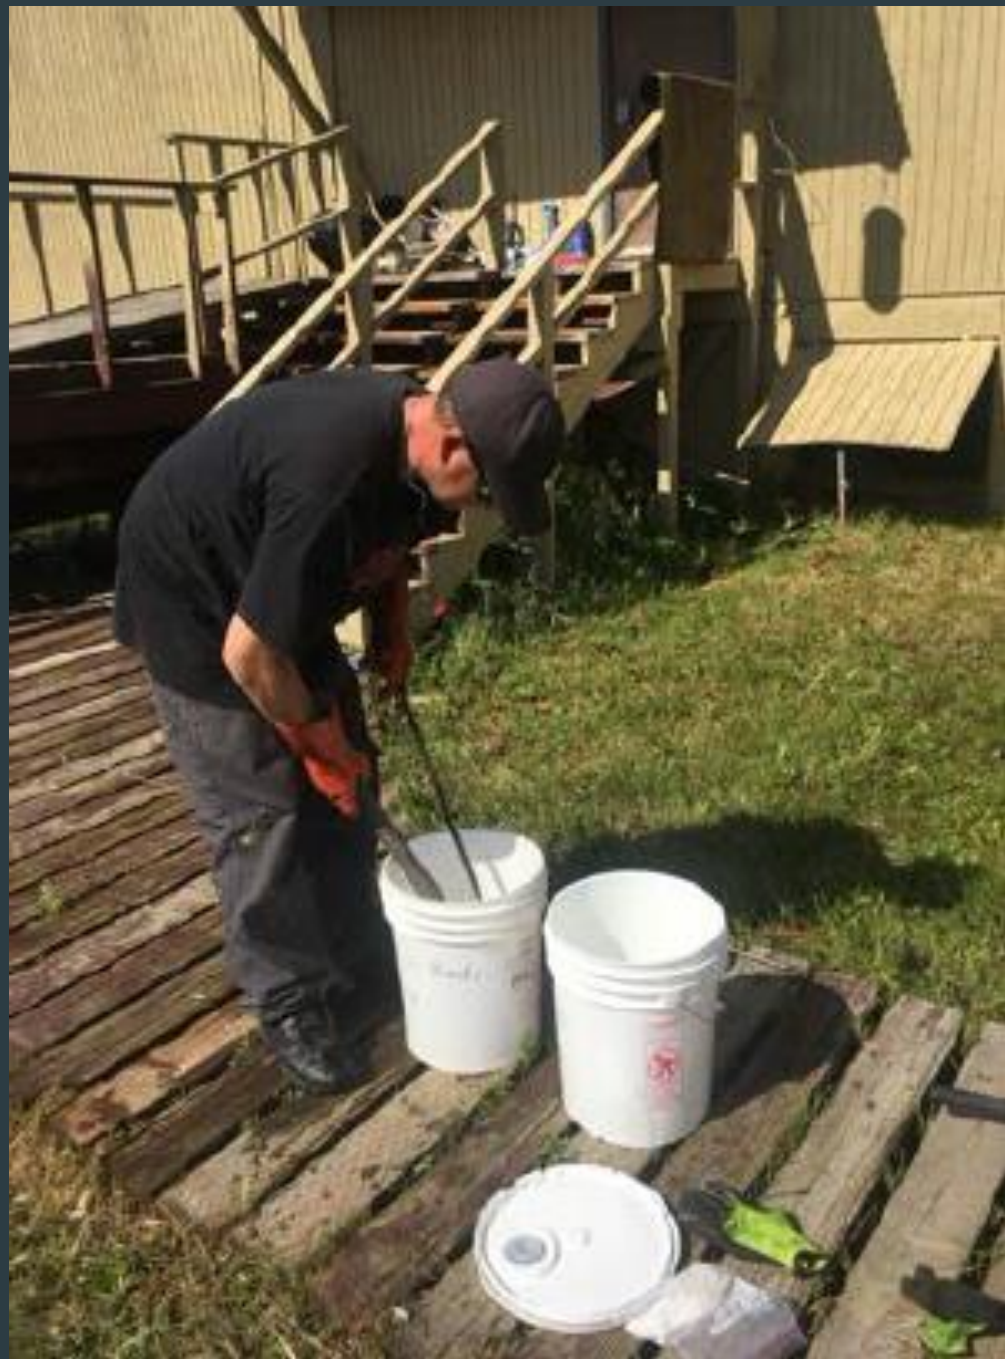
Decontamination  
of sampling equipment

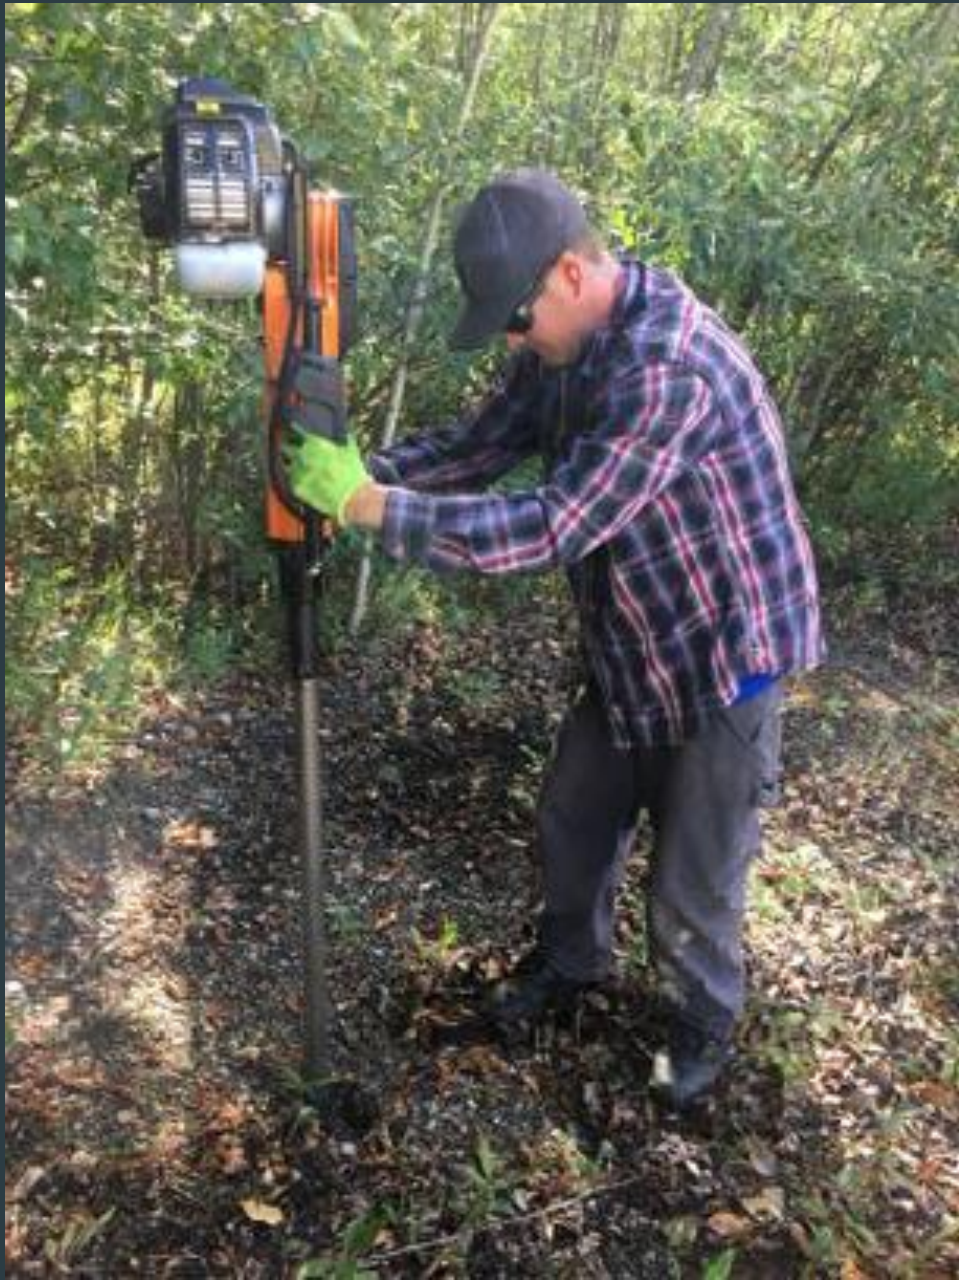
Installing a  
temporary  
groundwater  
well

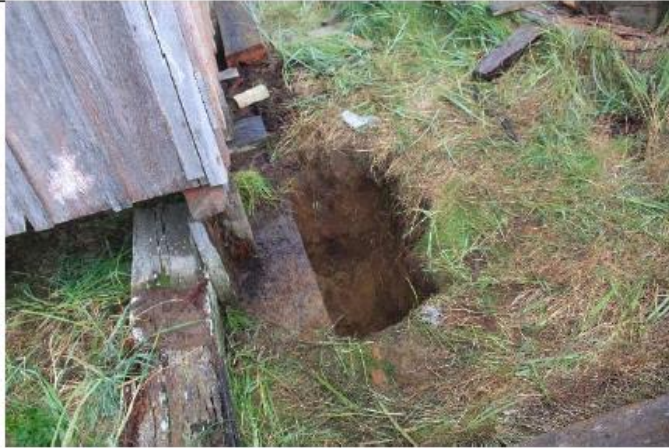
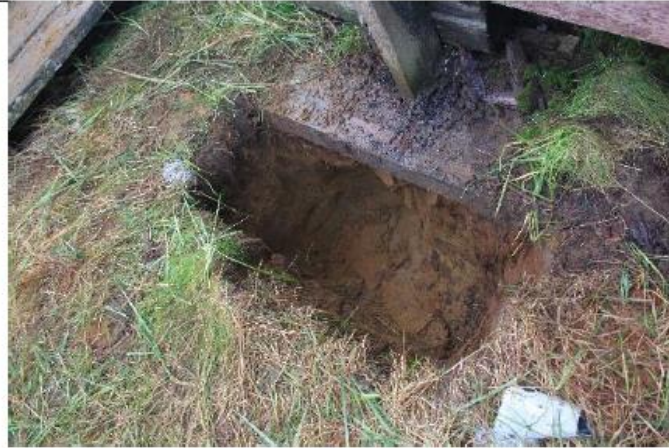
House Drum #1 excavation.

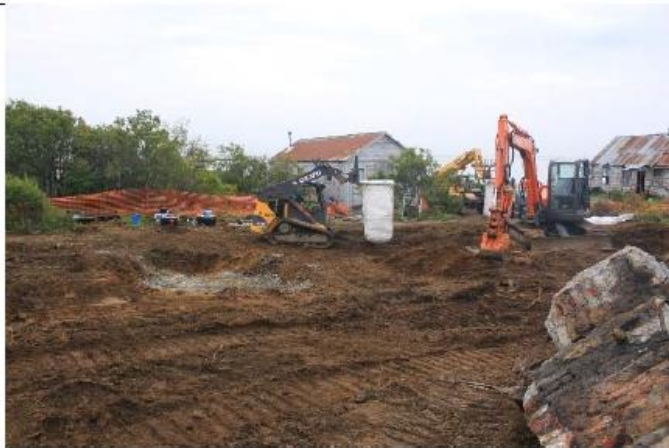
Power generation building site after demolition.

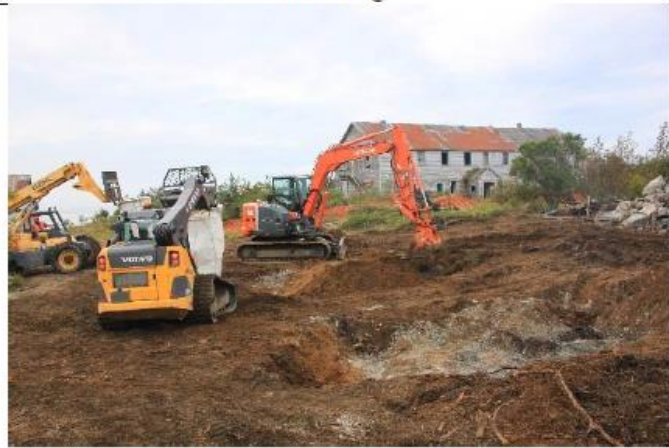
Beginning soil excavation at power generation building.
