JEWEL LAKE FECAL COLIFORM ASSESSMENT

2009-2010 Final Report

Prepared by:
Anchorage Waterways Council
P.O. Box 241774
Anchorage, Alaska 99524

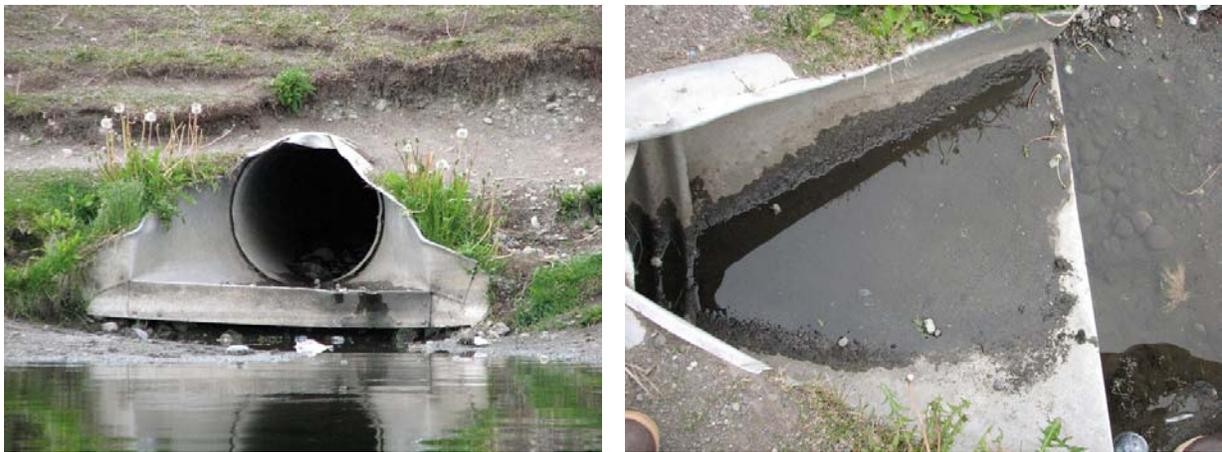
There are two storm water outfalls that drain runoff from a section of Dimond Blvd. and the parking lot at the south end of Jewel Lake and a residential area south of Dimond Blvd. into the south portion of Jewel Lake. When the 1997 EPA report was written, only one storm drain was discussed—apparently the one that drains the section of Dimond Blvd. and the parking lot. The report states, “EPA and ADEC personnel conducted a site visit of Jewel Lake to evaluate the potential fecal coliform contributions from the outfall. EPA and ADEC staff believe that runoff entering the drain is unlikely to contain significant fecal coliform loadings because the runoff drains a short section of paved road. Further, the drain discharges only episodically into the lake...(EPA 1997:7-8). What was not considered by Malloy (2009), who reported the foregoing conclusion, is that there are two storm drains at the south end of the lake. The second storm drain, shown in Figure 11, has been in place for several years, but perhaps not as far back as 1997. It was depicted on maps by the MOA’s Street Maintenance (2008), and by looking at the houses in the neighborhood catchment area south of Dimond Blvd., it has been emptying their stormwater runoff into the lake for several years.

Figure 11. Major stormwater outfall (originates on south side of Dimond Blvd.) after a rain event, June 2010 (Photo by Cherie Northon).

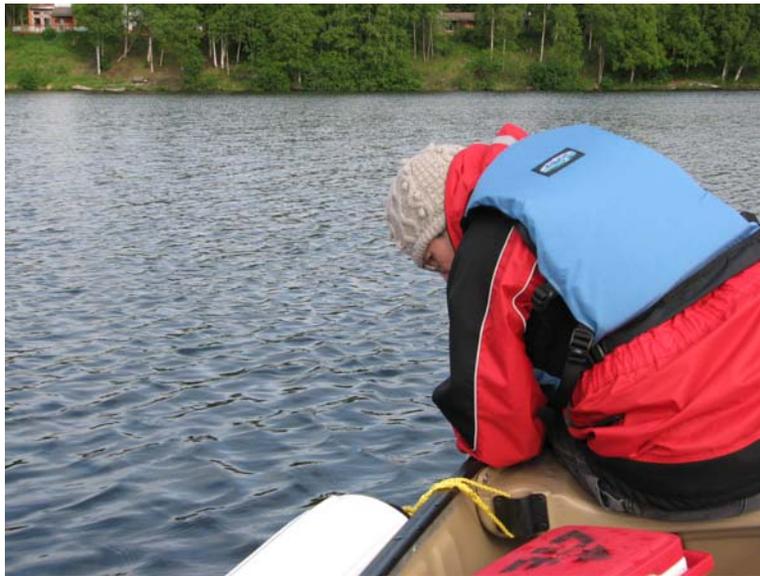
**Figure 12. Dr. Cherie Northon records the Secchi depth on Jewel Lake, June 2010
(Photo by Thom Eley).**

Secchi depth in Jewel Lake for the 2009-2010 sampling period ranged from 0.5 – 4.8 m, with a median of 2.5 and a mean of 2.6. Although the Secchi disk is used to measure water clarity and while we found the water amazing clear, we do not think it was very effective. In about 94% of our samples, the Secchi disk was on the lake bottom for the readings. Effectively what the Secchi data gives us is basically a bathymetric survey of the lake (Figure 24). However the monthly descriptive statistics are presented in Table 8, and the spatial distribution of Secchi measurements are mapped in Figures 25-31 .

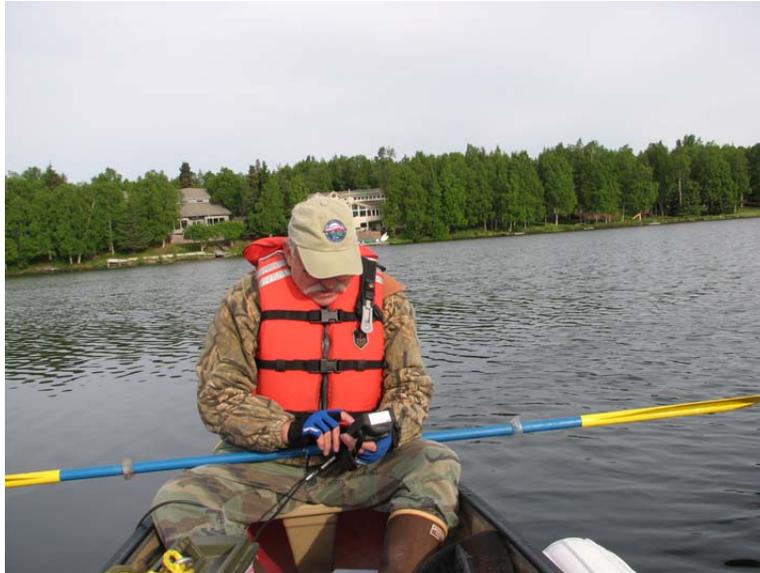
Figure 13. Dr. Thom Eley recording water temperature, pH, and dissolved oxygen with a YSI Professional Plus Instrument on Jewel Lake, June 2010 (Photo by Cherie Northon).

A YSI Professional Plus was obtained early in the 2009-2010 sampling season, and lake water pH was recorded at each sample site. During the sampling period (August-October 2009 and May-June 2010), 144 pH readings were taken in Jewel Lake. The readings ranged from a low of 6.91 to a high of 8.26. The lowest pH was found in May, but the lowest mean pH was in September and October (Table 12). The highest pH was recorded in October with the highest mean pH found in June. No pH sampling was done in July 2009 due to the non-availability of equipment.

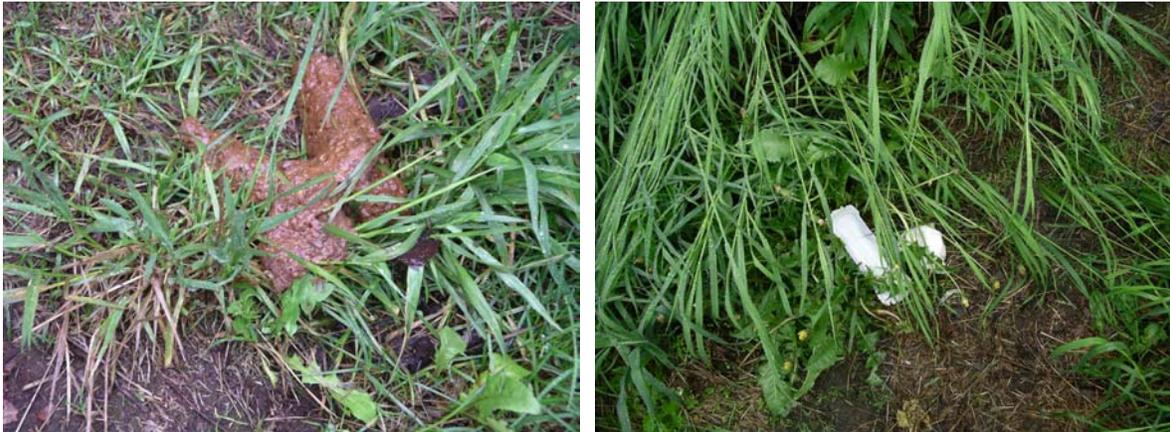
Humans were observed urinating into and near the lake, and evidence was found of humans defecating on land close to the lake shore. During a high rainfall event, the feces were in the direct path of a storm drain that enters the south end of Jewel Lake adjacent to the fishing area. These activities could provide human sources of fecal coliform.

Human waste near the lake (in a tussock surrounded by lake water) and adjacent wetlands. Humans can produce $1,950 \times 10^6$ CFU/AU⁴ (Yagow et al. 2001).

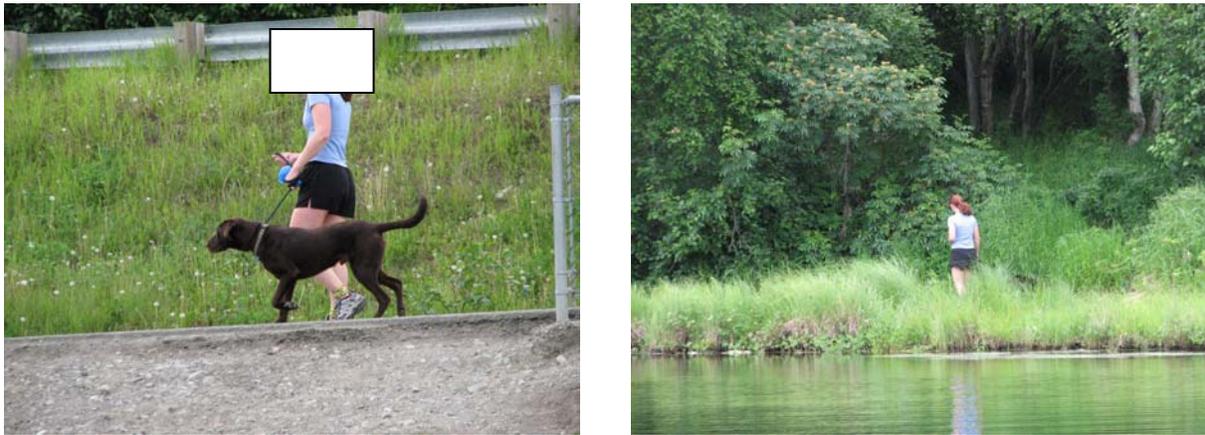
Dog feces are common on the Jewel Lake Park beach at the northeast corner of the lake. People were observed driving into the park's parking lot and turning their dogs loose to go defecate either in the grassy or wooded portion of the park. No one cleaned up after these dogs even though a "Scoop-the-Poop" station is located (and stocked with bags) and readily observable at the park. Additionally, dogs swim in the lake, and dogs are known to defecate when they swim. Dog feces were observed in abundance on the lake ice adjacent to the park in the 2010 winter and spring. This is a common ice fishing area, and many people bring their dogs with them. We also observed people stopping at the park and allowing their dogs to run on the lake ice and defecate.

People observed allowing their dogs to poop in the park woodlands and not cleaning it up — “Scooping the Poop!” Dogs can produce 500×10^6 CFU/AU (Yagow et al. 2001).

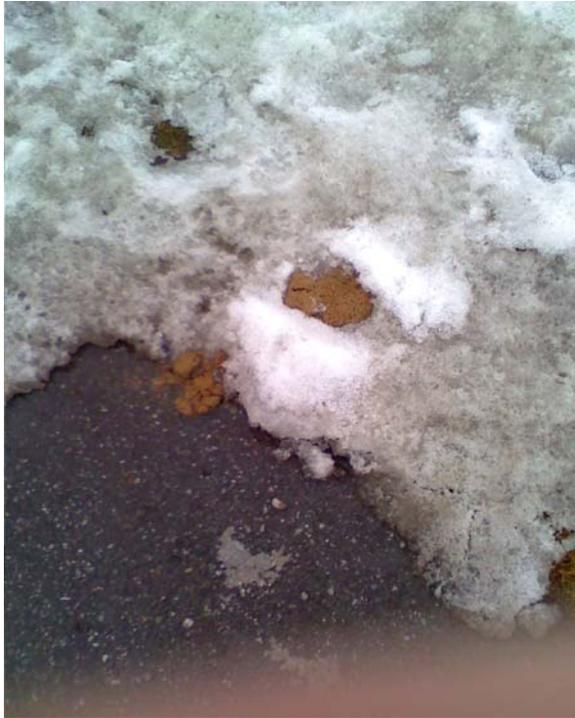
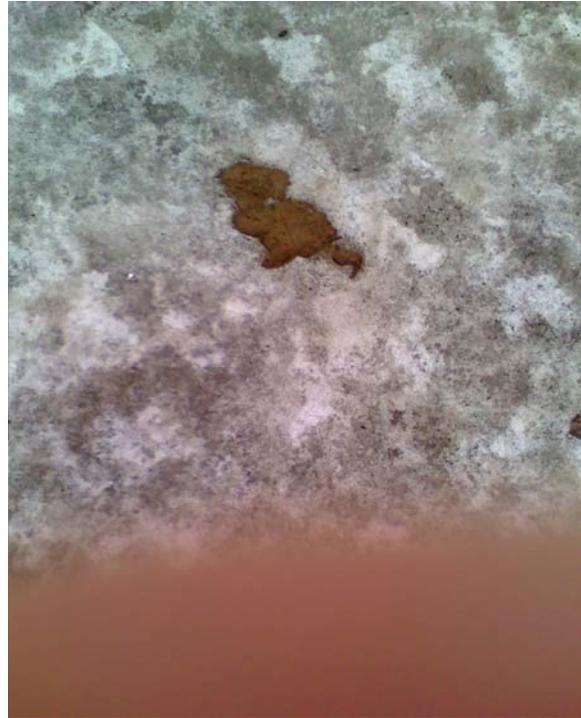
People allow their dogs to poop on the pavement and lake ice in winter (April 2010). Some of these folks are ice fishers, and others are transient folks that drive in and let their dogs out to do their business. Ironically, these were close to the Scoop the Poop Station which was stocked with plastic bags.

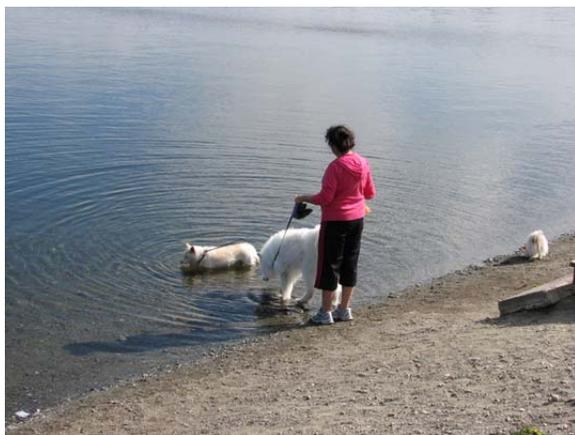
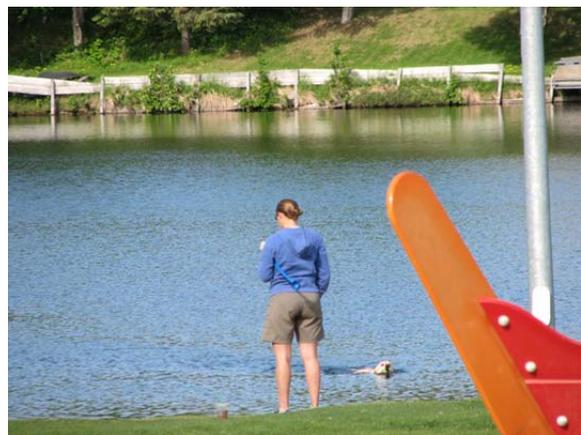
People and their dogs using Jewel Lake for recreation.

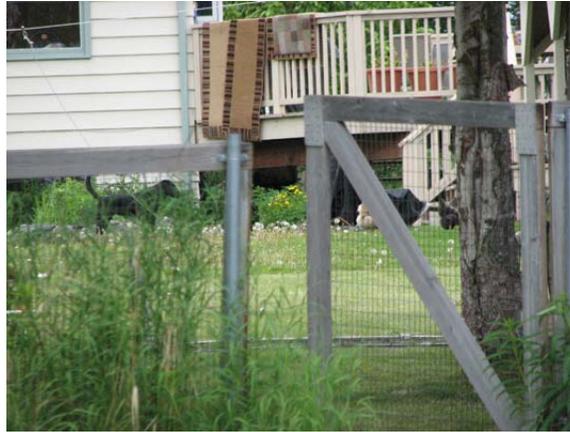
A yard with dogs and chickens on the east side. We could not determine if animal waste was being thrown into the lake, but there was a gate opening onto the edge of the lake.

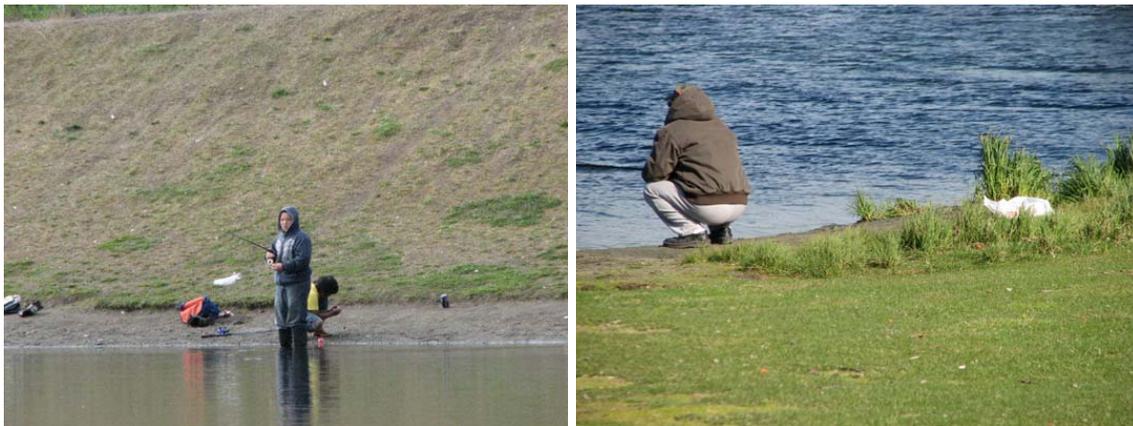
Jewel Lake is one of the more popular fishing lakes in Anchorage. The fisherman on the right urinated and defecated into at the Jewel Lake shore.

- People defecating in the wetlands and the lake. One fisherman was observed defecating in the lake in the park woods near the fishing dock on the south end of the lake—certainly a source of fecal coliform contamination.

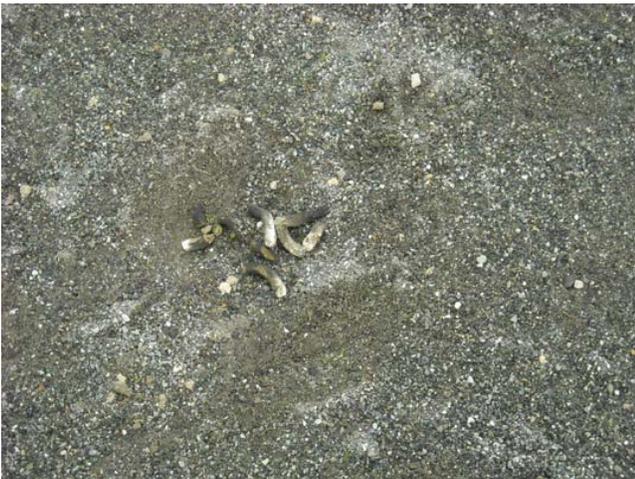
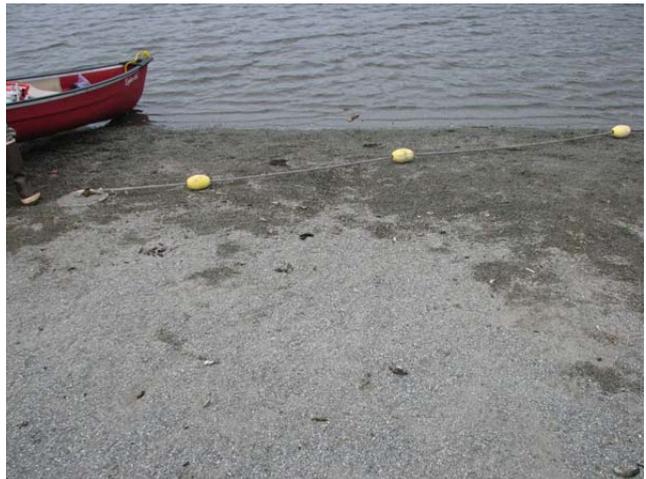
Canada Goose feces on beach.

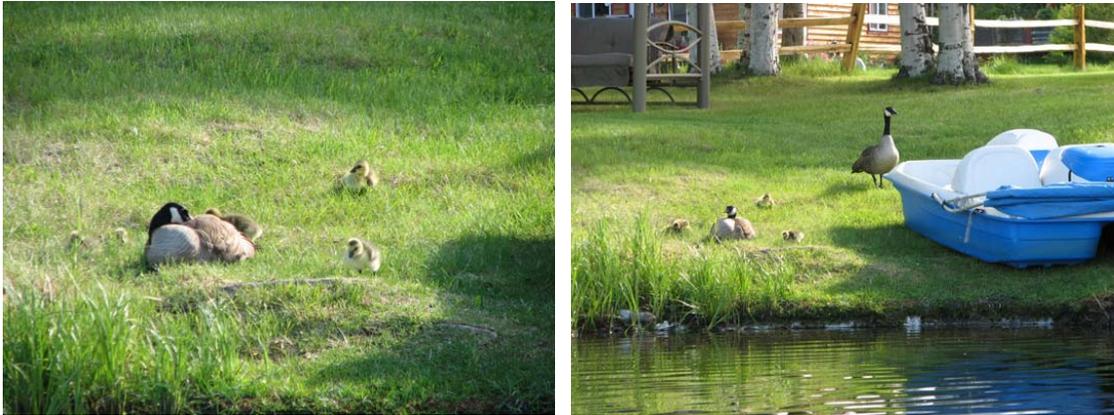
Manicured lawns of residents around Jewel Lake are attracting Canada Geese, and this residence appears to be a main breeding area for Canada Geese around. A wild goose can produce 130 to 800 x 10⁶ CFU/AU (Yagow et al. 2001).

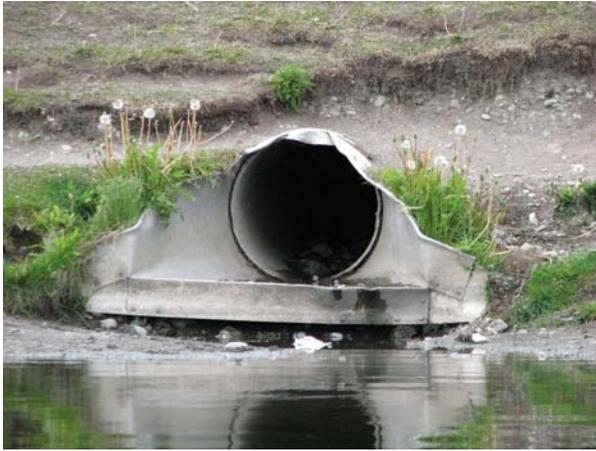
Stormwater Outfall #1

Figure 60. Stormwater Outfalls—the western-most stormwater outfall on the left [Outfall #1] and the eastern-most stormwater outfall on the right [Outfall #2], Jewel Lake, June 26, 2010 (Photos by Dr. Thom Eley and Dr. Cherie Northon).

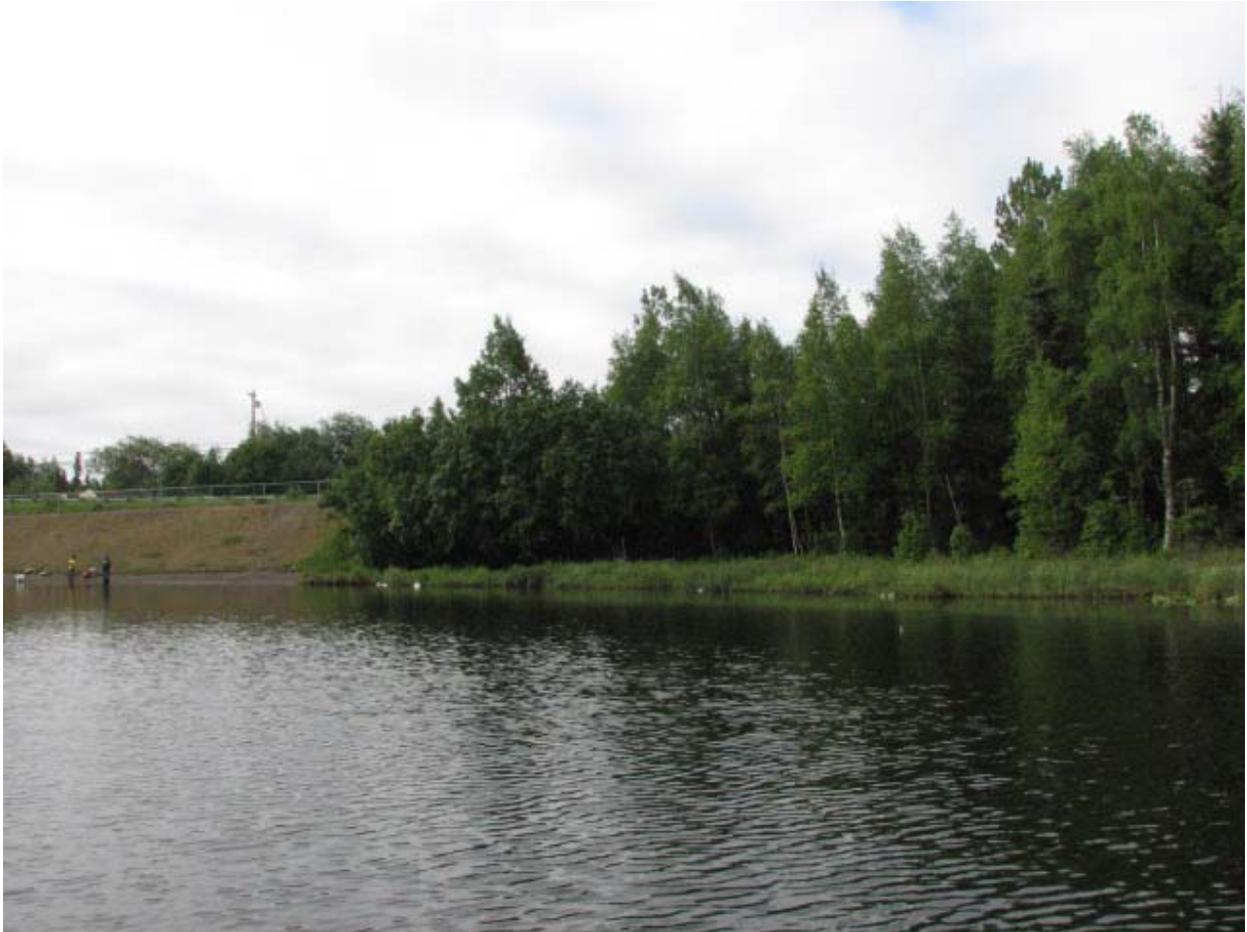
Figure 65. Area of park land (adjacent to fishing area) bordering Jewel Lake that received a Good (A) habitat quality rating based on the BMP assessment. The extreme left side of the photo shows the parking area at the south end of the lake which has a poor rating. (Photo by Dr. Cherie Northon).

Photos of each property were taken and are included in electronic Appendix A that accompanies this report. However, representative photos of good (Figures 65-66), fair (Figures 67-68) and poor (Figures 69-70) quality shoreline habitat are provided in this document.

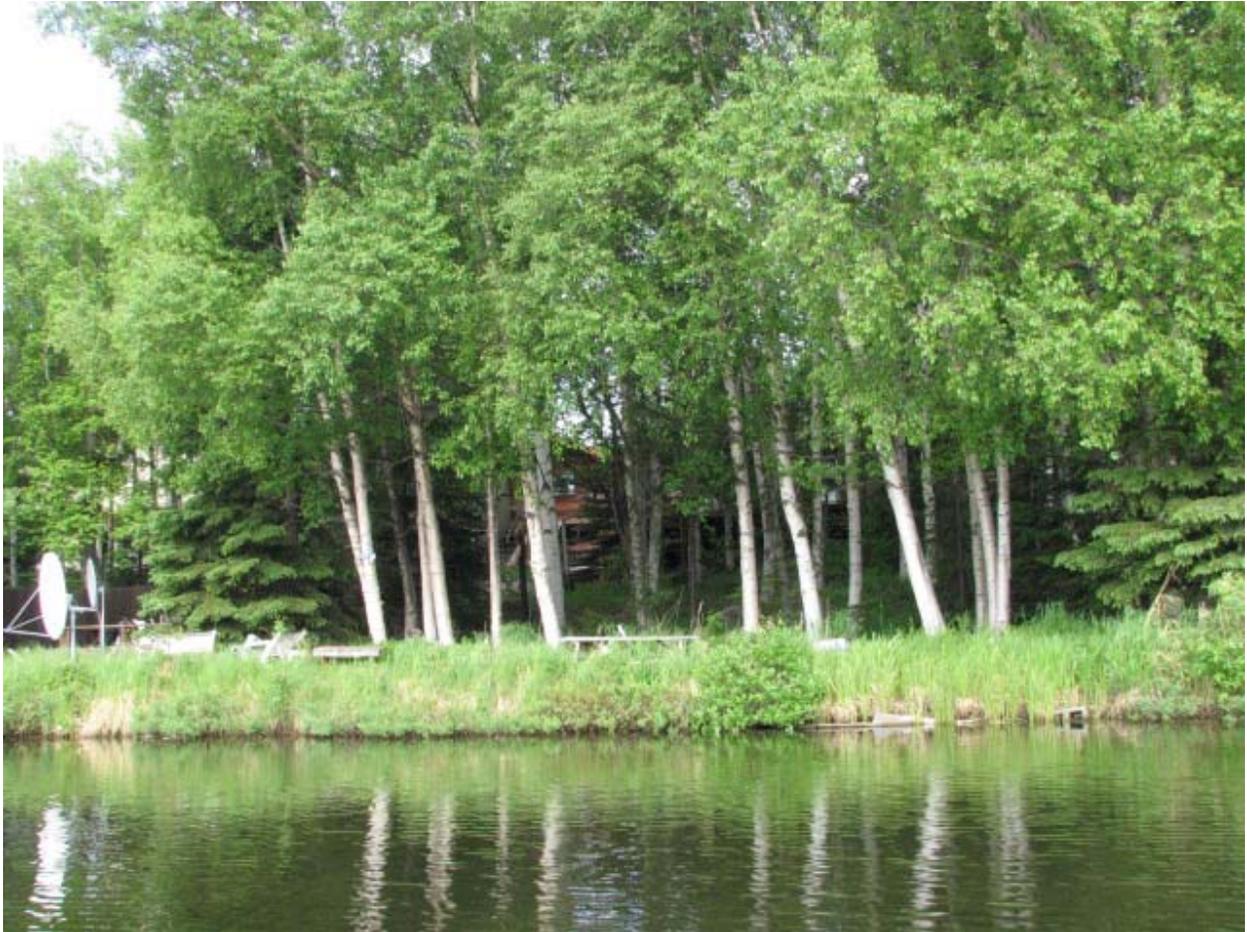
Figure 66. Example of lakeshore residential property on Jewel Lake that received a Good (A) habitat quality rating based on the BMP assessment. (Photo by Dr. Cherie Northon).

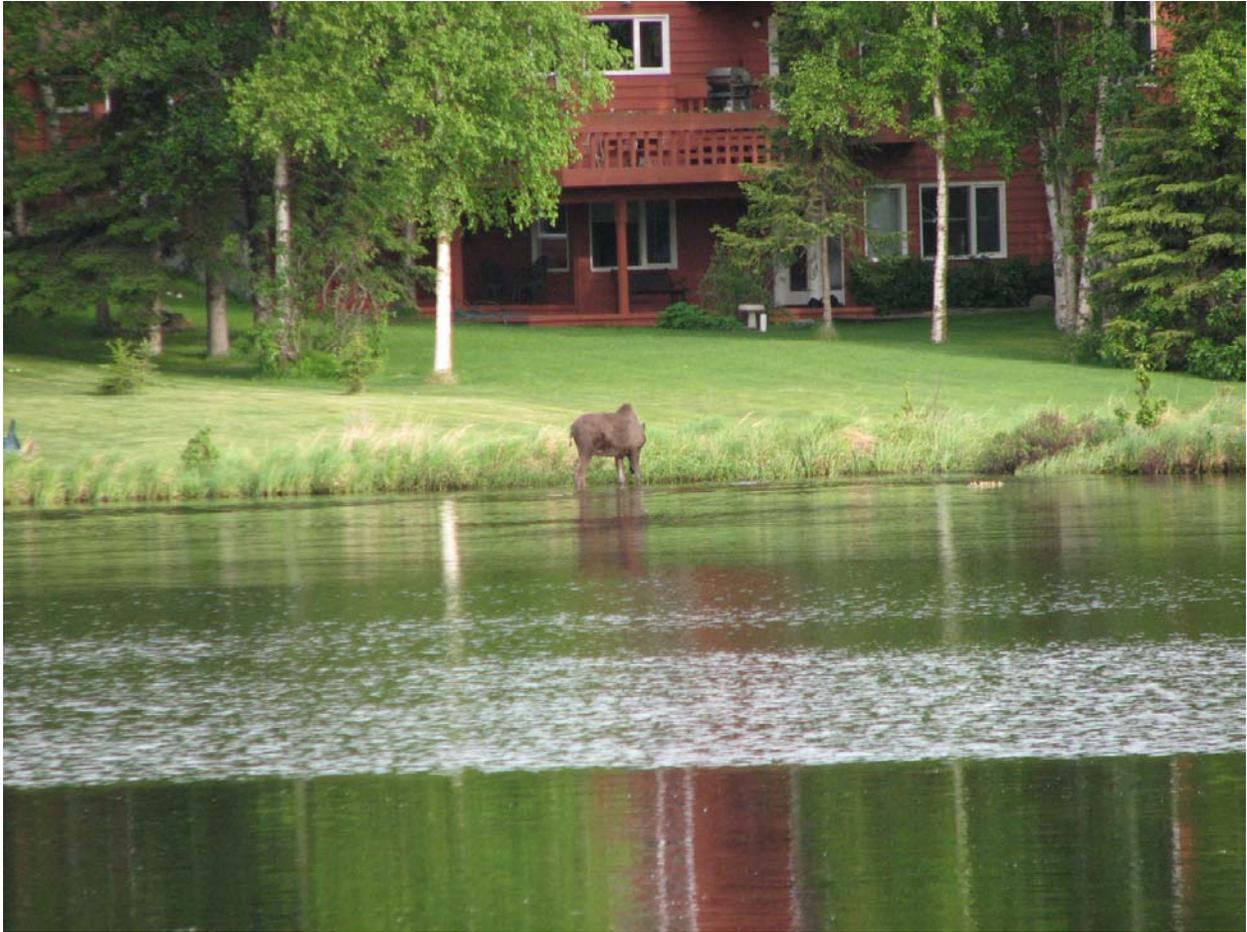
Figure 67. Residential property on northwest portion of lake that received a Fair (B) habitat quality rating based on the BMP assessment. (Photo by Dr. Cherie Northon).

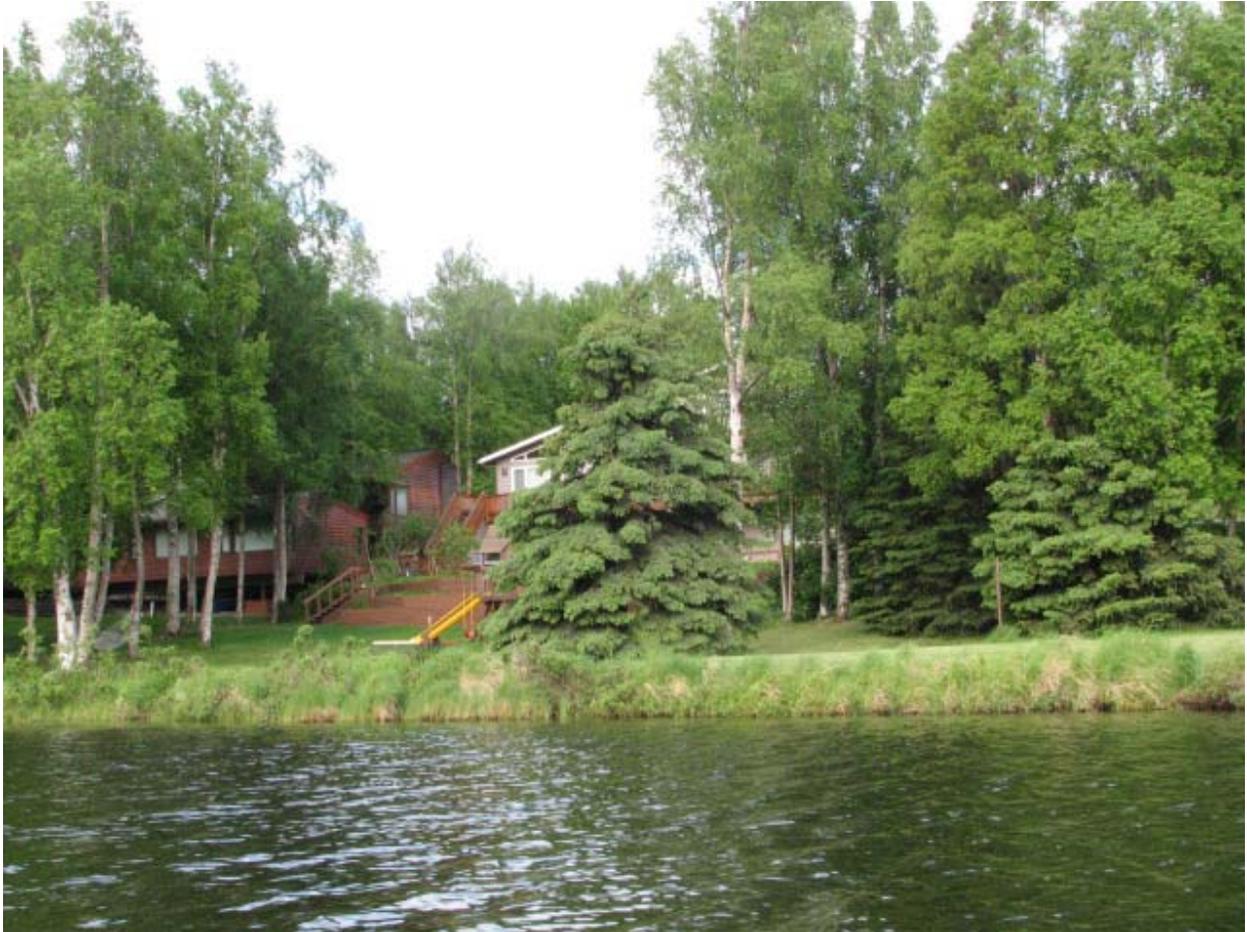
Figure 68. Another residential property on the west side of Jewel Lake that received a Fair (B) habitat quality rating. (Photo by Dr. Cherie Northon).

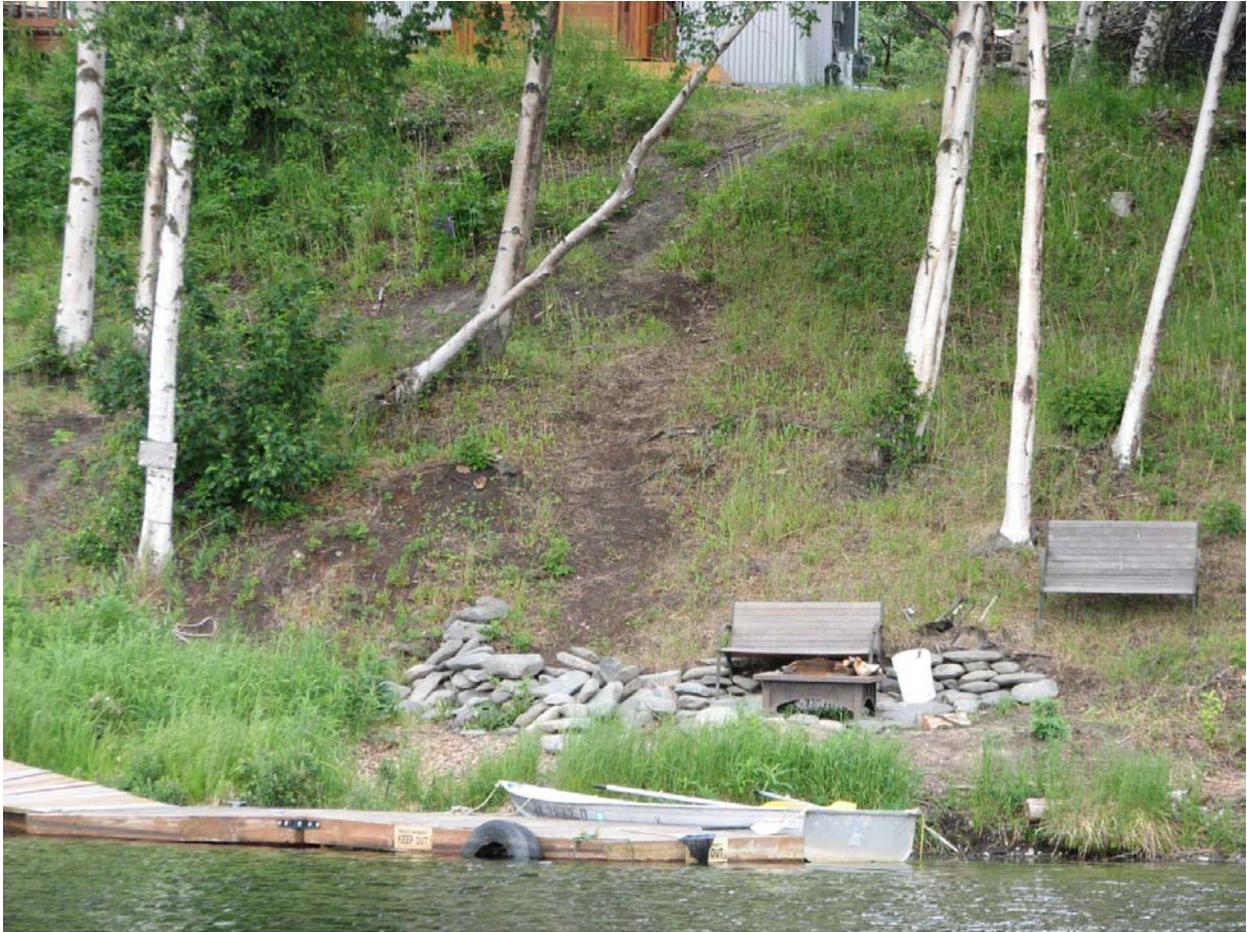
Figure 69. Residential property on the west side of Jewel Lake that received a Poor (C) habitat quality rating, due mainly to the lack of buffer present, bare areas and erosion on a steep slope, and debris (pallets) in the water. (Photo by Dr. Cherie Northon).

7. Properties with steep slopes to the lake should have a mitigating process to prevent vegetation deterioration and erosion as a result of people and pets going up and down the slope.

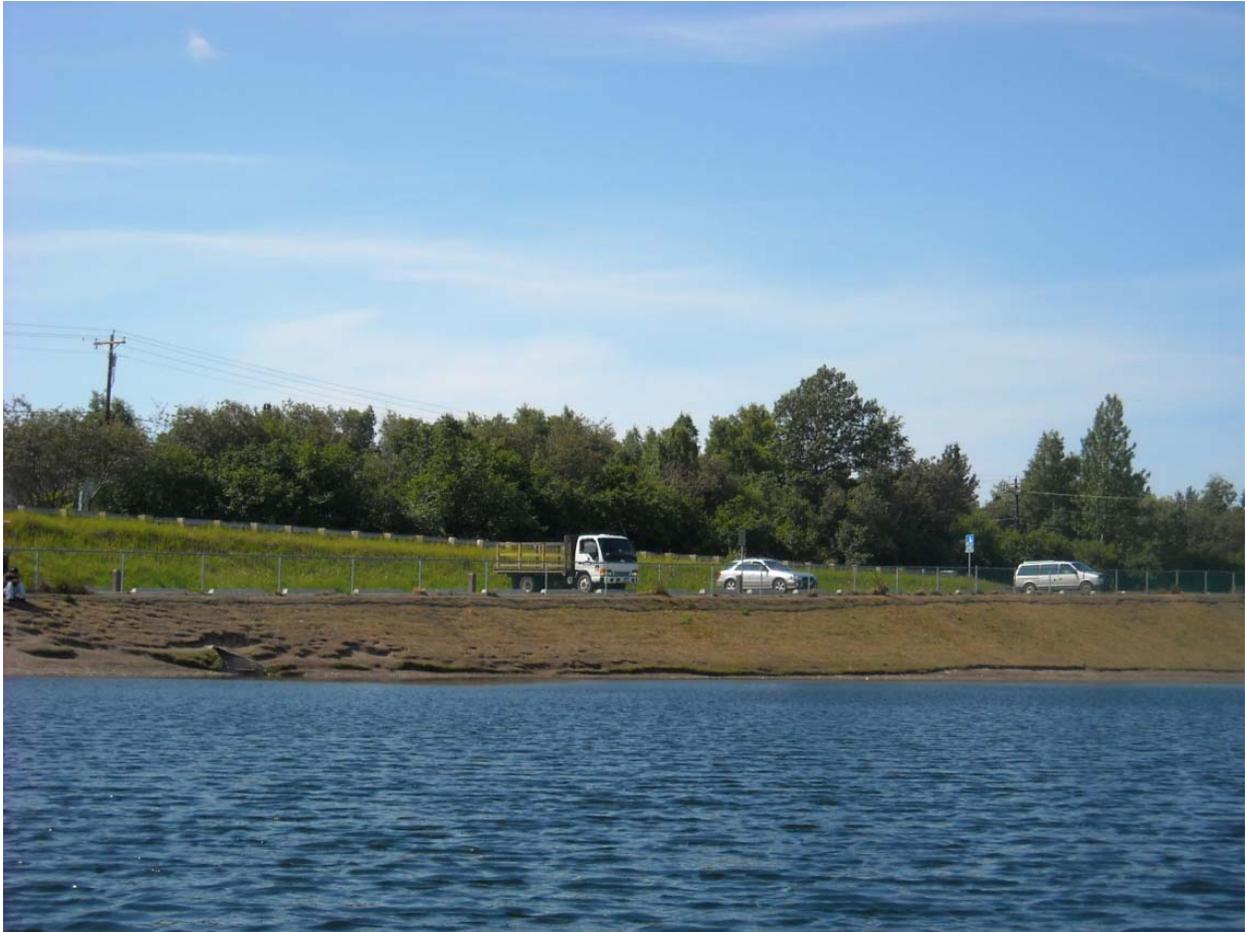
- Bare soil on steep terrain on the west side of the lake, which could result in increased sediment run off into the lake—possible source of fecal coliform contamination. This bare soil appears to have resulted from trips up and down the hill to docks in the lakes. One property owner has constructed a switch back system down to the lake, and has gone to great lengths to successfully re-vegetate damaged areas. Another property owner has terraced their property to create small level areas to catch precipitation instead of having runoff.

Figure 70. Parking and fishing area at the south end of the lake showing bare slope, trails where people have walked up and down the slope, stormwater outfall, and all matter of debris on the beach. This area received a Poor (C) rating. (Photo by Dr. Cherie Northon).

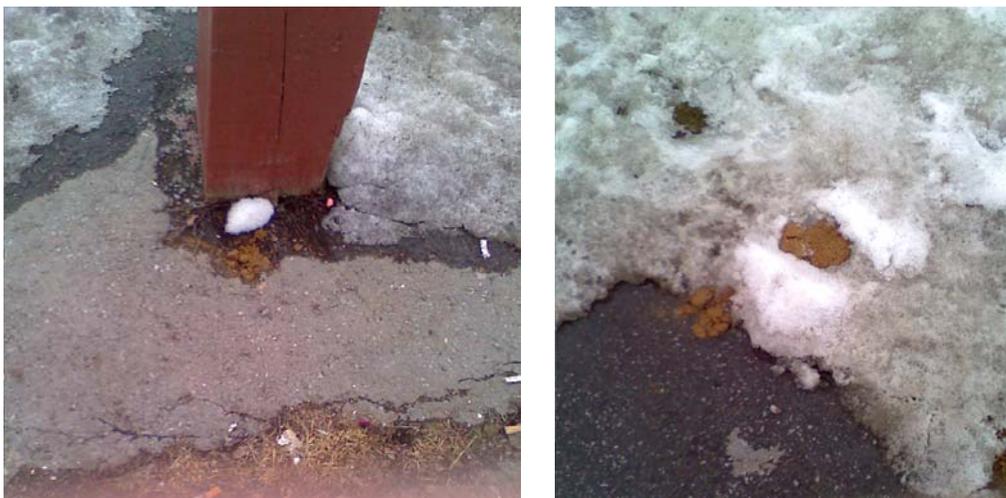
Figure 71. Dog waste by parking lot barrier and dog waste on asphalt walkway to beach, Jewel Lake, April 4, 2010 (Photos by Dr. Cherie Northon).

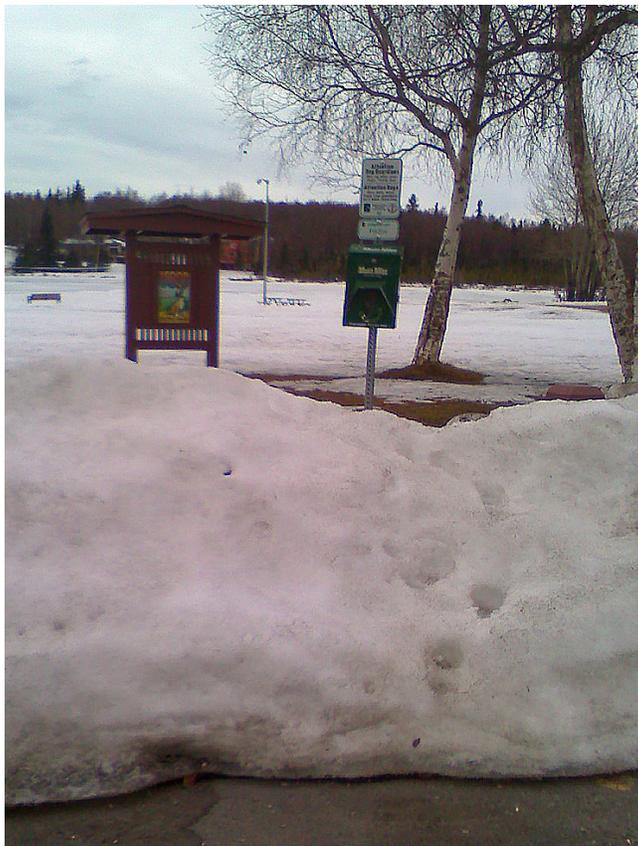
Since this slopes down toward the beach and lake, it is likely that much of it ended up in the lake after breakup. There is some irony here, because within 50' of this recreation area is a Scoop-the-Poop Station (always supplied with bags) and a sign asking residents to clean up after their pets.

**Figure 72. Scoop the Poop station and Scoop the Poop sign, Jewel Lake, April 4, 2010
(Photo by Dr. Cherie Northon)**

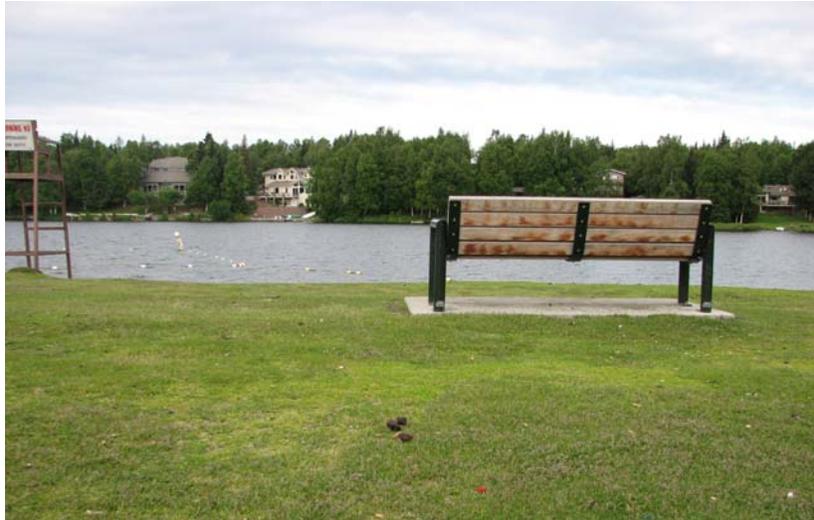
Even on the last sampling visit to Jewel Lake on June 29, 2010, two large piles of dog feces were found on the grassy area next to a bench and a garbage can by the beach, and within 75' of the Scoop-the-Poop Station.

Figure 73. One of two dog feces piles observed June 29, 2010, Jewel Lake (Photo by Dr. Cherie Northon).
