EDWARD K. THOMAS BUILDING
JORDAN CREEK
GREEN INFRASTRUCTURE PROJECT
FINAL REPORT

JUNEAU WATERSHED PARTNERSHIP

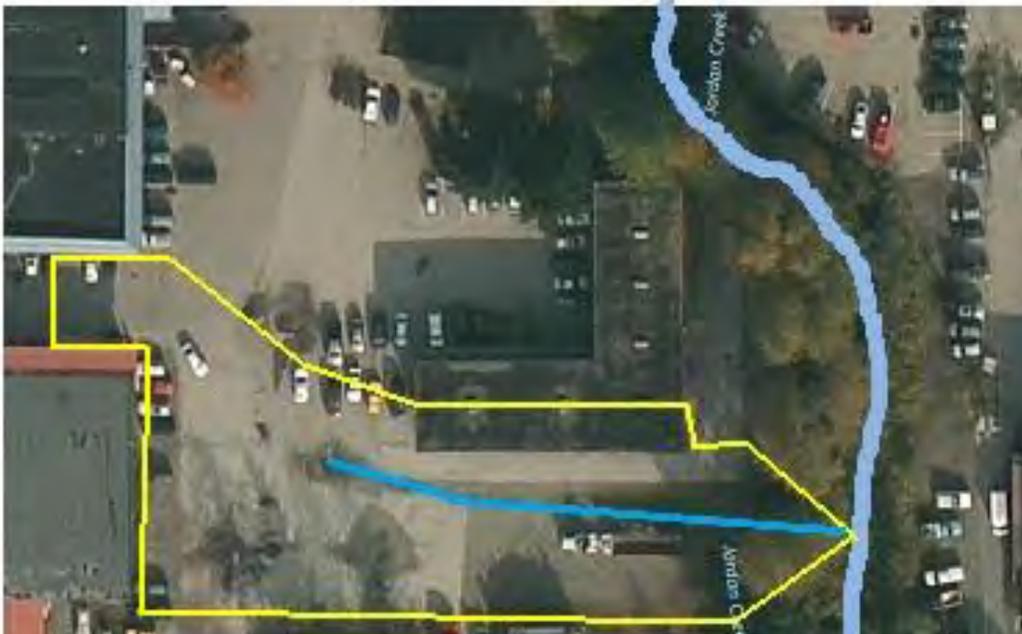
Due to pavement wearing and setting, stormwater from the adjoining paved surfaces circumvents the storm sewer system, flows across the unpaved driver training area, and discharges untreated into Jordan Creek. The area contributing to the stormwater discharge is 36,000 ft² (0.83 acres) (Figure 3 and 4).

Figure 3. The Edward K Thomas Building project site showing the area contributing to the stormwater discharging to Jordan Creek in yellow.

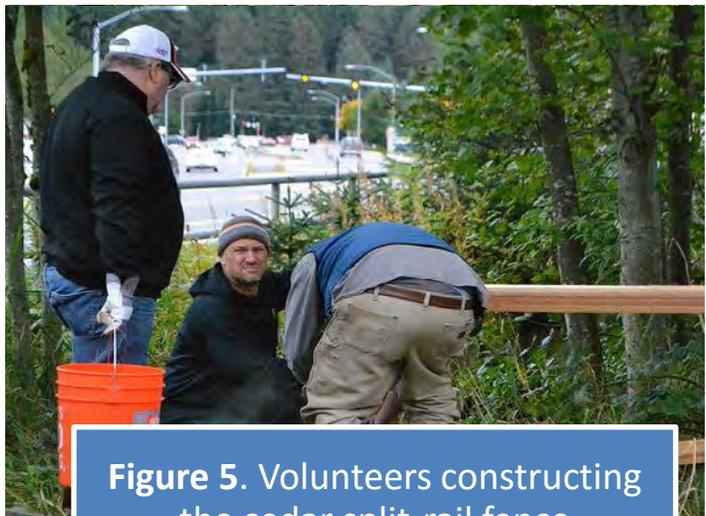
Figure 5. Volunteers constructing the cedar split-rail fence

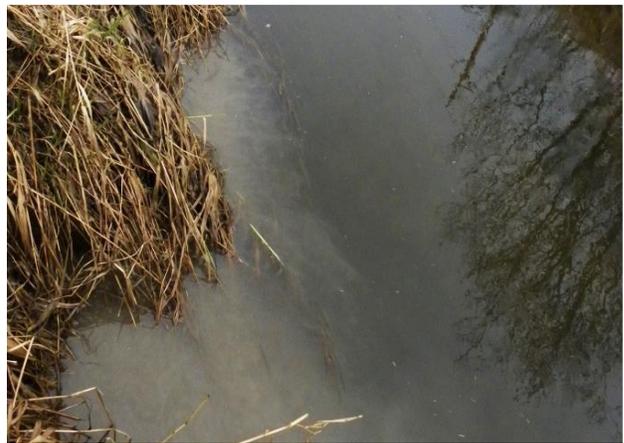
Figure 9. Sediment discharging into Jordan Creek from the Edward K. Thomas building site prior to the installation of the rain garden.

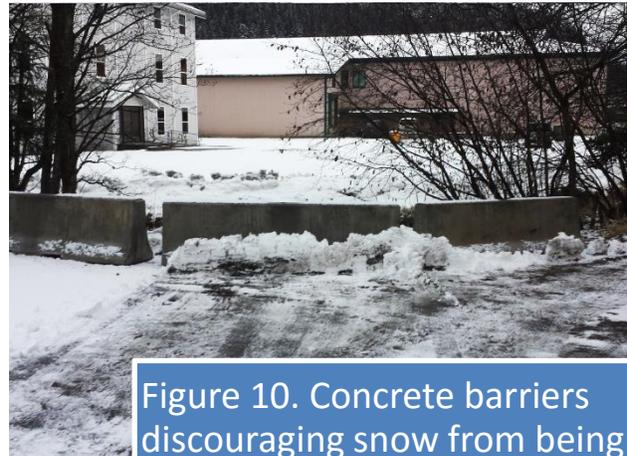
Figure 10. Concrete barriers discouraging snow from being plowed into the creek.

The other element of this project is the cedar split-rail fence and concrete barriers. These benefit Jordan Creek by discouraging snow from being plowed into the riparian area, reducing snow as a source of sediment and other pollutants. The concrete barriers were placed in the locations with the highest impact, where snow was most frequently pushed into the stream. Concrete barriers were also placed in front of the rain garden in order to protect it from the trucks using the adjacent parking lot. However, the barriers do not prevent a snow plow operator from lifting snow over the barrier, so on-going observation and discussions with CCHITA may be needed to ensure proper winter maintenance techniques.

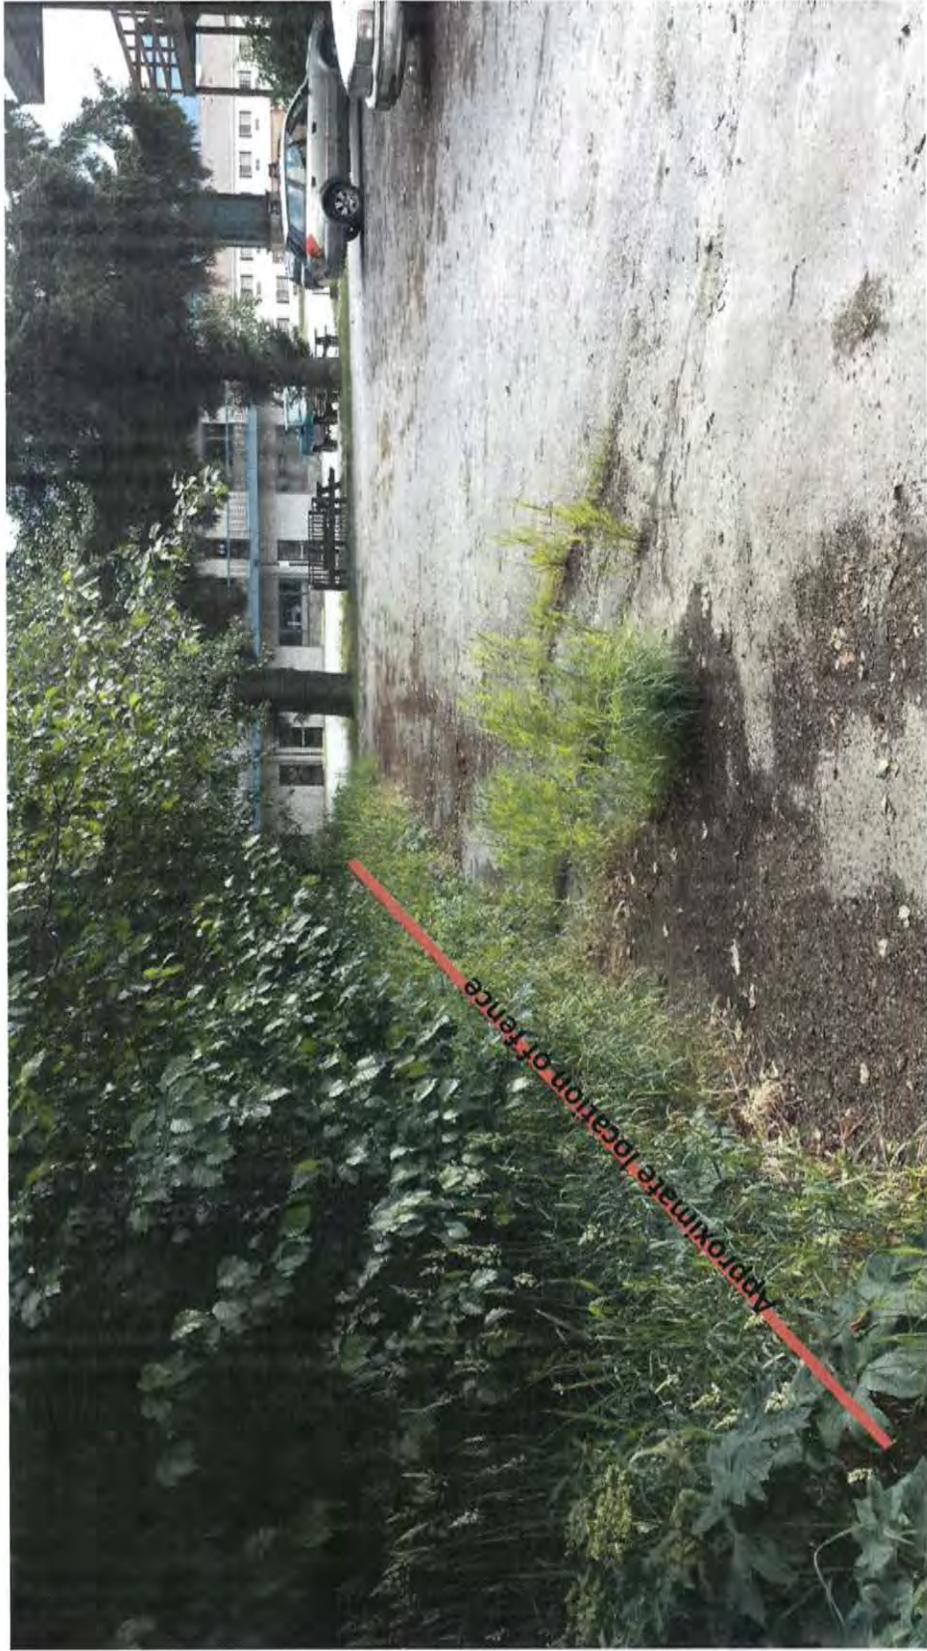
Figure 5. Northern most end of property, looking south. Split rail fence will be placed along the edge of pavement, in the vegetation, as shown.

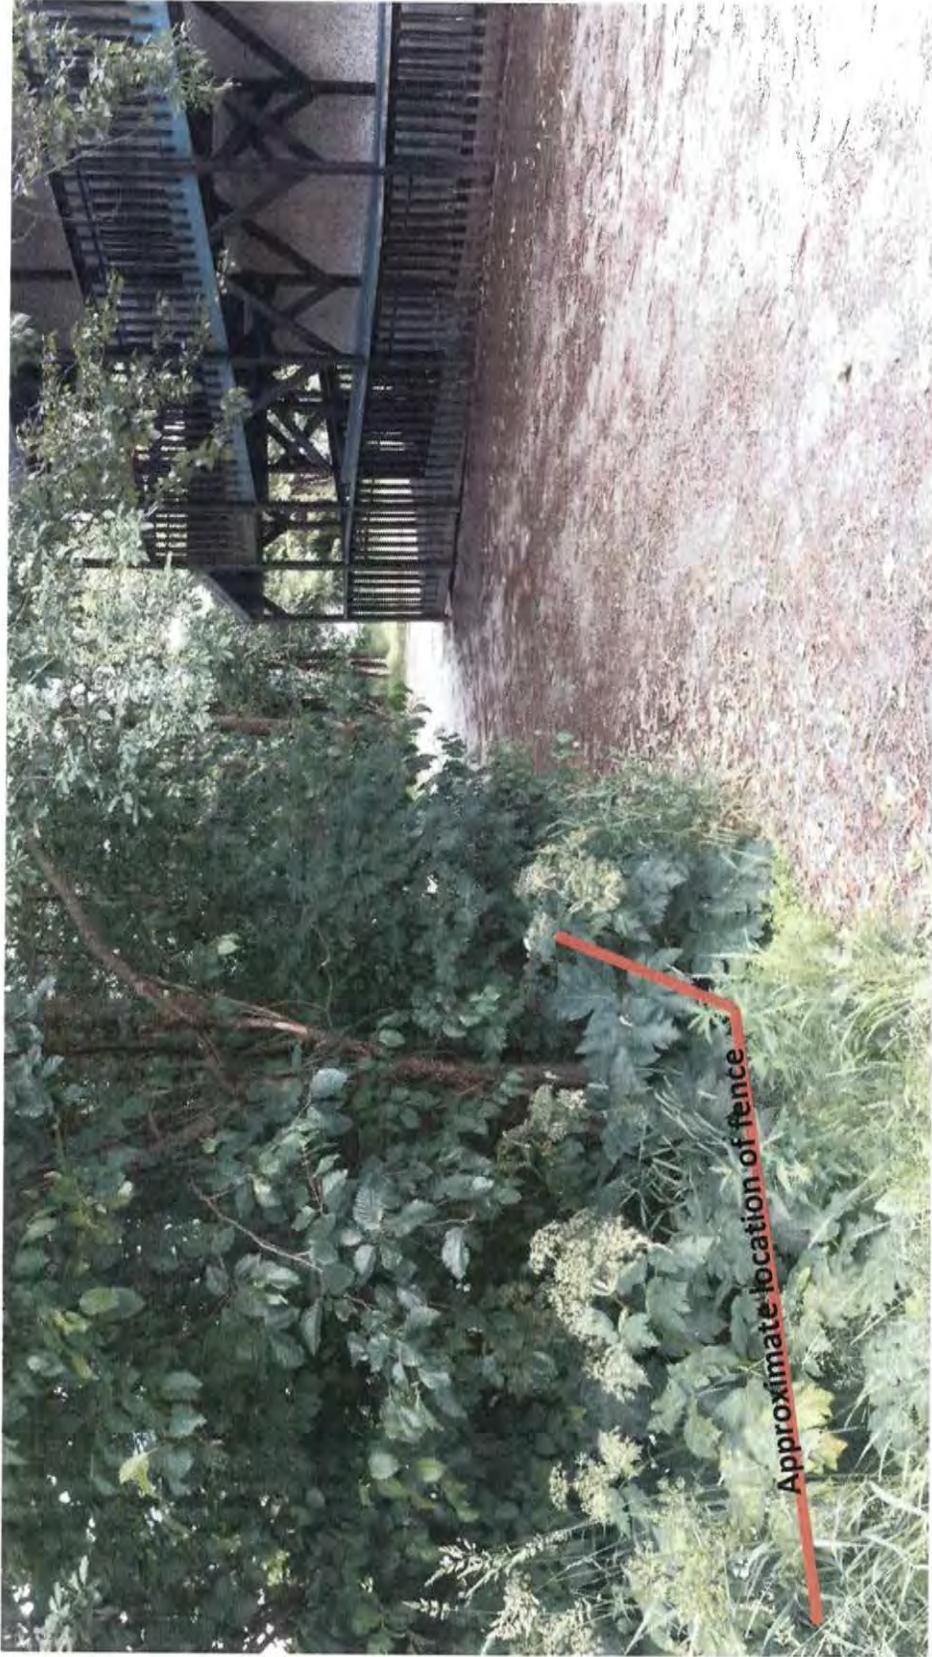
Figure 6. North side of the Edward K Thomas Building, looking east toward back parking lot. Concrete barrier will be placed along the edge of pavement within the vegetation on the corner at this location because snow is piled here and often is pushed into the stream.

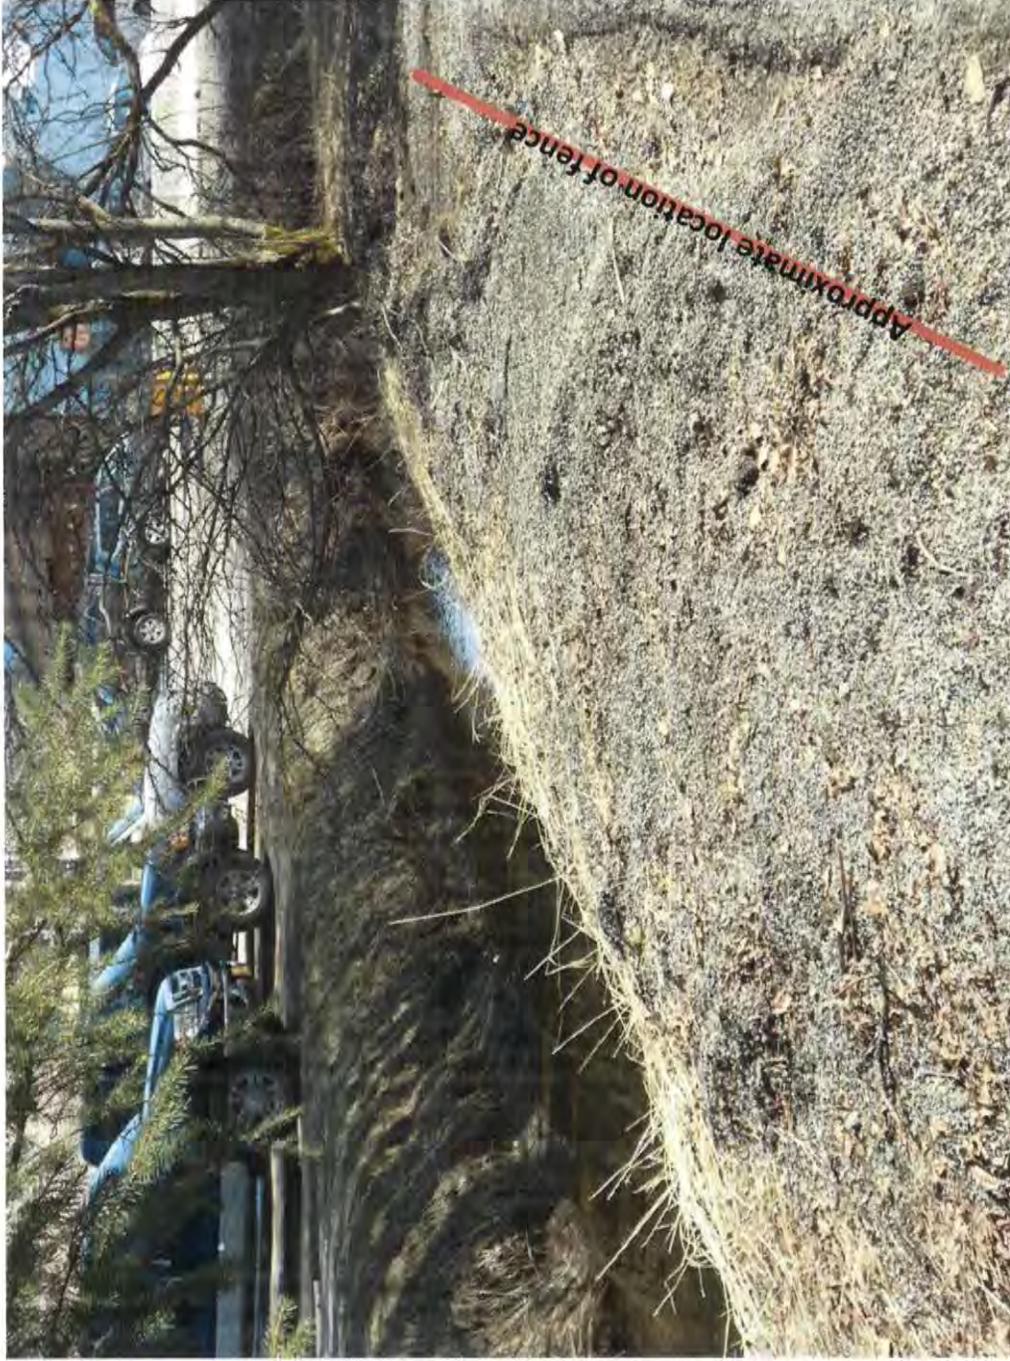
Figure 7. North side of the Edward K Thomas Building, looking east toward back parking lot. Concrete barrier will be placed along the edge of pavement within the vegetation (not yet emerged in this photo) due to risk of impact from plow; however, this length may be replaced with split rail fence depending on funds and land-owner preference.

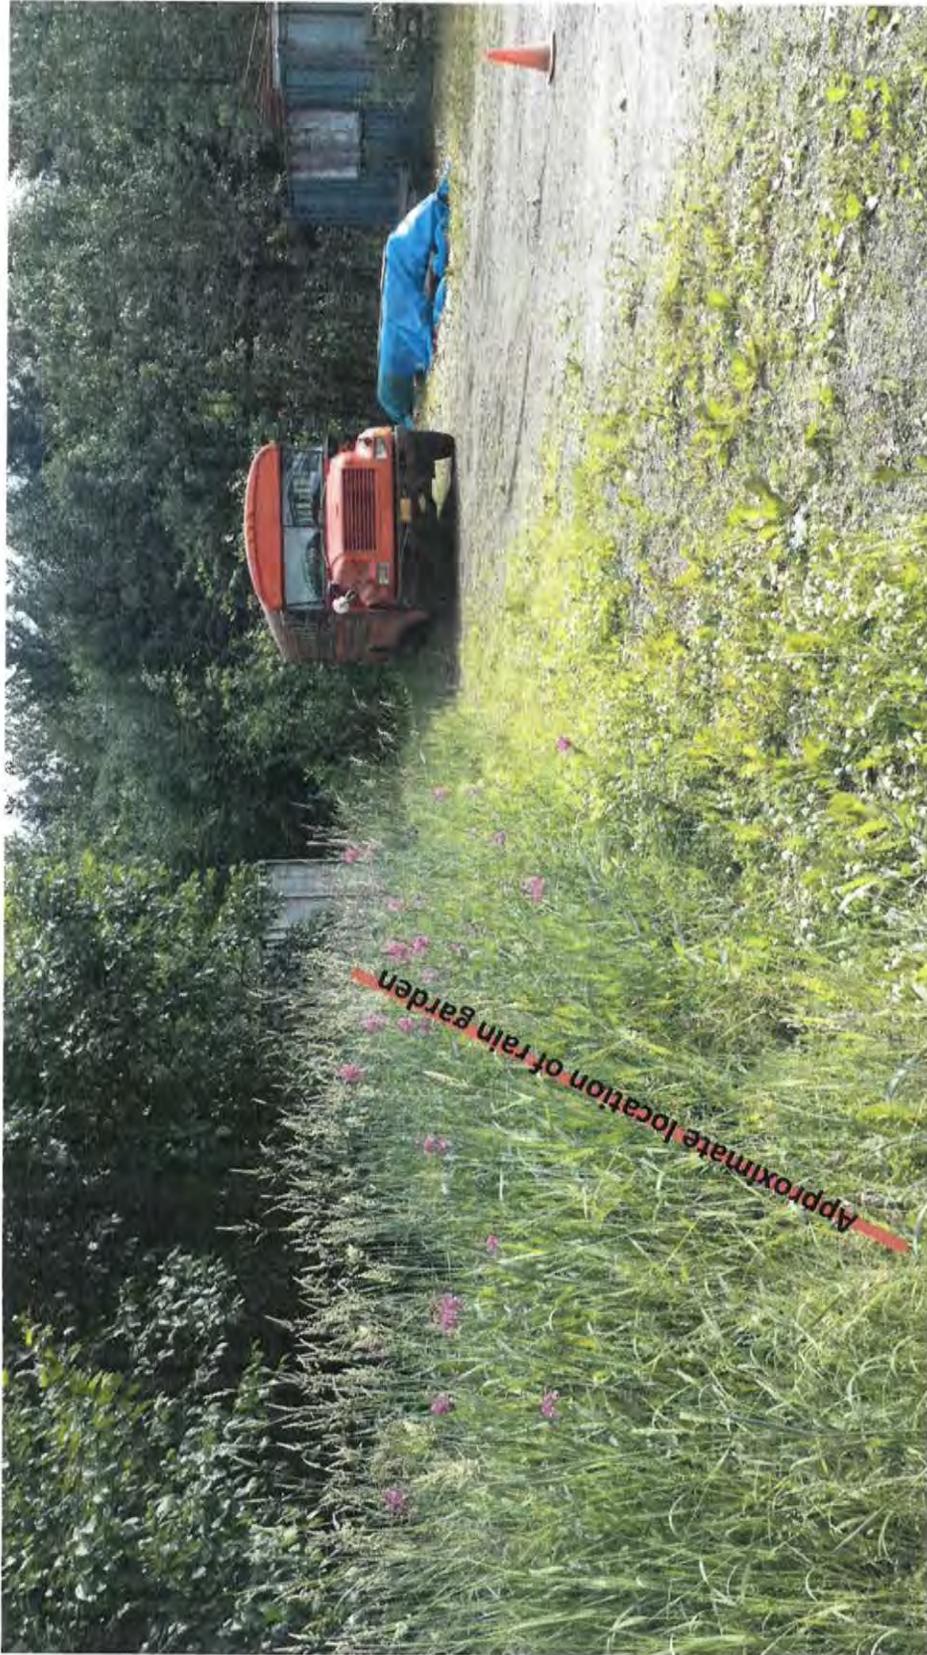
Figure 8. Edge of driver training area where the rain garden will be located. The rain garden will encompass the area from near the tree line to just outside the vegetated area. The length of the rain garden will end just before the connex in the background.

The rain garden will be within 35 to 50 feet from Jordan Creek. The rain garden will require approximately 270 yards of excavation and placement of approximately 120 yards of gravel and topsoil. Rain gardens are not specifically listed in the CBJ Manual of Stormwater Best Management Practices. However, the Infiltration Basin BMP states, "the basin can be designed as ... a shallow earthen rain garden." Therefore, the rain garden was sized according to the procedure outlined in the CBJ Manual for the Infiltration Basin BMP (attached). The calculated water quality design volume is approximately 3,368 ft³. The rain garden will be vegetated using native plants during construction and will be re-planted in the spring of 2016.

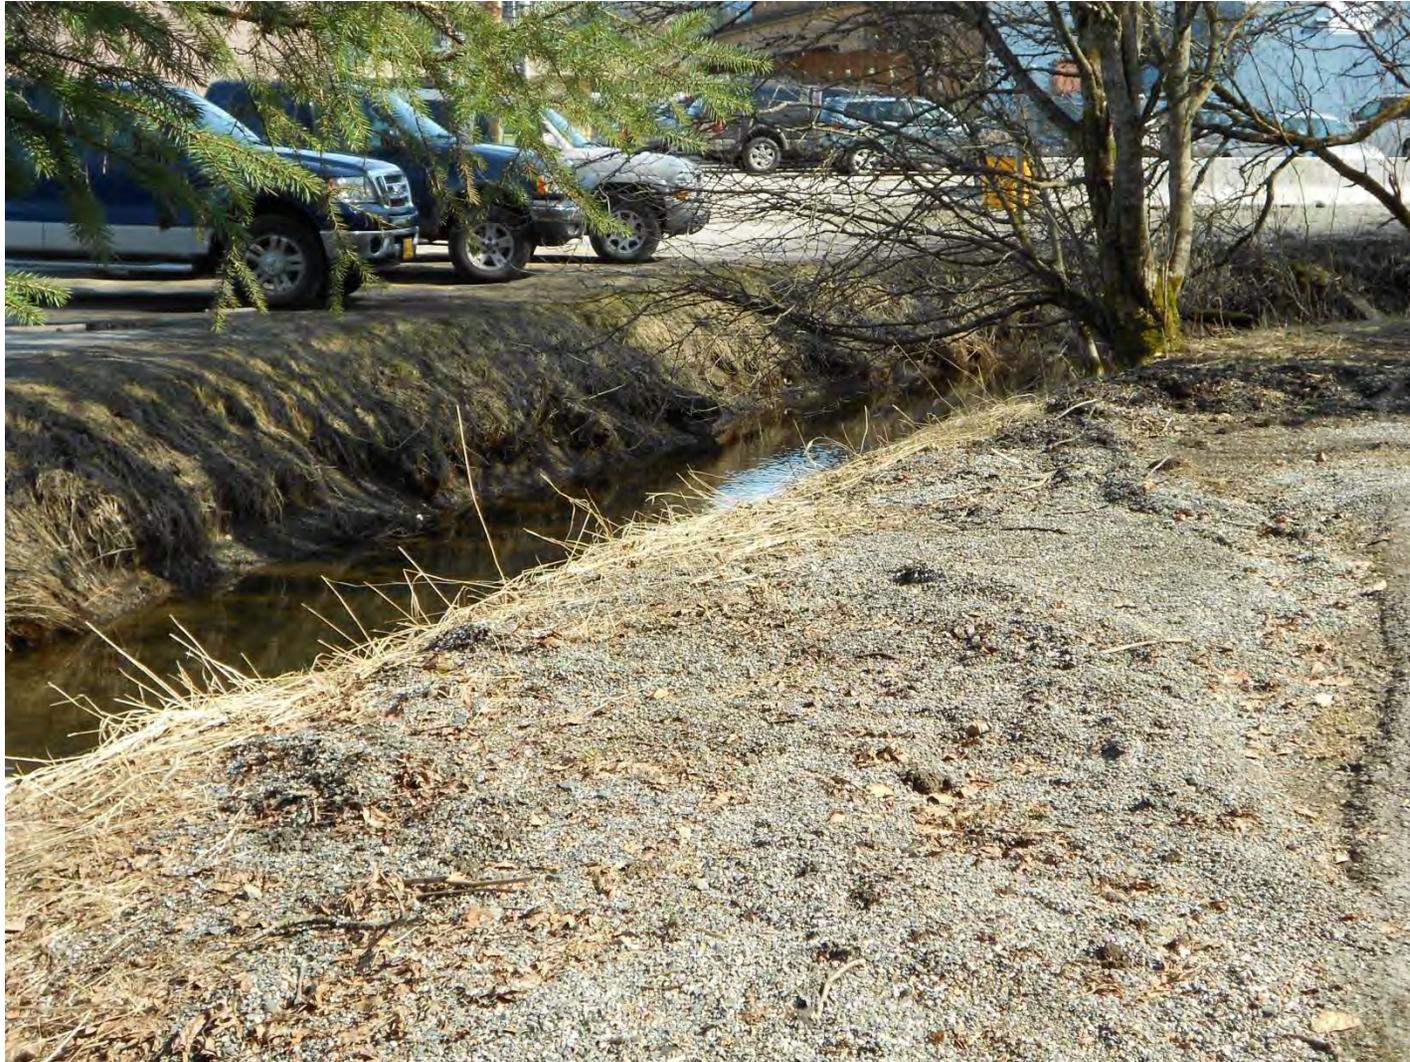
Figure 3. North side of the Edward K Thomas Building, looking east toward back parking lot. Note the sediment from melted snow. Vegetation not yet emerged. Photo taken April 2014.

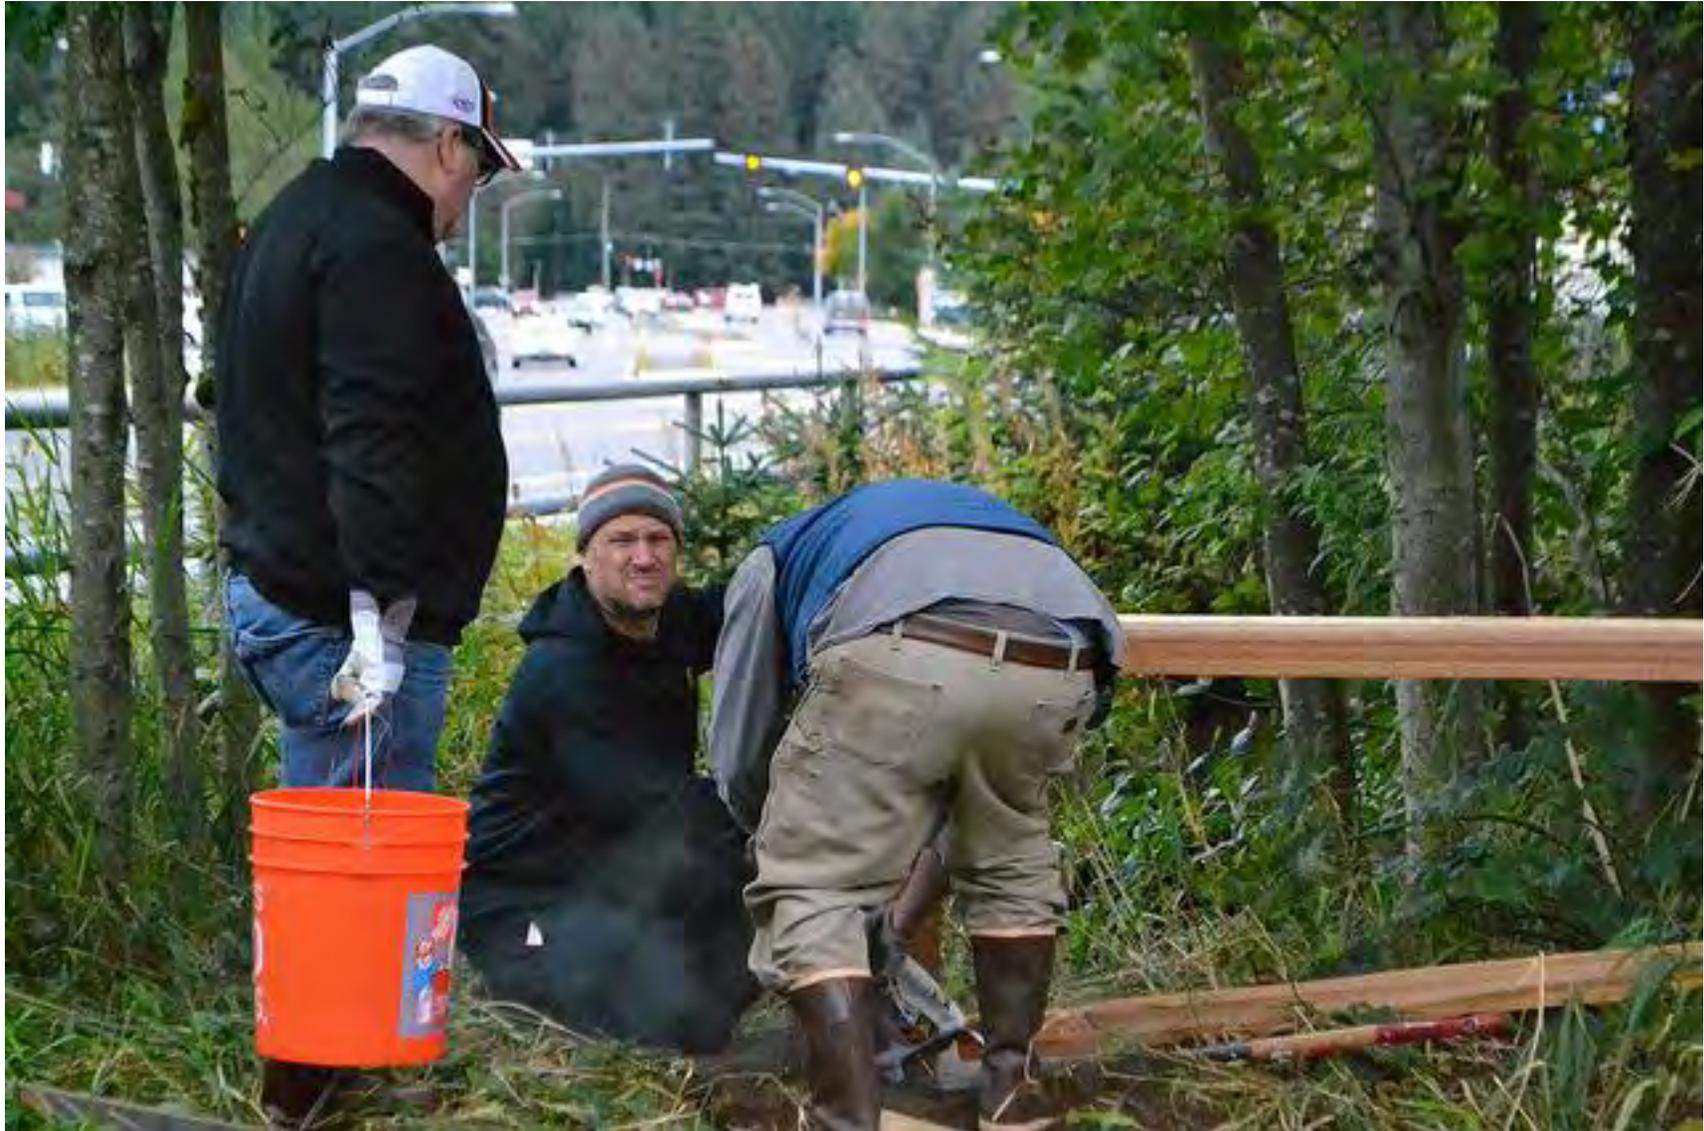
Figure 10. Installing the first length of fence. Photos taken September 2015.

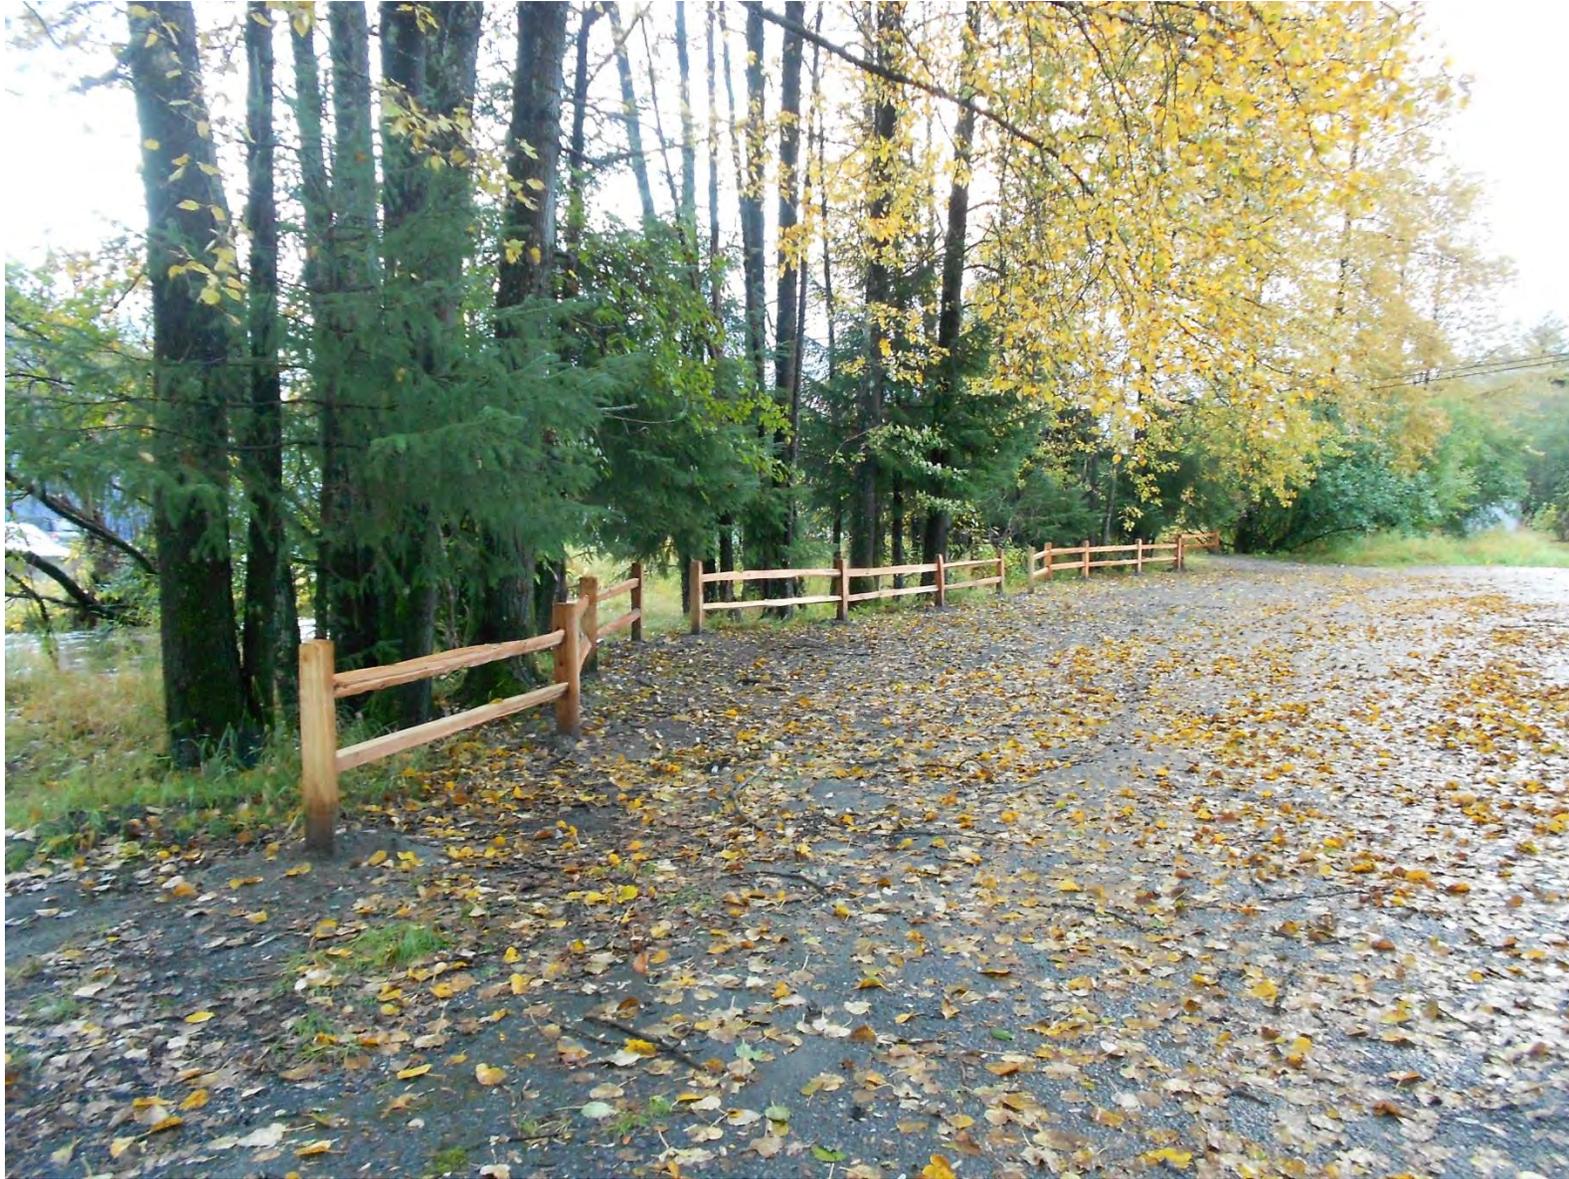
Figure 19. The finished fence along the back of the Edward K Thomas Building. Photos taken September 2015.

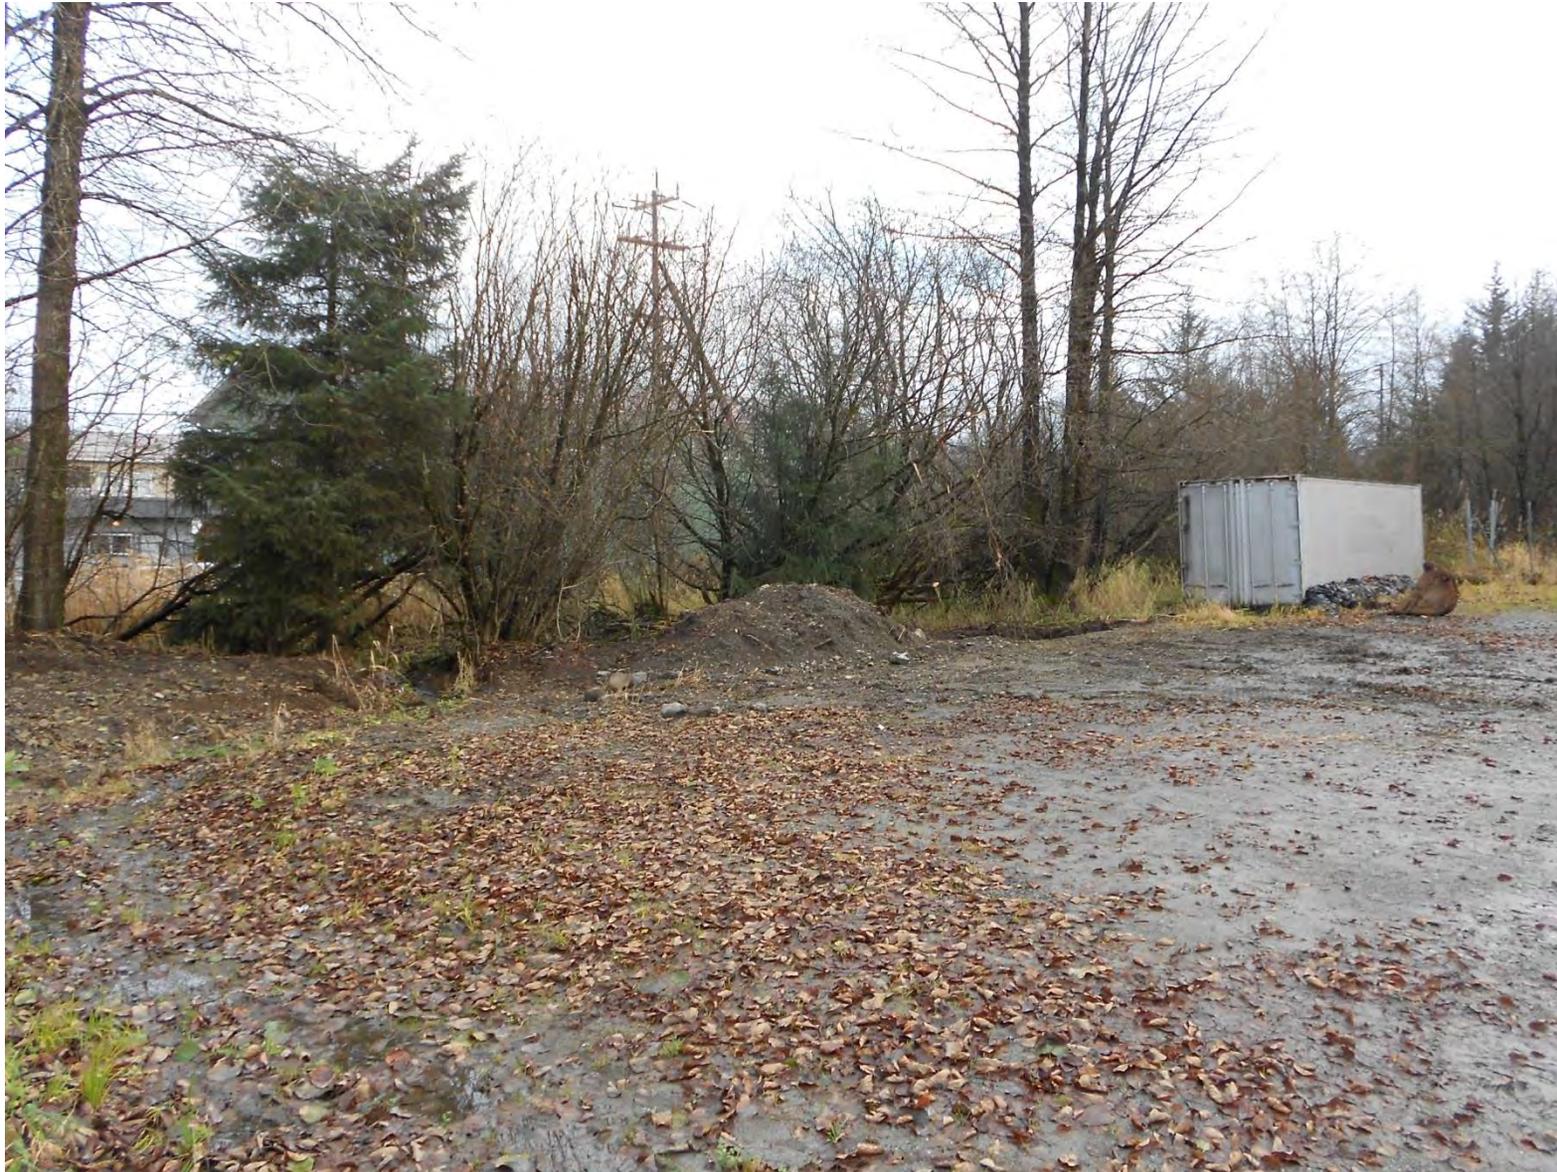
Figure 22. Start of rain garden excavation. Photo taken November 2015.

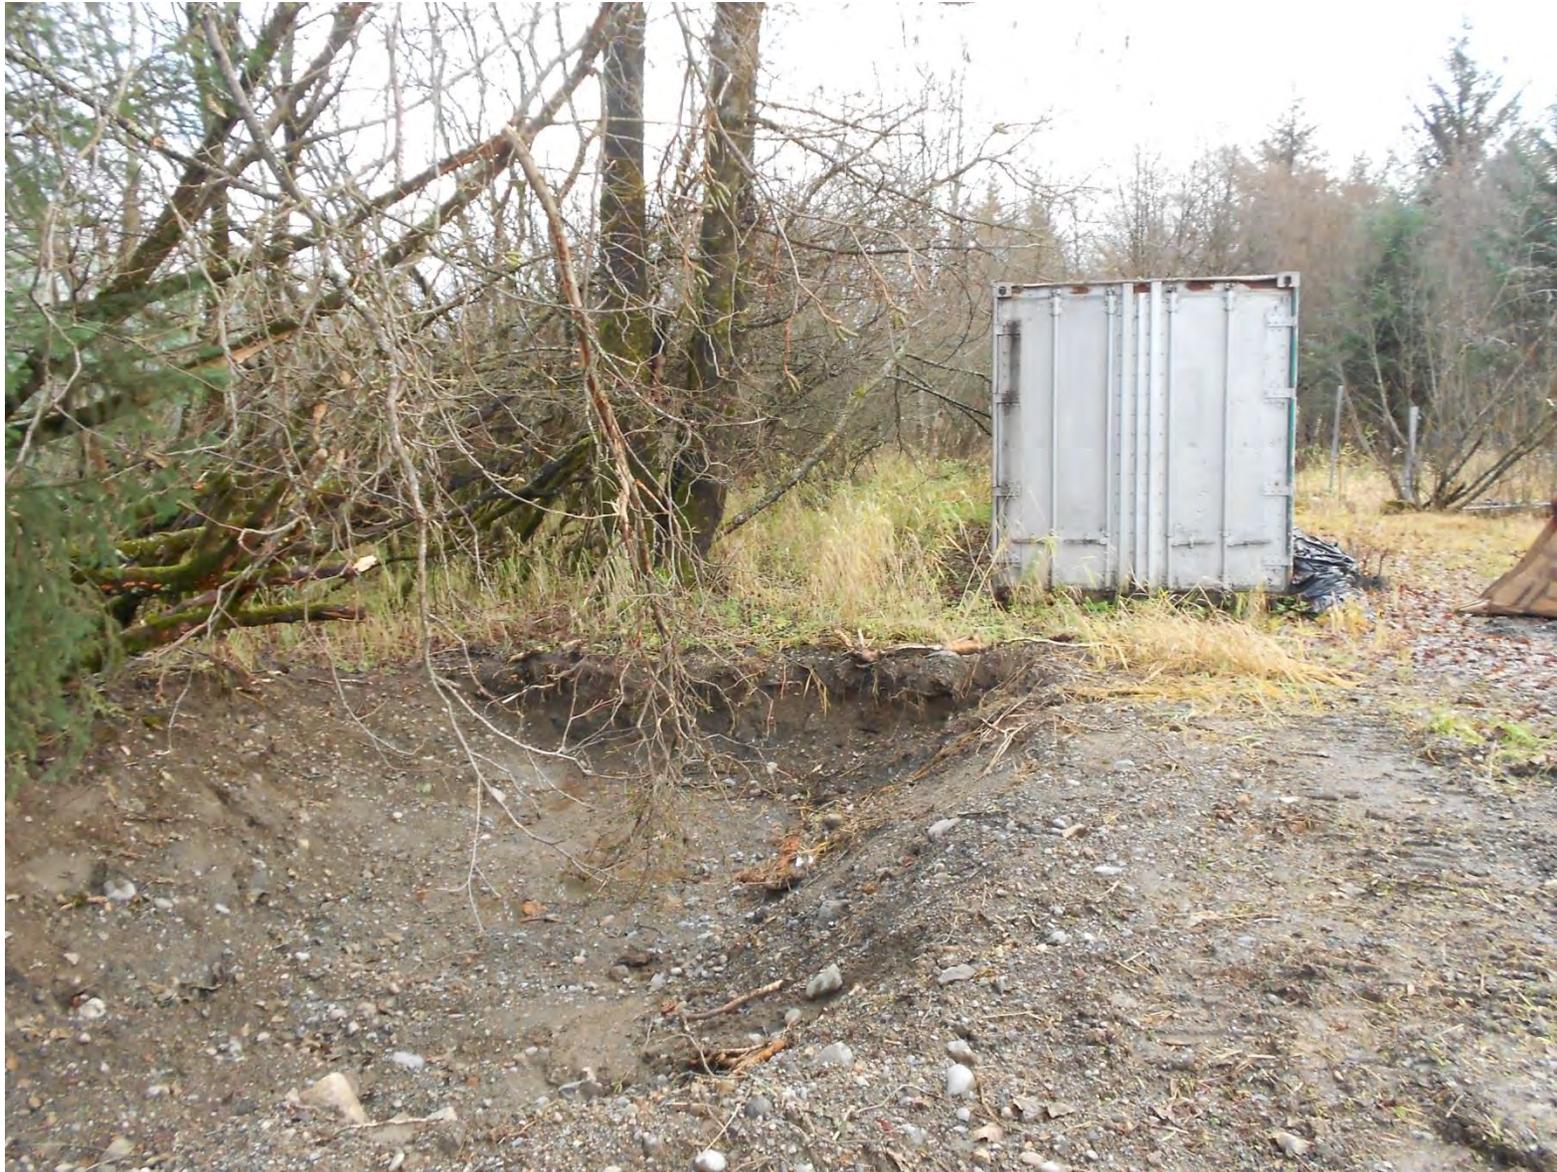
Figure 23. Close-up of the rain garden excavation. Photo taken November 2015.

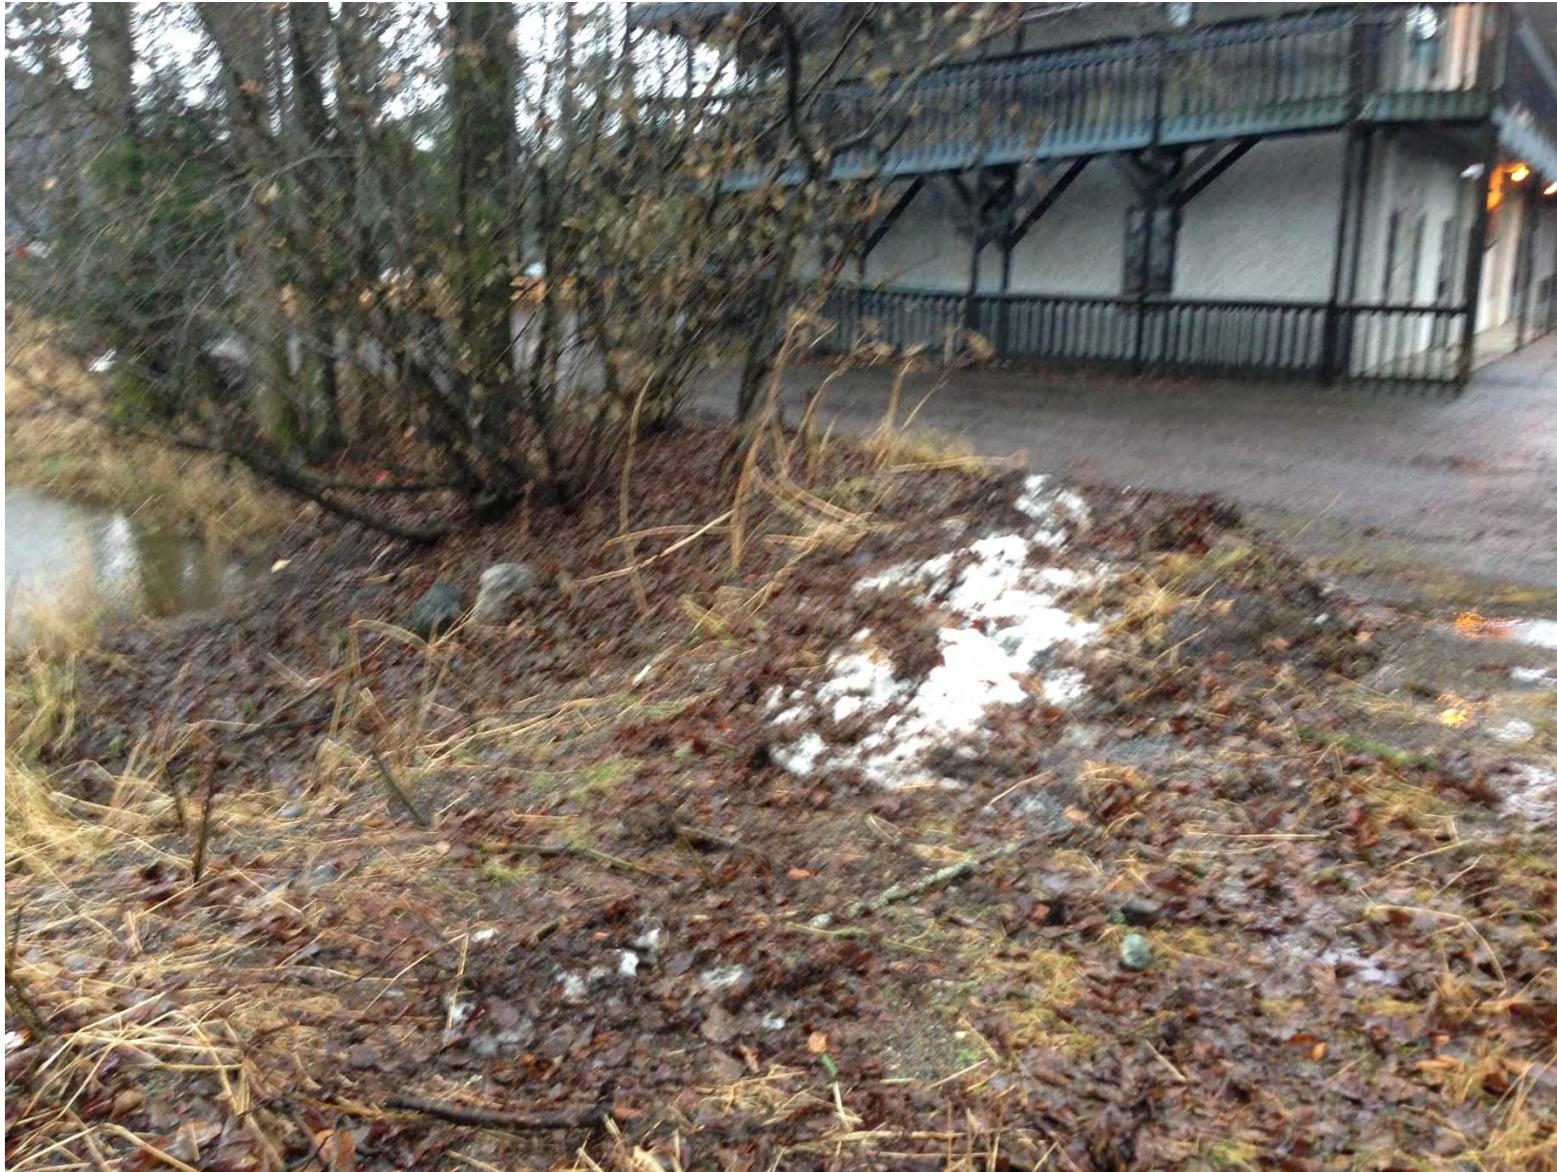
Figure 24. Snow plowed into area with new riparian plantings. Photo taken November 2015 by DEC.

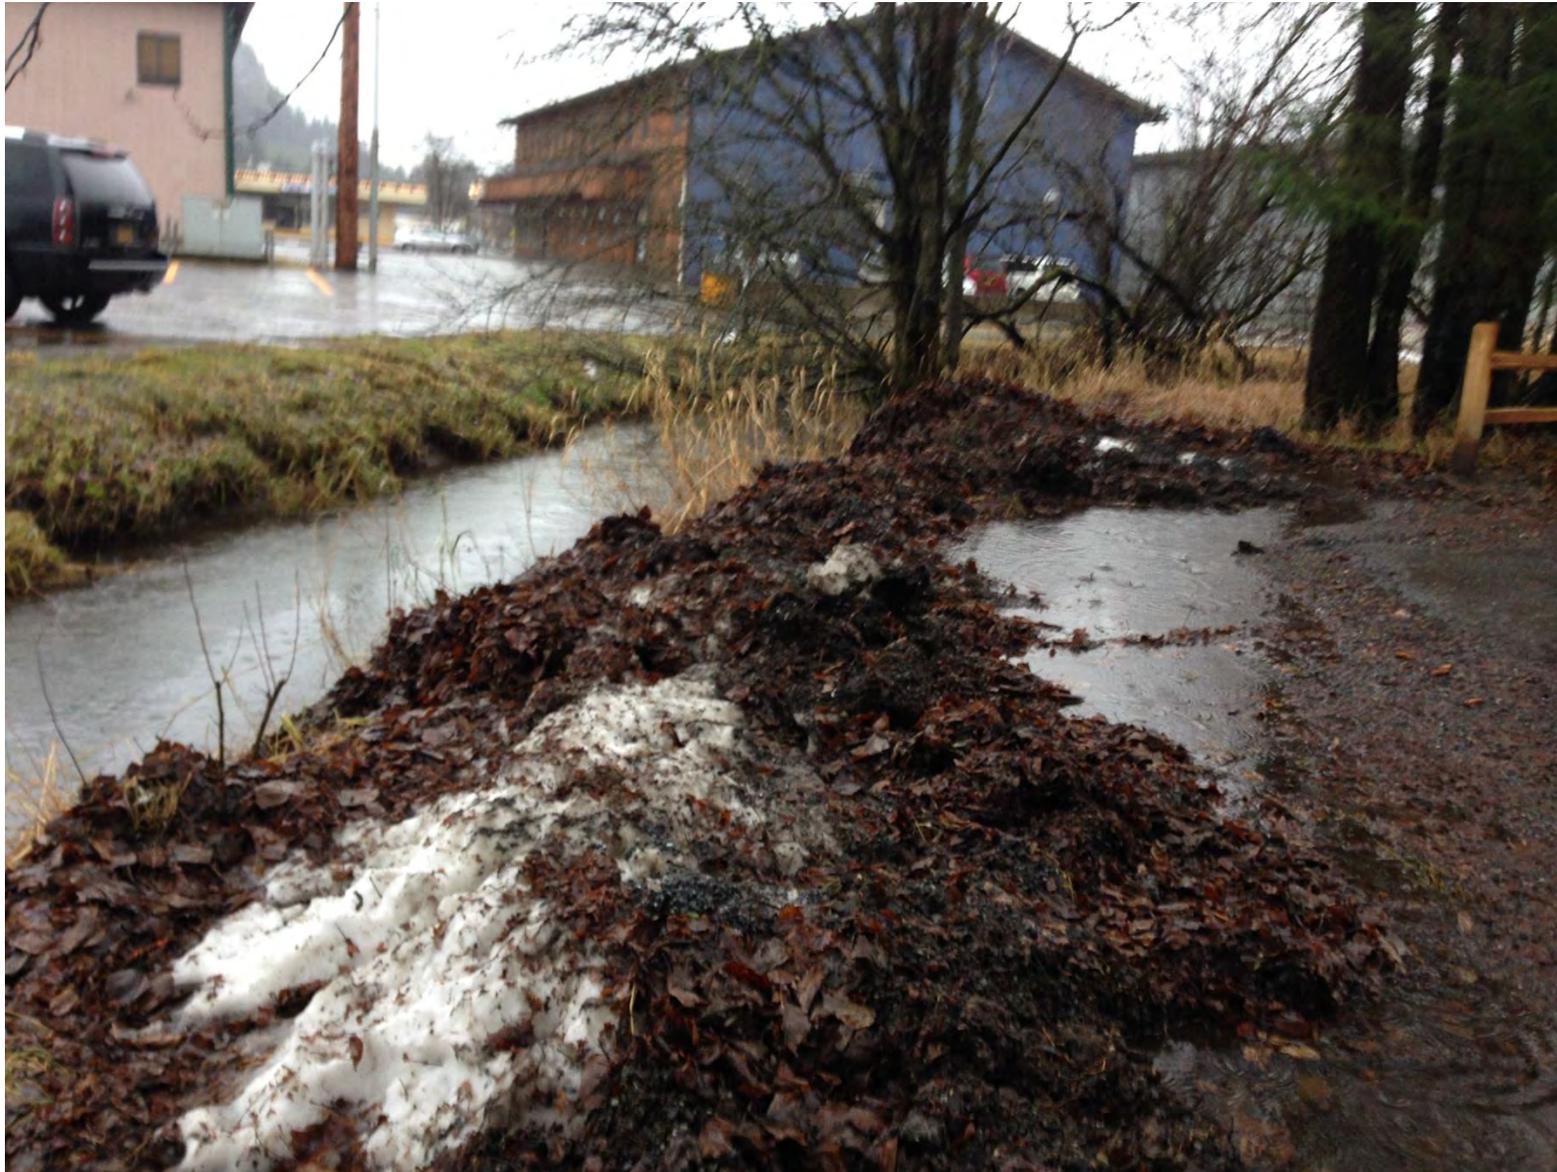
Figure 25. Snow plowed into area with new riparian plantings. Photo taken November 2015 by DEC.

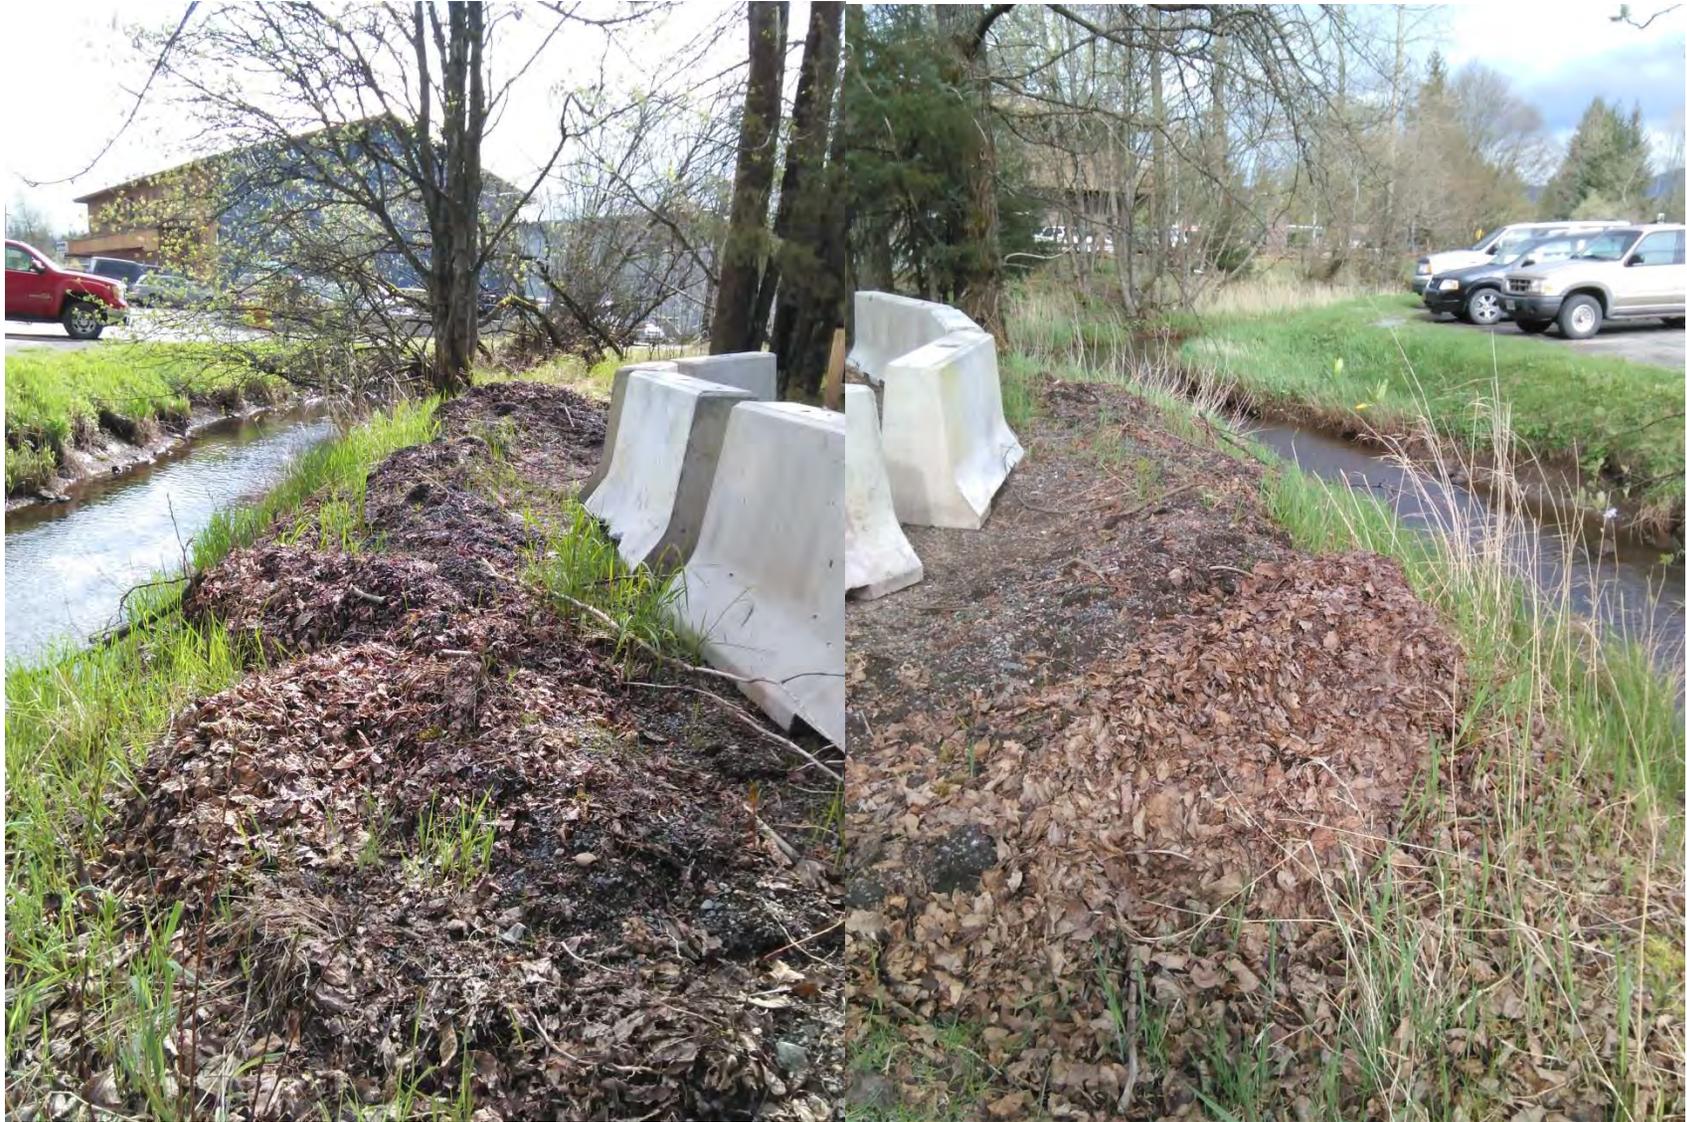
Figure 30. Spring assessment of riparian plantings at the back corner of property looking downstream (left) and upstream (right). Winter plowing caused the leaf and sediment deposits prior to placement of the concrete barriers. This location is the most impacted from last winter. Photos taken by JWP on April 15, 2015.
