EDWARD K. THOMAS BUILDING
JORDAN CREEK
GREEN INFRASTRUCTURE PROJECT
FINAL REPORT

JUNEAU WATERSHED PARTNERSHIP

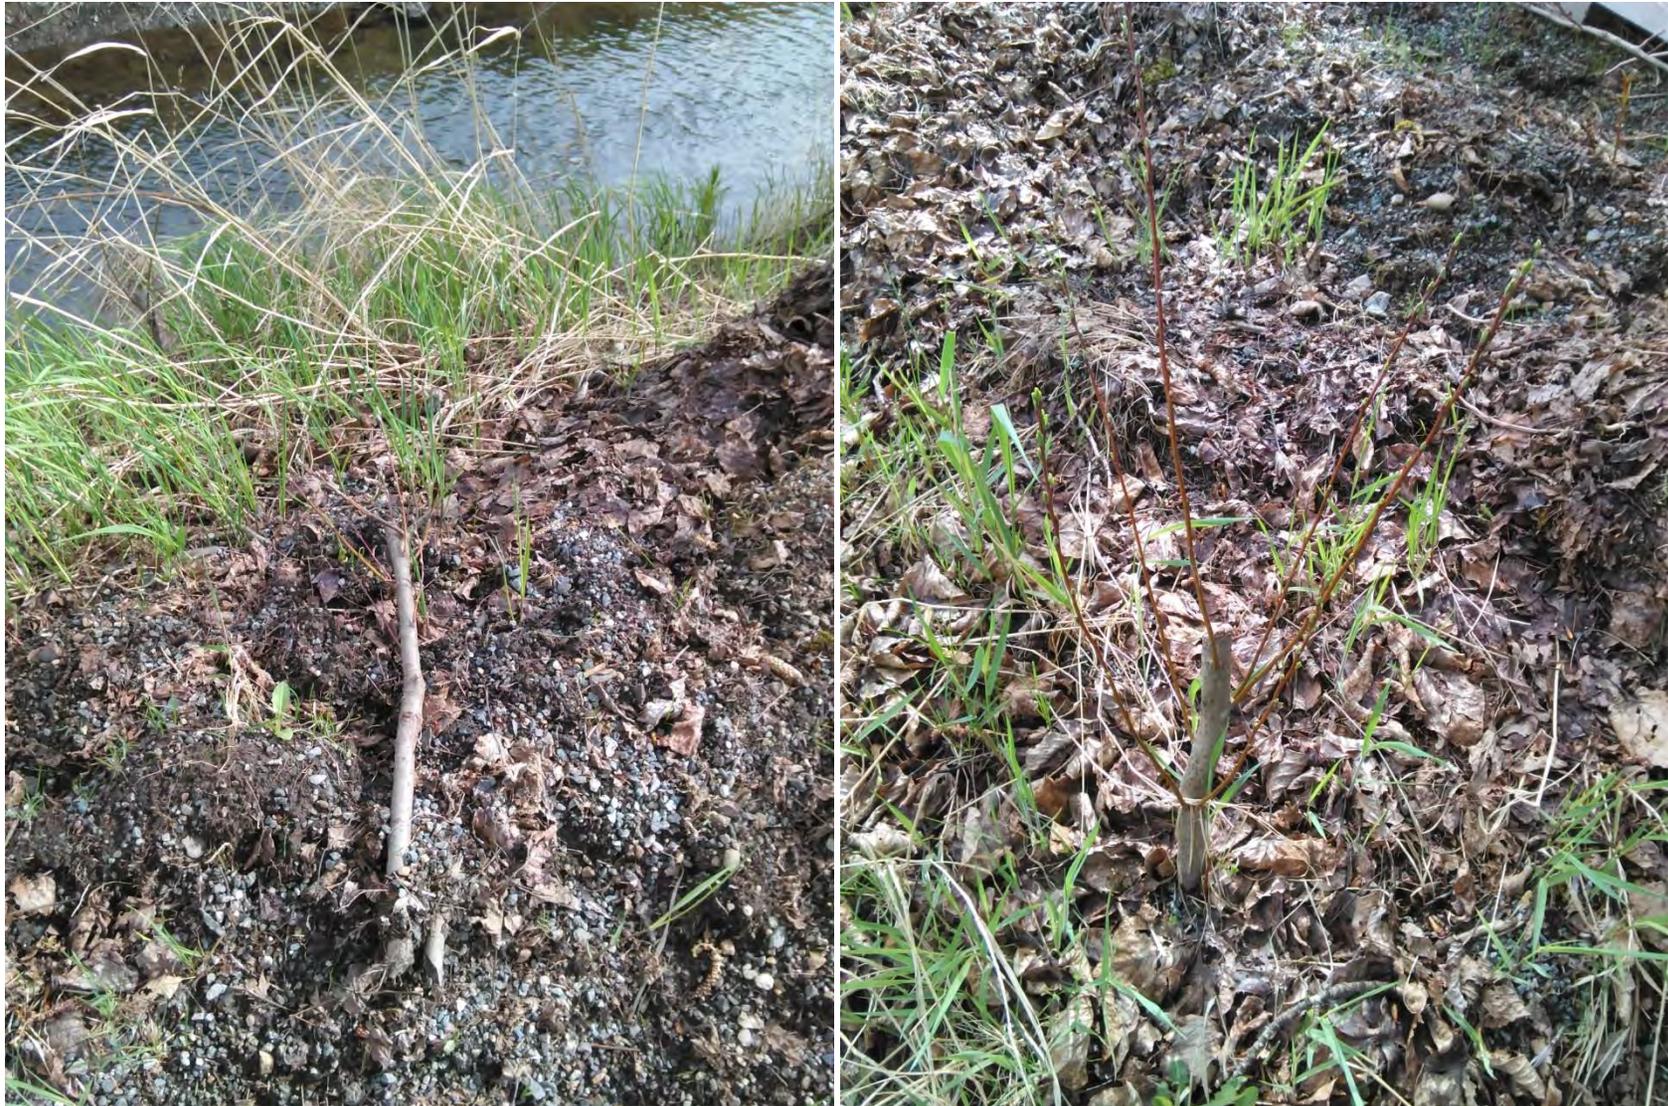
Figure 31. Spring assessment of riparian plantings at the back corner of property with examples of plants that were damaged (left) and plants that are thriving (right). This location is the most impacted from last winter. Photos taken by JWP on April 15, 2016.

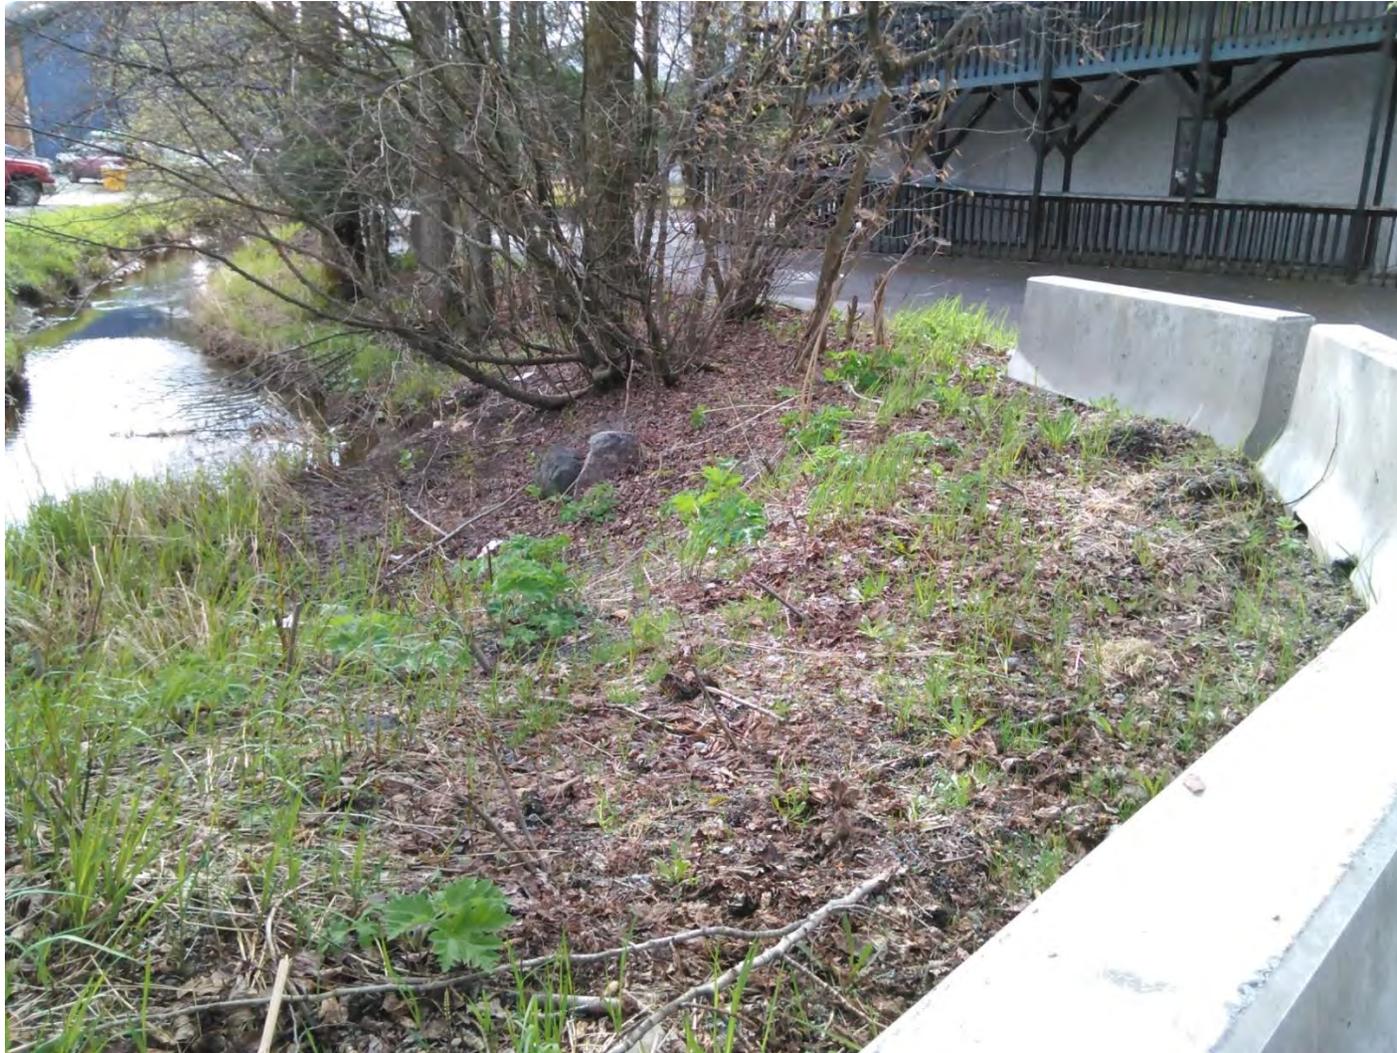
Figure 32. Spring assessment of riparian plantings at the front corner of the property. Winter plowing caused the leaf and sediment deposits prior to placement of the concrete barriers. However, this location was not as impacted as the back corner from last winter. Photos taken by JWP on April 15, 2016.

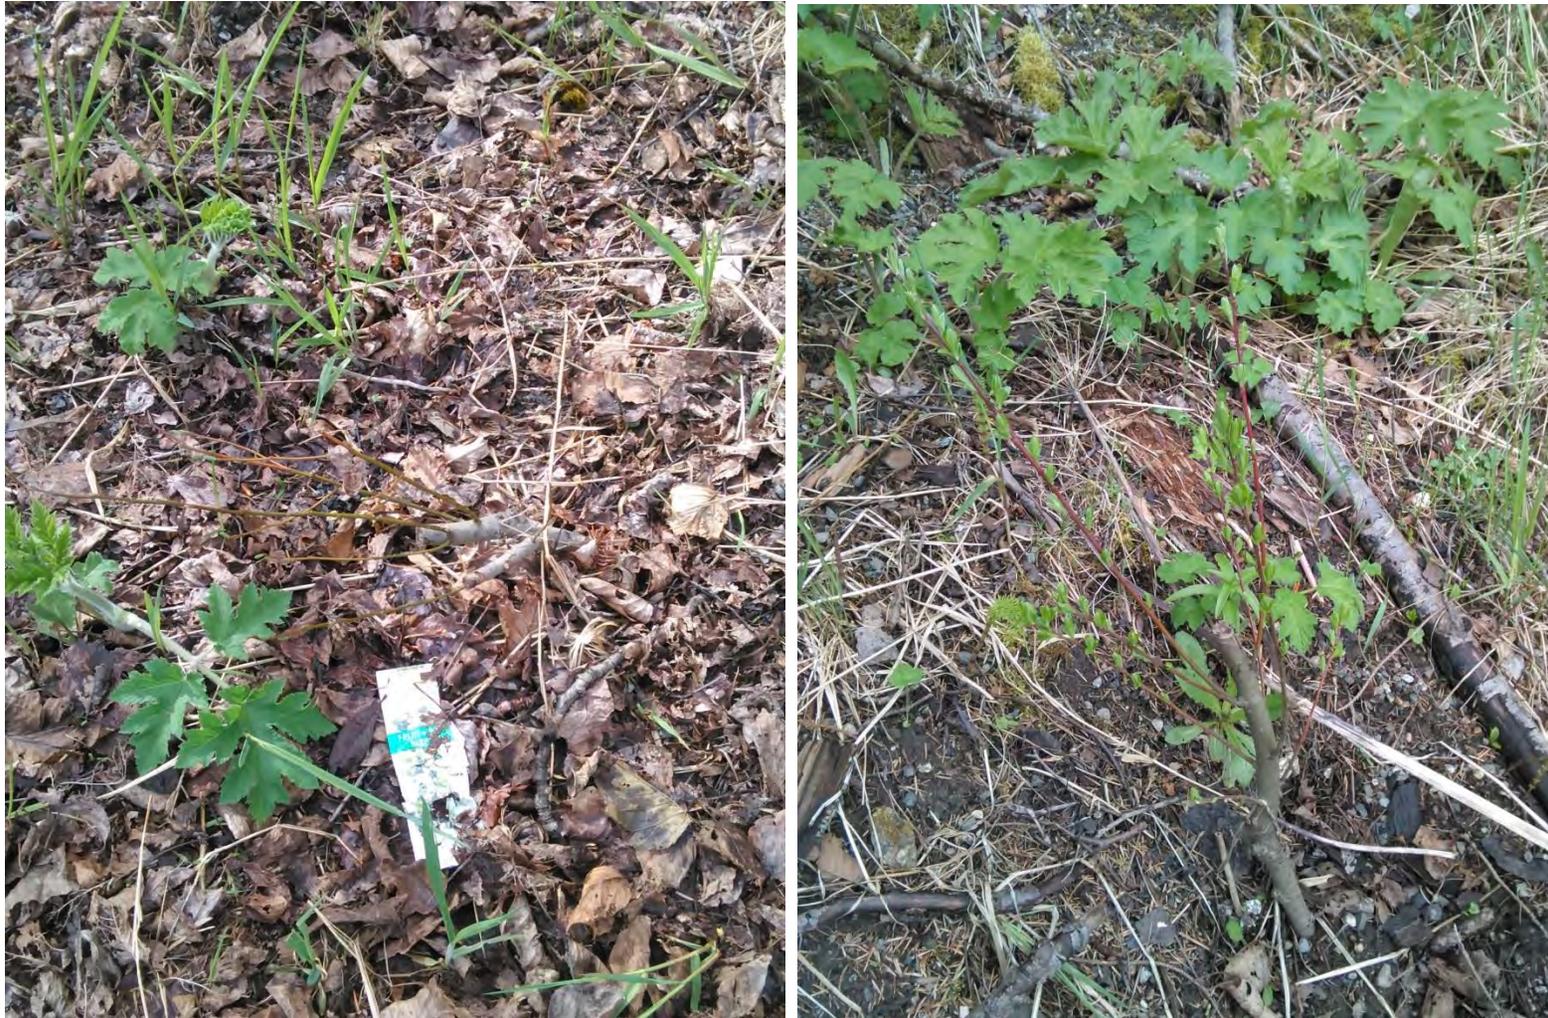
Figure 33. Spring assessment of riparian plantings at the front corner of property with examples of plants that were damaged (left) and plants that are thriving (right). This location was mildly impacted from last winter. Photos taken by JWP on April 15, 2016.

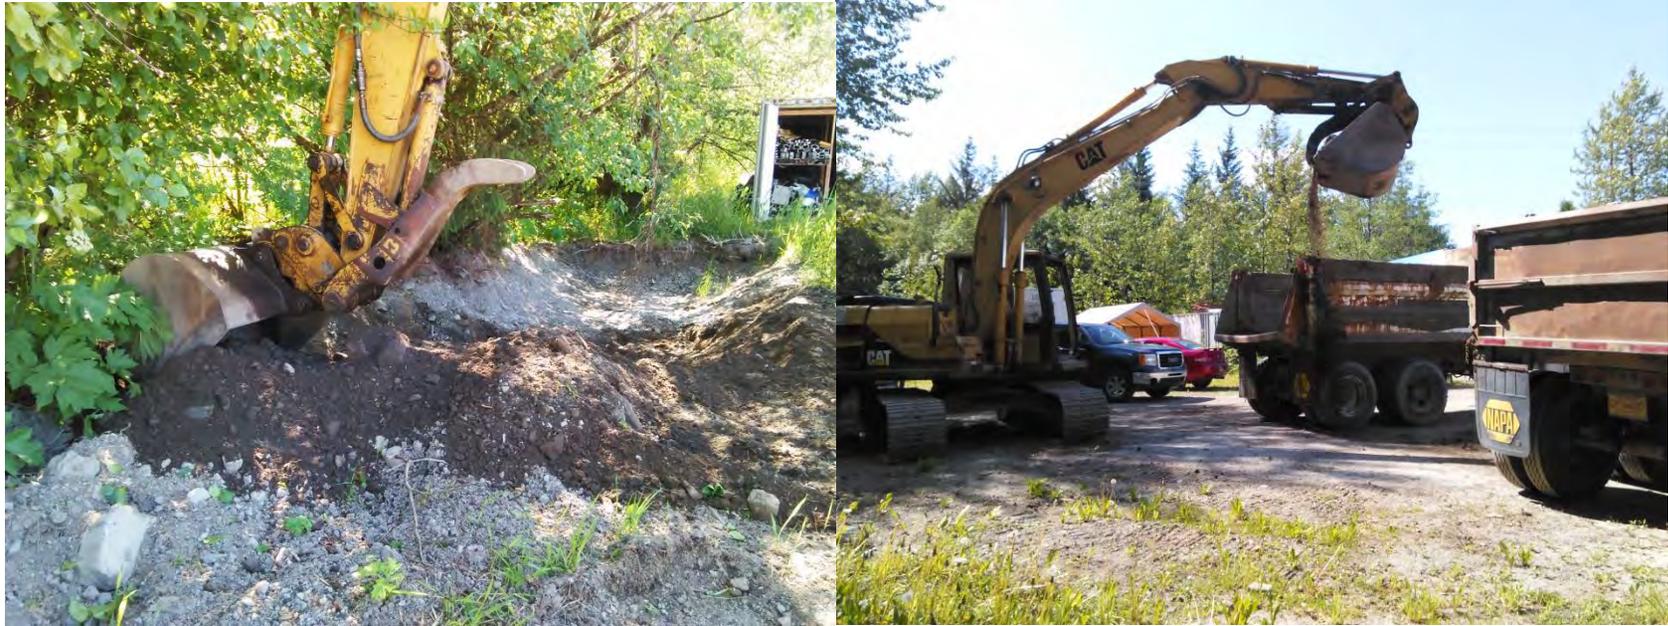
Figure 34. Start of the final construction of the rain garden on May 28, 2016. Photos taken by JWP.

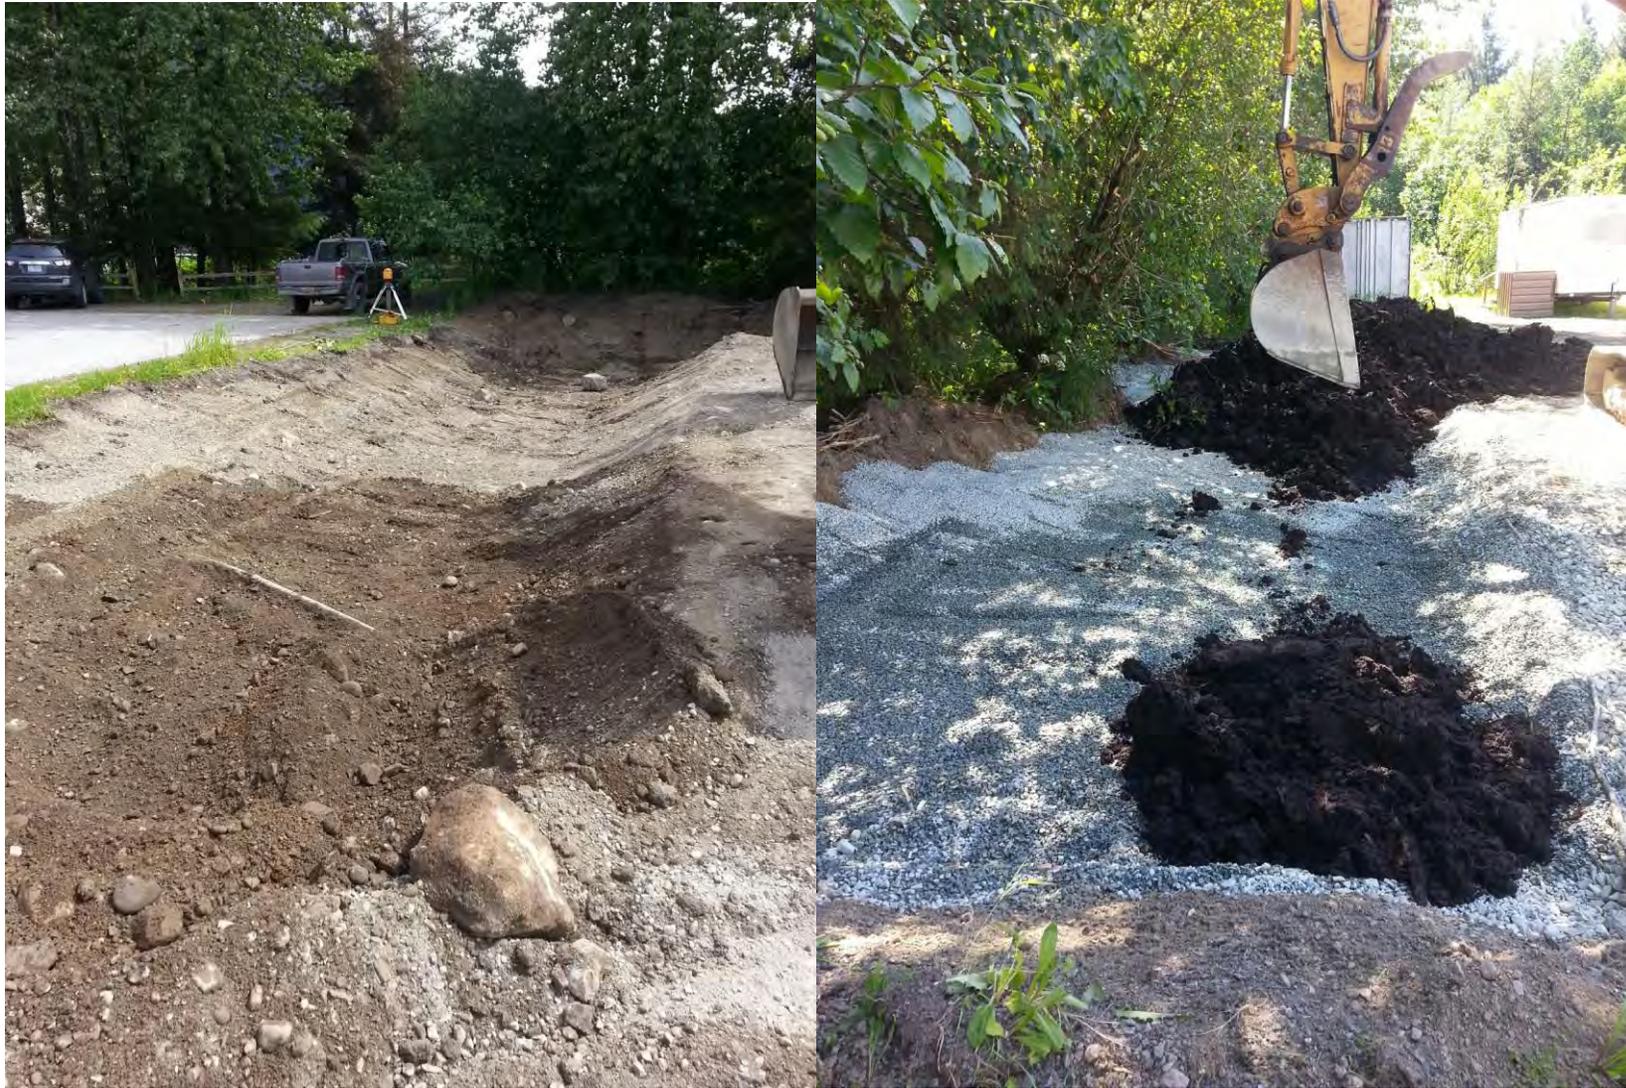
Figure 35. Construction of the rain garden and rock swale continues. The rock swale excavation (left) and placement of drain rock and top soil in the rain garden (right). Photos taken by Dave Hanna, SOURCE, LLC., on June 9, 2016.
