Vanderbilt Creek Watershed Recovery and Management Plan

Vanderbilt Creek Watershed in Juneau, Alaska

Author: Amy Sumner
Prepared for: Juneau Watershed Partnership
June 2007

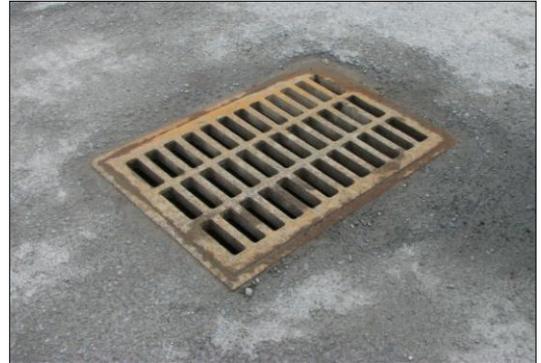
Figure 5. A storm drain on Short Street that transports sediment directly into Vanderbilt Creek.

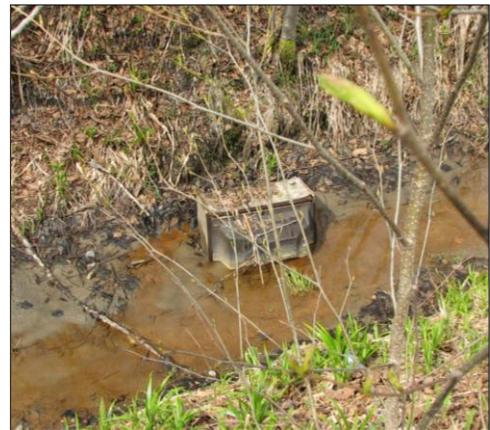
Figure 6. A TV in a ditch that drains from Charles Way to Vanderbilt Creek.

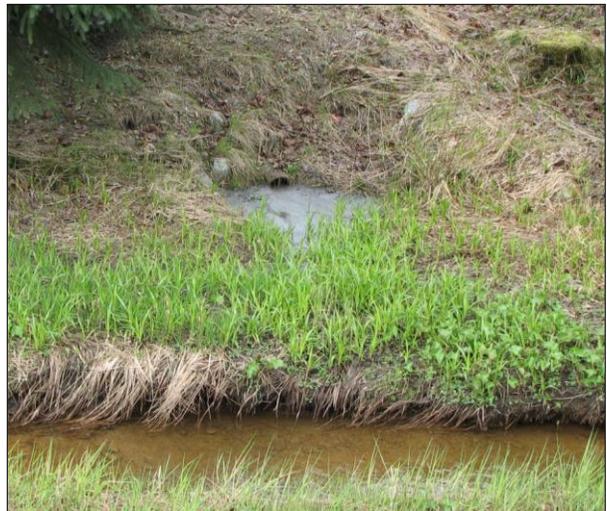
Figure 7. A small drain with a pool of sludge accumulating near Vanderbilt Creek.

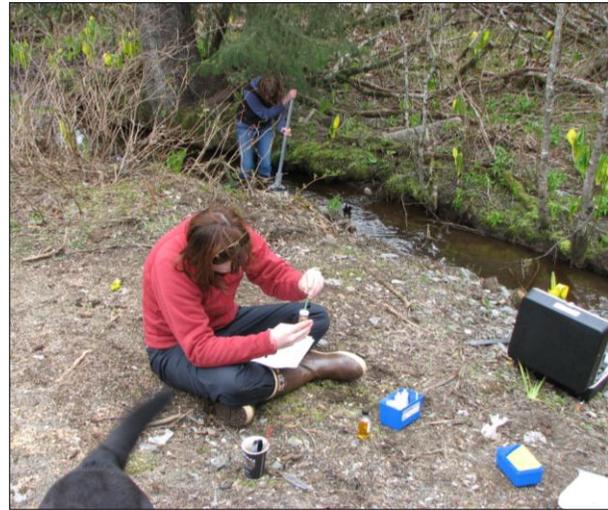
Figure 8. JWP volunteers conducting a rapid bioassessment on Vanderbilt Creek.

The Juneau Watershed Partnership (JWP) volunteers conducted a rapid bio-assessment of Vanderbilt Creek in May 2007 (Figure 8). Using the volunteer-level methods developed by ENRI, data was collected along a 25-meter portion of the ENRI sampling site on Vanderbilt Creek. The JWP data was collected in association with this project to establish a point in which to begin current discussions of the stream's health. Data from JWP's rapid bioassessment suggest that Vanderbilt Creek's water quality continues to be impaired (see Appendix C).

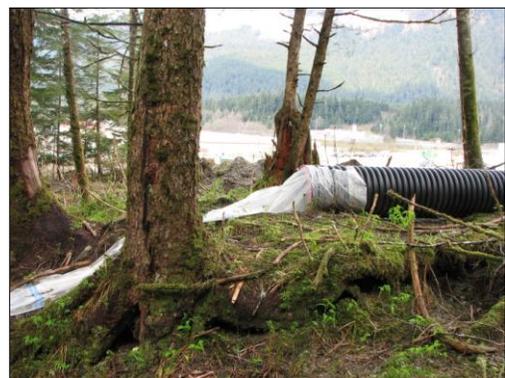
Figure 9. The temporary water diversion conduit that transports stormwater from the hill behind Home Depot into Vanderbilt Creek. June 2007

Action 1.3.2: Work with Home Depot to improve quality of stormwater diverted into Vanderbilt Creek.

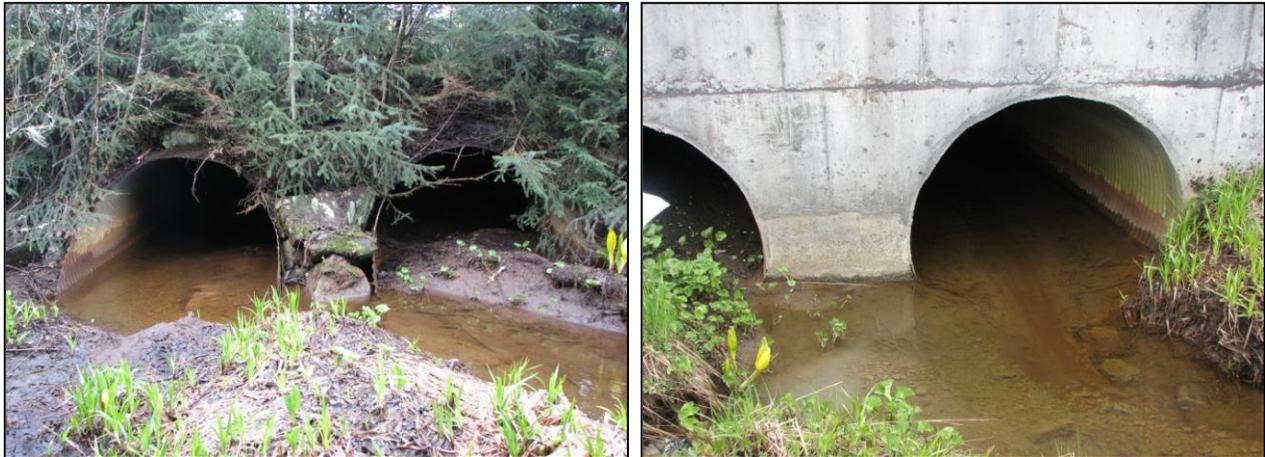
Figure 10. The inlet (left) and outlet (right) of the Glacier Highway culverts. As shown, one of the culverts has failed due to sediment build up.

The pair of culverts that direct the mainstem of Vanderbilt Creek under Glacier Highway have several problems that make them a priority for replacement. Both culverts are closed-bottom which could affect the presence of natural substrate and hydrologic conditions, and there is visible rotting of the culvert material in one of the culverts.

In addition, the culverts are not placed in a manner that creates an appropriate fish crossing. One of the culverts has failed, and does not seem to be directing stream flow (Brian Frenette, personal communication, May 13, 2007). This particular culvert appears to be blocked by a sediment bank that formed at the inlet of the culvert. According to Brian Frenette, at high flow this culvert may provide a velocity barrier to fish, and he recommends that these culverts should be replaced with a bridge.

Action 2.3.1: Replace culverts located on Glacier Highway, near the north entrance of Western Auto/Grant Plaza

Before a decision is made to replace the culverts with a bridge, the crossing can be assessed using the USFS “FishXing” software, and the crossing conditions can be assessed to determine what type of structure would be the best replacement.

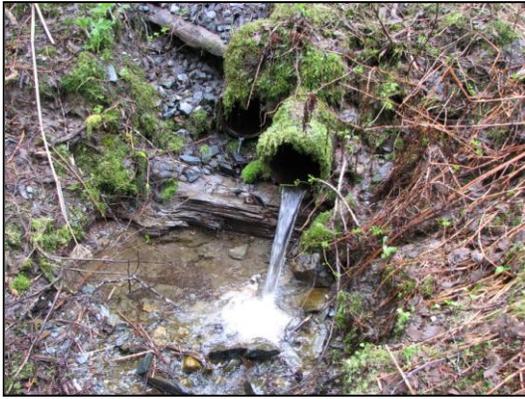
The Vanderbilt Creek tributaries along the Lemon Creek Trail bisect active alluvial fans, which appear to provide excellent coho habitat (Brian Frenette, personal communication, May 13, 2007). However, many of the culverts directing tributaries under the Lemon Creek Trail are too small in diameter and have perched outlets. In addition, the Lemon Creek Trail, which is actually a 15-ft wide drivable gravel route, is acting like a dike and constricting water flow. Both the culverts and the road are subsequently disconnecting much of the habitat at the toe of the alluvial fan.

Figure 11. One of several undersized, perched culverts on Vanderbilt Creek along the Lemon Creek Trail

Action 2.3.2: Replace culverts on several Vanderbilt Creek tributaries along the Lemon Creek trail with bridges and reconnect the habitat.

Though fish have not been seen using many of these tributaries (Pat Quigley, personal communication, May 13, 2007), Frenette suspects that coho have historically used the waters and will do so again once the habitat is reconnected. Replacing these culverts with bridges would allow each tributary to flow naturally across the landscape, reconnecting the habitat. Frenette says proper stream crossings would also prevent road washout along the Lemon Creek Trail. Again, these culverts can be assessed using the US Forest Service' (USFS) "FishXing" software and alternatives for replacement structures can be considered.

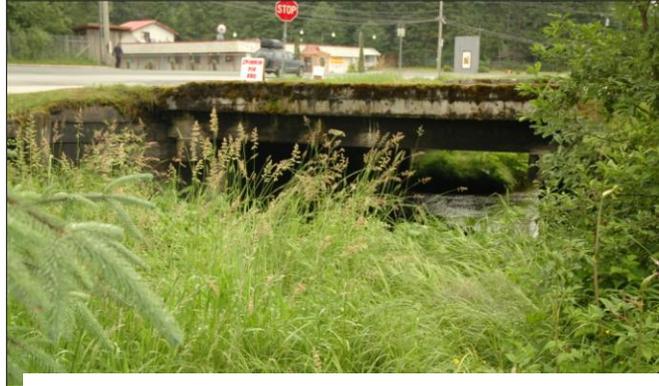
Two creosote bridges cross Vanderbilt Creek on Glacier Highway, providing access to Grant's Plaza/Western Auto and Jerry's Meats. There is also an additional creosote abutment that is currently not being used as a bridge.

Figure 12. One of the creosote bridges crossing Vanderbilt Creek. Photo by: Eric J. Chandler

Action 3.1.3: Remove the creosote bridges and abutments located on Glacier Highway.
