Willow Creek Water Quality and Habitat Assessment

Alaska Department of Environmental Conservation

Jeffrey C. Davis, Gay A. Davis, Hanna Ramage, and Michelle Briggs
P.O Box 923, Talkeetna AK, 99676
arri@arrialaska.org 907.315.4631

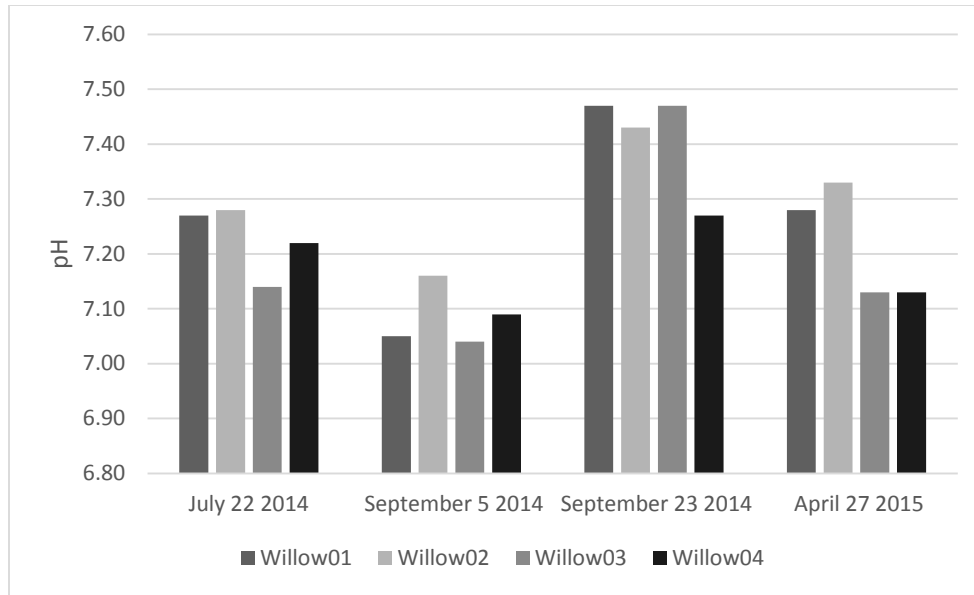
Figure 2. Stream water pH at all sampling locations, measured during summer baseflow (July 22), two fall storm events (Sept 5 and 23), and spring flow.

Results for in situ water quality measurements are shown in figures 2 through 4. Stream water pH was over 7.0 on all sampling dates. pH was highest for all four sites on September 23, 2014, during the second fall storm event, while the lowest pH was recorded on September 5, 2014, the first storm event. Stream water pH likely varies from the rising to falling limb of the hydrograph through a storm event as soil organic acids are flushed from upland and riparian forests and wetlands. Stream water pH tended to decrease downstream with the lowest values at downstream sites. Specific conductivity generally increased throughout the season, as shown in Figure 3. The lowest specific conductivity was recorded in July 2014 at all four sites, while the highest specific conductivity was recorded at all four sites in April 2015. Dissolved oxygen was near saturation at all sites throughout the study as shown in Figure 4. Willow01 had the lowest percent saturation of dissolved oxygen at 92.2% on April 27, 2015 at Willow01 when ice cover was still present, while the highest percent saturation of dissolved oxygen was at Willow02 on September 23, 2014, at 104.0%.

This study results indicate that water quality and habitat in Willow Creek are generally in good condition, with some areas that may warrant further monitoring. *In situ* measurements of water chemistry were fairly consistent throughout the data collection period. Stream water pH remained

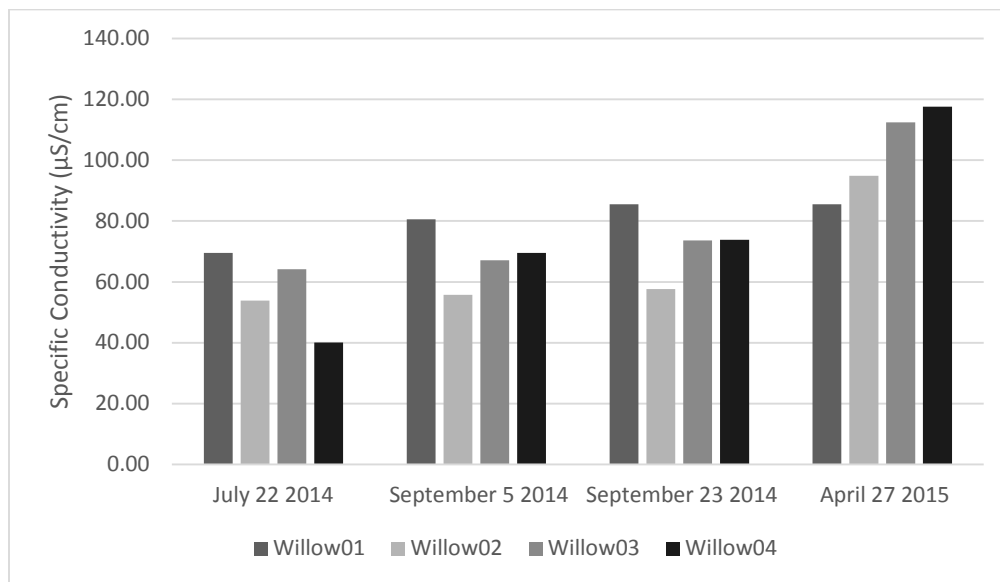
Figure 3. Specific conductivity at all sampling locations, measured during summer baseflow, two fall storm events, and spring flow.

between 7.00 and 7.50 on all sampling dates, with lower measurements at the beginning of a storm event and higher measurements after a period of increased precipitation during the month of September. Specific conductivity was highest in April 2015 and increased at downstream sites, which could be due to the use of road salts during the winter. High conductivity during spring sampling has been observed in other streams at higher latitudes (Corsi et al. 2010). Dissolved oxygen was at or near saturation at all sites. The lowest measurement, 92.0% saturation at Willow01 in April 2015, was likely lower due to compete ice cover upstream of the sampling location.

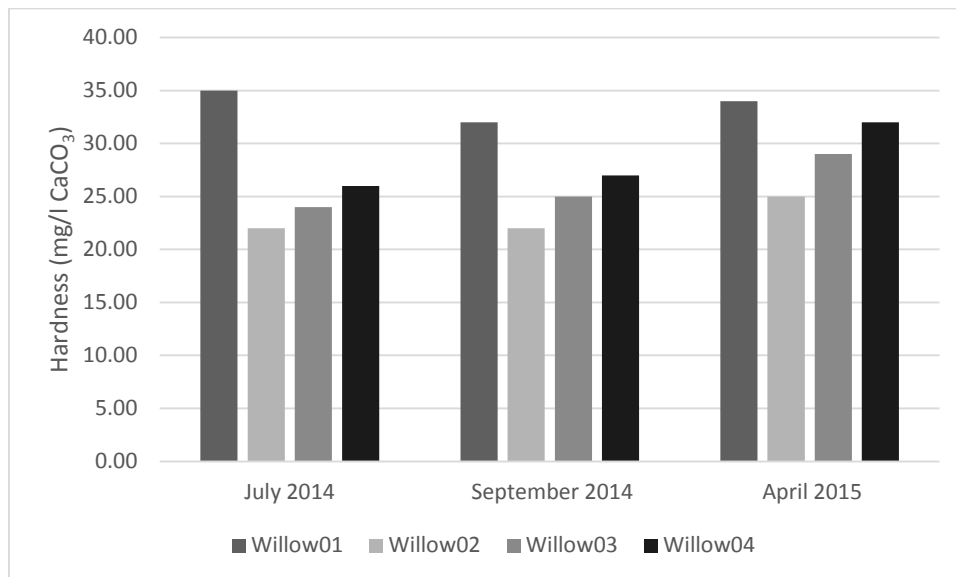
Figure 6. Hardness measured at all four sites during summer baseflow, a fall storm event, and during spring flow.

Alkalinity and hardness remained consistent throughout the study, and measurements were similar to those in the Little Susitna River (Davis and Davis 2007). Levels of inorganic nitrogen and ammonia nitrogen were low, and nitrogen was detected at only one site in July and September 2014. Levels were slightly higher in April 2015. It is likely that nitrogen is a limiting nutrient in Willow Creek, as molar N:P ratios were low (ranging from 3.15 to 14.74), and nitrogen was not detected in many of the samples. Low stream nitrogen has been observed previously in the Little Susitna River and other area streams during the growing season as nitrogen is taken up by upland and riparian vegetation.

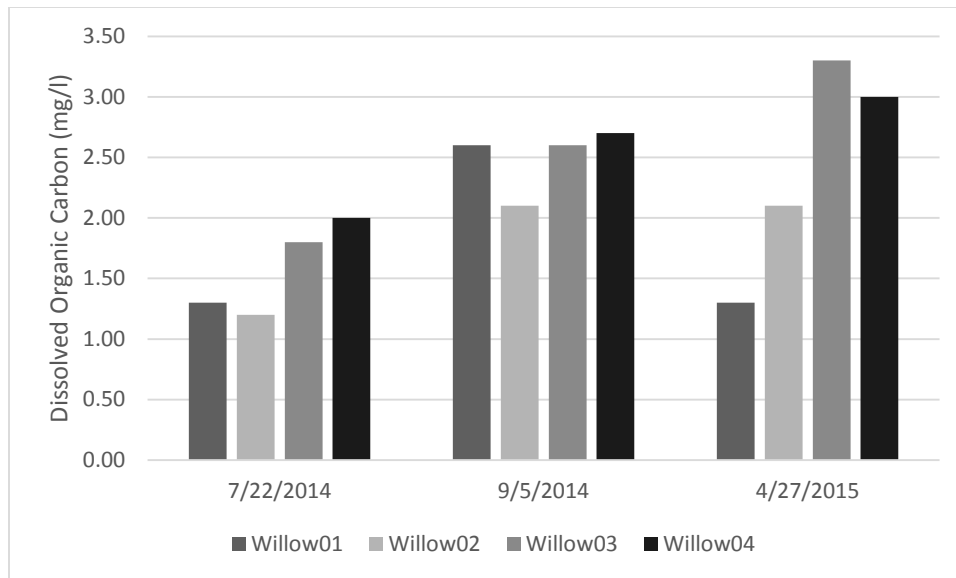
Figure 7. Dissolved organic carbon measured at all four sites during summer baseflow, a fall storm event, and spring flow.

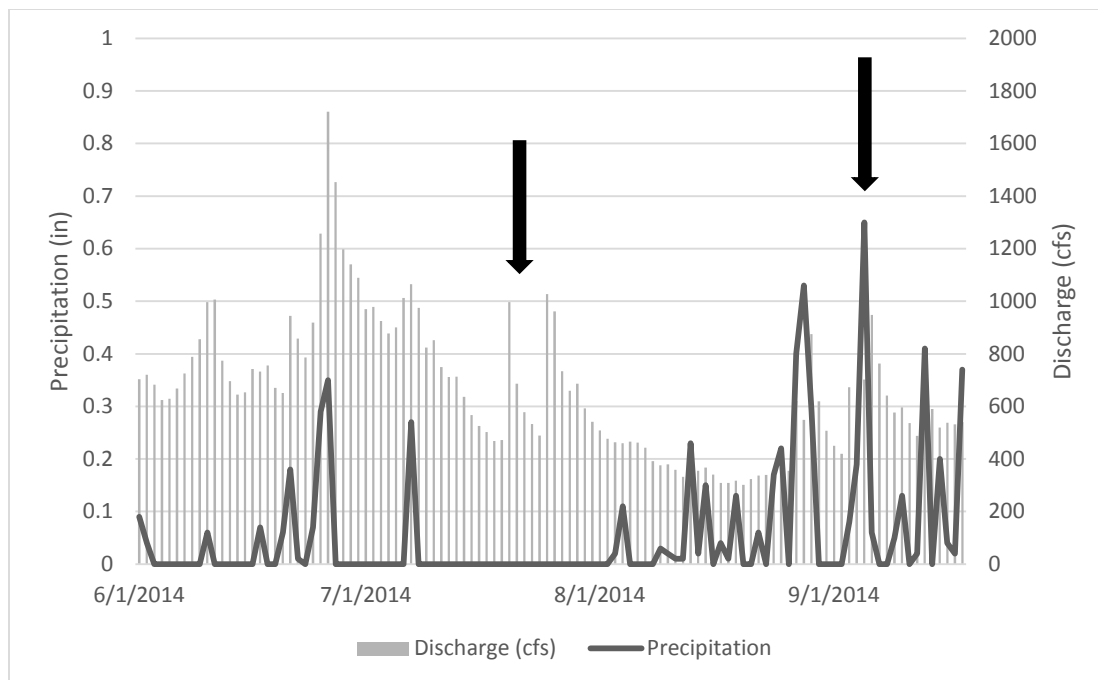
Figure 8. Total daily precipitation and average daily discharge during the open water months of 2014. Arrows indicate water sampling events on July 22 and September 5 2014.

Discharge peaked for the season on June 26 2014 at 1720.8 cfs, coinciding with a rain event (Figure 8 and 9). Following this peak, discharge tended to decrease until the beginning of September, when rainfall became more frequent.

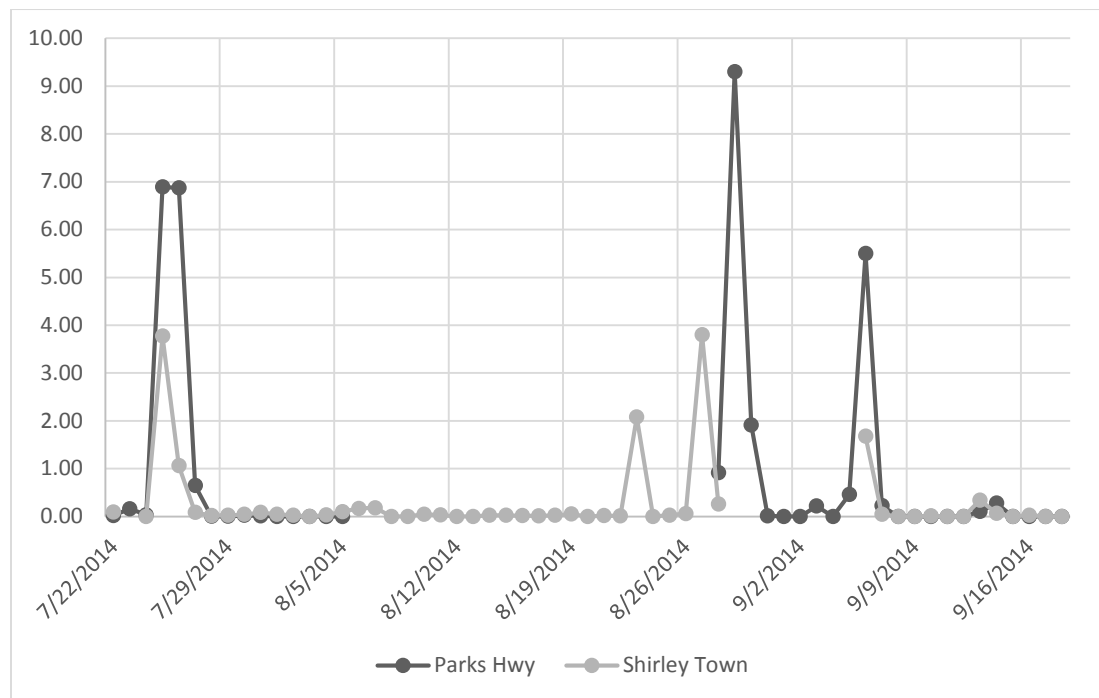
Figure 10. Daily average turbidity measured at the Shirley-Town Bridge and downstream of the Parks Highway crossing.

Throughout most of the season, turbidity was 0 NTU or just above 0 NTU at both the Parks Highway site and the Shirley Town Bridge site (Figure 10). Turbidity spiked on July 25-26, associated with a period of increased discharge. Turbidity also spiked several times in late August and in September, as precipitation increased. Turbidity increases were greater at the Parks Highway compared to measurements upstream at Shirley-Town Bridge. Turbidity always decreased to very low values following rapid increases. Stream flows began to increase in May with the highest value during the study period in June at over 1000 cfs.

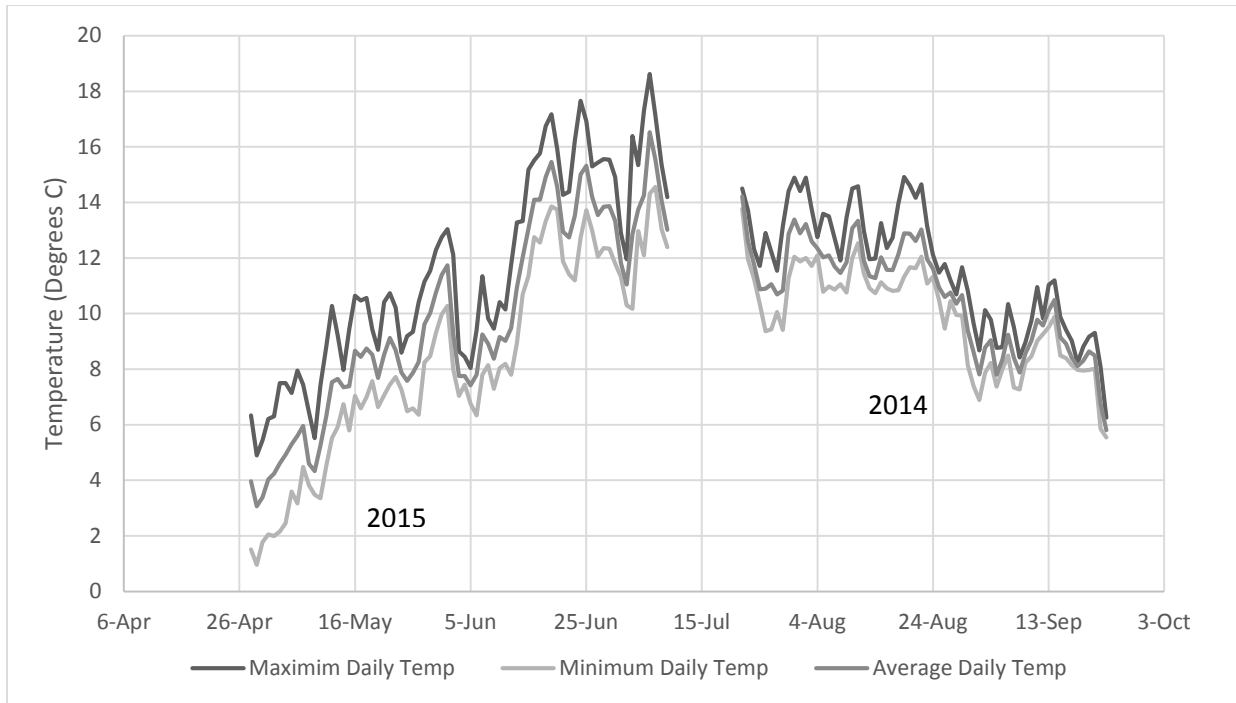
Figure 14. Maximum, minimum, and average daily temperature at Willow04 during periods of open water from July 2014-July 2015.

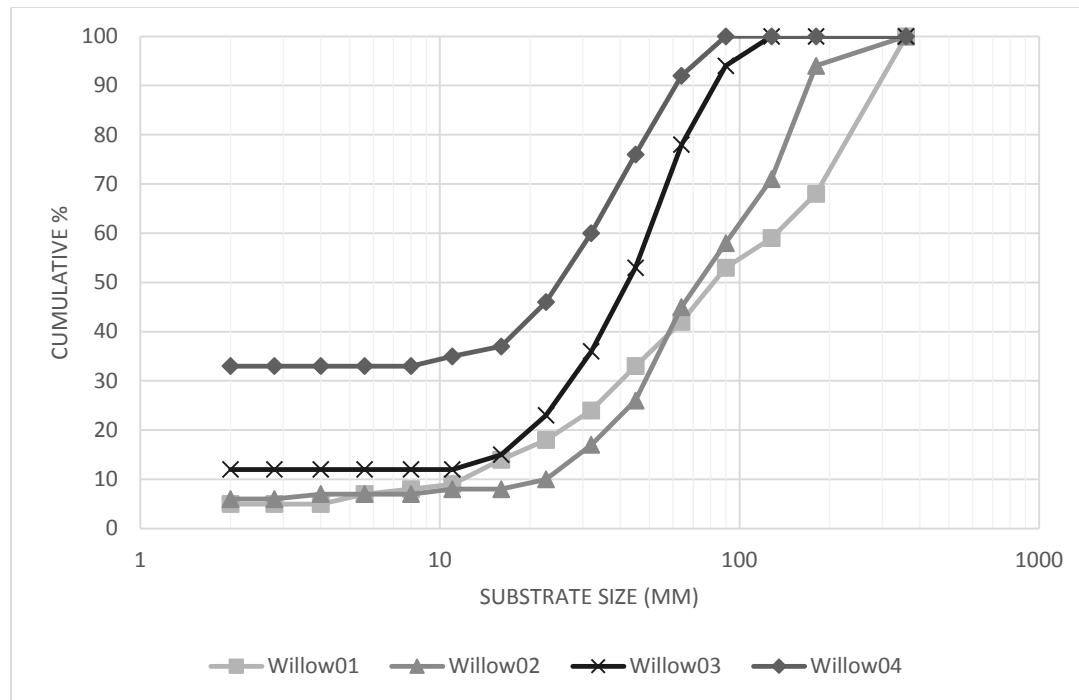
Figure 15. Cumulative substrate size distribution at all four sites.

The substrate size distribution shows that overall mean particle size decreases downstream. Willow01 and Willow02 had very similar substrate a D50 of 90 to 100mm and <5% fines (Figure 15). Particle size was smaller at Willow03 with a D50 of 40m and percent fines >10%. The lowest site, Willow04 lacked large cobble and boulders (D50 of 35 mm), highly embedded cobbles, and had a high percentage of fines (>30%). Embeddedness measured in Willow01 was due to loose sand in contrast to the downstream sites where embeddedness was due to dense silt.

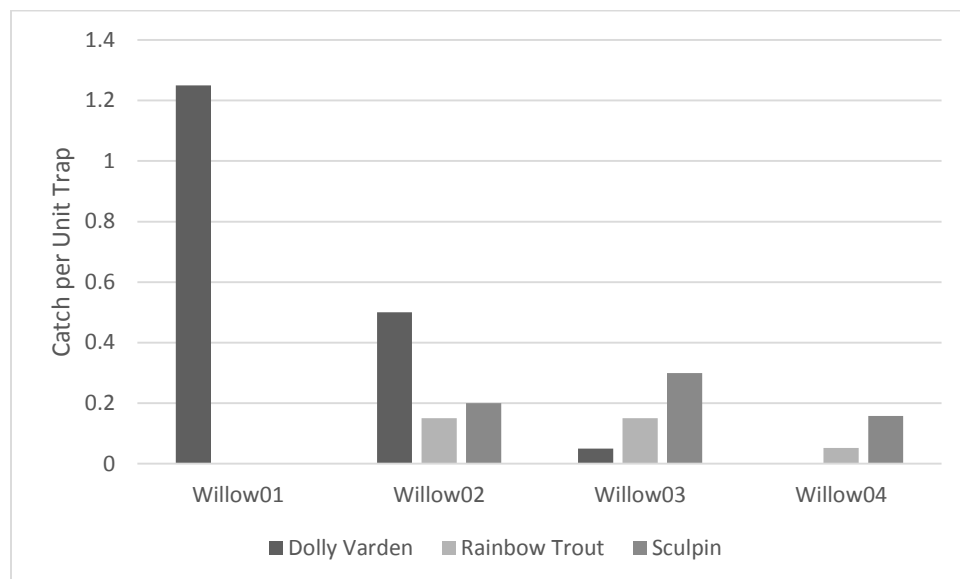
Figure 18. CPUT of juvenile resident fish showing Dolly Varden more abundant in the upper sites and rainbow trout at the lower two sites in samples collected on July 29 and 30, 2014.

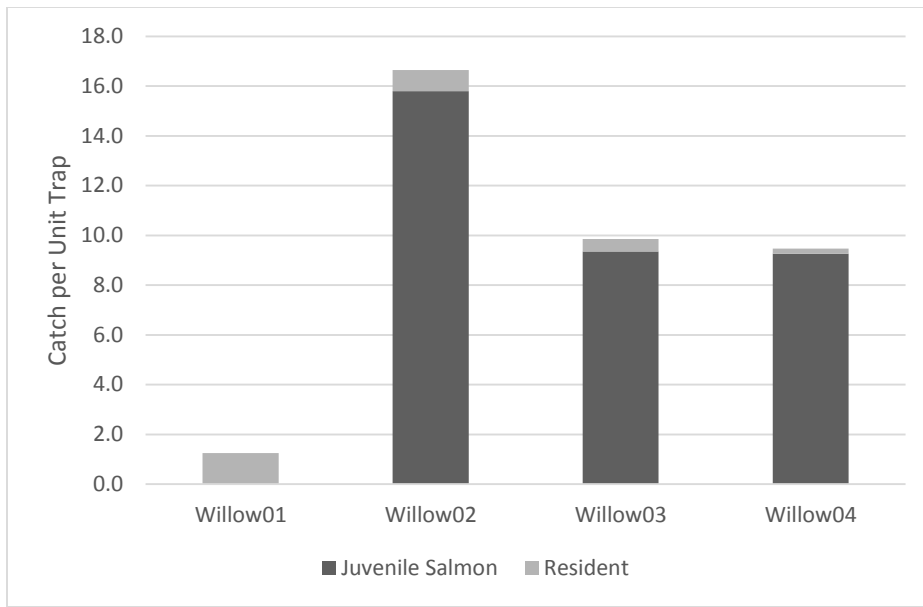
Figure 19. Juvenile salmon were absent from the upper river sampling site, on July 29 and 30, 2014, but dominated catch from Willow02 downstream.

Juvenile Chinook and coho salmon were found at Willow02, Willow03, and Willow04, but were absent from catches at Willow01 above the canyon. Ratios of resident to anadromous fish are shown in Figure 19. Willow01 had only resident fish, while Willow02, Willow03, and Willow04 had a much greater percentage of juvenile anadromous fish than resident fish minnow trap samples.

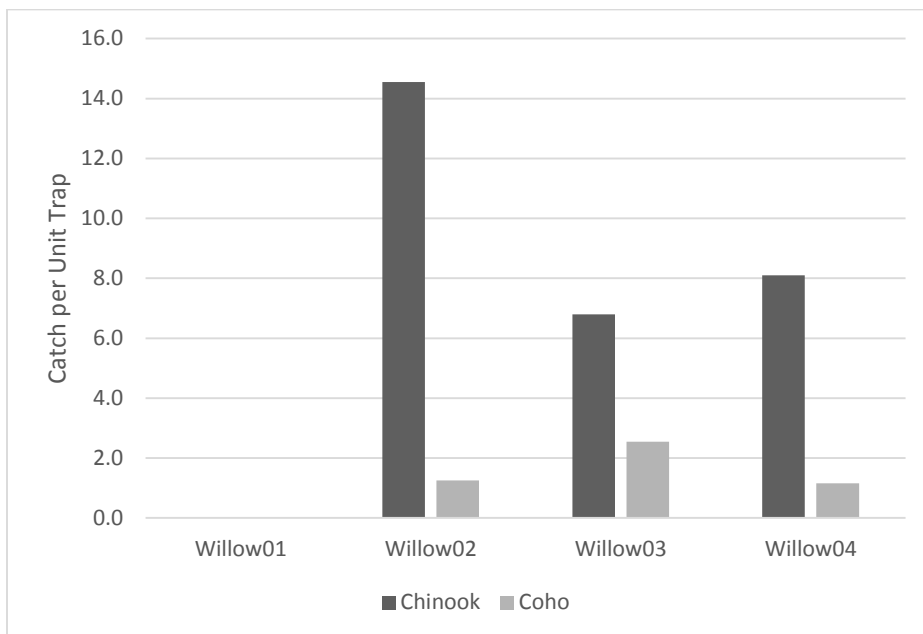
Figure 20. Juvenile Chinook and coho salmon catch per unit trap at each of the four sites on July 29 and 30, 2014, showing the greater abundance of Chinook salmon compared to coho salmon.

Chinook salmon were present in greater numbers than coho salmon at each of the sites where juvenile salmon were present. Willow02 had the highest ratio of Chinook to coho and the highest catch per unit trap of Chinook salmon, with 14.6 Chinook per trap (Figure 19). Chinook salmon tended to be larger at downstream sites. Willow04 had the highest Chinook median fork length (Figure 21) at 65 mm, while Willow02 had the lowest Chinook median fork length at 57 mm. Chinook at Willow02 had the highest median condition factor, while Chinook salmon at Willow03 had the lowest (Figure 22).

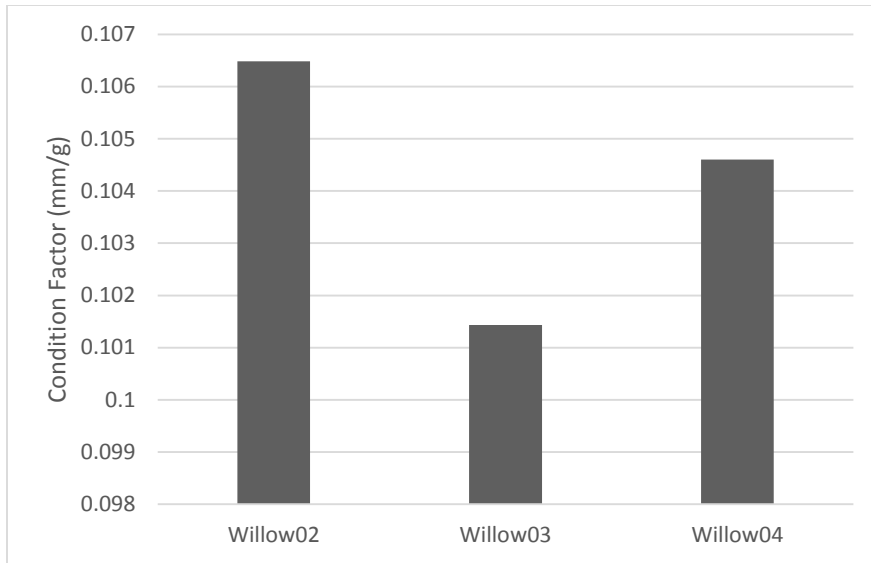
Figure 23. Condition factor for juvenile Chinook salmon.

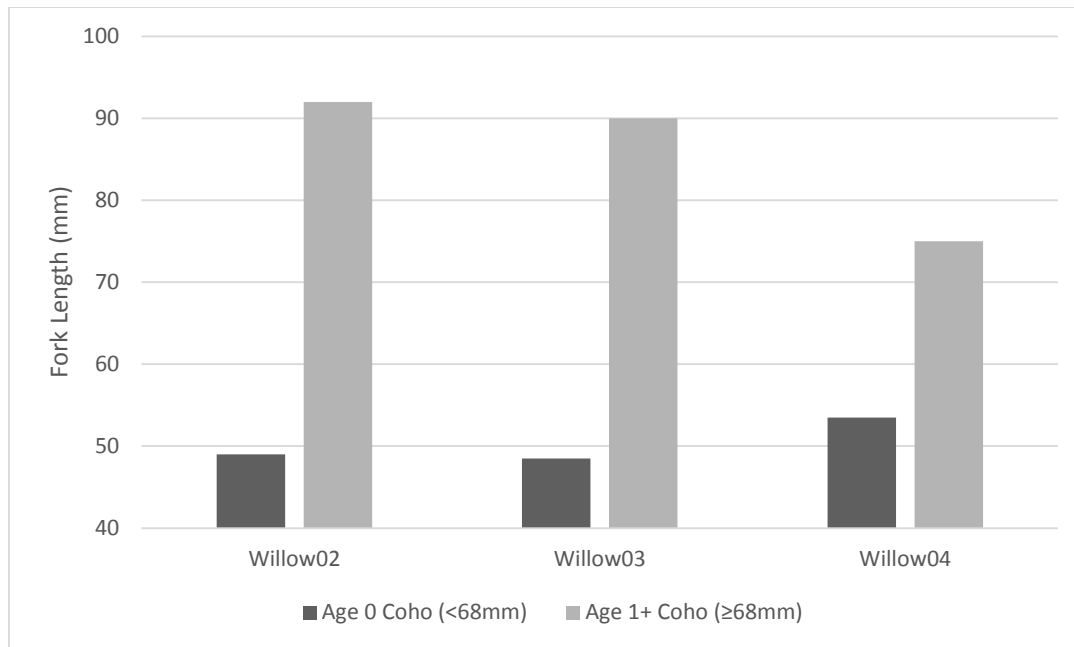
Figure 25. Median coho salmon fork length for Age 0 fish and Age 1+ fish at Willow02, Willow03, and Willow04.

Age 0 and Age 1+ coho salmon were present at Willow02, Willow03, and Willow04, and coho showed greater variation in size than Chinook salmon (Figure 23). Age 1+ coho salmon tended to be larger at upstream sites, while Age 0 coho were larger at downstream sites. Willow04 had the highest median fork length for Age 0 coho, but the lowest median fork length for Age1+ coho, as shown in Figure 24. Median condition factor for coho salmon tended to decrease at downstream sites (Figure 25).

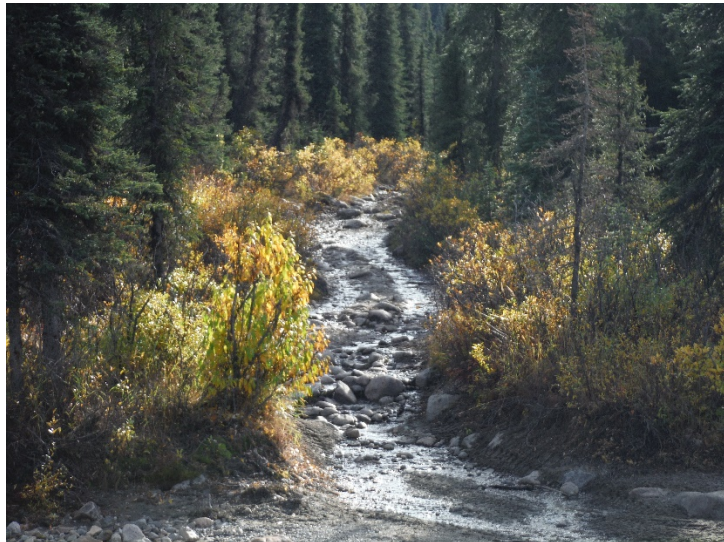
Photograph 2. Riparian
modification at Willow01, taken
September 23 2014

Bank and riparian vegetation modification at all sampling locations was due to ATV trails, residential development, and fishing trails (foot traffic). Riparian modification ranged from 150 to 650 m² of 2,000 m² total. Bank modification ranged from 0% at Willow02 and Willow03 to a high of 12.7% at Willow04. Riparian and bank modifications at Willow01 also caused by an ATV trail (Table 10). There was a trail from the Willow Fishhook road to a Willow Creek point bar at Willow01. The trail parallel the river upstream (Appendix A Photograph 1 and 2). At Willow02, both the right and left banks had riparian modifications due to residences, creating the largest area of riparian modifications out of the four sites. Willow03 and Willow04 had riparian modifications due to ATVs and fishing trails at Willow03 and foot fishing trails at Willow04. The highest amount of bank modification was measure at Willow04 where bank sloughing was occurring with the break point along the fishing trail (Appendix A Photograph 9).

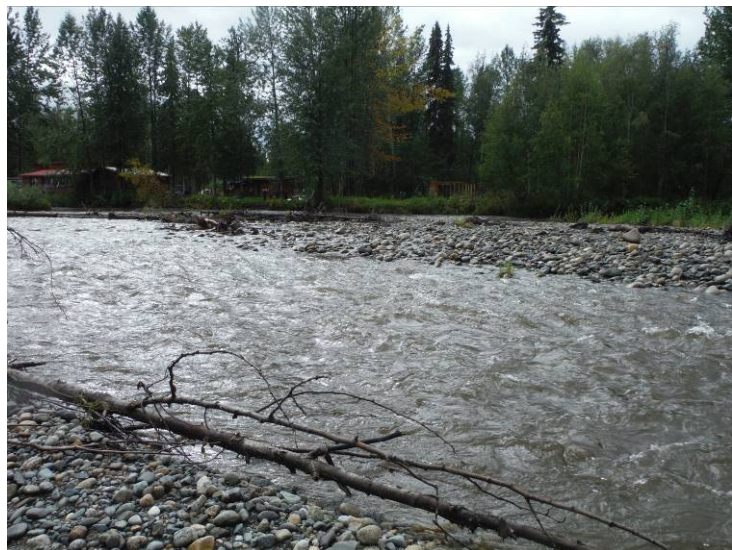
Photograph 5. Residences along
the bank at Willow02, taken August
27 2014

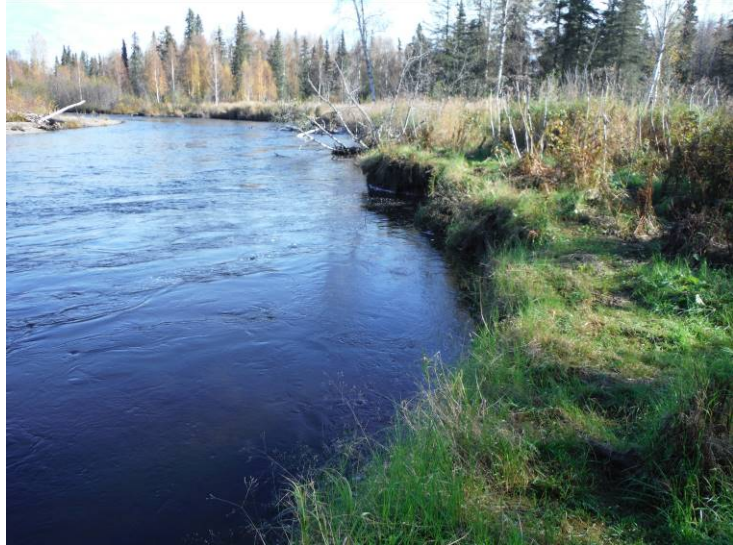
Photograph 9. Riparian
modification at Willow04, taken
September 23 2014

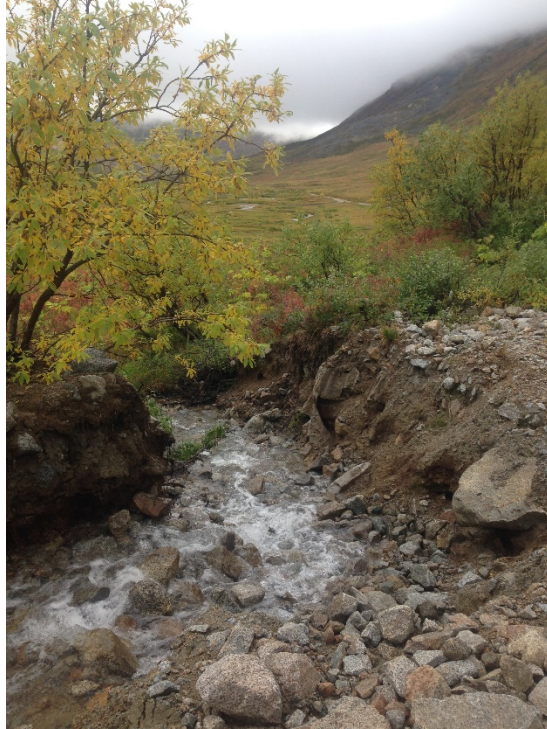
Photograph 11. Eroded road bed in
Hatcher Pass, October 2014.
