**June 2006
Final Community Action Plan**

Anchor River State Recreation Area

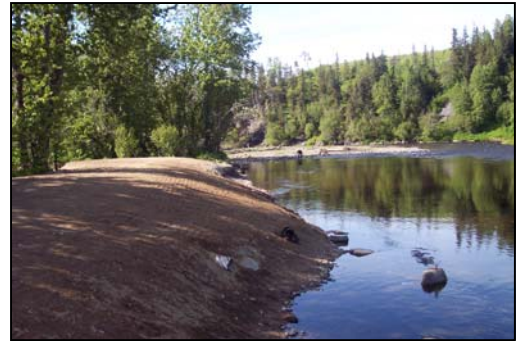
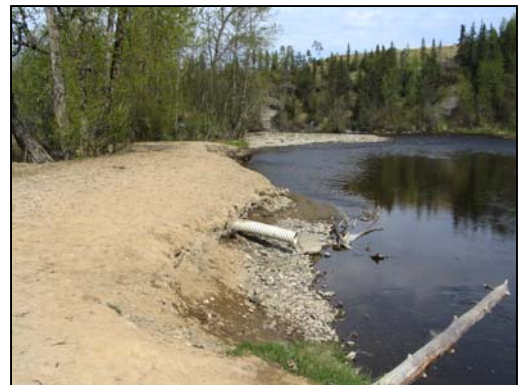
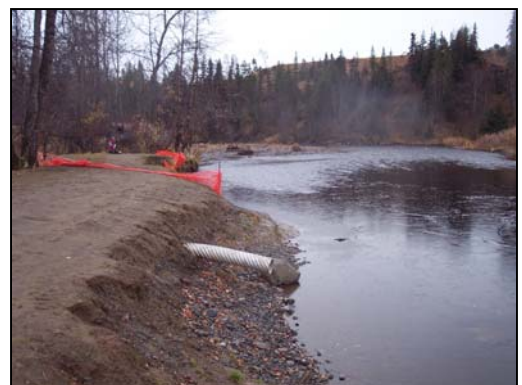
- Picnic Hole
 - Right streambank sloughing and erosion rates are increasing in the past two years, as seen by the increased exposure of the culvert on the left streambank.
 - Meetings held with Alaska State Parks, Community Rivers Planning Coalition, the Natural Resources Conservation Service indicate that removing the fill placed at this site and restoring the area's natural floodplain will help reduce erosion rates
 - If not possible to restore the area's natural floodplain, a recommendations for a streambank restoration project has been made, consisting of rootwads and willows, similar to the 2003 installation
- 90 Hole
 - Sloughing rates on the left streambank appear to be both naturally and human caused. River energy is naturally eroding the left streambank, yet human pressure on the bank is causing compaction and increasing

In the photo series above, the Picnic Hole erosion over a two year period is evident (May 2004, May 2005, October 2006, respectively).

- the likelihood of erosion.
- Observations of emergent vegetation on the right streambank indicate streambank recovery on this bank.

The concerns identified at the Picnic Hole will only be exacerbated if intervention does not occur. Erosion rates witnessed in 2005 (especially after spring breakup) indicate that streambank loss is increasing.

Construction of a trail and access to the river from the left streambank would be ideal, but on-site conditions and limited funds may prohibit this. Providing proper fishing etiquette information is recommended and could serve to reduce streambank impacts.

Continued visits and monitoring of the dynamic river system is recommended to understand the rates of erosion and deposition in this system.
