# Summary of Actions to Help Rehabilitate Streambanks and Improve Recreation in Anchor River State Recreation Area

Final Report, July 31, 2019

Homer Soil and Water Conservation District

ACWA project to develop bank restoration plans along the lower Anchor River

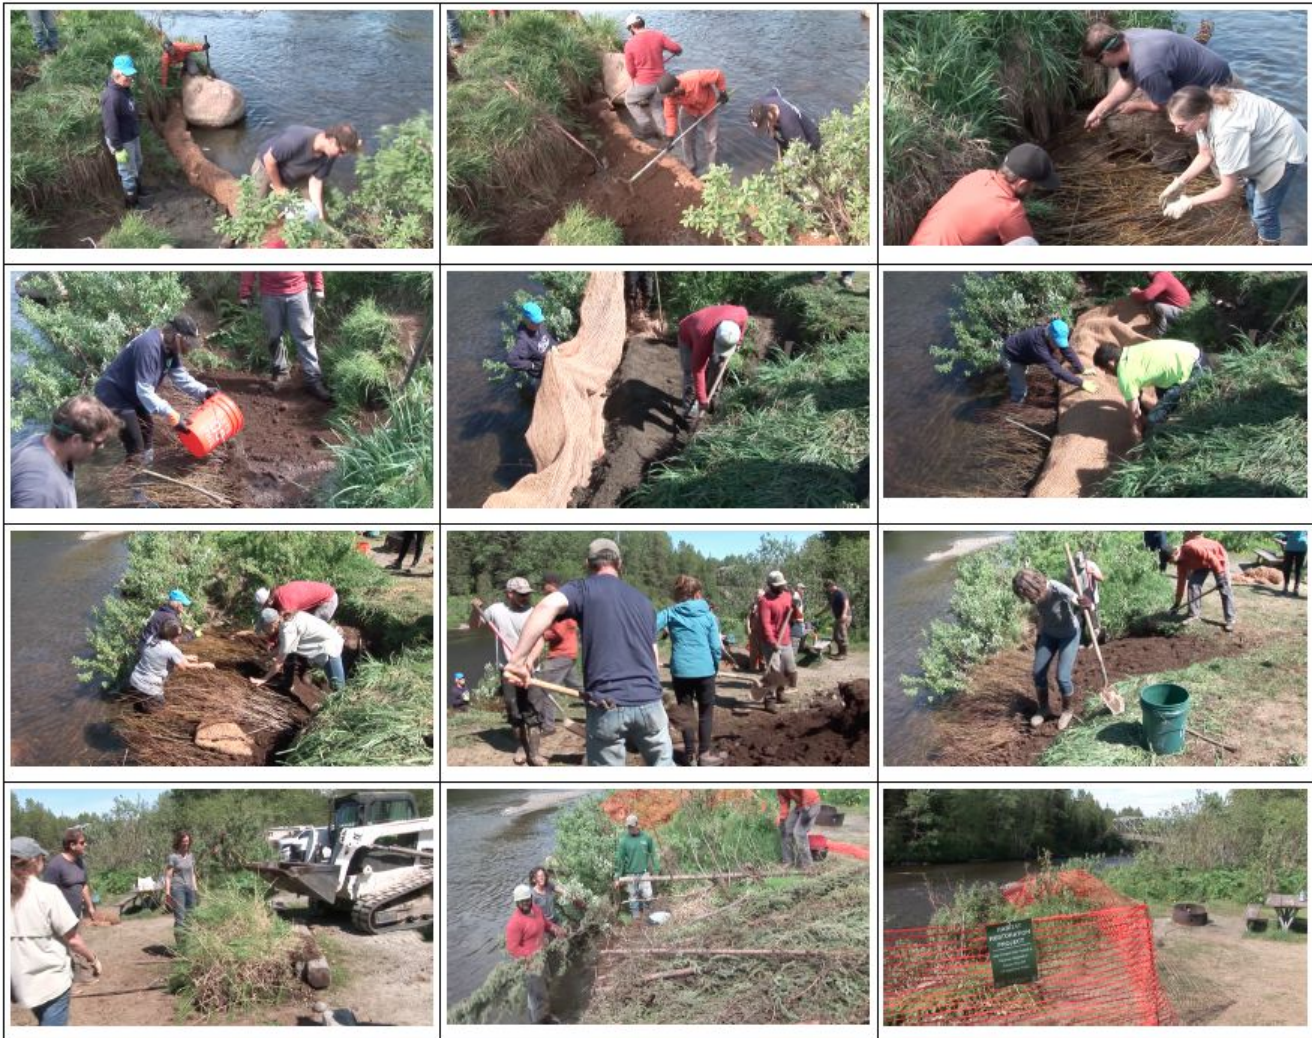
**Before**

This area had been excessively trampled, leaving the bank denuded and prone to erosion. Without vegetation, it offered poor habitat for juvenile salmon and little protection against natural erosion processes.

**After**

Thanks to the volunteers who helped install this bioengineering project, the bank now will have willows rooting to hold the bank as well as woody debris to offer habitat and hiding places for juvenile salmon.

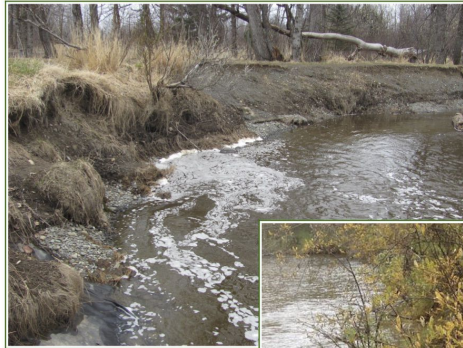
Above: Eroding trampled streambank

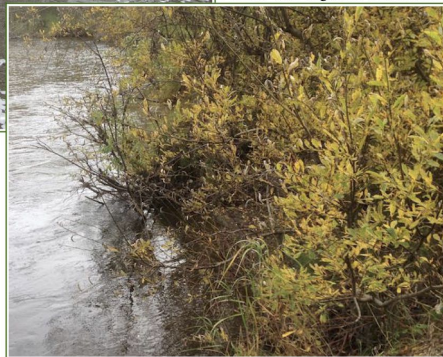
Below: Well-vegetated streambank

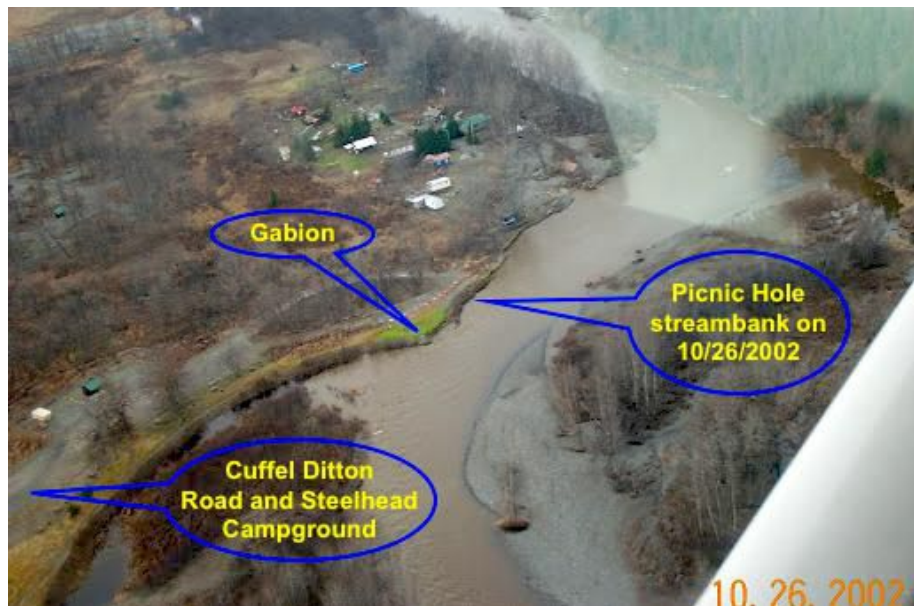
The photograph at right shows the Picnic Hole streambank during flooding on October 26, 2002. Greenness suggests that the gabion area had been recently worked on. Photographs on the following page show the gabion and downstream erosion as it looked in 2018.

Much of the erosion just downstream of the gabion is due to a back eddy created by the gabion itself. Video footage taken by Homer Soil and Water on May 9, 2018, shows the action of this back eddy, see <https://youtu.be/BIVz4OwHrkQ>.

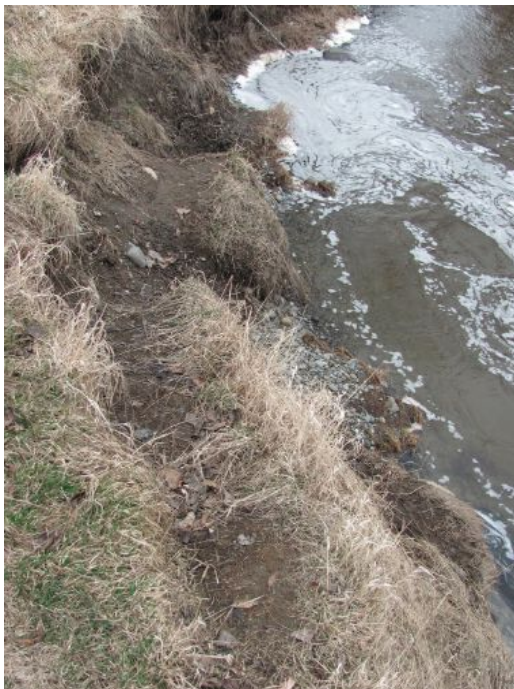
Figure 3. Photos of eroding streambank adjacent to the Picnic Hole

At left: Trampling and sloughing ("unzipping") of streambanks just downstream of the gabion contribute to accelerated erosion, HSWCD 5-9-18

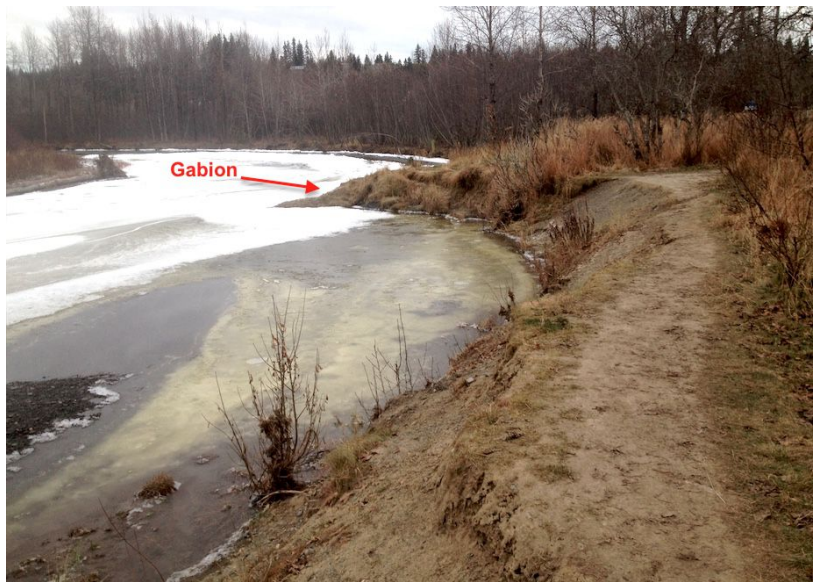
Above: Looking upstream towards gabion; bank vegetated and eroding, HSWCD 11-6-18

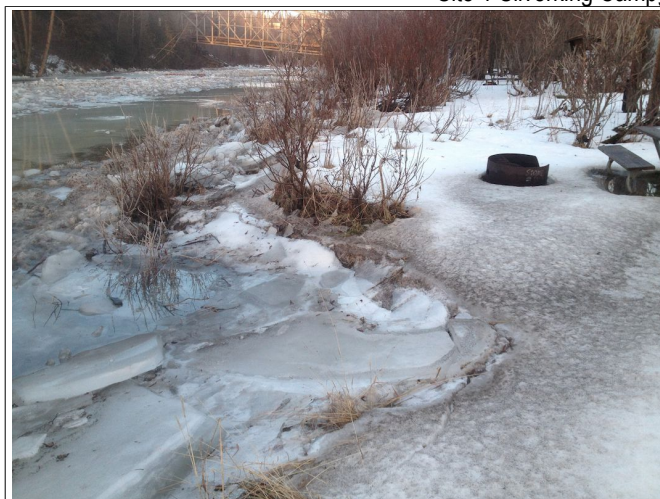
Site 1 Silverking Campground before restoration

January 25, 2019

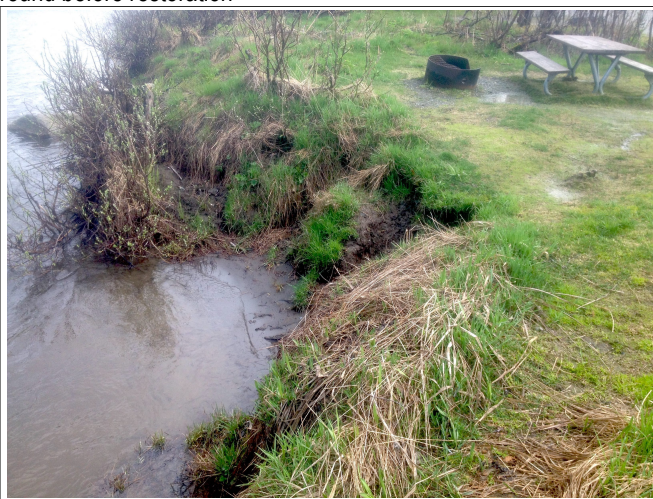
June 3, 2019

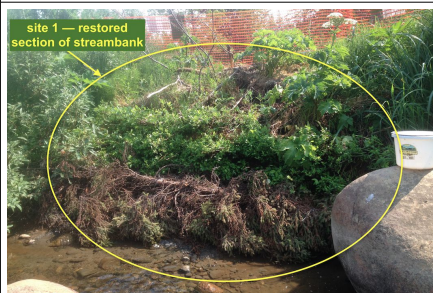
Site 1 on July 6, 1 month after installation

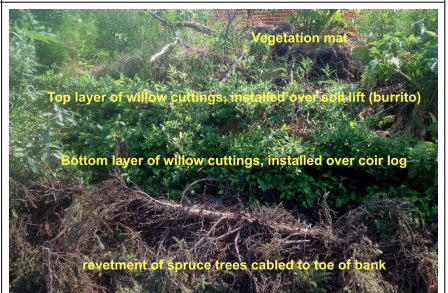
Site 1 on July 6, practices labeled
