Evaluate Fecal Coliform Bacteria for Two Anchorage Watersheds

Alaska Clean Water Actions Grant # 18-07– Task 8

By Cherie Northon, Ph.D.
Executive Director
Anchorage Waterways Council
February 28, 2019

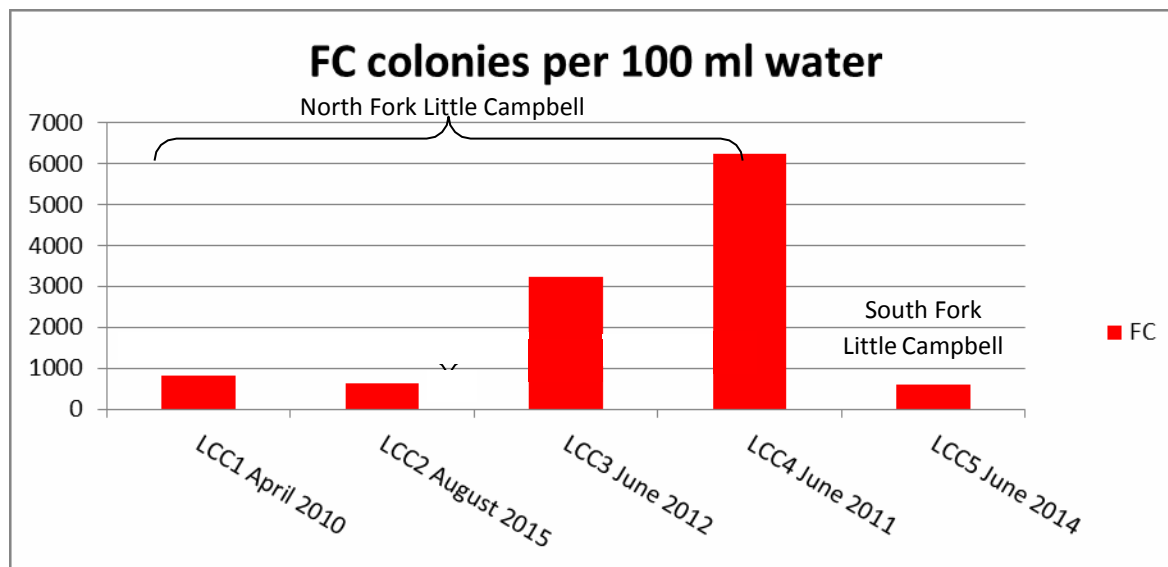
Figure 6. Highest recorded site readings by date for FC monitoring from 2010 to 2017 – Little Campbell Creek

Figure 6 is also an interesting graph. When highest recorded values are placed in their creek locations, rather than showing an increase as the North Fork Little Campbell Creek runs downstream to Campbell Creek, the number of FC colonies actually decreases. The

highest exceedance is on the South Branch of the North Fork which is about 1.4 miles from Elmore Road an area bounded by BLM at Campbell Creek, Abbott Loop Community Park, and Far North Bicentennial Park. Once the creek enters at Elmore Road, it runs primarily through a residential area except for a 10 acre parcel known as the F Bar J Ranch which boards horses (Figure 7). A report by Davis and Davis for DEC suggests that this stable could be contributing bacteria to the North Fork Little Campbell Creek (2010:21).

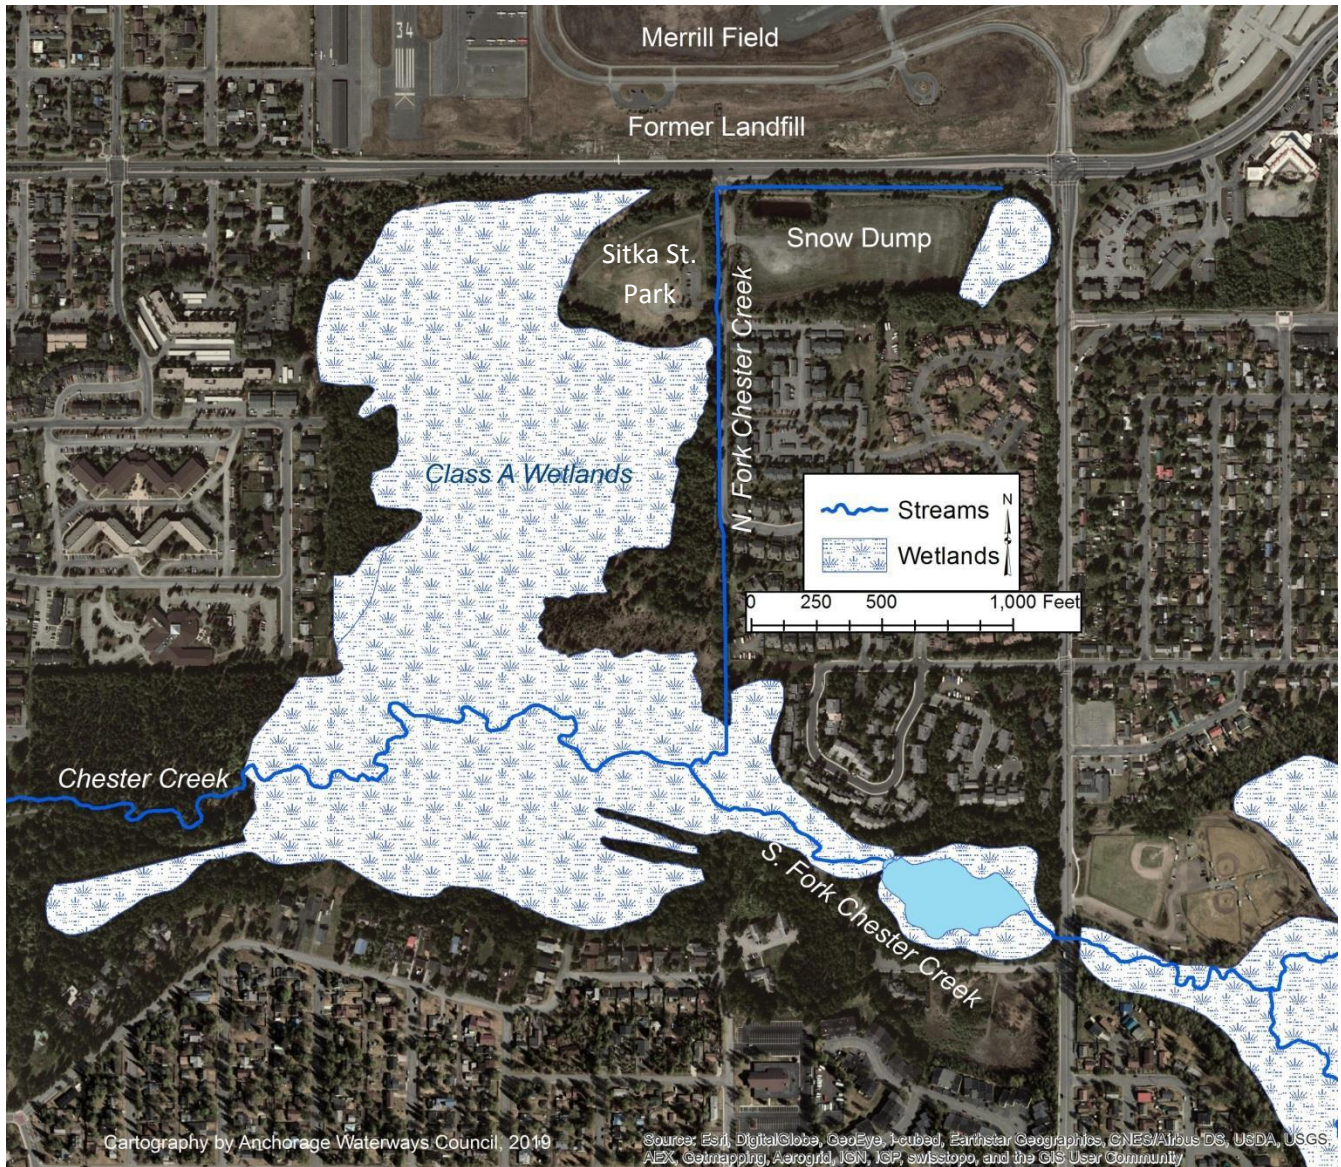
Map 3. Chester Creek by Merrill Field and Former Landfill

Another tributary, North Fork Chester Creek, flows south under Merrill Field in a culvert, exits at 15th and Lake Otis, and runs in a ditch due west to Sitka St. and then due south until it joins Chester Creek. The former Merrill Field landfill is located just north of 15th Ave., and it was used from the 1940s until 1987 when it was closed. It covers about 200 acres with a depth of 30'. According to a 1990 USGS report by Brunett, there has been concern about leachate which was tested for in 1989. That report concludes that while there are minor amounts of contaminants reaching much of the wetlands between 15th and Chester Creek, their concentration in the groundwater is generally less than U.S. EPA standards for drinking water (1990:1). Today this area holds Sitka Street Park which is classified as Class A wetlands and a municipal snow dump.

Although there would be no FC issues from the leachate, the snow dump and park area could be contributing FC to the North Fork Chester Creek before it converges with Chester Creek. Recommendation two: the areas above the snow dump and sites below it should be tested for FC.

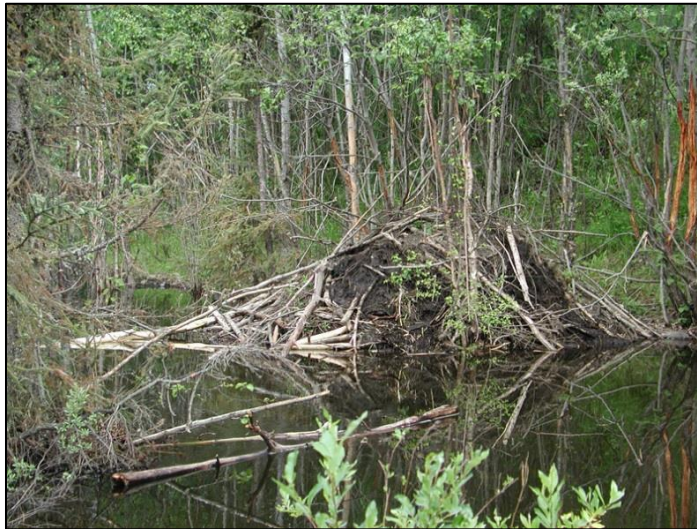
Figure 9. Beaver lodge in the Windsong sedimentation basin June 6, 2006 (Photo by C. Northon)
