**Alaska Department of Environmental Conservation
410 Willoughby Avenue, Suite 303
Juneau, Alaska 99801-1795**

**Total Maximum Daily Load (TMDL)
for Residue in the Waters of
Jordan Creek in Juneau, Alaska**

May 2005

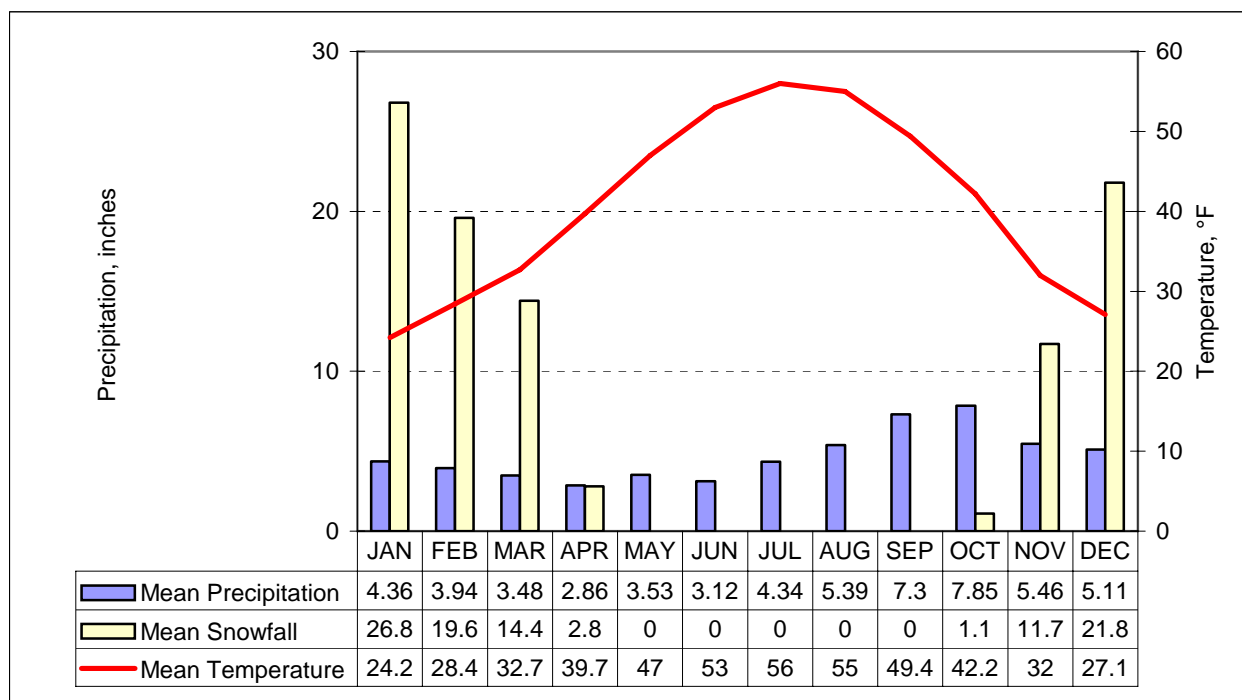
Figure 1-5. Monthly average precipitation and temperatures at Juneau International Airport

Summer temperatures average around 55°F. Autumn begins in early September and ends in late October with temperatures falling in September and snowfalls increasing in November. Winter lasts from November to early April, with the coldest temperatures typically occurring in January. Winter temperatures average around 28°F. Spring begins in late April with moderate precipitation and increasing temperatures. Figure 1-5 presents a summary of monthly averages for rainfall, snowfall and temperature at the Juneau International Airport (National Weather Service Station 504100), based on the period of record at the station from January 1950 to May 2004.

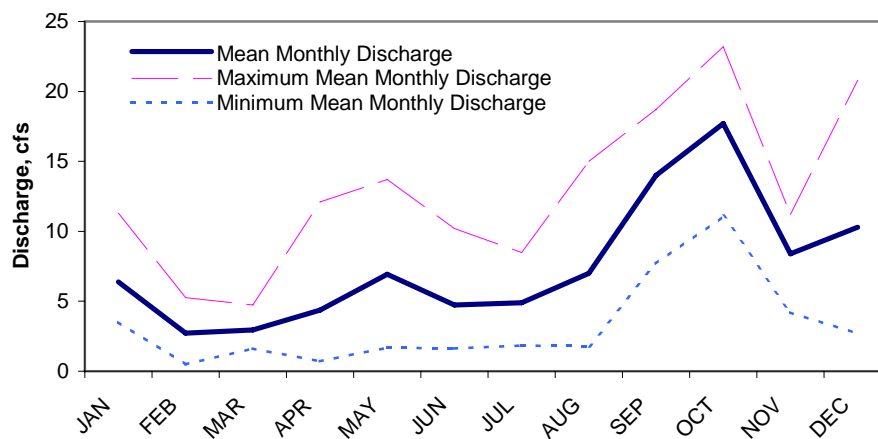
Figure 1-6. Mean Monthly Hydrograph for Jordan Creek, 1997-2003

The mean monthly hydrograph for the USGS recording station at Egan Drive is shown in Figure 1-6. Mean monthly discharge is shown, as well as the maximum and minimum mean monthly discharge for each month over the record period of 1997-2003. The annual mean flow for the record period was 7.61 cubic feet per second (cfs). Instantaneous discharges as high as 150 cfs have been measured following heavy precipitation events, and as low as 0.3 cfs during dry spells.

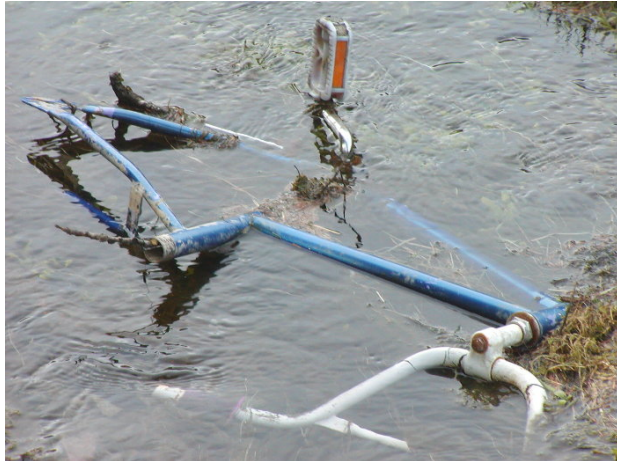
Typical metal debris in creek

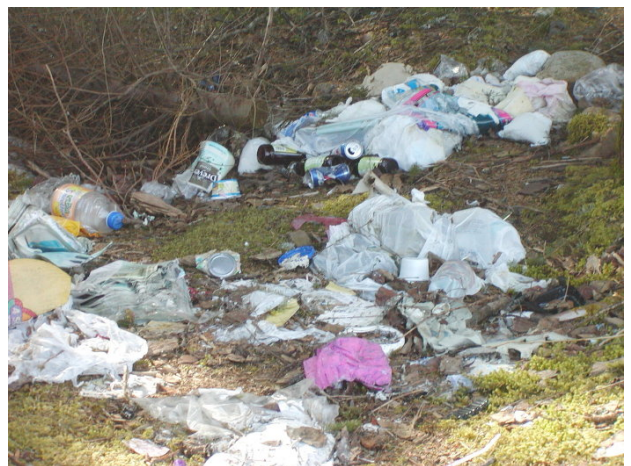
Garbage dragged into the woods by bears

The undeveloped east side of Jordan Creek along Thunder Mountain provides excellent bear habitat. Improperly stored garbage has been documented as a prime bear attractant and has been a source of concern both from a public safety and a litter problem. The City and Borough has maintained records of bear sightings and problem bears in the Mendenhall Valley. Records show that many of the bear sightings are in the more densely populated areas that lie at the edge of the forest, such as Thunder Mountain Trailer Park. Most trailer residents do not have garages or outbuildings, and find it difficult to keep trash indoors between weekly collections. Household garbage pulled into the creek or its banks because of improperly stored garbage is a substantial source of debris in the upper Jordan Creek watershed. In addition to bears, dogs also play a role in pulling unsecured garbage into the creek.

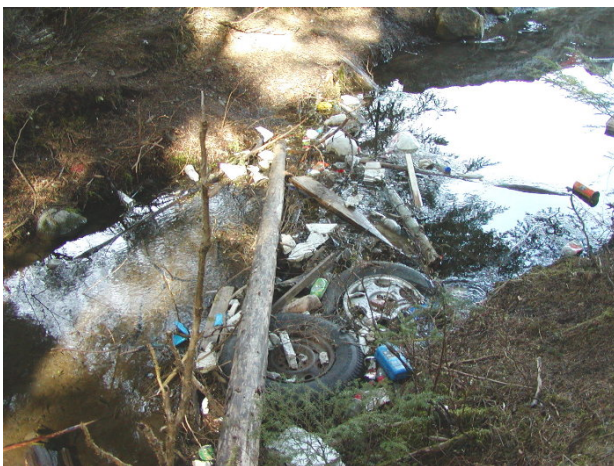
Debris caught behind a log

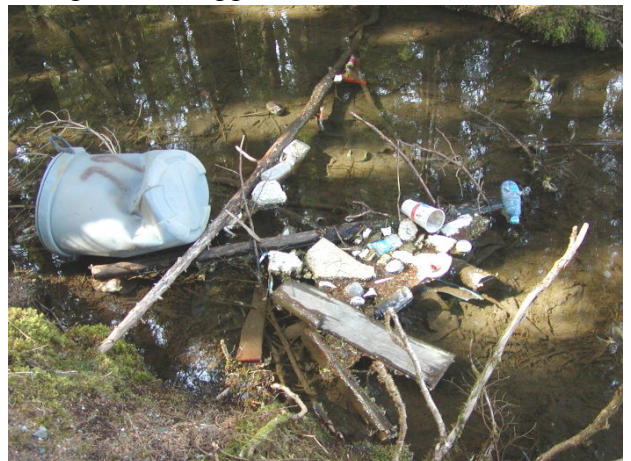
Garbage cans dragged into the creek

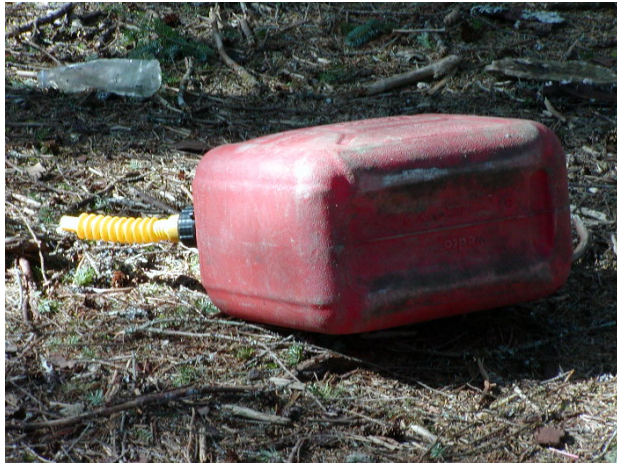
Potential hydrocarbon pollution

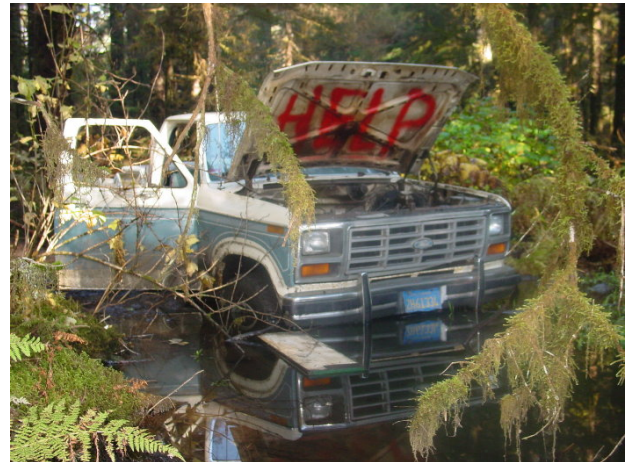
Truck stuck in creek and abandoned

The types of residue observed along Jordan Creek include dimensional lumber scraps, plywood, paper, plastics, household garbage, glass, metals and car batteries. On October 3, 2004 an abandoned pickup truck was discovered in the creek off the end of Valley Boulevard. The Alaska Department of Environmental Conservation filed a pollution incident report when petroleum sheens were observed discharging from the vehicle. Incidents such as this are difficult to avoid given the proximity of the creek to a number of roads (Valley Boulevard, Dudley Street, Forest Lane, Nancy Street). In some cases, residents and street maintenance personnel have put up barriers such as large rocks, but in other cases, there is no physical barrier to prevent direct access to the creek. This also increases access to allow use of the creek as a dumping ground for junk such as old tires.
