Alaska Department of Environmental Conservation Waterbody Field Report

Chena River: Fairbanks, Alaska

Prepared by: J. Fisher¹

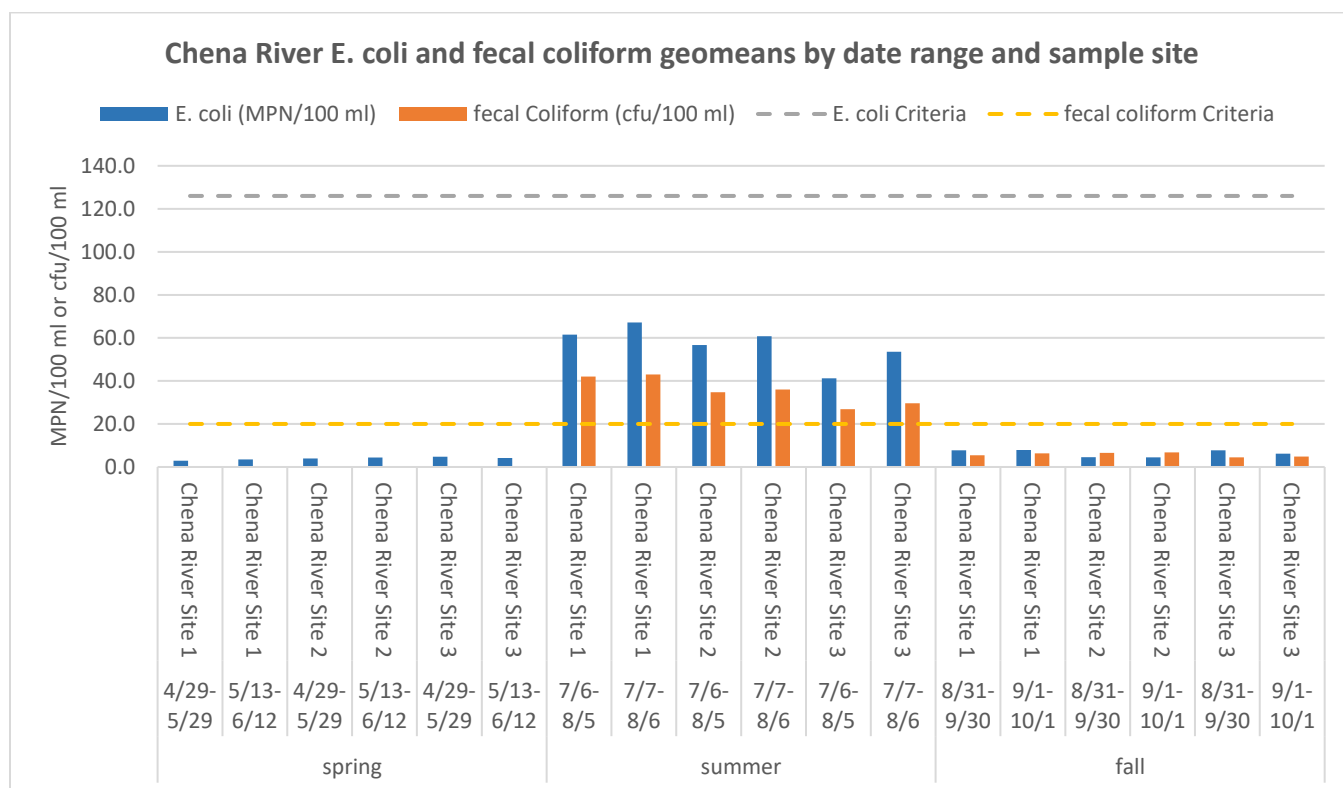
Figure 9. *E. coli* and fecal coliform 30-day geomeans by date range and sample site for 2024. Geomeans were calculated for 30-day periods in which there were at least five sampling events. The gray dashed line indicates the water quality geomean criterion for fecal coliform (20 cfu/100 ml) and the yellow dashed line indicates the water quality geomean criterion for *E. coli* (126 cfu/100 ml).

For pathogens, where sample results may vary on an exponential level, a type of average called a geometric mean (geomean) is used. Geomeans for both *E. coli* and fecal coliform were highest at Chena River Site 1, followed by Chena River Site 2 and then Chena River Site 3 (Tables 5, 6, 7, 8 and Figure 9). Exceedances of the geomean criteria occurred during the summer sampling period at all three sites. More than 10% of the fecal coliform results exceeded 40 cfu at all three sampling sites. All sample results for fecal coliform and *E. coli* are included in Appendix A.

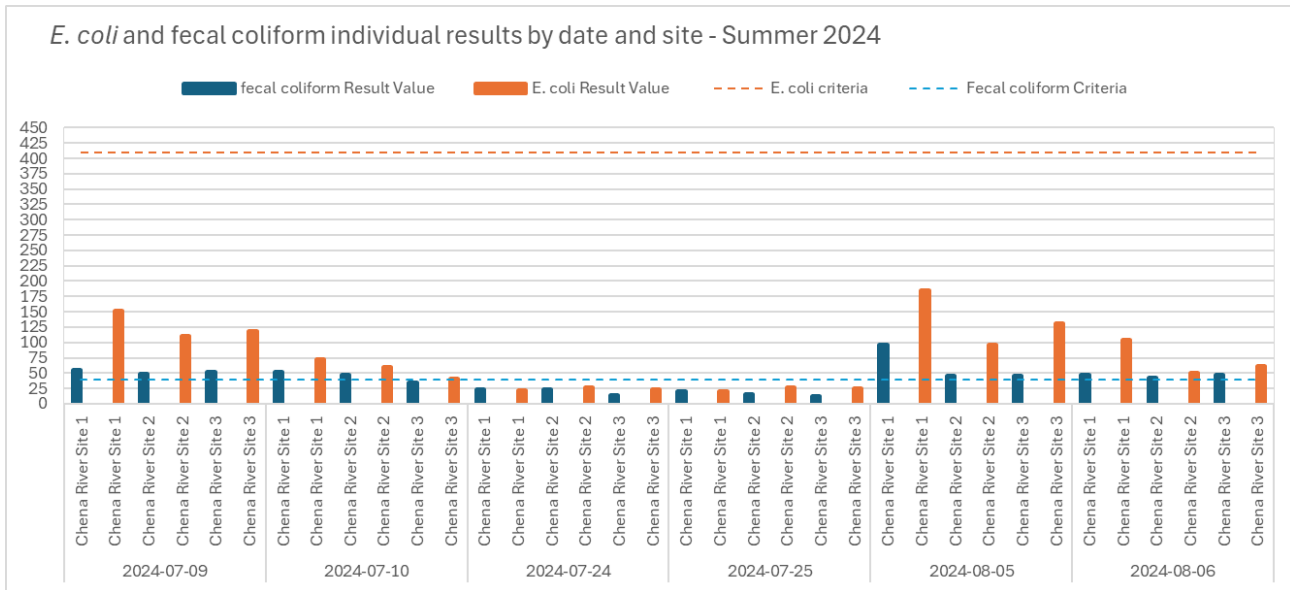
Figure 11. Summer 2024 E. coli and fecal coliform results by date and site. Dashed lines indicate water quality criteria for E. coli not-to-exceed (410 MPN/100 ml) and fecal coliform not-to-exceed (40 cfu/100 ml).

The summer sampling period yielded the highest pathogen levels of the three sampling periods. This is likely due to substantial rain events, which increased runoff into waterways, particularly during the July 9 and August 5 sampling events. Additionally, during the summer months as air temperatures increase, so do water temperatures promoting bacterial growth.

Fecal coliform concentrations exceeded the criteria at all three sampling sites on July 9, August 5, and August 6, as shown in Figure 11 and detailed in Appendix A (Table A.1). These exceedances coincide with significant rainfall events and may indicate effects of runoff pollution. Table 5 shows that 50% of calculated 30-day rolling geometric means for fecal coliform at each site exceeded the 20 cfu/100 mL standard during summer. Table 6 shows that 33% of individual fecal coliform results at Sites 1 and 2, and 25% at Site 3, surpassed the not more than 10% of results may exceed 40 cfu/100 mL criterion. In contrast, no *E. coli* exceedances were recorded for either the geometric mean (Table 7) or single-sample thresholds (Table 8), despite elevated concentrations during high-runoff events.
