## ALASKA DEPARTMENT OF ENVIRONMENTAL CONSERVATION

SITUATION REPORT (SITREP)

## 2020 VMT Sump Oily Water Spill

SITREP #: 3

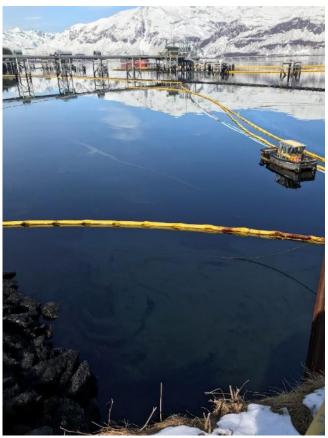
Figure 1. Spill containment and recovery activities at the VMT on April 14, 2020. Courtesy ADEC

**RESPONSE ACTION:** The oil traveled beneath the snow covered surface and came out near the head of Berth 4 into Port Valdez. A tanker was loading at Berth 5 at the time of the incident, but was not affected by the spill. Sheen has been seen east of Berth 4 to the VMT small boat harbor. Most of the sheen is contained behind the Berth 4 area with sorbent boom and sweeps, and two layers of hard yellow boom. Oily water is being skimmed from a corralled 30ft by 30ft area inside the boom. Two Current Buster boom systems are being deployed outside of the boomed area, with trained fishing vessels to catch any escapement. Overflights and vessel surveillance of the area are ongoing. Crews are working to determine the amount of contamination in and around the sump. The USCG and ADEC have been on scene to observe Alyeska's response actions.

An additional layer of bigger boom was deployed outside of the hard yellow boom to enhance the containment of sheen. Boom has been deployed to protect the Solomon Gulch Hatchery and the Valdez Duck Flats. Oil skimming operations have continued and as of 6:00 AM today 681 bbls (28,602 gallons) of oil water mixture has been collected. Crucial skimmers have been utilized over the last 24 hours and this is reflected in the recovery numbers, as the crucial skimmers are more efficient and capture less water. Additional booming has been

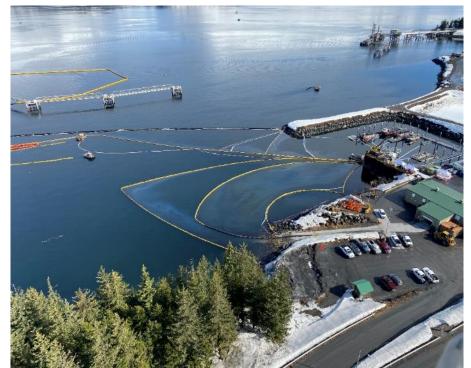
Figure 2. Overhead photo of the VMT Small Boat Harbor looking East April 16, 2020. Courtesy APSC

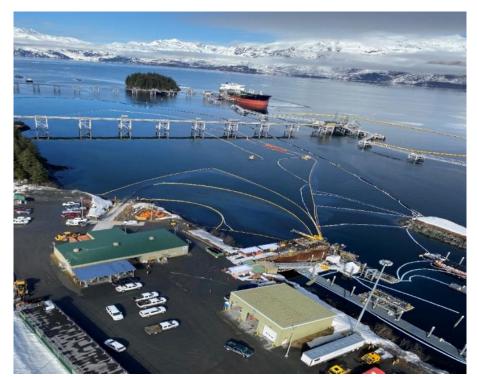
Figure 3. Overhead photo of the VMT Small Boat Harbor looking West April 16, 2020. Courtesy APSC
