RE: ClearStak Report – The Efficacy of the ESP on Cordwood Stoves

Executive Summary
The Efficacy of ESP on Cordwood Stoves (July 15, 2020)

EXECUTIVE SUMMARY

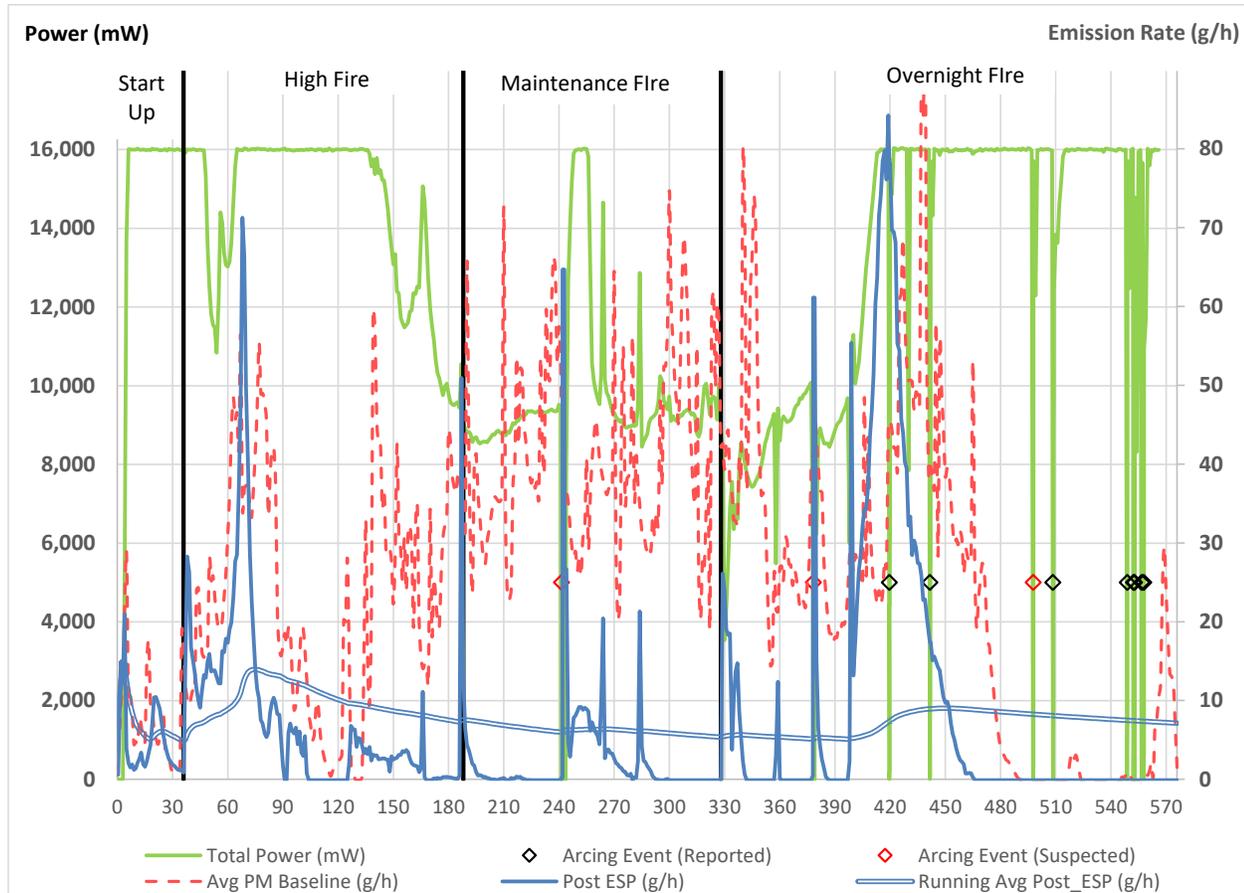
Figure ES-1. Non-Catalytic Stove 9 with ESP, Run 4, Entire Run (minutes 0-576)

Figure ES-1 shows Baseline and Post-ESP emission rates along with EPS power⁴ and arcing events⁵ for the entire test cycle. Average Baseline emissions from the stove (dashed red line) were not measured concurrently with emissions out of the ESP. The baseline is shown for reference as an approximate indicator of stove emission levels, but it does not represent stove-out emissions *during* the ESP test and, thus, does not match up minute by minute with Post-ESP emissions as measurements were not collected simultaneously.

As seen in the figure, the ESP powers up during minute 4 of the test (green line) and remains there through the end of Startup at minute 35. Post-ESP emissions are reduced once the ESP powers on. There is an uptick of PM emissions (blue line) at the start of the High Burn phase when the stove is reloaded. ESP power drops below full-power between minutes 48 and 63 during which emissions rise consistently until the device returns to full power and good emission control is restored. Running average PM emissions (double blue line) continue on a decline course into and through the Maintenance Fire phase. The ESP operates below full power but successfully limits emissions to an average of 6 g/hr since the start of the test (again more than twice the 2.5 g/hr certification level).

This level of performance continues into the start of the Overnight Fire phase, but is interrupted at minute 240 by the first in a sequence of arcing events (8 Reported and 3 Suspected). The first is associated with a spike in emissions from the ESP that nearly reaches the highest level of emissions observed during Baseline testing. Cumulative PM emissions tick up during the initial arcing events but decline thereafter to zero levels to end up at an average rate of 7.2 g/hr over the entire test. In this phase, ESP performance is reduced somewhat by arcing events compared to the Maintenance Fire phase. While not evident in Figure ES-1, a review of the minute specific values reported for the Overnight Fire phase

A key finding from the testing is that the ESP performs relatively well on the non-catalytic cordwood stove as long as an excessive build-up of creosote is not present. During such operation, it is successful in reducing total PM emissions to 7.2 g/hr compared to average (uncontrolled) stove emissions of 24.9 g/hr during Baseline testing. One limiting factor is the 4-minute delay at the start of the test before the ESP begins to operate, which is determined by the device’s design. A second limiting factor is the occurrence of arcing during the Overnight Fire phase. These factors, however pale in comparison to the effect of creosote build-up on ESP performance, which occurred after 34 hours of dry cordwood use. Removal efficiency calculated for ESP #3 depends on the measurement method but ranged from zero for the filter values (actually there was a slight increase in average PM relative to the Baseline) to 31% for the TEOM values.

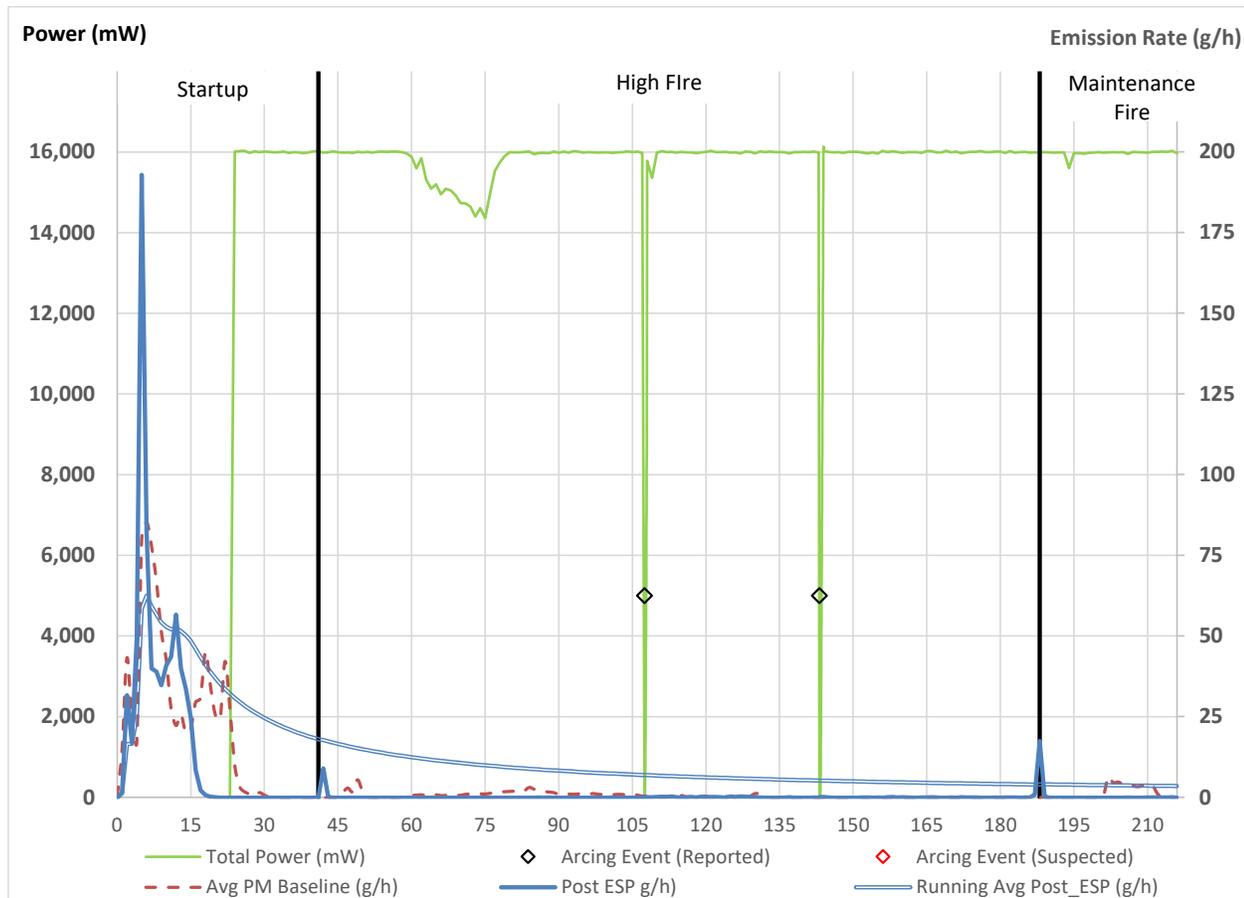
Figure ES-3 Catalytic Stove with ESP, Entire Run (minutes 0-216)

Figure ES-2 illustrates this using test run ESP #3 which was most representative of the average ESP performance. Post-ESP emissions (blue line) were very high in the first few minutes of the test. By

minute 16, Post-ESP emissions fall significantly, suggesting that the catalyst has reached light-off. The ESP powers on (green line) during minute 24 of the test, but with post-ESP emissions already at diminished levels it contributes relatively small incremental emissions control. PM emissions tick up at the start of the High Fire and Maintenance Fire phases when the stove is reloaded, but they start at the already low Baseline (uncontrolled) levels during those phases. The two arcing events during the High Fire phase have no detectable impact on PM emissions, unlike the non-catalytic stove tested.

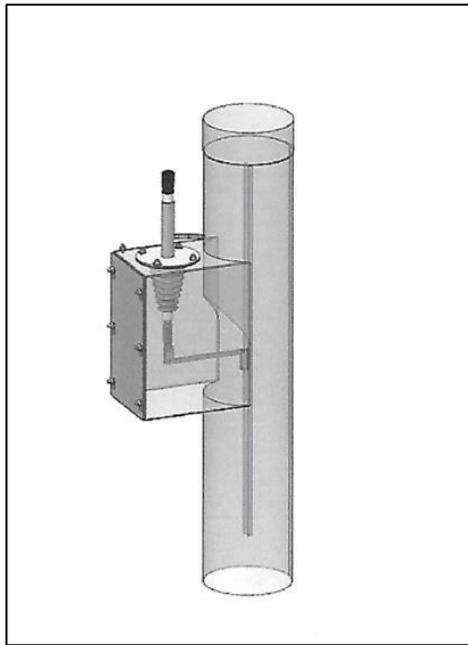
Figure 1. OekoTube Electrostatic Precipitator¹

The OekoTube ESP, Figure 1, is designed as a retrofit device to reduce harmful PM emissions from wood and coal burning appliances. It uses a high voltage electrode to release electrons that adhere to the walls of the chimney by electrostatic forces where they collect large PM flakes. The PM separating efficiency is documented in the manual as 70-80%.

The technology for the OekoTube ESP is all the same despite varying models and sizes. The OekoTube ESP is adaptable to various installations and can be inserted outside on the chimney rooftop or installed indoors. The OekoTube ESP has a maximum power consumption of 30 Watts and becomes active when an internal temperature sensor, installed in the stack tube portion just above the insulator box, detects a change in temperature within the stack. During standby, power consumption reduces to as low as 0.7 Watts. For the purpose of this research, the indoor 39-inch model will be used. More information of the OekoTube ESP will be provided as Appendix A of this report.

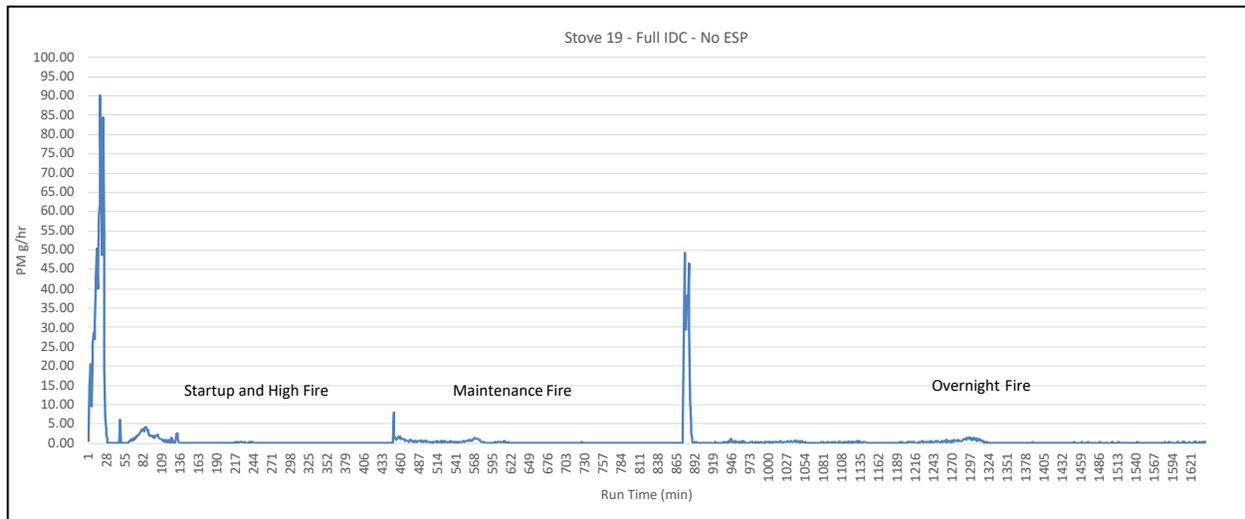
Figure 2. Catalytic Stove 19 IDC Test Example

After baseline testing of Stove 19, it was concluded that PM emissions from this particular catalytic stove model were too low for the ESP to make a significant, if any, impact on reducing PM emissions due to the stove's ability to burn at a very slow burn rate while still maintaining an active catalyst (Figure 2). Therefore, it was decided to perform a modified and shortened version of the IDC to compare PM emissions during phases with higher burn rates where PM is present at higher quantities. The test runs included a normal Startup, a modified High Fire with air damper completely open for the full phase, and a partial Maintenance Fire with air damper open at ~10% and the test ending after 30 minutes from the fuel loading PM spike in Maintenance Fire. Overnight Fire burn phase, a long period of sometimes 8 hours or more of low heat demand, was not included in the modified IDC for Stove 19.

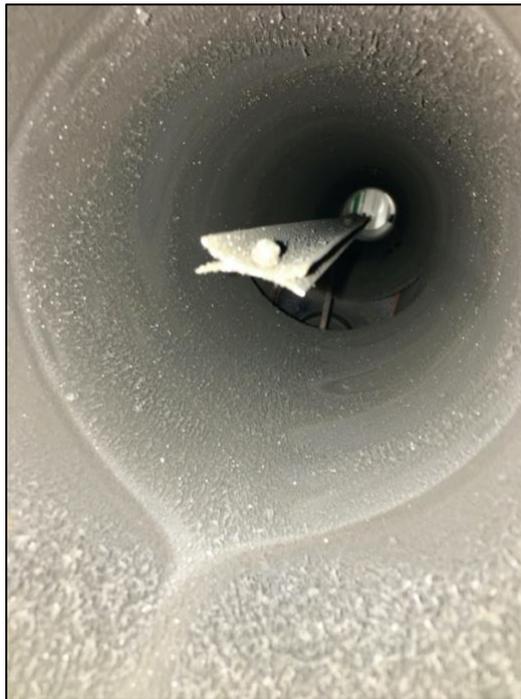
Figure 3. ESP At Start of Test Series

The OekoTube ESP was used in previous tests in a collaborative effort with Fairbanks North Star Borough and NESCAUM and had a total run time of 105 hours. The ESP was conditioned on a Step 1 certified cord wood stove for 24 hours and then cleaned for testing on a Step 2 certified Pellet stove. Cleaning involved using a wire chimney brush and a vacuum to gently remove build up on the ESP's walls without disturbing the centered electrode. The ESP was not cleaned after pellet stove testing because of little to no buildup on the ESP walls. The light buildup that remained was a feathery and dusty texture that was not hard coated on the walls, but rather was fragile and easily fell out between movement during install. Below is an image of the ESP after use on a pellet stove and before this test series (Figure 3).

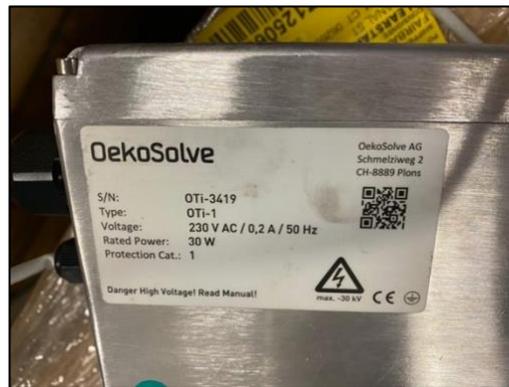
Figure 4. ESP Identification

The 6-inch diameter and 39-inch length OekoTube ESP was installed at 48 inches from the stove flu collar per recommendation of Oekotube. The stack pipe used before and after the ESP was single wall black stove pipe. The following ESP was used for all test runs and details are in Figure 4 and the installation for the ESP is displayed in Figure 5. A stack k-type thermocouple was placed above the ESP at about 24 inches, to prevent short circuiting of the electrode. The stack pipe and ESP combination extended 15 feet from the base of the woodstove and top of floor scale.

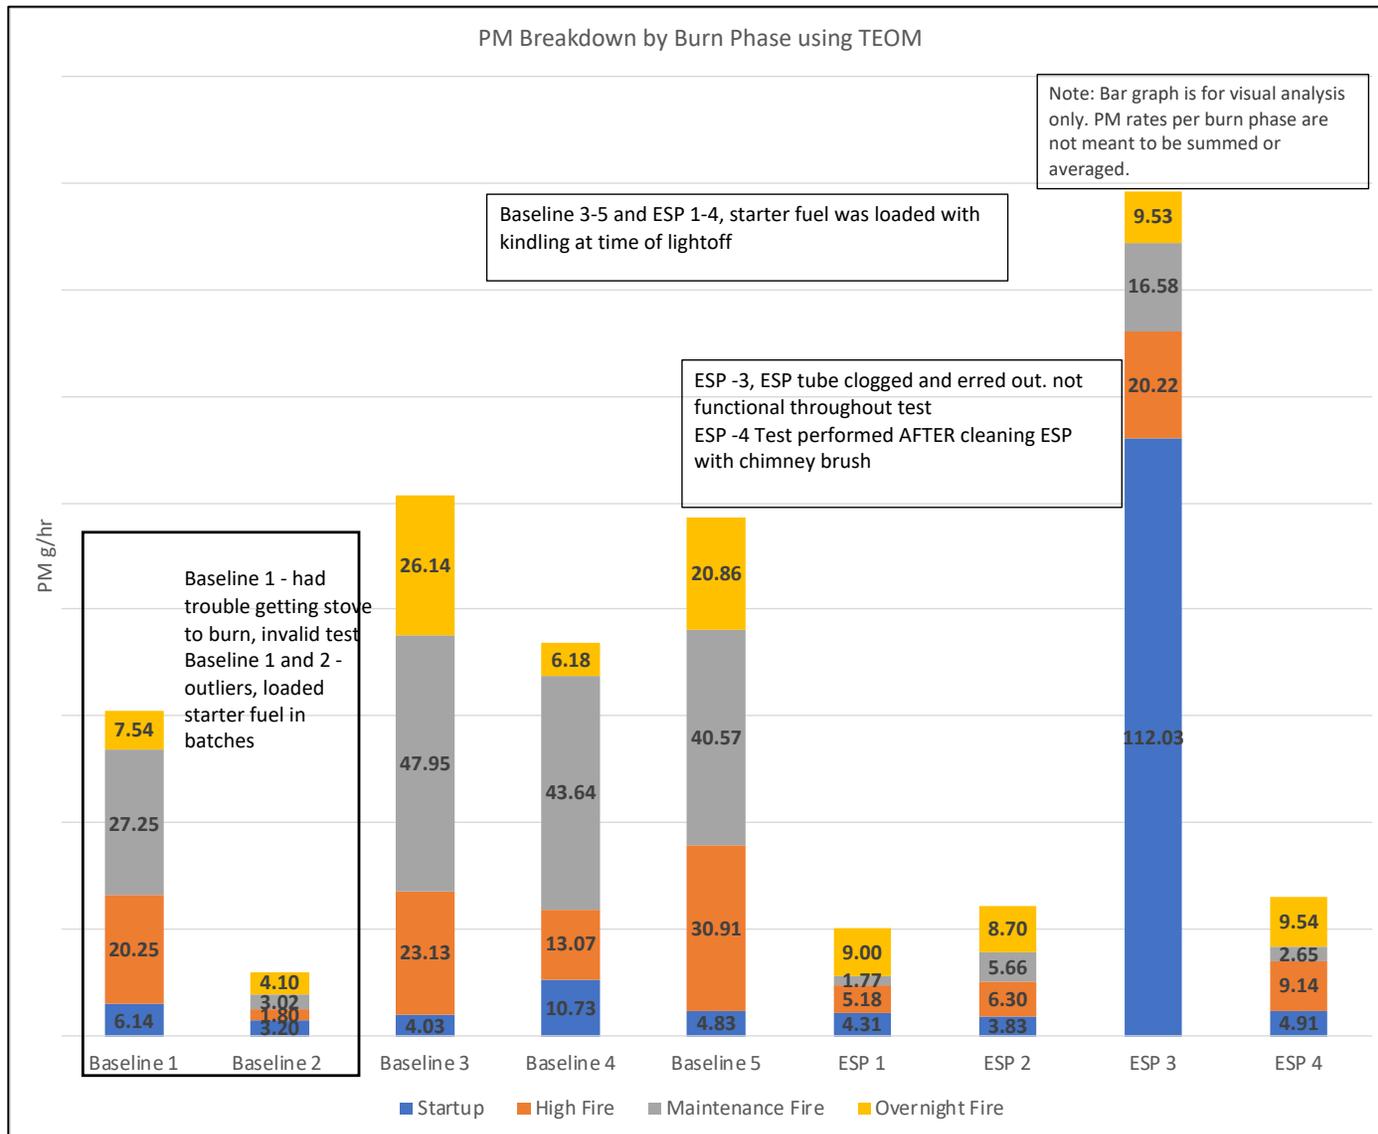
Figure 6. Non-Catalytic Stove 9 PM Phase Comparison

IDC Breakdown PM in g/hr* - TEOM Only														
	Baseline 1	Baseline 2	Baseline 3	Baseline 4	Baseline 5	ESP 1	ESP 2	ESP 3	ESP 4	Average Baseline g/hr**	Average ESP g/hr***	Baseline Avg. % of Total PM	ESP Avg, % of Total PM	% Average Efficiency
Startup	6.14	3.20	4.03	10.73	4.83	4.31	3.83	112.03	4.91	6.53	4.35	2.0	4.3	33.4
High Fire	20.25	1.80	23.13	13.07	30.91	5.18	6.30	20.22	9.14	22.37	6.87	19.1	23.7	69.3
Maintenance Fire	27.25	3.02	47.95	43.64	40.57	1.77	5.66	16.58	2.65	44.05	3.36	48.9	12.8	92.4
Overnight Fire	7.54	4.10	26.14	6.18	20.86	9.00	8.70	9.53	9.54	17.73	9.08	29.9	59.2	48.8

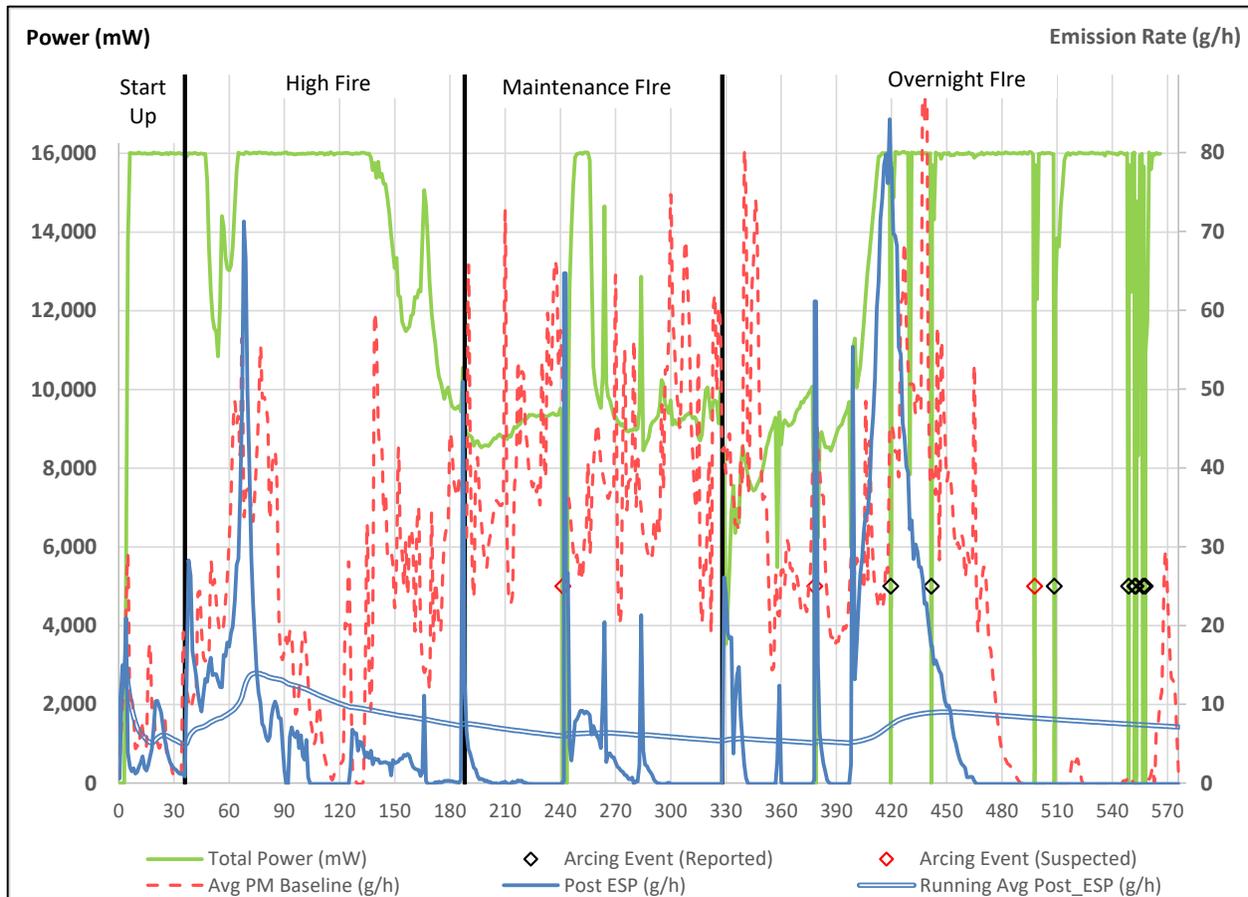
Figure 7. Non-Catalytic Stove 9 with ESP, Run 4, Entire Run (minutes 0 -575)

To provide a basis to understand the performance of the ESP device, the TEOM and ESP operational data were combined and processed to permit a graphical display of emissions performance on a consistent basis during the test. This work was performed by Rincon Ranch Consulting, under subcontract to Trinity Consultants on behalf of the Alaska Department of Environmental Conservation (ADEC) and is included in this report at the request of ADEC; an explanation of the methodology and graphs for all ESP tests is presented in Appendix G. Test run ESP 4 was selected as representative of the ESP's overall performance in the testing and, specifically, of device performance with a light creosote coating lining the ESP walls. Figure 7 shows Baseline and Post-ESP emission rates along with EPS power⁴ and arcing events⁵ for the entire test cycle. Average Baseline emissions from the stove (dashed red line) were not measured concurrently with emissions out of the ESP. The baseline is shown for reference as an approximate indicator of stove emission levels, but it does not represent stove-out emissions *during* the ESP test and, thus, does not match up minute by minute with Post-ESP emissions.

As seen in Figure 7, the ESP powers up during minute 4 of the test (green line) and remains there through the end of Startup at minute 35. Post-ESP emissions are reduced once the ESP powers on. There is an uptick of PM emissions (blue line) at the start of the High Burn phase when the stove is reloaded. ESP power drops below full-power between minutes 48 and 63 during which emissions rise consistently until the device returns to full power and good emission control is restored. Running average PM emissions (double blue line) continue on a decline course into and through the Maintenance Fire phase. The ESP operates below full power but successfully limits emissions to an average to 6 g/hr. since the start of the test.

This level of performance continues into the start of the Overnight Fire phase, but is interrupted at minute 240 by the first in a sequence of arcing events (8 Reported and 3 Suspected). The first is associated with a spike in emissions from the ESP that nearly reaches the highest level of emissions observed during Baseline testing. Cumulative PM emissions tick up during the initial arcing events but decline thereafter to zero levels to end up at an average rate of 7.2 g/hr over the entire test. In this phase, ESP performance is reduced somewhat by arcing events compared to the Maintenance Fire phase

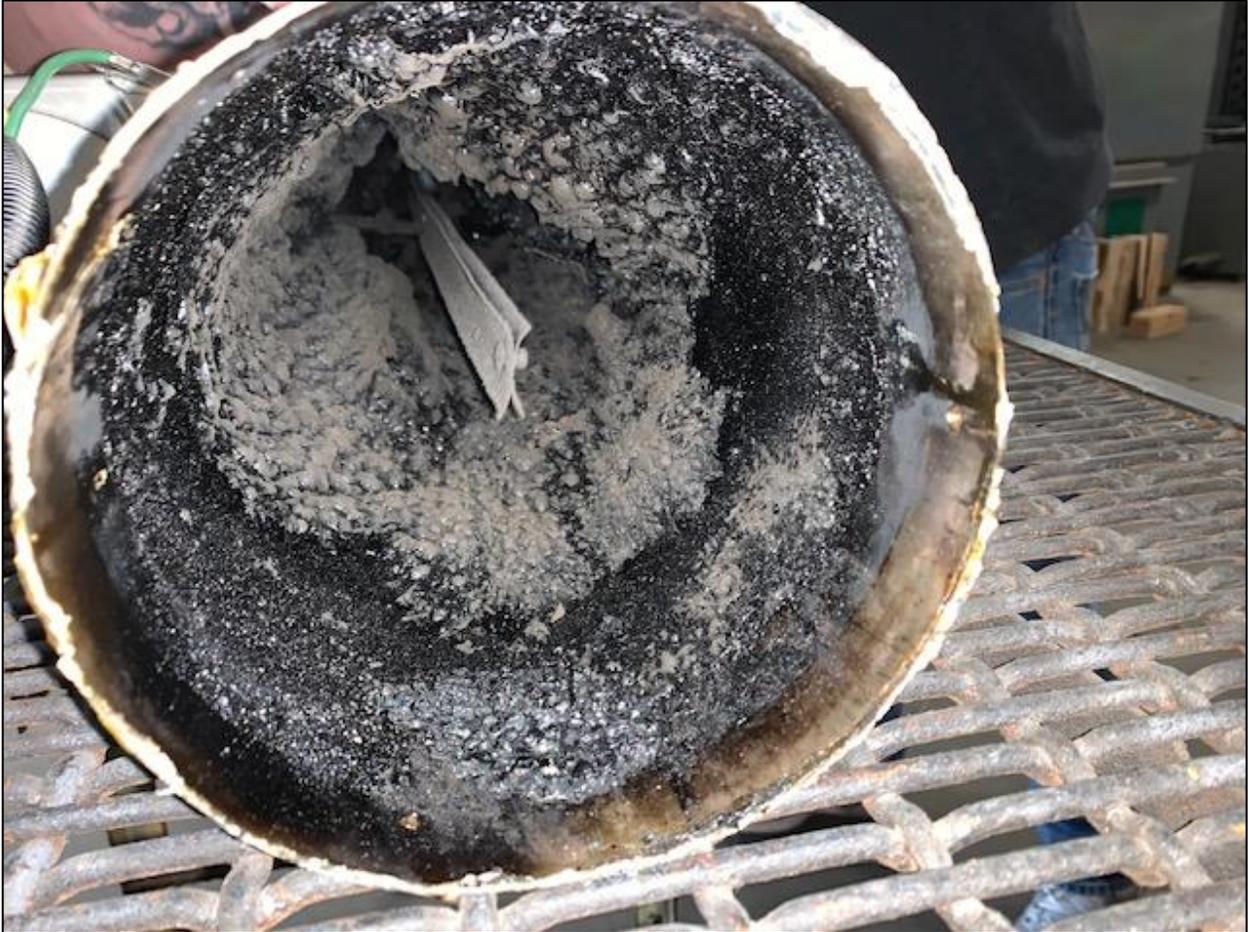
Figure 10. ESP Failure Picture 1

ESP Test Run 3 was run on February 13th, 2020 on Stove 9, a Step 2 certified cordwood stove. The test began at 7:31 AM. Data collected by the ESP, including power, voltage, error codes, and temperature are stored on a live Excel macro worksheet at 1 second intervals. The maximum voltage at the electrode during steady state should be 30,000 Volts and tends to vary based on stove operation and may drop to 0 briefly during arcing events before ramping back up, which has been observed in previous tests. Around 11 AM a technician observed that the voltage readings were very low. Scrolling through earlier data from the morning, it was observed that the electrode had been functioning at this low voltage for hours. It was not until 2:41 PM that the LED light on the ESP went from solid green (active) to a solid red indicating an error. Despite the error, the ESP continued to operate even at its low functional state instead of shutting down and powering off the electrode. According to the manual, a solid red light could mean a myriad of faults, such as a dirty insulator or insulator box, excessive deposits in the flue, an uncentered electrode, damaged voltage cables, damaged voltage module, or problem with the temperature sensor. Upon removal of the ESP, it was discovered that excessive deposits of creosote had partially restricted flow. See Figure 10, Figure 11, and Figure 12 for pictures of the ESP after ESP 3 test run and then after cleaning. Unfortunately, while trying to review the second by second data in the live feed from the ESP, the macro sheet crashed and data from that event was lost. However, an image of the screen was taken that day by technicians trying to troubleshoot during the test and can be viewed in Figure 13.

This buildup was after three cordwood test runs for a total of 34 hours. After cleaning the ESP, a black tacky thin coating remained clinging to the ESP walls. Technicians were instructed to clean the ESP in a way that would mimic what a typical homeowner may be capable of and have available in their home.

Therefore, we used a wire chimney brush down the sides of the walls. Technicians could have used a lab grade acetone or other reagent to try to remove the tacky hard coating on the walls, but it was not recommended in the user manual and it was decided that this was not something a typical user may think to do on their own.

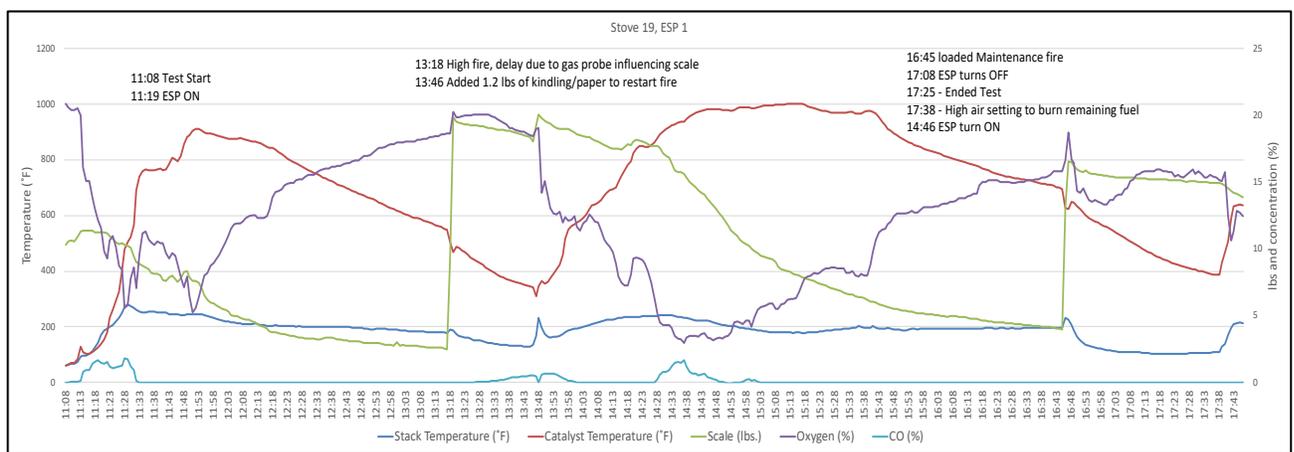
Figure 15. Catalytic Stove 19 ESP Test Run

Technicians observed that sometimes the ESP would go inactive during the tail end of a phase or shortly after the beginning of a new phase during testing of Stove 19. Stove 19 is designed to burn long and slow during a low demand burn, like in the Maintenance Fire phase. This slow burn allows the Stove 19 to operate at low stack temperatures. It is possible that a decreasing stack temperature rate or low steady stack temperature may trick the ESP logic into thinking that the fire has gone out and signal the ESP to power down. This is important to note because it is possible that the ESP could potentially fail to capture PM emissions during transitional periods of low to high heat demands with low stack temperatures. An example is displayed in Figure 15 .
