Alaska Department of Environmental Conservation (ADEC) Solid Waste Program (Doug Huntman and Sarah Durand) conducted a Coastal Impact Assistance Program (CIAP), Waste Erosion Assessment and Review (WEAR) site visit for the Village of Red Devil, September 15th, 2014. The following narrative is a brief description of our findings during the September inspection.

WEAR Sites

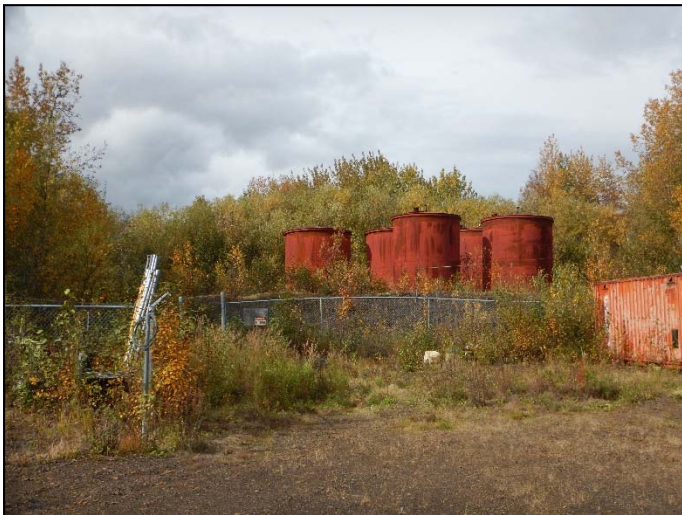
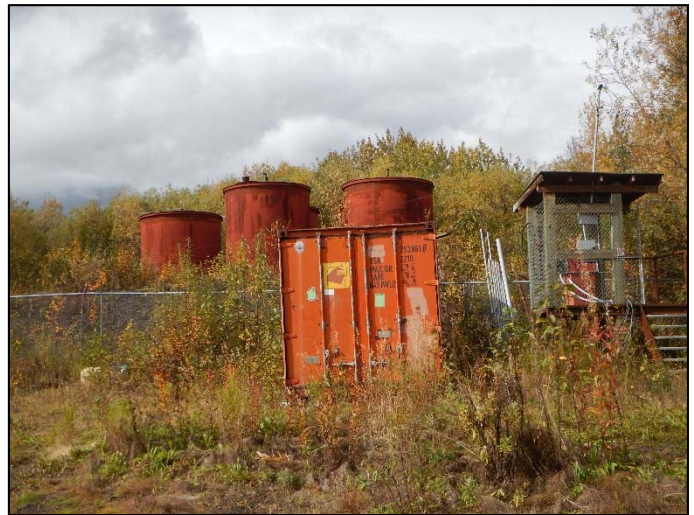
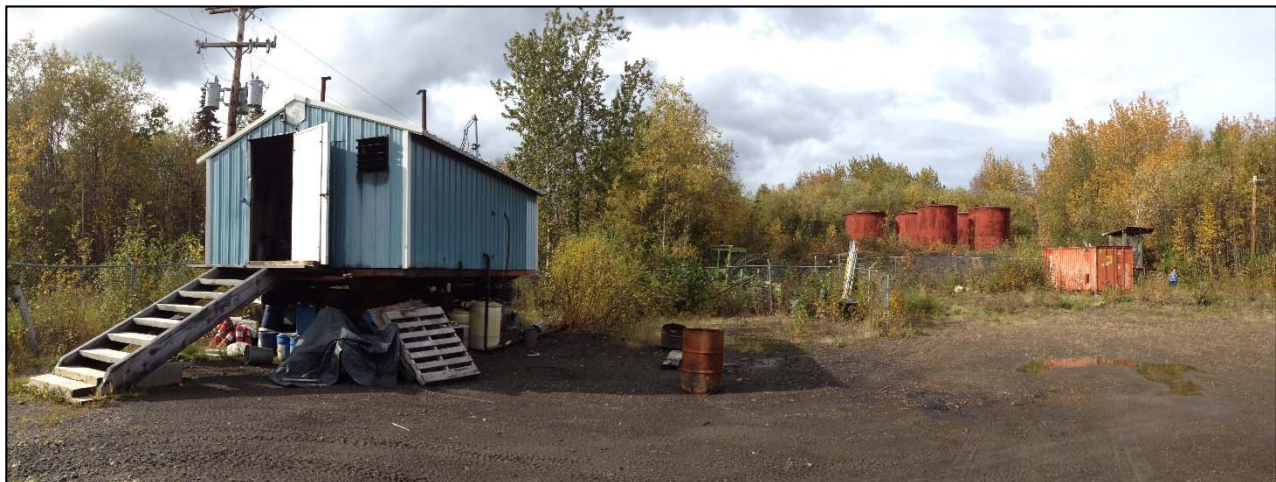
- **MKEC Tank Farm, 61.783103/-157.339408 (Active)** — The tank farm is a known Contaminated Site (File ID 2442.38.002) due to historic spills at the tank farm's current location and previous adjacent location. It is owned by the Middle Kuskokwim Electric Cooperative Inc. (MKEC) and consists of five vertical approximately 10,000 gallon diesel tanks. The tanks sit in an earthen bermed and fenced area. This tank farm supplies fuel to the power plant and serves as the public fueling station. According to locals the area floods regularly, but it has not flooded above the berms. The site is located approximately 750 feet from the Kuskokwim River. According to local residents, this has been an active site for fuel storage since the early 1960's.

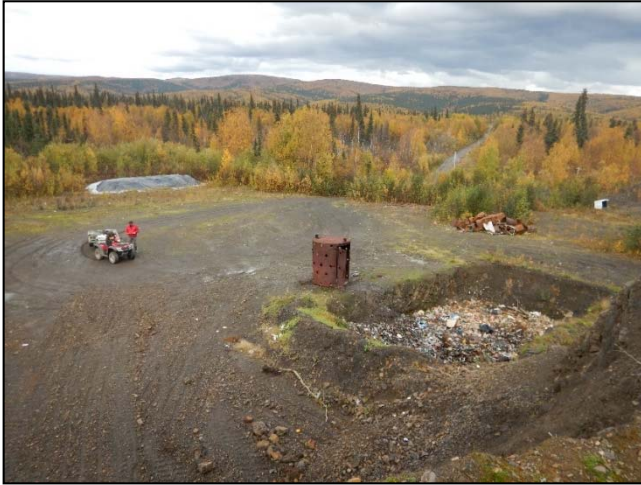
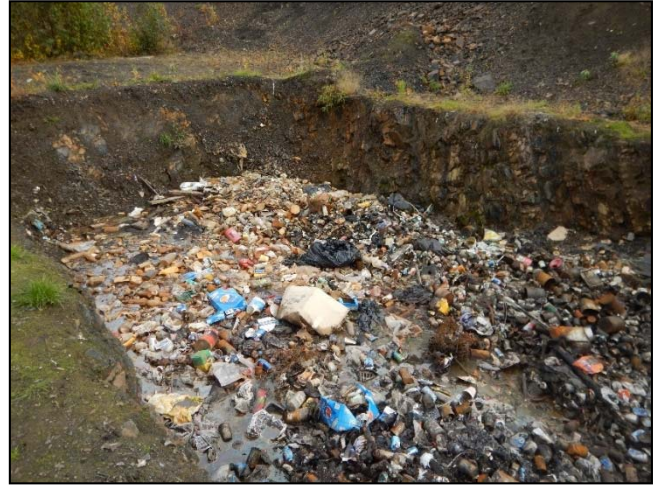
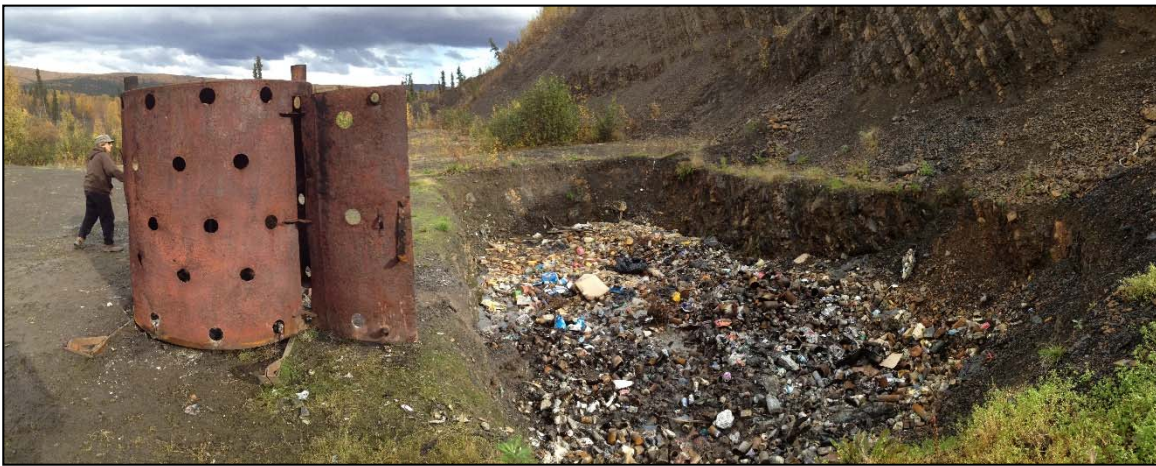
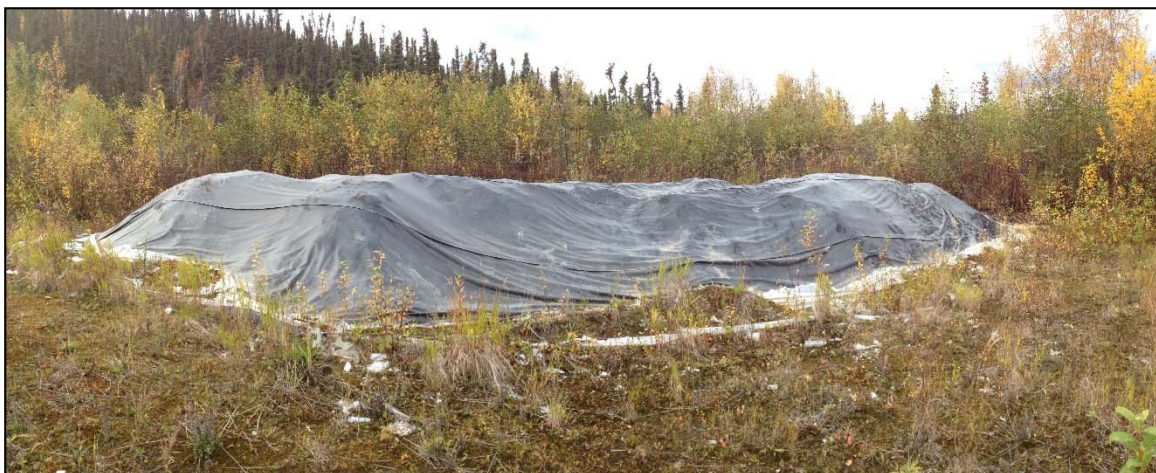
- **Landfill, 61.77606/-157.34724 (Active)** – The landfill is an unpermitted facility operated by the Village of Red Devil. It operates as a trench and fill with no fence or berms and a homemade burn unit. It is located on a hillside above town approximately 2500 feet from the Kuskokwim River. There is no history of flooding at the landfill although runoff flowing into the trench has been an issue in the past. A small trench at the south end of the landfill is used for septage. There is a large polluted soil stockpile in the northeast corner of the landfill that is approximately 60 feet by 15 feet. It appears to be on a liner and is covered with tarps. The polluted soil is from a 2009 spill at the MKEC Tank Farm in the community. The soil was sampled in 2011; however no further work has been done to remediate or dispose of it.

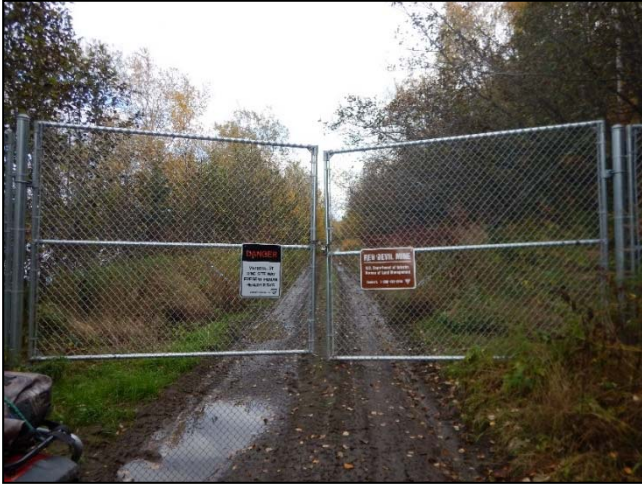
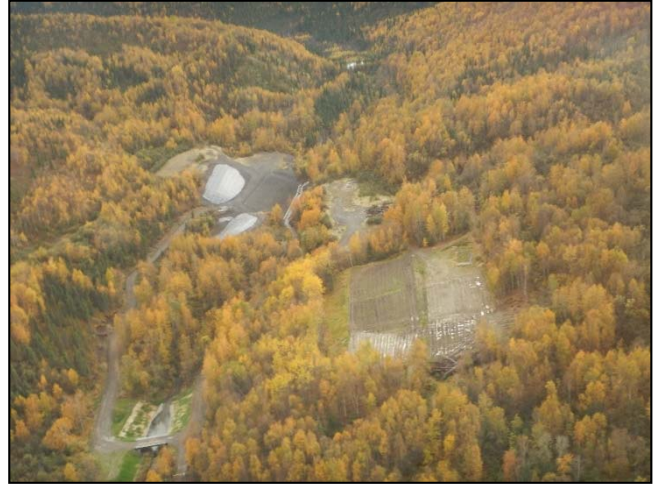
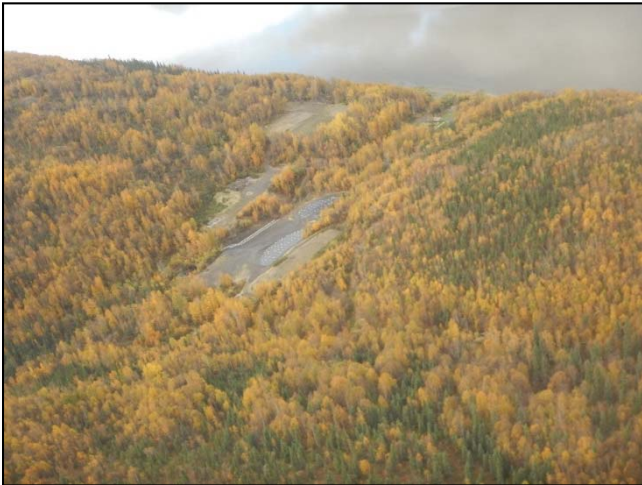
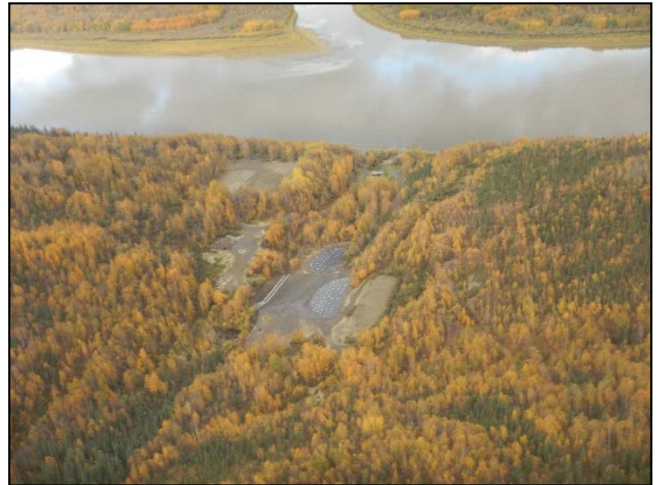
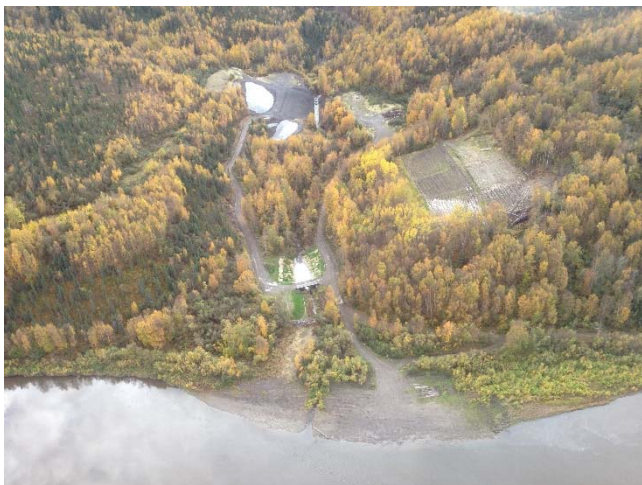
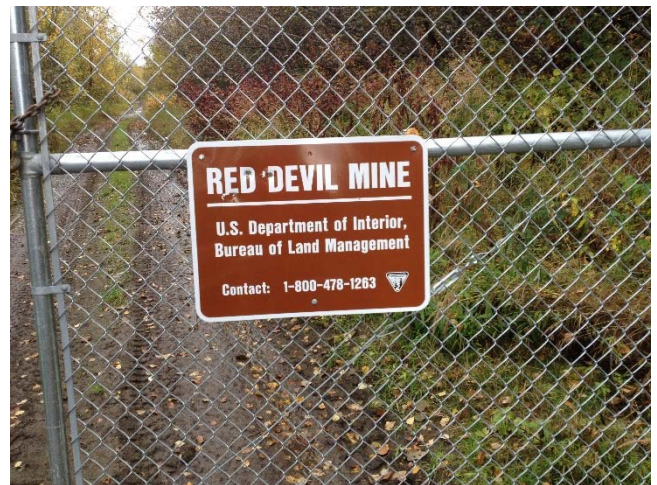
- **Red Devil Mine, 61.759731/-157.314467 (Active)** – The Red Devil Mine is an active Contaminated Site (File ID 2442.38.001). It operated as an above ground and underground cinnabar mine and mercury production facility from 1933 to 1971. The site is owned by the Bureau of Land Management (BLM) and is being addressed as a Comprehensive Environmental Response, Compensation, and Liability Act (CERCLA) (commonly known as Superfund) site. The site includes inert and industrial landfills under federal jurisdiction. According to BLM the mine tailings are actively leaching Arsenic, Antimony, Lead, and Mercury. The Red Devil mine site is located on the south bank of the Kuskokwim River 1.5 miles upstream from the Village of Red Devil. The entrance is gated and locked with no local access onto the mine site.
