ALASKA DEPARTMENT OF ENVIRONMENTAL CONSERVATION
Division of Spill Prevention and Response
Prevention Preparedness and Response Program
SITUATION REPORT (SITREP)

Tug *Western Mariner* Grounding Neva Strait

SITREP #: 4

DATE/TIME OF DISTRIBUTION: March 27, 2022, at 3:00 p.m.
Information current as of March 27, 2022, at 12:00 p.m.

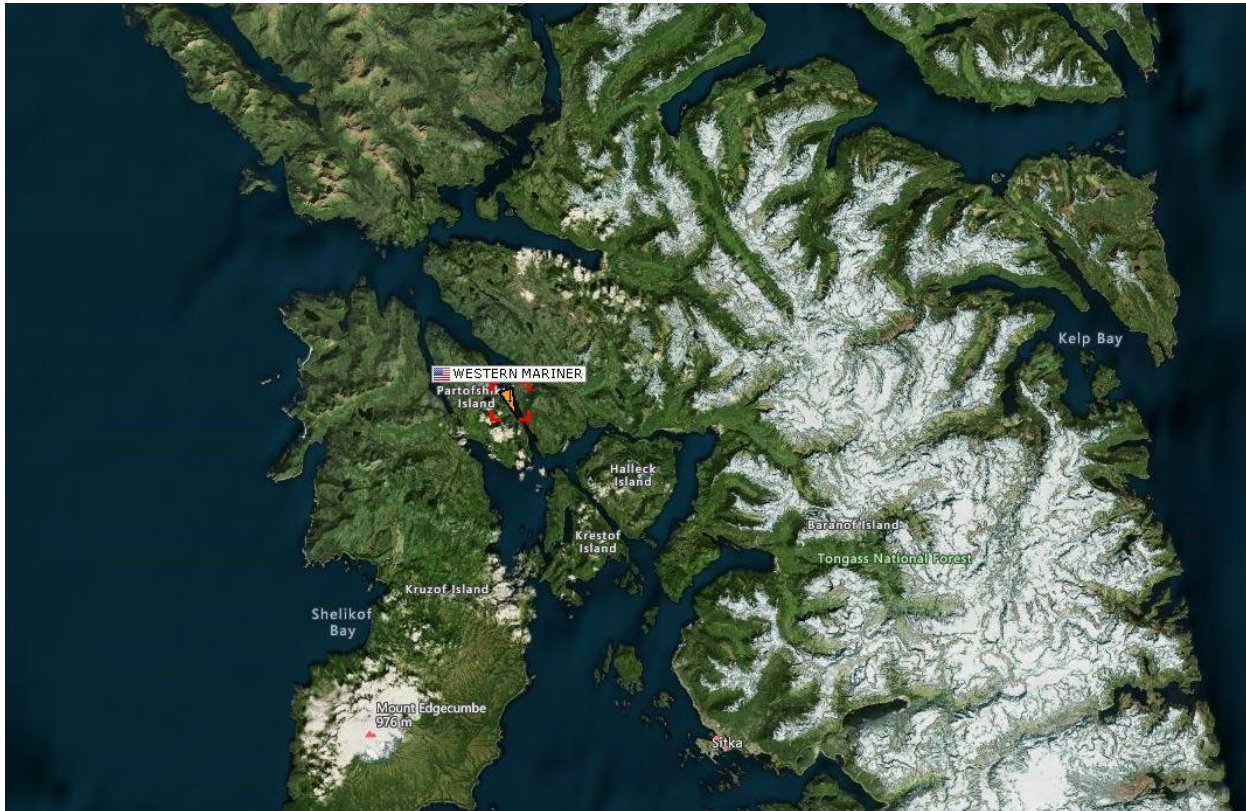
Figure 1. Incident Location.

INCIDENT LOCATION: Neva Strait, approximately 18 miles northwest of Sitka (Lat/Long: 57.26982, -135.59315).

On March 21st and 23rd, 2022, the Alaska Department of Fish and Game (ADFG) conducted overflight surveys and did not observe any herring spawning or schooling near the sheen. On March 24th, 2022, around 8:30 am, ADFG conducted overflight surveys and observed 20,000 tons of herring in Hayward Strait (Figure 1) that were moving into Krestof Sound. The survey observed broken sheening that extended into Olga Strait as well as Krestof Sound, extending south to the north end of the Magoun Islands. Subsequent overflights showed that the sheening outside of Neva Strait had dissipated throughout the day.

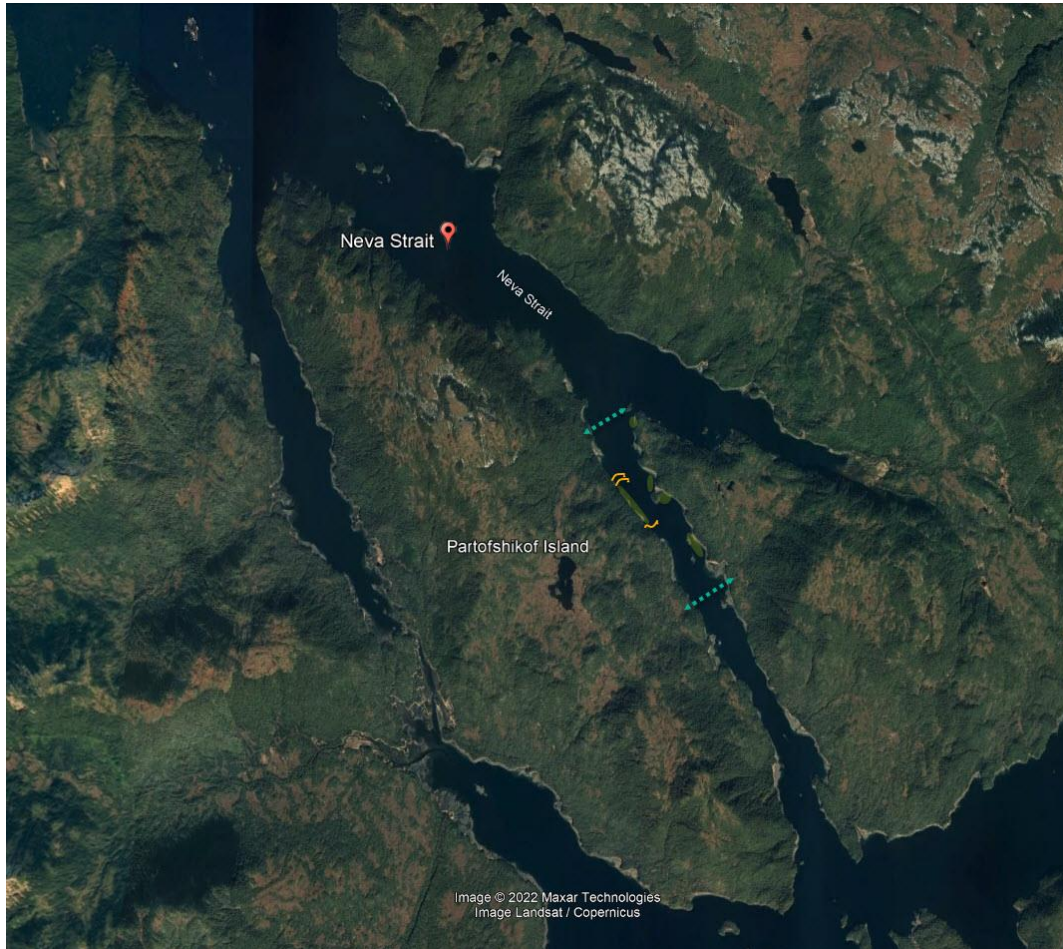
There continue to be two overflights a day to observe wildlife and sheen around the response. An overflight conducted by SEAPRO on March 26, 2022, at 2:10 pm, observed no visible sheen outside Neva Strait. Rainbow sheen was observed between the J-boom configurations on the west shore of Neva Strait directly around the vessel. Along the eastern shore rainbow sheen was observed between Entrance Island and just south of Wyvill Reef, predominantly in areas with a sandy shoreline or directly around the grounding site.

Figure 2. Incident location. The yellow lines demark the extent of a wider rainbow sheen observed by an overflight conducted by SEAPRO on March 26, 2022. No visible oil sheens were observed outside the green lines. Photo by SEAPRO.

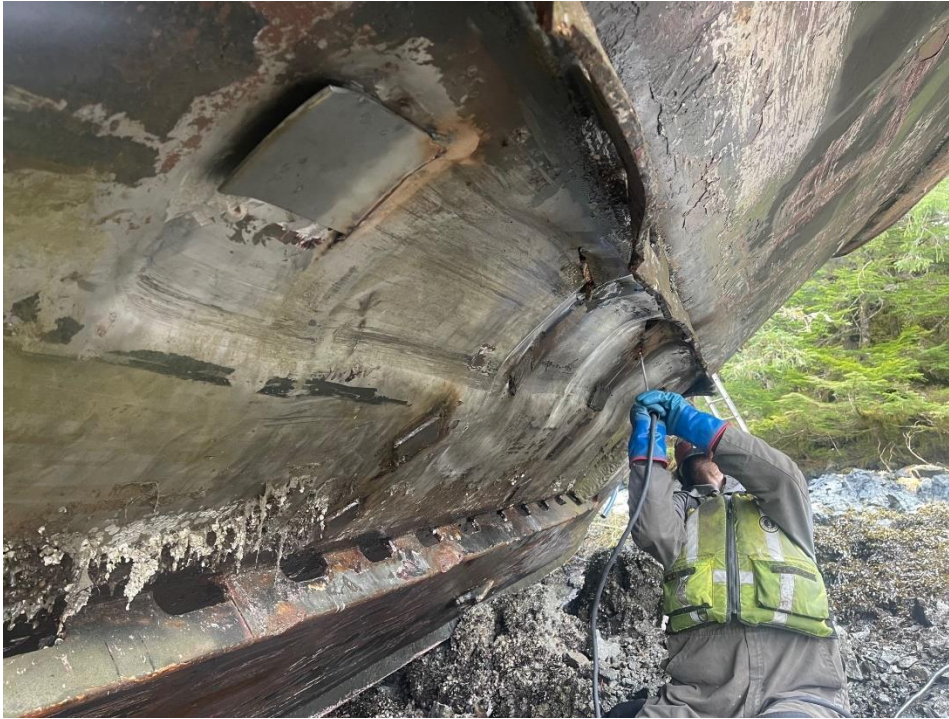
Figure 3. Global Diving and Salvage, Inc. crewmember continues fabrication welding on the hull of the *Western Mariner* on March 25th. Photo by Global Diving and Salvage, Inc.

On March 25, 2022, the Western Towboat Co. crew were able to start the starboard generator on the *Western Mariner* to provide power to hydraulic systems to support upcoming efforts to refloat the vessel. Global crew continued to complete welded repairs to the hull to strengthen temporary patches used to achieve source control on March 24. Overnight, Hanson Maritime continued to monitor changes in the boom configurations and the vessel buoyancy.

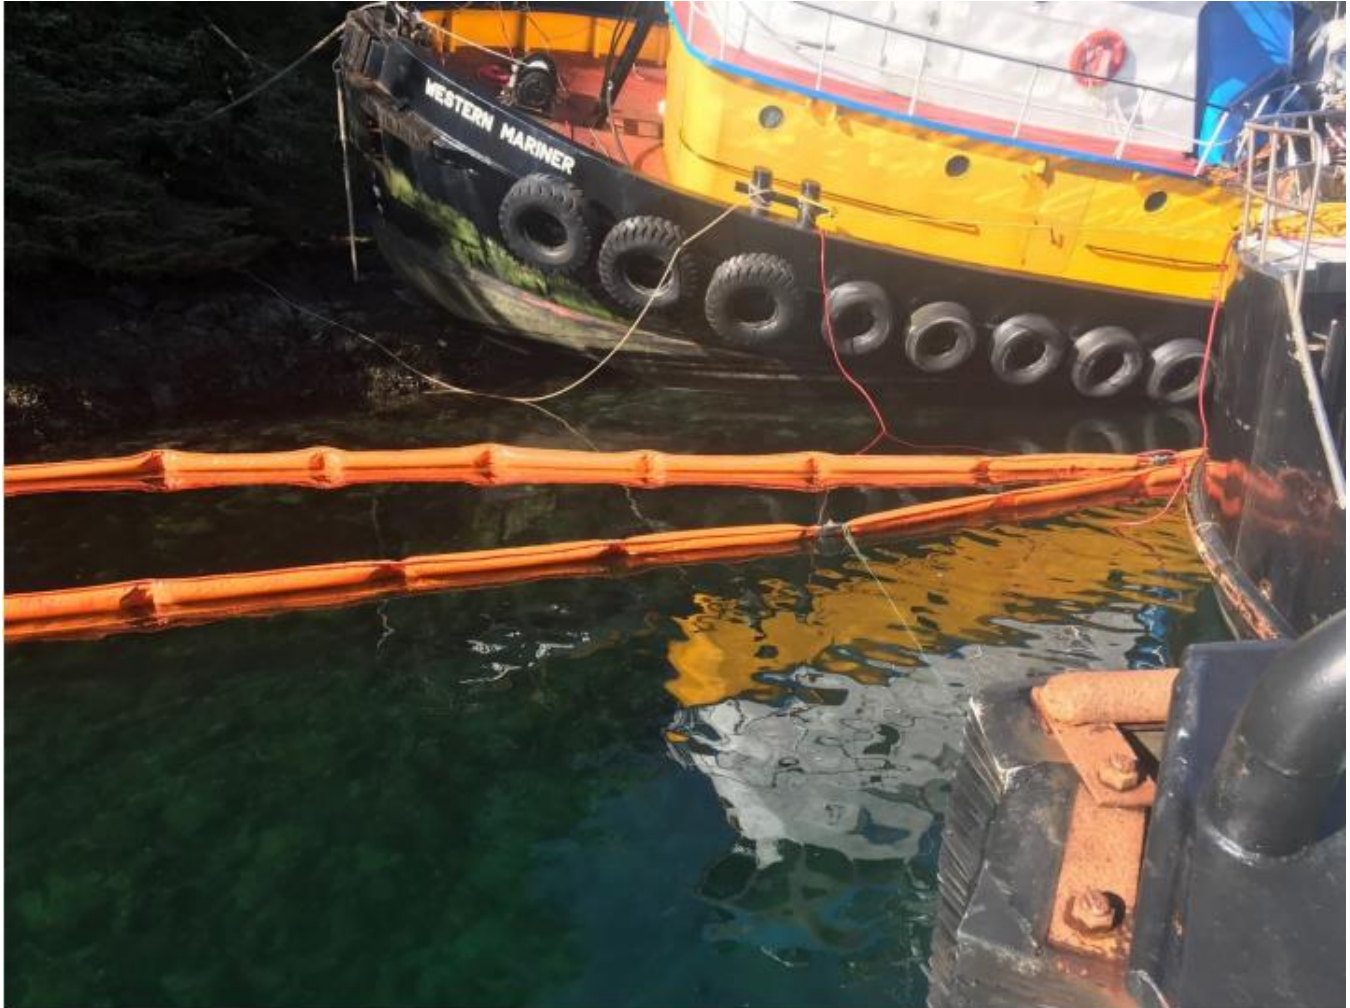
Two layers of containment boom **remain** deployed around the vessel. Absorbent materials placed between the layers of boom are passively recovering diesel from the water surface. **There is no longer enough fuel within the secondary containment to support skimming operations. Any remnant sheen within the boom configuration continues to be addressed with absorbent materials. A total of 1,750 gallons of oily water was skimmed from within the containment boom.**

Figure 4. Image of the *Western Mariner* within the primary containment as of March 26th. Photo by Global Diving and Salvage, Inc.
