# DETAILED ACTION PLAN

## ALAKANUK OLD BIA SCHOOL

### WASTE EROSION ASSESSMENT & REVIEW (WEAR)

MAY 2015

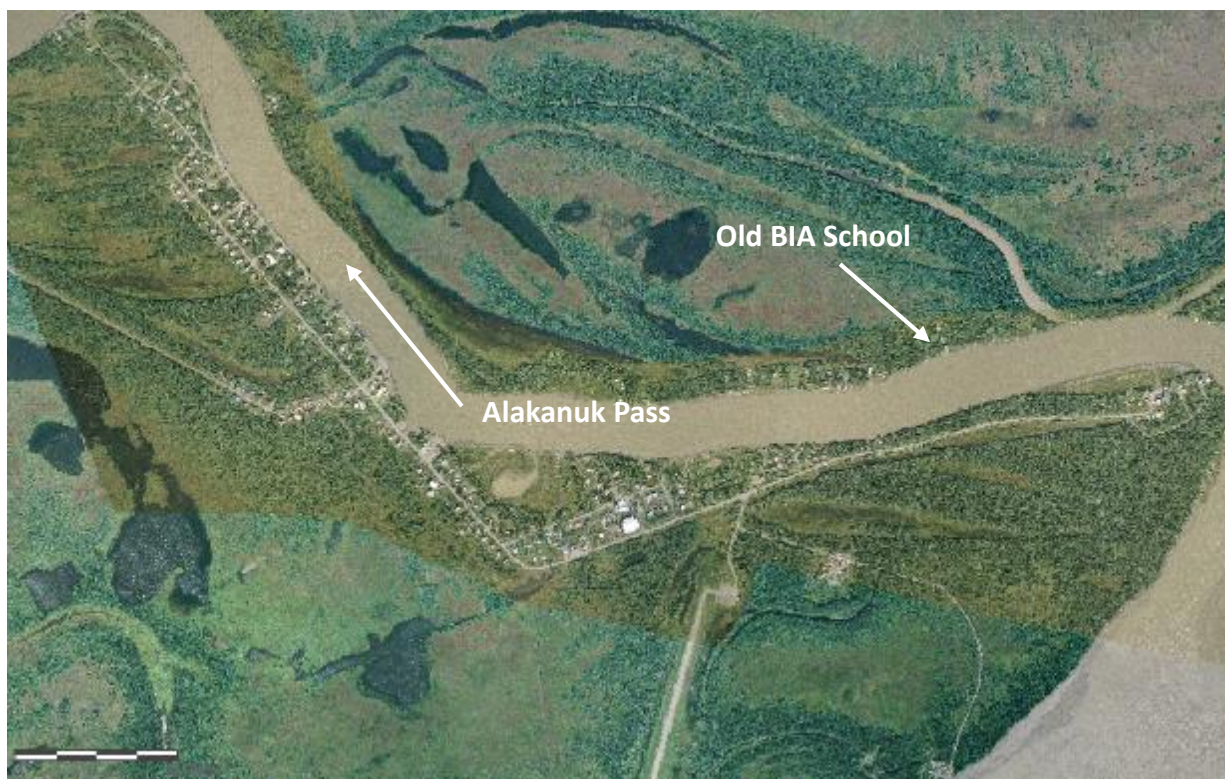
The **Alakanuk Old Bureau of Indian Affairs (BIA) School** is a site located at latitude 62.688290 and longitude -164.634385 upstream and across the river from the village. It is located on the north shore of the Alakanuk Pass, which is a tributary of the Yukon River, and was inspected for the Waste Erosion Assessment and Review (WEAR) project on July 10, 2012.

The Alakanuk Old BIA School consists of three old school buildings owned by the BIA. The school has been abandoned since the 1980s. It was reported that the old school had a fuel tank, but it has been removed and no evidence was seen of an old tank or contaminated soil during the 2012 WEAR inspection.

Imagery Dated 2006, WEAR Map at <http://dec.alaska.gov/eh/sw/wear.html>

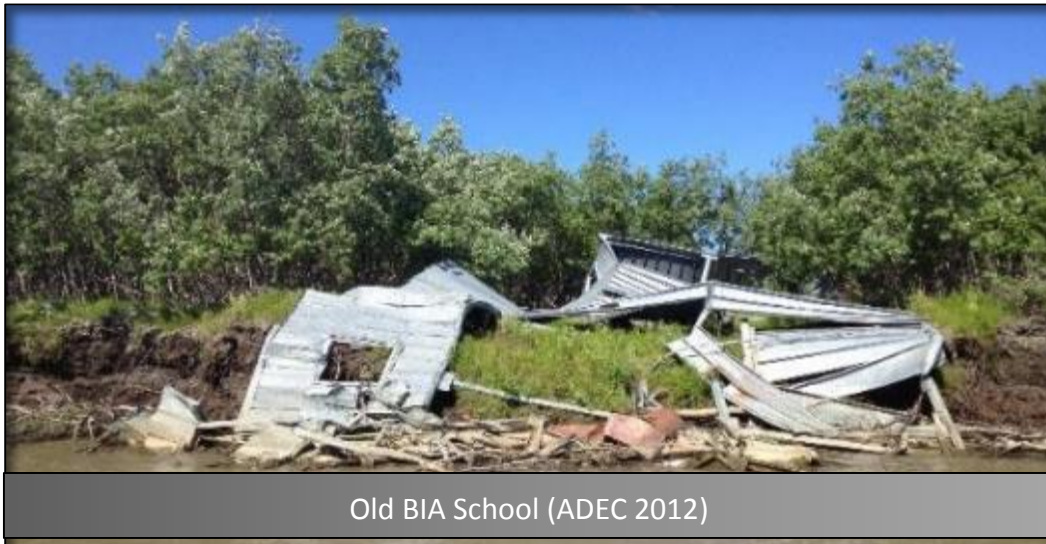
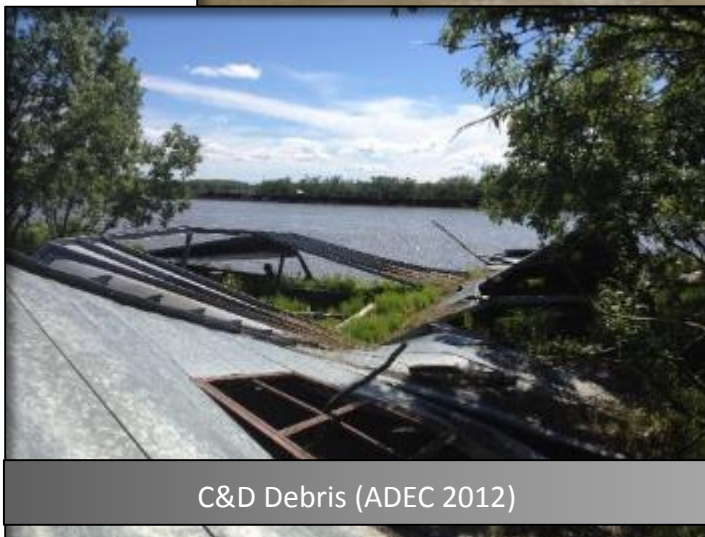
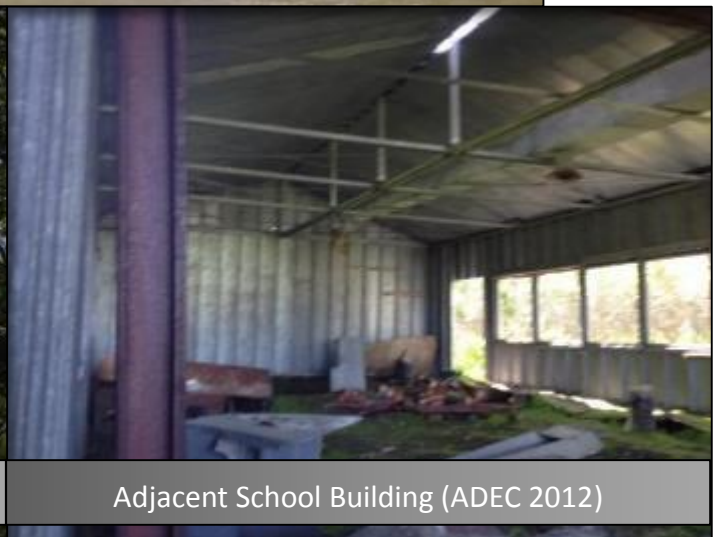
This site contains construction and demolition (C&D) debris that is a concern due to the possible presence of asbestos-containing materials. Asbestos was widely used in construction materials prior to the 1980s and remains in many rural communities in their older structures. Asbestos is known to cause lung cancer, but does not pose a health risk if it remains contained and is not released to the environment. Asbestos released to water due to erosion is less of a health concern; however, asbestos fibers released to the air pose a more significant risk to human health and the environment. Once asbestos fibers are released they are difficult to clean up, which can result in both short term and long term impacts.

It is recommended to complete an asbestos survey for the site, then to remove the buildings and dispose of them in an ADEC permitted landfill. As the site is already falling into the river, it is necessary to begin planning and seeking funds to remove and cleanup this site before erosion can further deteriorate the Old BIA School.

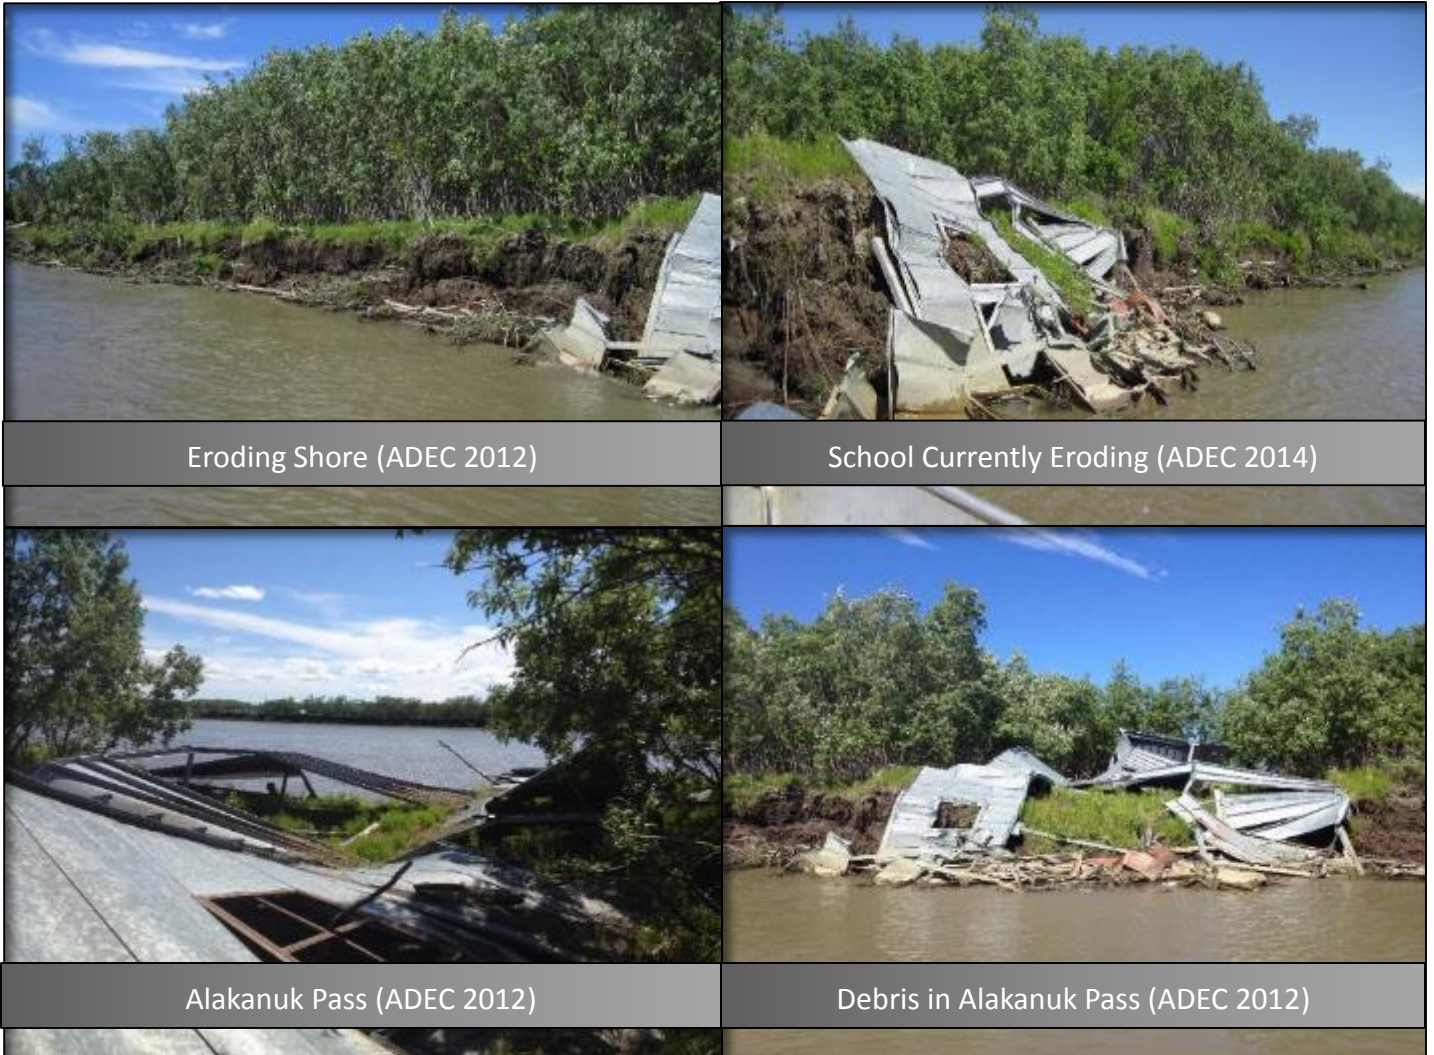
The US Army Corps of Engineers 2009 study, *Alaska Baseline Erosion Assessment (BEA)*, lists an estimated erosion rate of 2 feet per year for Alakanuk. According to the BEA, erosion occurs two times during the year: spring break-up and the fall storm season. During breakup, the Yukon River experiences high flows due to thawing snow and ice as well as surges caused by the failure of ice jams upriver. The soil at this site is silt and sand, which is more easily eroded than other soil types.

During the 2012 WEAR site inspection, the school was actively eroding into the river and it was reported by local residents that ice was the main contributor to erosion.

Immediate action is recommended for this site as it is actively eroding into the river. Erosion mitigation is not recommended for this site as the rest of the community is on the south shore of the Alakanuk Pass, and mitigation would not protect any active or in-use structures.
