CIAP WEAR Trip Report  
Alakanuk (population 703)  
July 10, 2012 and July 10, 2014

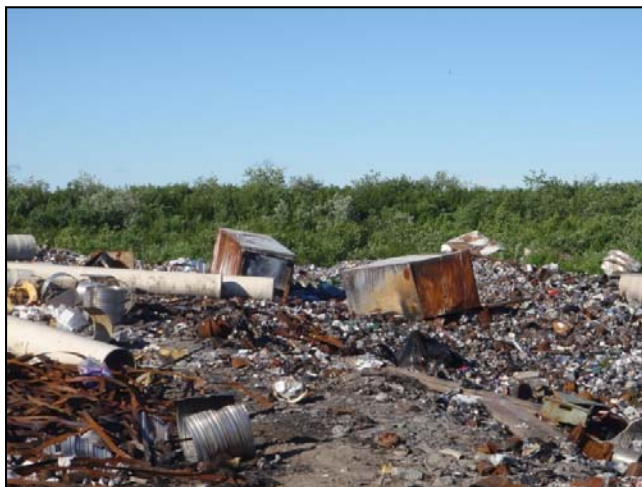
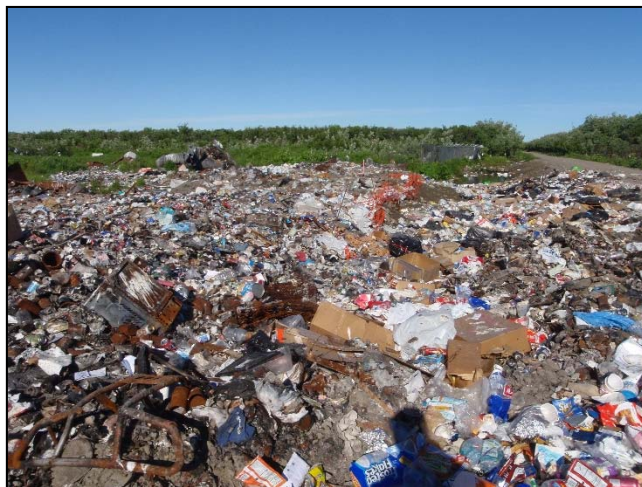
**2012 Photos**

- **Landfill, 62.682772/-164.640963 (Active)** – This unpermitted landfill is an area-fill landfill set atop silty, sandy soil common to the area. The site is 5 acres in size and floods every year in the spring. It has been in place since the 1990s. It is not managed well by the City of Alakanuk and is subject to many of the pitfalls of a self-haul site in Western Alaska. The landfill spills out of the site and covers half of the dump road with raw garbage. The site suffers from open burning, open dumping, and prohibited items mixed with municipal waste. The conditions remained unchanged from 2012 to 2014. The landfill is approximately 1,100 feet from Alakanuk Pass and 2,100 feet from the Yukon River.

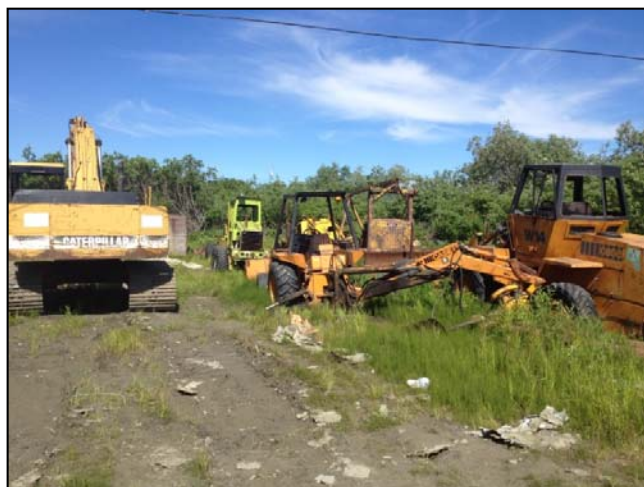
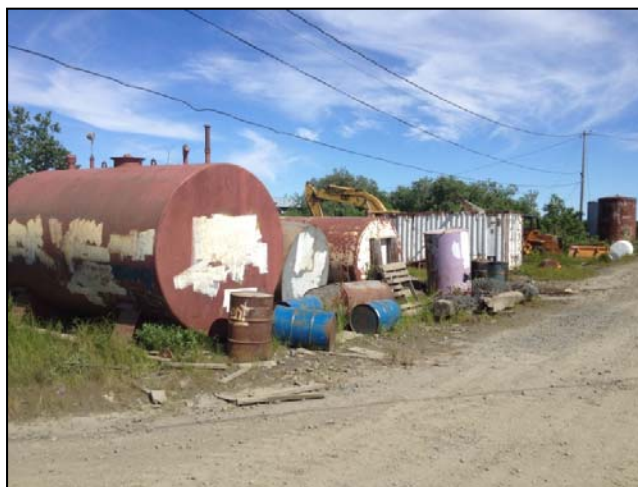
- **Boneyard, 62.687597/-164.668538 (Active)** – This site is a collection of dead equipment, old machinery and several decommissioned fuel tanks. Most of the machinery is still full of fluids including but not limited to oil, hydraulic oil, and fuel. Batteries for the most part also appeared in the vehicles. The shoreline is made up of a silty material and is eroding at a rapid rate. One interview from an Alakanuk resident indicated that the shoreline has eroded over 100 feet in the past year. The boneyard is located less than 200 feet from Alakanuk Pass.

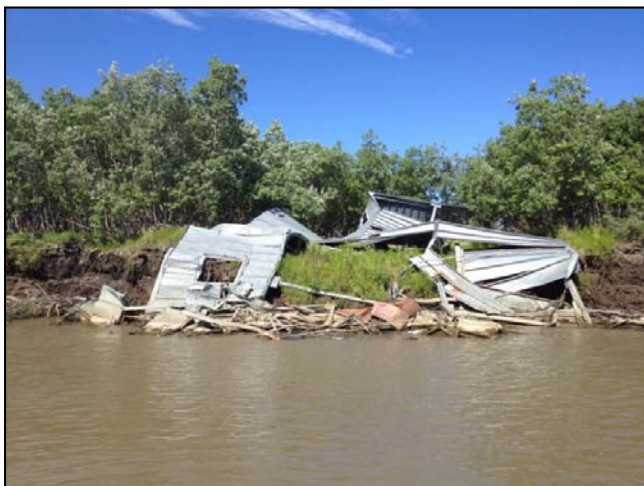
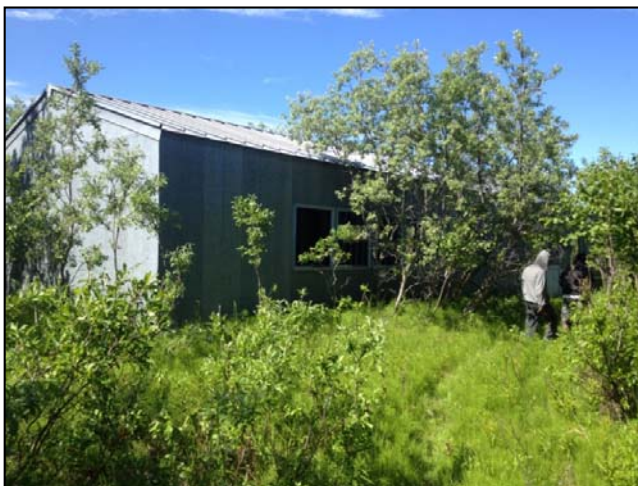
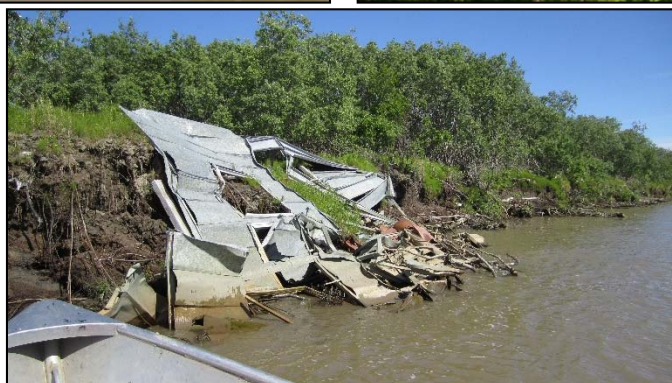
- **Old BIA School, 62.688290/-164.634385 (Abandoned)** – This site has been abandoned since the 1980's. It consists of three old school buildings owned by the Bureau of Indian Affairs (BIA). The first building is actively eroding into the river and is halfway in the river. Contaminates are primarily metal, wood and glass from the school. It was reported that the old school had a fuel tank, but it has been removed and no evidence was seen of an old tank or contaminated soil during the inspection. This site is on the north shore of Alakanuk Pass.

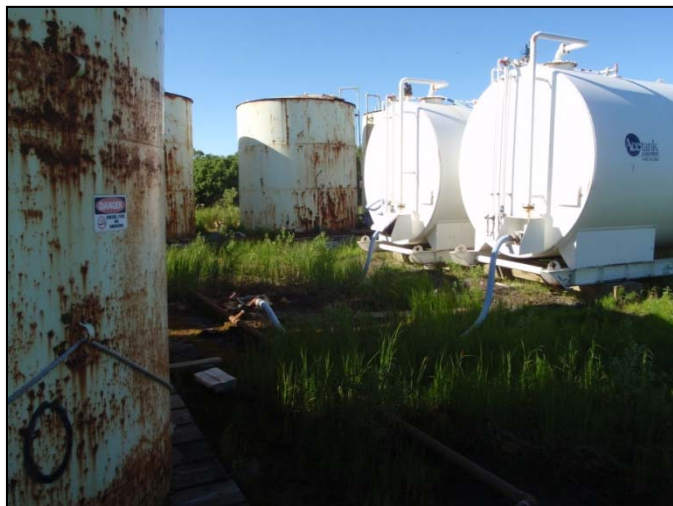
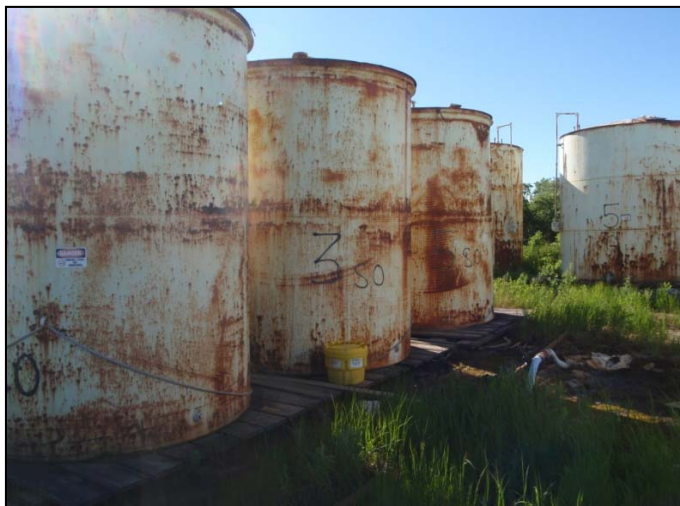
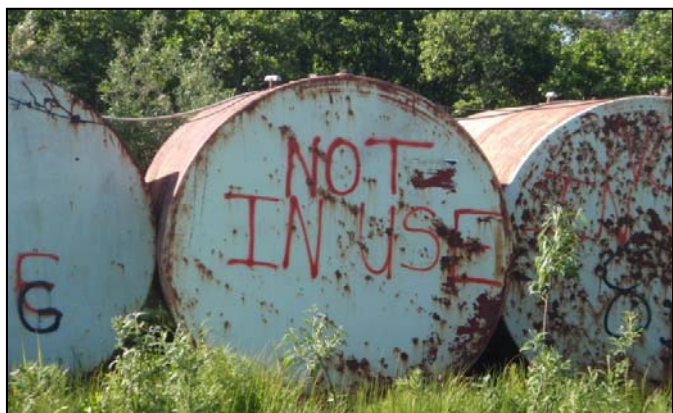
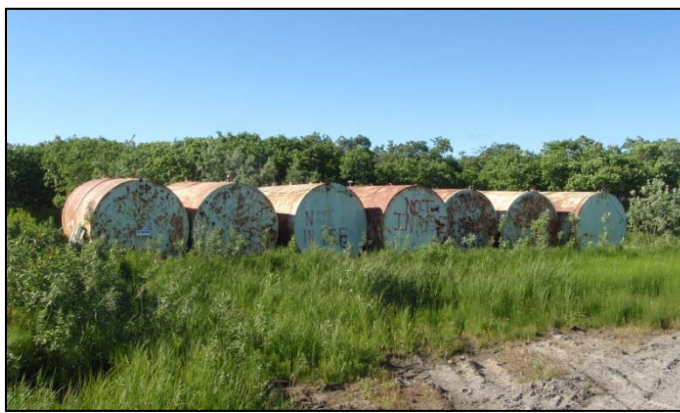
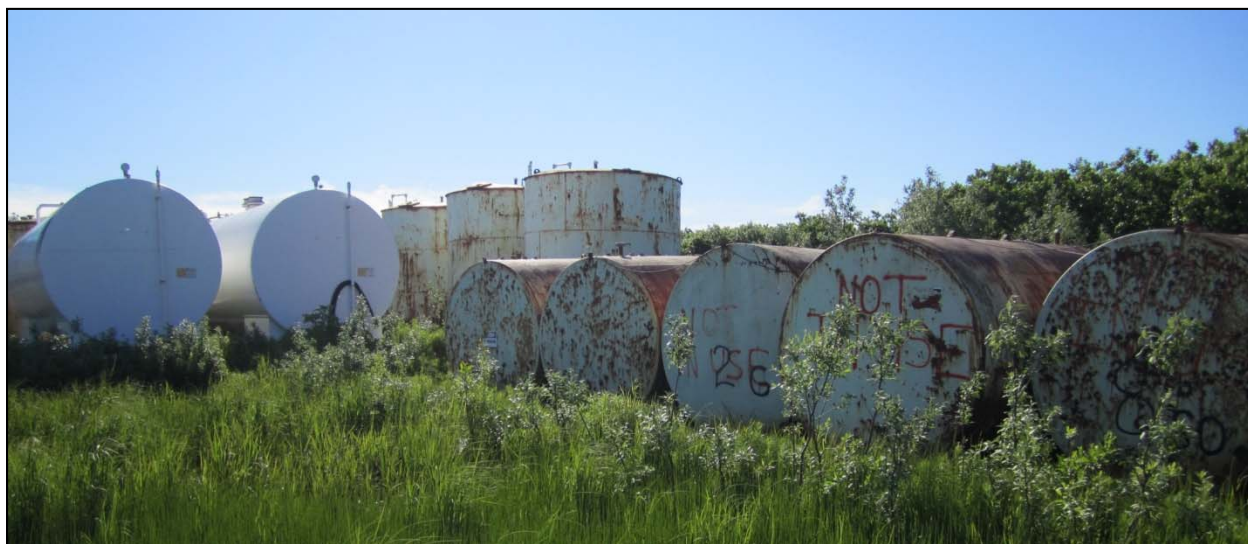
- **Native Store Tank Farm, 62.686646/-164.621956 (Active)** – This tank farm contains two new 12,000 gallon horizontal tanks that are currently in use by the store. There are also 17 vertical and horizontal tanks that have been disconnected and are no longer in use. All tanks have been used for gasoline or diesel storage. The ground around the old tanks shows evidence of contamination from spills over the years. Most old tanks are raised on pallets within earthen bermed areas with a liner. The Alakanuk Native Corporation owns the site. This site is susceptible to flooding and is less than 500 feet from the eroding bank of Alakanuk Pass.

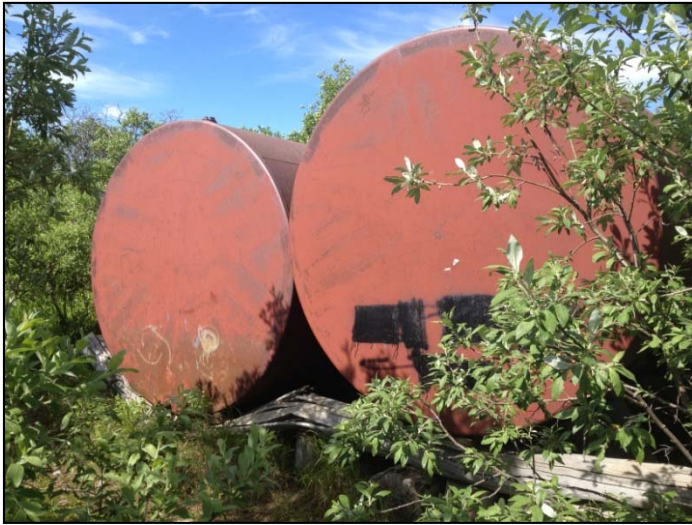
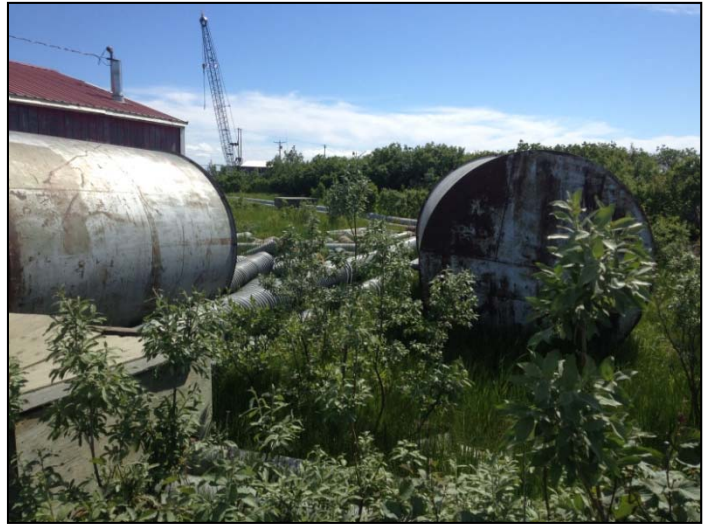
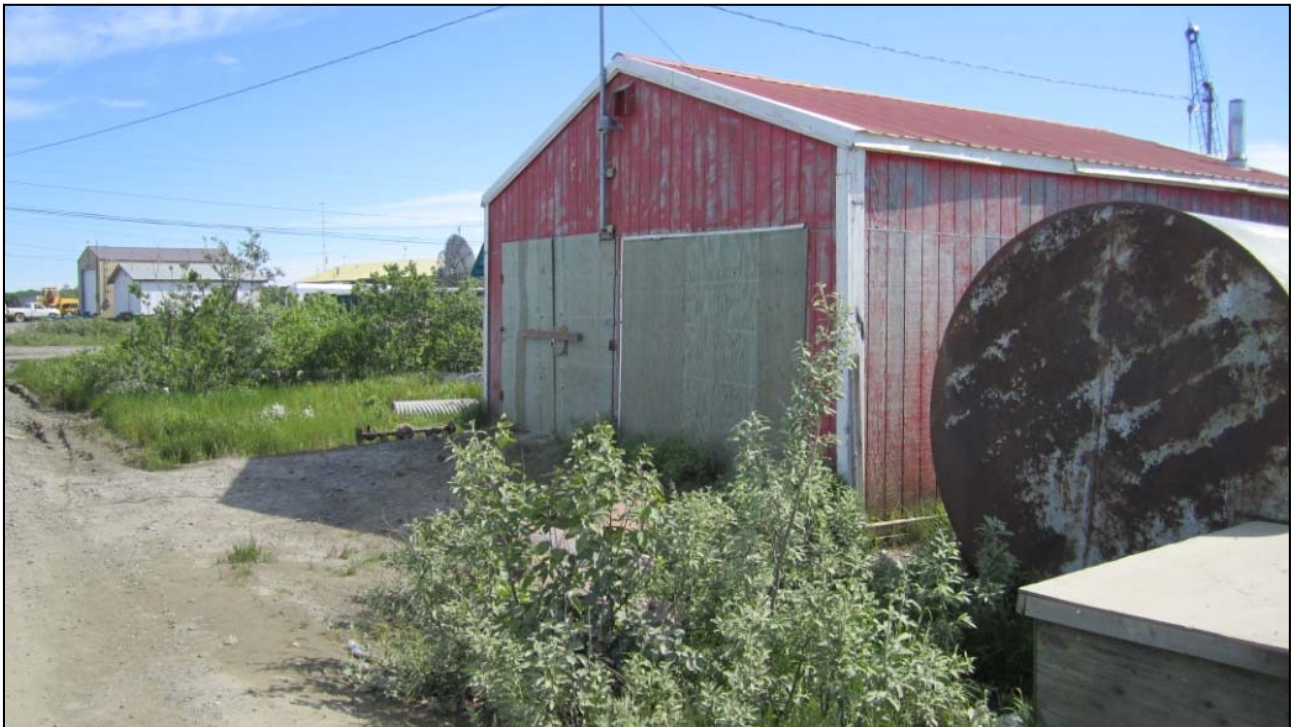
- **Old Fire Department, 62.686882/-164.669700 (Abandoned)** – There is a collection of four, old abandoned tanks at the Old Fire Department. It is not clear if they were used by the Fire Department or if they were moved there. It was reported there are contaminants from the diesel day tank. The site is 480 feet from the Alakanuk Pass shoreline and is subject to flooding.

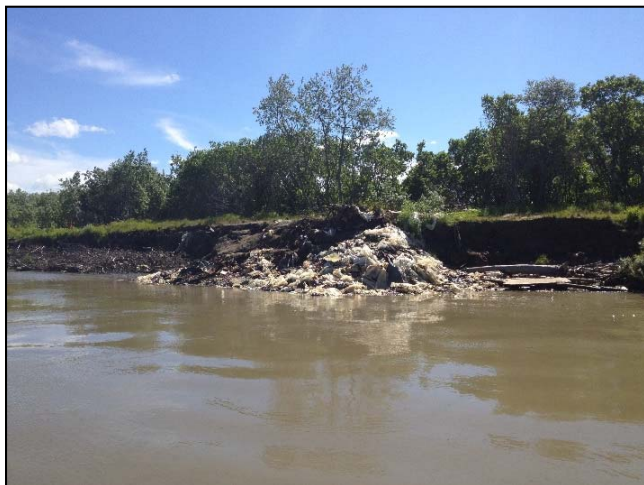
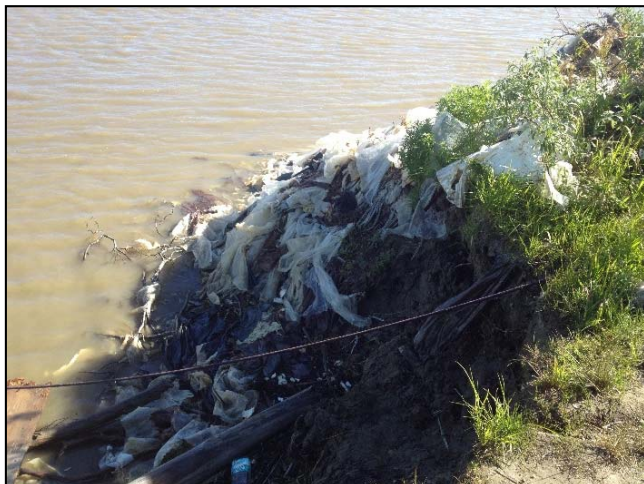
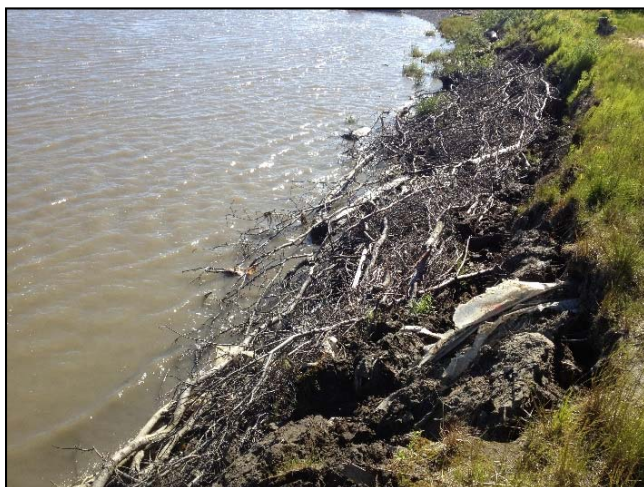
**2012 Photos**

- **South Side Dump Site, 62.685556/-164.653611 (Closed)** – This eroding landfill was the recipient of a Brownfield Assessment in 2007 under the Contaminated Sites Program (File ID 2403.57.001). The landowner is the City of Alakanuk. The landfill was reportedly used during the construction of the high school in the mid 1970's. Primary contaminants are construction and demolition debris such as plastic, wood, and metal. The landfill was built 70-75 feet from the bank of Alakanuk Pass, but has since eroded enough that about half of the landfill has washed into the river. The waste is visible approximately 80-100 feet along the shoreline and is in direct contact with the water. This site was inspected again, two years later in July 2014. A significant amount of plastics had washed away and the riverbank had eroded a few feet.
