CIAP WEAR Trip Report
Aleknagik (population 204)
July 9th, 2012

Alaska Department of Environmental Conservation (ADEC) Solid Waste Program and Contaminated Sites Program (Kitrina Persson, Bill O'Connell, and Jamie Gorman) conducted a Coastal Impact Assistance Program (CIAP), Waste Erosion Assessment and Review (WEAR) site visit for the Village of Aleknagik, July 9th, 2012. Tina Carr, the Village Council IGAP Coordinator, helped coordinate our visit. The following narrative is a brief description of our findings during the July inspection.

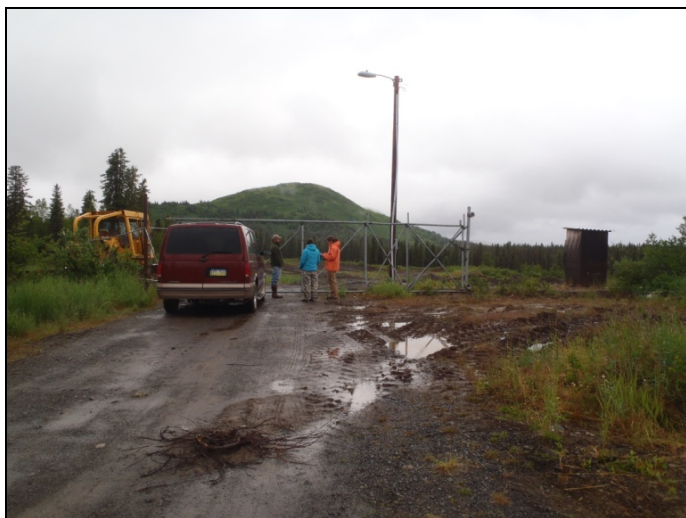
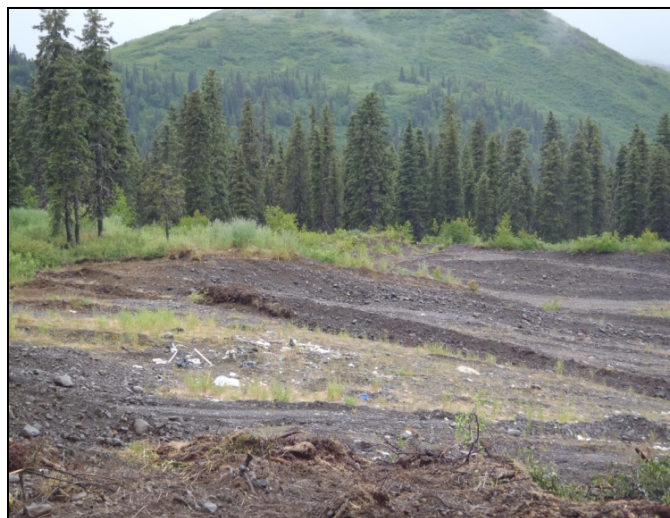
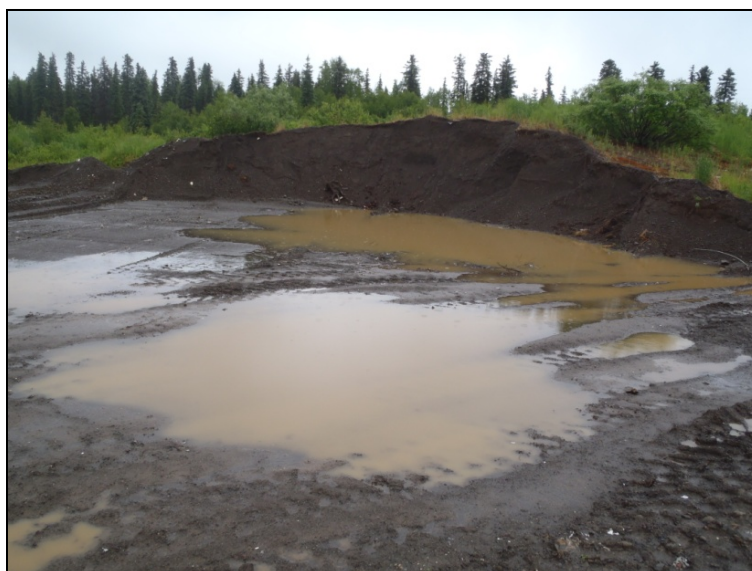
- **South Shore Landfill, 59.236923/-158.666956 (Closed)** – This landfill was in the process of being closed during our visit. There was sufficient cover of soil, but trash was visible in some areas where the cover had settled. The topography of the site consisted of a pit in the center and a raised perimeter which was level with the surrounding land. Vegetation was beginning to sprout. The site is located approximately 2.25 miles from Lake Aleknagik.

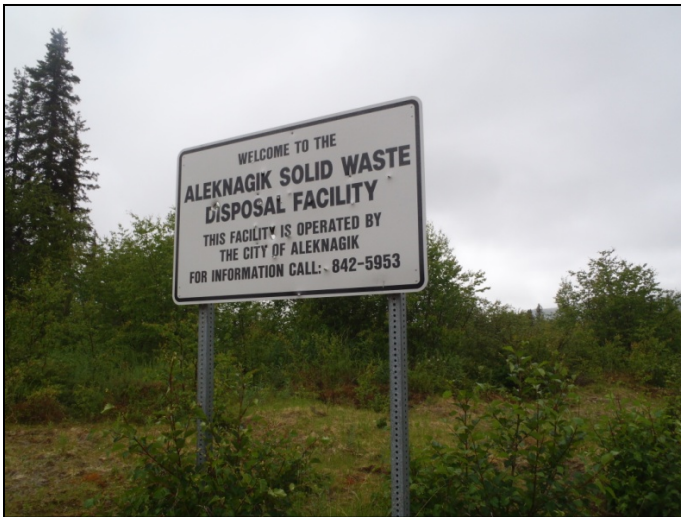
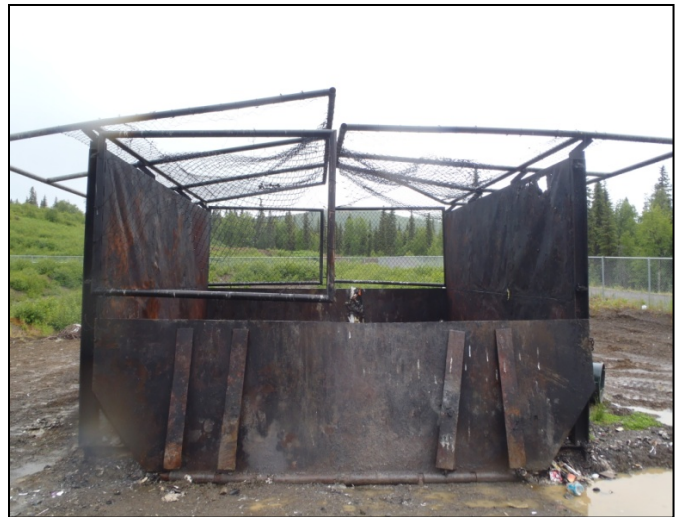
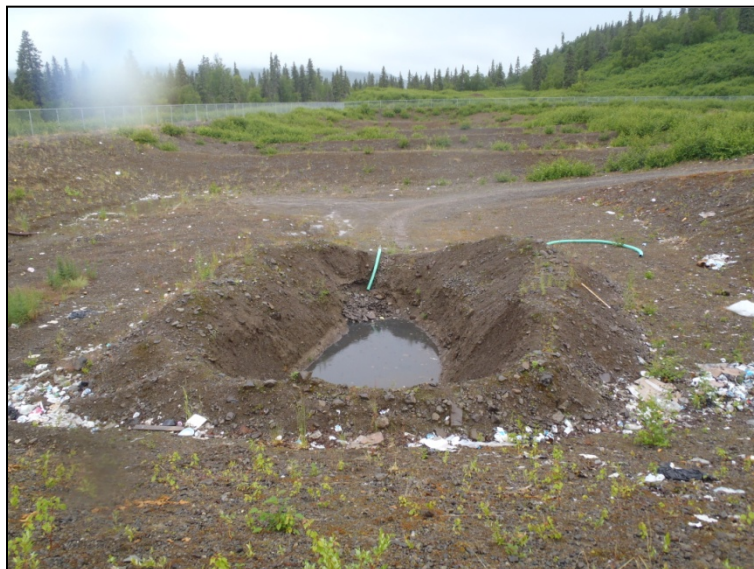
- **North Shore Landfill, 59.301863/ -158.615318 (Active)** – This permitted, Class III landfill is operated by the City of Aleknagik and began operating around 2006. It is located about 1.6 miles north of Lake Aleknagik. The site is completely fenced and uses a burn box to incinerate the majority of the city's waste. There was also a sewage treatment area within one of the landfill's cells. The facility has an operator and proper signage. Outside of the enclosed landfill is a designated salvage area with everything from snow machines to refrigerators and bicycles; however, Aleknagik had recently lost their certified Freon removal technicians. The landfill was well managed and located at a higher elevation than the rest of the community.

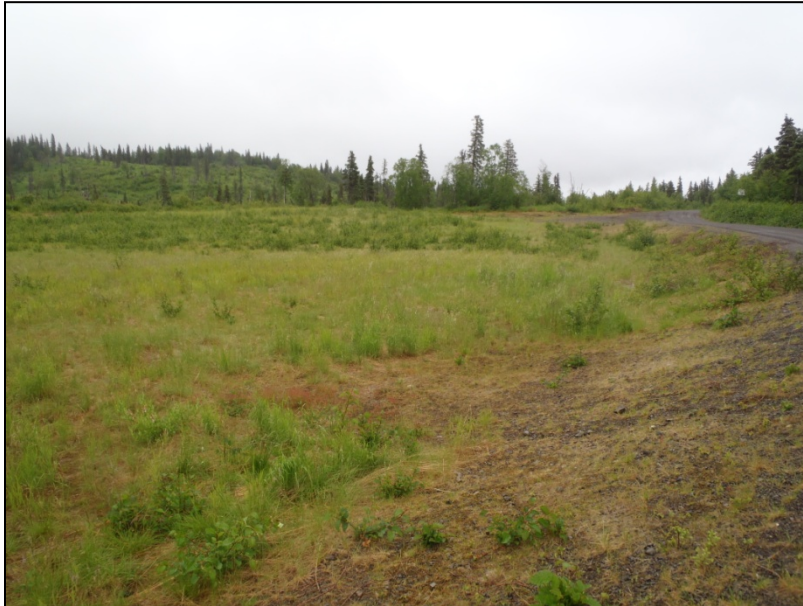
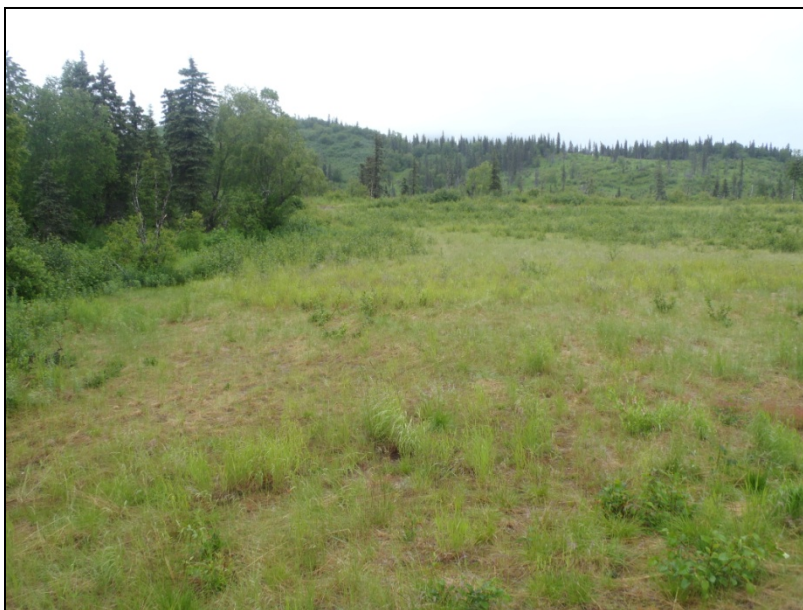
- **Landfill, 59.285991/-158.610948 (Closed)** – This closed landfill site was operational until around 2006, when the North Shore Landfill was opened. It is located about 0.85 miles northeast of Lake Aleknagik and 1.05 miles south of the North Shore Landfill. The area was well covered with even grass growth throughout. Aside from being treeless, the site blended in with the surrounding vegetation. The site is elevated above Lake Aleknagik, which is less than a mile away.
