CIAP WEAR Trip Report  
Aniak (population 541)  
May 24, 2012 & September 10, 2013

**2012 WEAR Sites**

## 2013 WEAR Sites

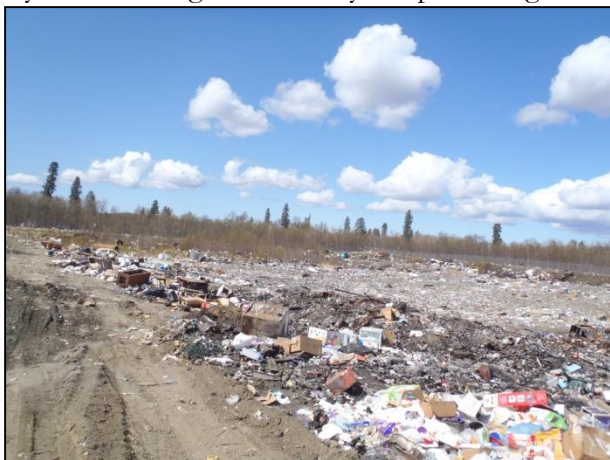
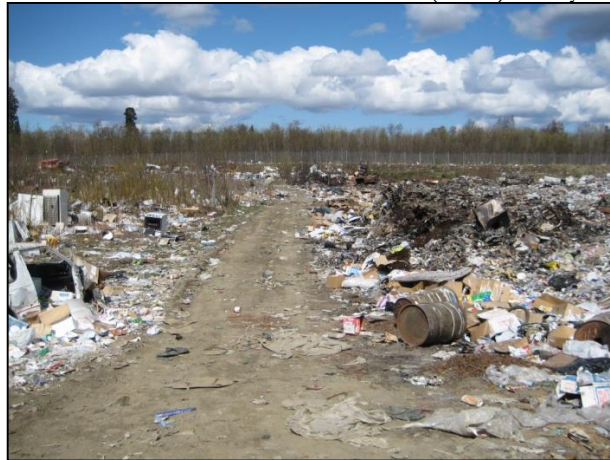
- **Landfill, 61.585558/-159.595336 (Active)** – This landfill is located approximately 1.5 miles west of town. It is a fenced, self-haul landfill that operates with minimal management from the City. The site has been in operation since the late 1980s and accepts municipal and construction and demolition wastes. Waste is spread throughout the 5 acre site and residents open burn. The landfill is located more than 1,500 feet from the Kuskokwim River, which is eroding at 2 feet per year according to the Army Corps of Engineers 2009 Baseline Erosion Assessment (BEA) study.

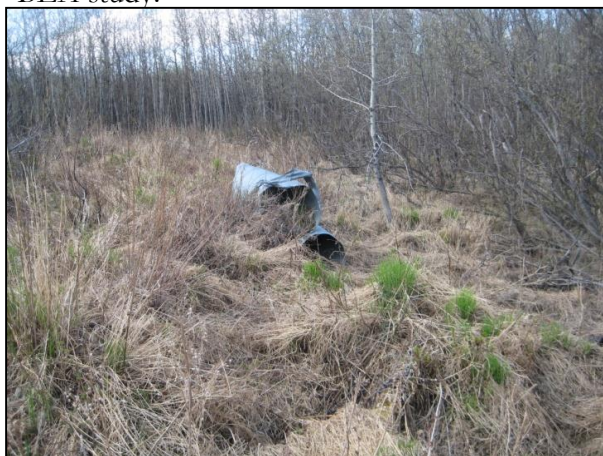
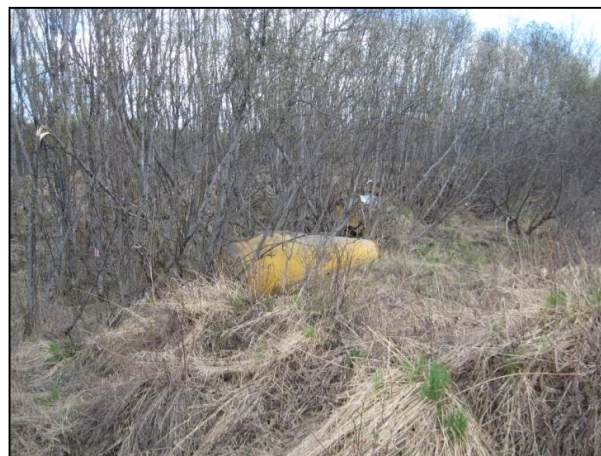
- **North Landfill, 61.586563/-159.572446 (Closed)** – This landfill is located directly north of the active sewage lagoon approximately 1 mile west of the village. The landfill was operated during the 1980's. Although the landfill is covered, debris such as metals and drums are apparent at the surface. An elevated forested area exists between the landfill and the river. It is located approximately 300 feet from the Kuskokwim River, which is eroding at 2 feet a year per the BEA study.

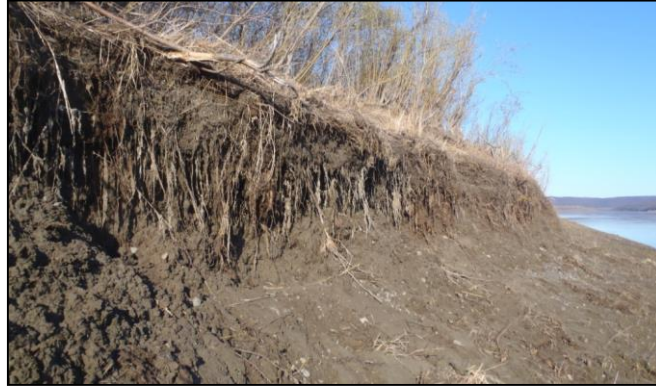
- **Runway Landfill, 61.586473/-159.553446 (Eroded)** – Local residents reported this landfill was located along the Kuskokwim River by the north end of the runway. It was operated from the 1960's to 1980. It has completely eroded into the river, although boaters still report the occasional barrel or other trash in the river bank. We were not able to locate the landfill specifically, but relied on local knowledge to site its former location.

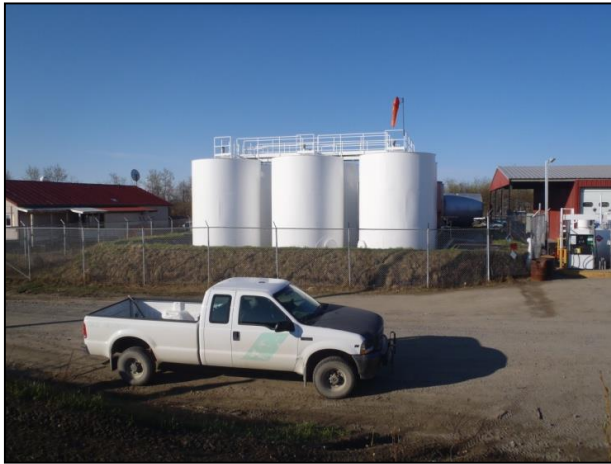
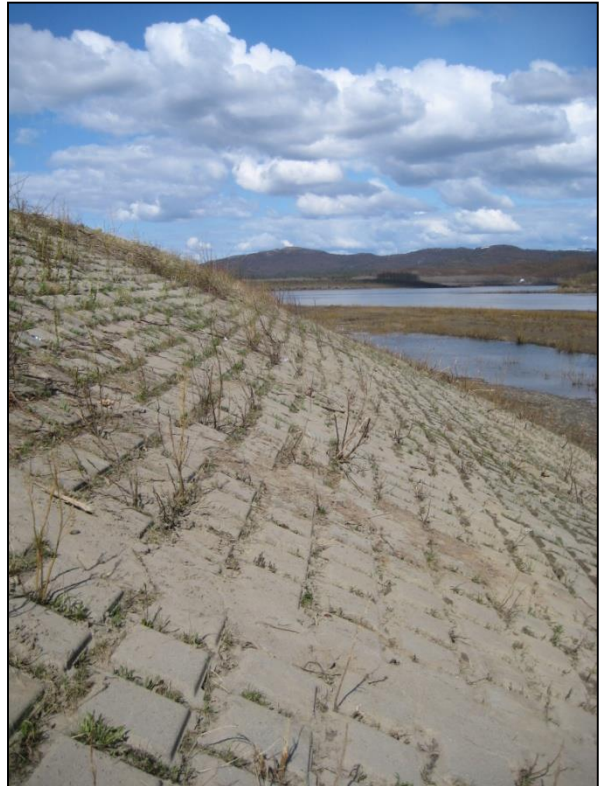
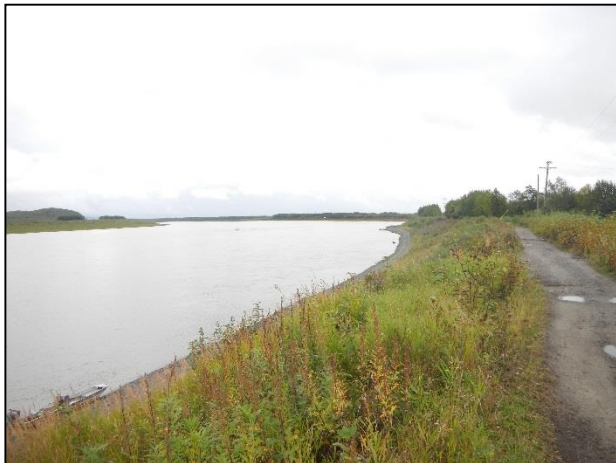
- **Crowley Tank Farm, 61.581991/-159.536261 (Active)** – This tank farm is located in the center of town approximately 100 feet from the Kuskokwim River and is owned by Crowley Fuel Services. The riverbank upstream of this site is reinforced with concrete blocks. The BEA study calculated erosion at 0.75 feet per year in this section of riverbank.

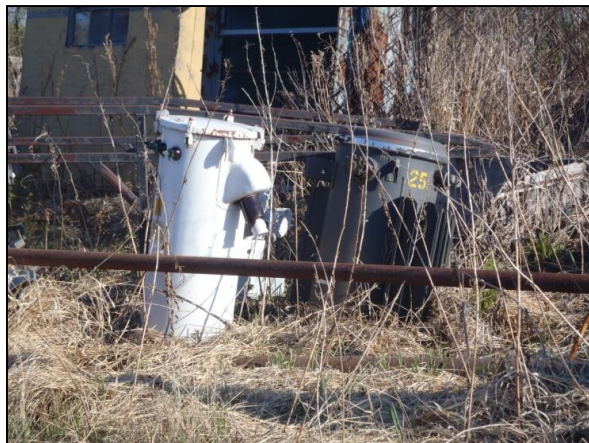
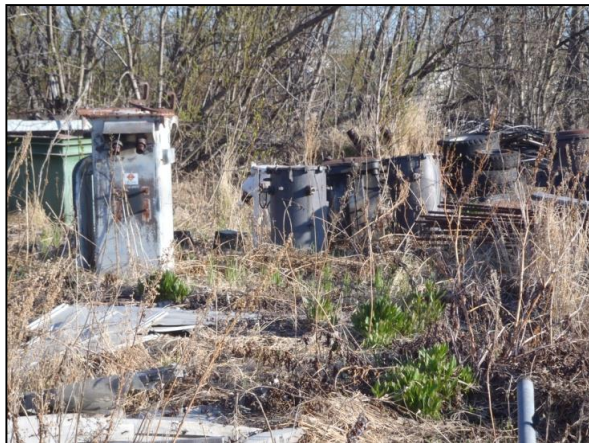
- **Transformer Lot, 61.581164/-159.535471 (Abandoned)** – There is an empty lot within the town of Aniak where a number of transformers are being stored or have been abandoned. There was also various scrap metal and equipment in the lot. Although we did not observe any staining, from the apparent age of the transformers, some could contain polychlorinated biphenyls (PCBs). The site is over 270 feet from the Kuskokwim River, which is eroding at 0.75 feet a year per the BEA study.

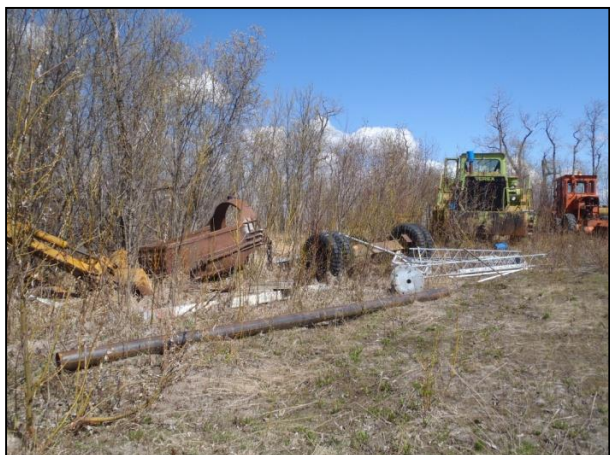
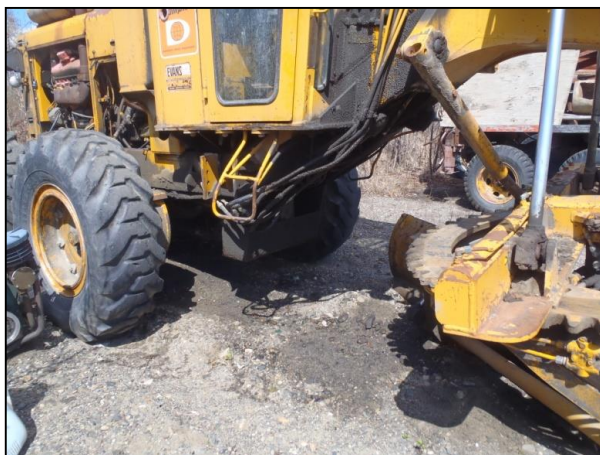
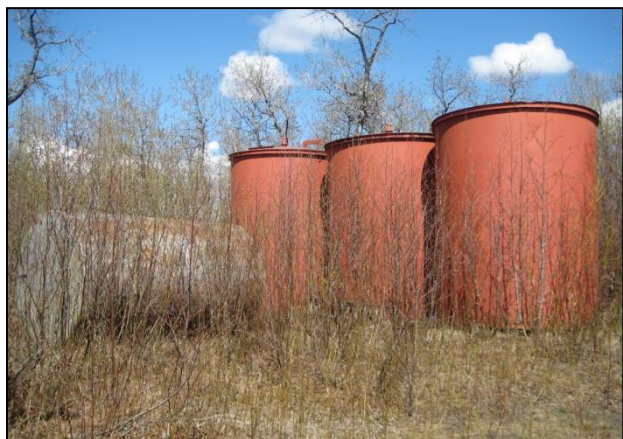
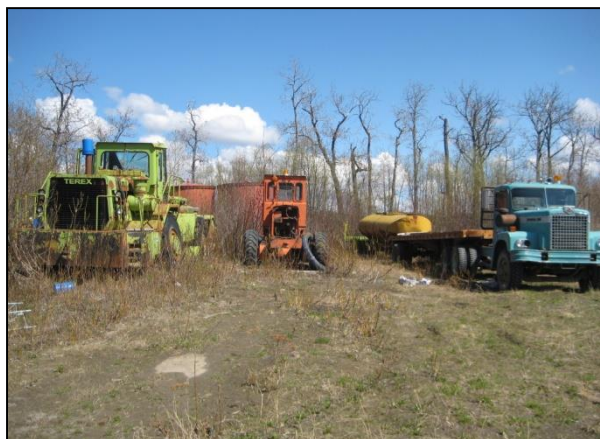
- **Boneyard, 61.591492/-159.601325 (Active)** – The boneyard is located approximately 1.5 miles west of town and ½ mile east of the barge landing. It contains primarily old trucks and equipment with some other metals including fuel tanks. Some staining was present on the ground around the equipment. The boneyard is located approximately 150 feet from the Kuskokwim River. The BEA study calculated erosion at 2 feet per year in this section of riverbank

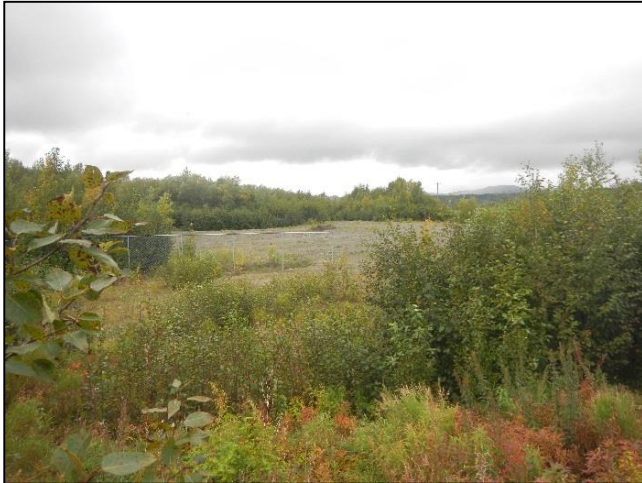
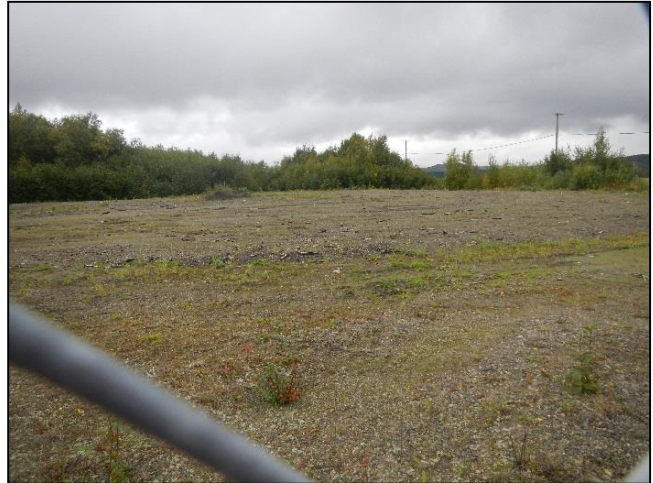
- **ADOT&PF Runway Apron, 61.582026/-159.551934 (Active)** – This is an active Contaminated Site (File ID 2404.38.006) located off the runway near Aniak High School. The petroleum contamination present came from former large bulk fuel tanks, drums, large GE generators, and miscellaneous debris. All tanks and debris were removed from the site and the contaminated soil is being land farmed at the site to remediate the contamination. The landfarm is completely fenced. The land is owed by Alaska Department of Transportation and Public Facilities (ADOT&PF) and is located approximately 1,420 feet from the Kuskokwim River.

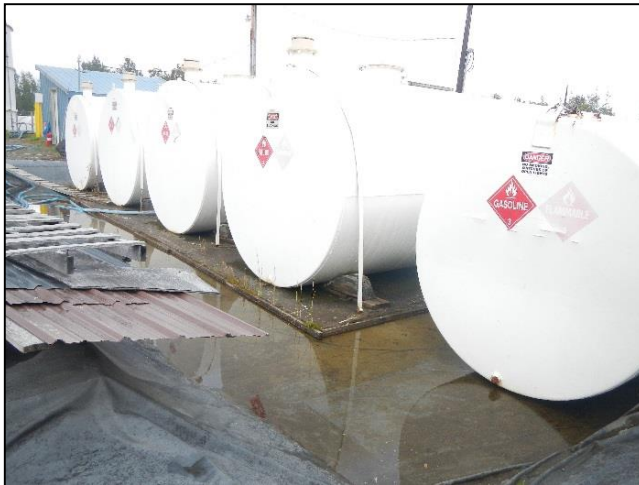
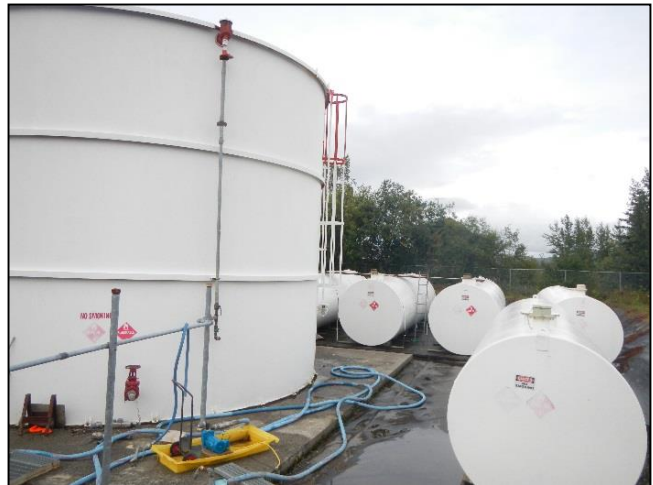
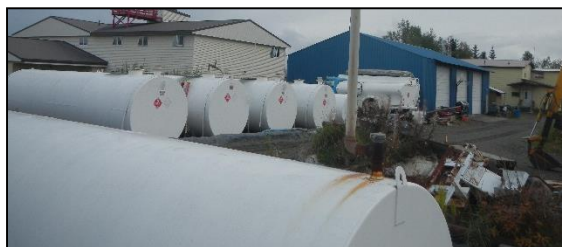
- **Aniak Light & Power Tank Farm, 61.581144/-159.534518 (Active)** – This tank farm is owned by Aniak Light & Power and is fully fenced. There are nine horizontal tanks of fuel oil, two horizontal tanks of gasoline, and one very large vertical tank of fuel oil. The tanks are in a lined containment berm, and the liners seems to be holding about half an inch of water. There were several areas of darker soil that may be due to contamination. The site is located approximately 220 feet from the Kuskokwim River.

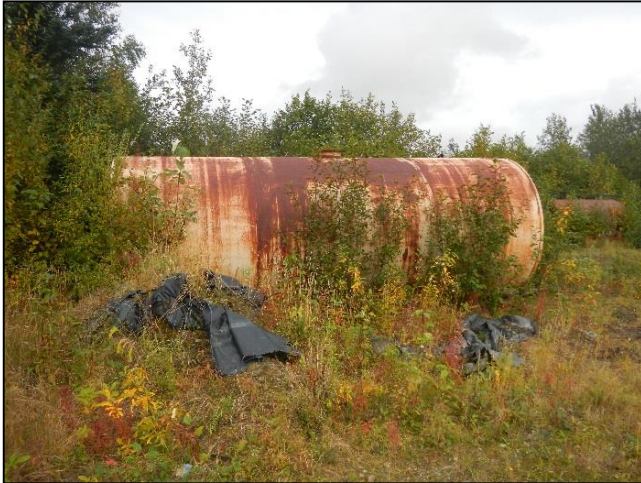
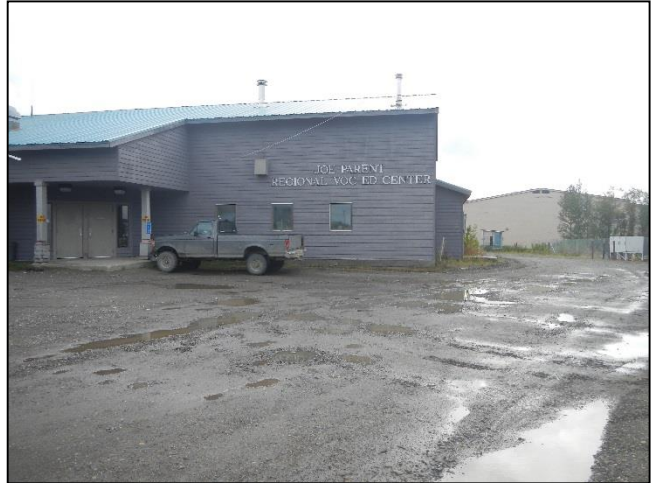
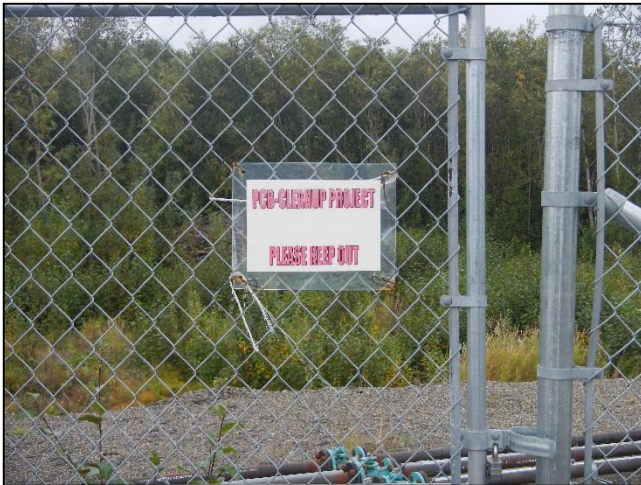
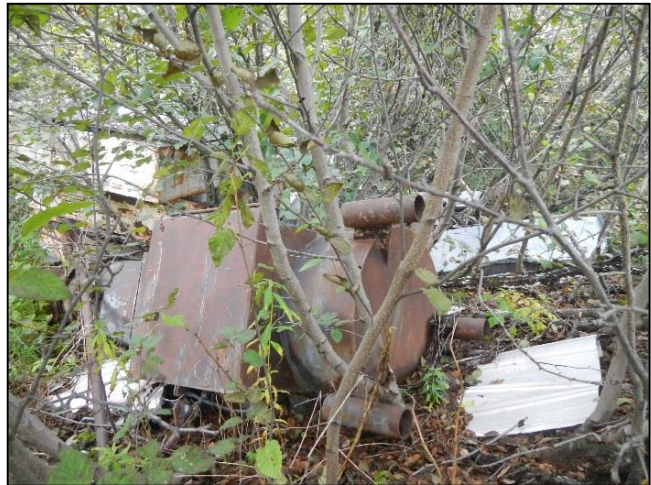
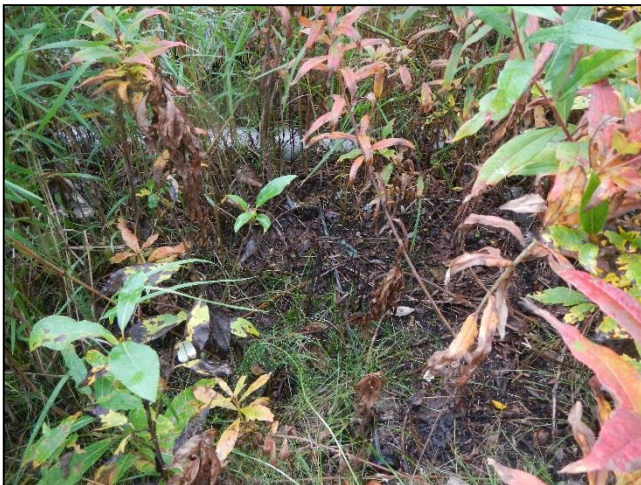
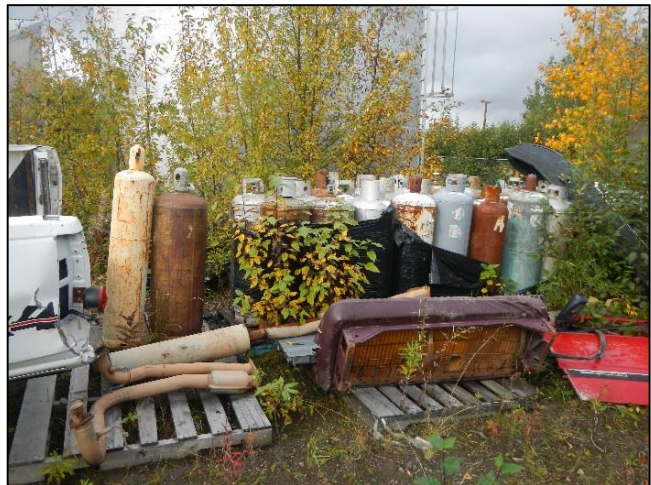
- **Former White Alice Communications Site, 61.580471/-159.550536 (Active)** – Formally an Air Force White Alice Communications facility that operated from 1955-1979, this site is owned by the State of Alaska ADOT&PF. The Aniak High School and Middle School buildings are located on this an active Contaminated Site (File ID 2404.38.007) with PCB and petroleum contamination. Various clean ups have occurred to remediate or remove the PCB contamination and work continues to occur to cleanup this site. During the site visit, on the runway side of the school buildings we found 2 decommissioned fuel tanks labeled 'Permanently Closed' with blackened vegetation near the metal piping. There were also several 55 gallon drums marked "motor oil," approximately 28 gas containers, and an overgrown school waste storage site. The site is 1,800 feet from the Kuskokwim River.
