Alaska Department of Environmental Conservation (ADEC) Solid Waste Program (Kym Bronson and Sandra Woods) conducted a Coastal Impact Assistance Program (CIAP), Waste Erosion Assessment and Review (WEAR) site visit for Adak on June 28th, 2014. Steve Skeehan, Navy Technical Representative, participated in the site visit. The following narrative is a brief description of our findings during the June inspection.

WEAR Sites

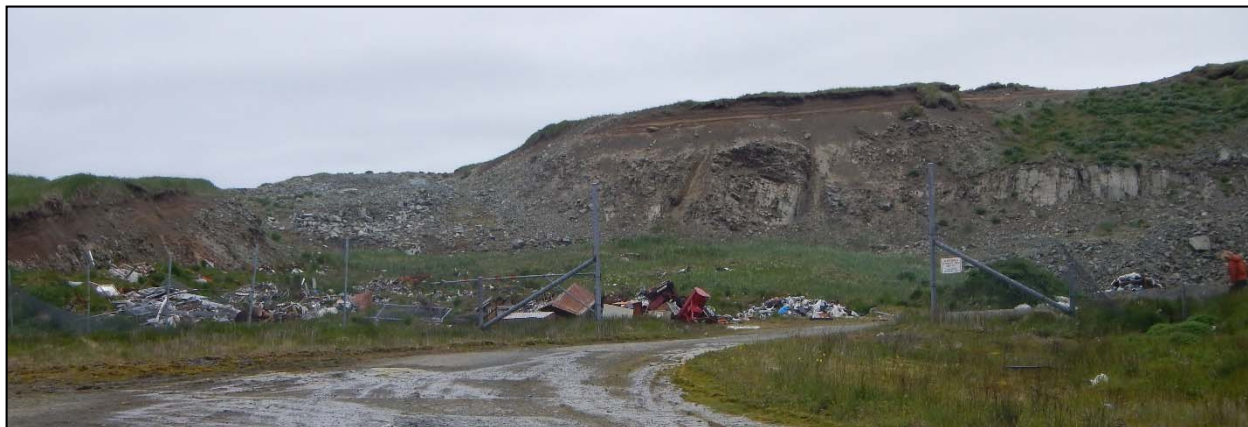
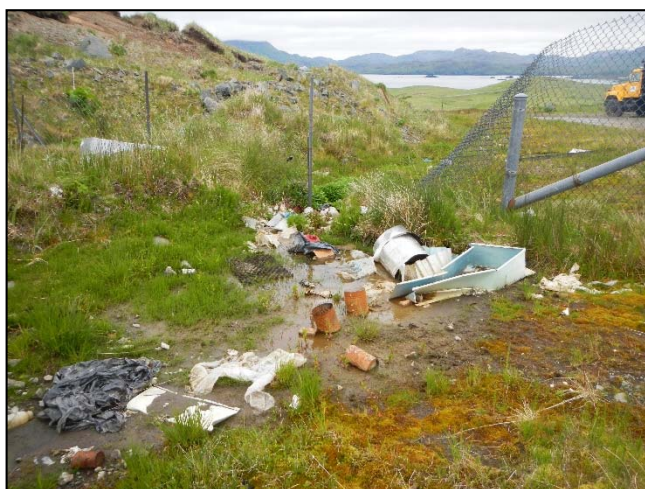
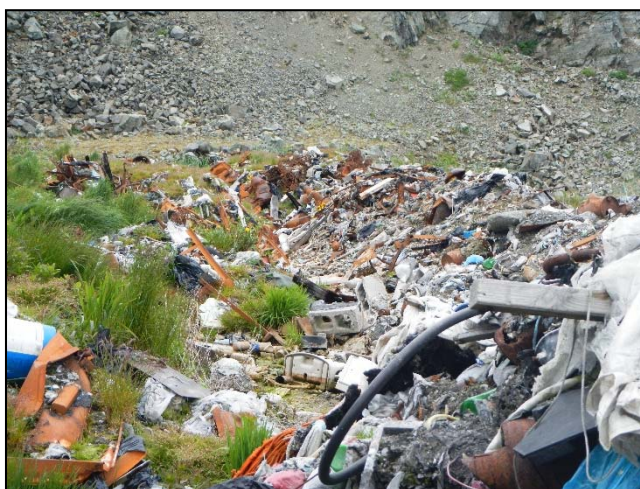
- **Husky Road Landfill, 51.914176/-176.616378 (Active)** – This 2 acre site is the community's current, active and permitted landfill. It began use in 2000 and is operated by the City of Adak. The City collects municipal waste in dumpsters throughout town, then brings the waste to a burn cage on the north side of town. Ash and unburned waste is taken from the burn cage and disposed at this site. It accepts municipal waste, ash and construction and demolition debris. The landfill does not accept or store household hazardous waste. Only landfill operators are allowed into the landfill. The site is fenced, gated and locked; however the fence is falling down in places. The site is an old gravel pit with gravelly and sandy soil. The nearest body of water likely to erode is Kuluk Bay, 3600 feet to the southeast.

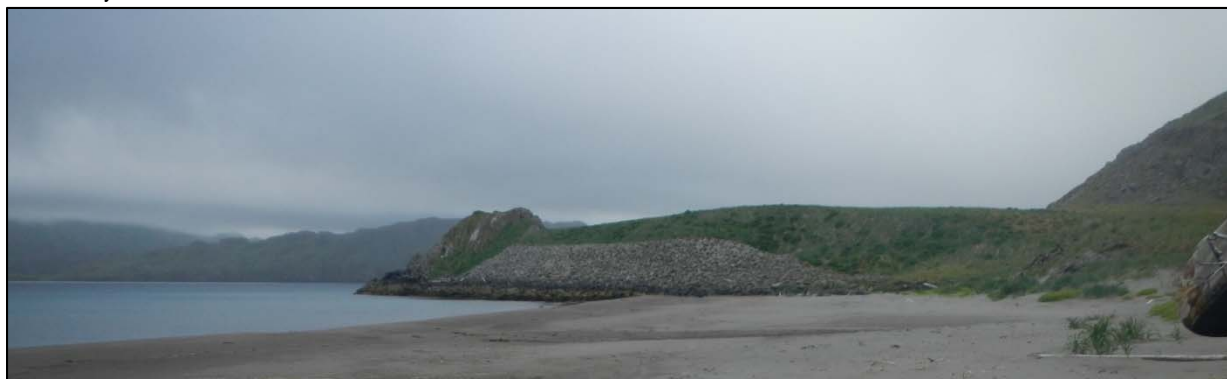
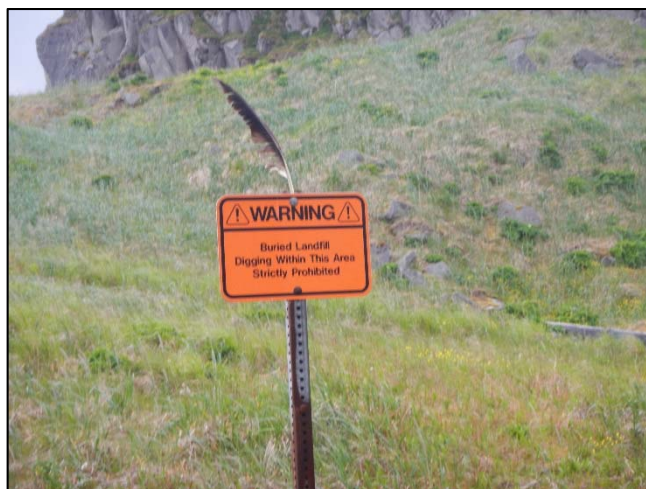
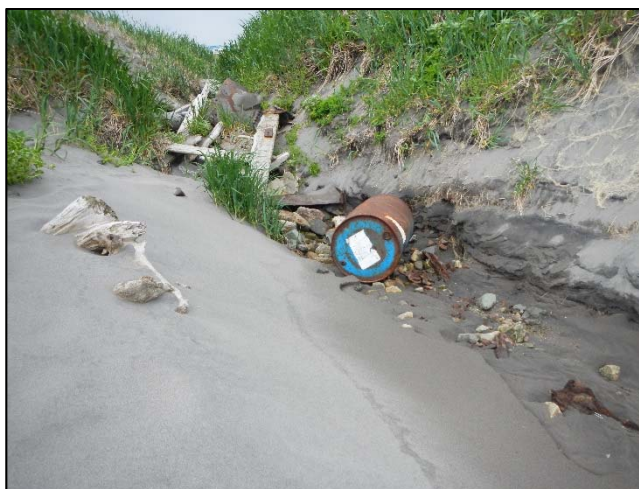
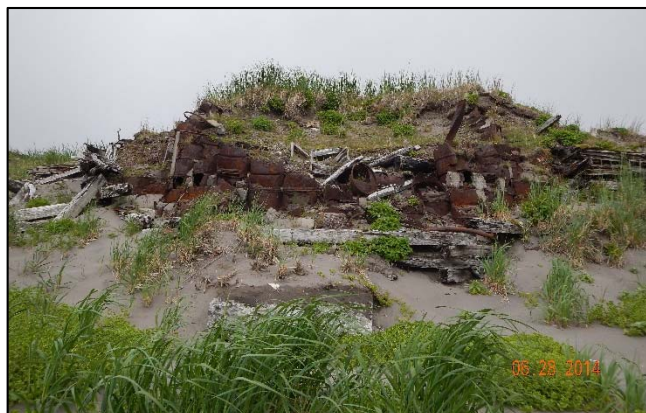
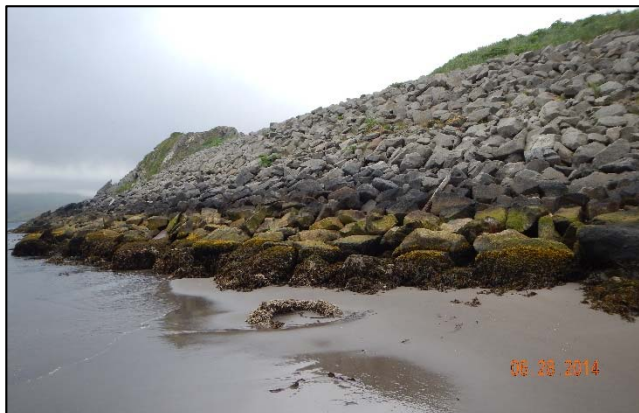
- **Naval Air Station Metals Landfill, 51.866878/-176.628308 (Retired)** – The Metals Landfill is located immediately southeast of the main housing areas in Adak. The landfill is bounded by Monument Hill on the west and Kuluk Bay on the east. It is managed through the Contaminated Sites Program (File ID 2501.38.004.04) under the name *Adak SWMU 13 Metals Landfill*. The site status is ‘Cleanup Complete- Institutional Controls’. The landfill began operations in the 1940s and received a variety of wastes including municipal waste, construction waste, paints, chlorinated and non-chlorinated solvents, batteries, scrap vehicles, medical waste, and sewage sludge. In 1970 restrictions were placed on what could be placed in the landfill. Sewage sludge disposal began after the waste water treatment plant installed a dewatering press in 1988. The landfill stopped receiving wastes in 1989. A portion of the landfill was designated a hazardous waste unit in 1989, and was closed in 1996. The rest of the landfill was closed in 1996 also. Closure included removal of debris, implementation of surface water erosion controls, construction of a landfill cap, placement of a vegetative cap, implementation of institutional controls for access and land use, and long-term monitoring. Rip-rap was placed on the ocean side to prevent erosion. This site is inspected every other year as required by the Institutional Controls. The site occupies 60 acres and is located on Kuluk Bay.

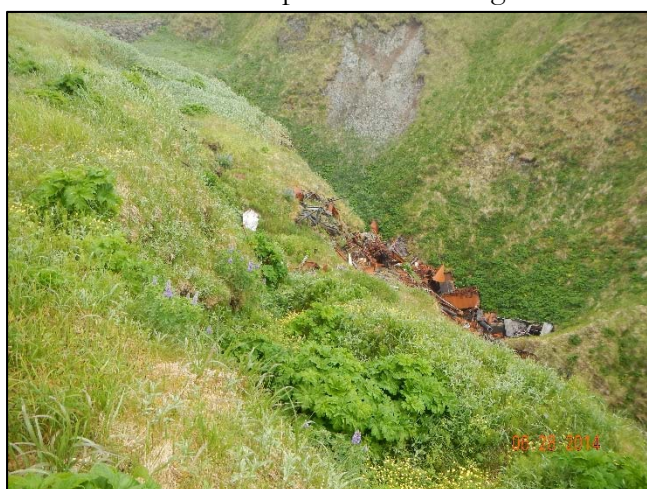
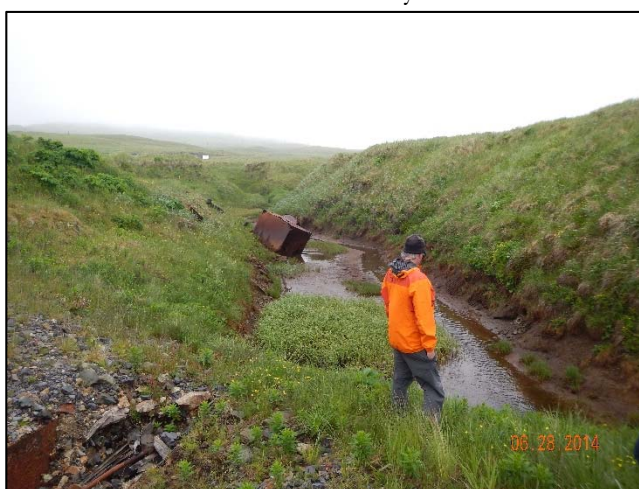
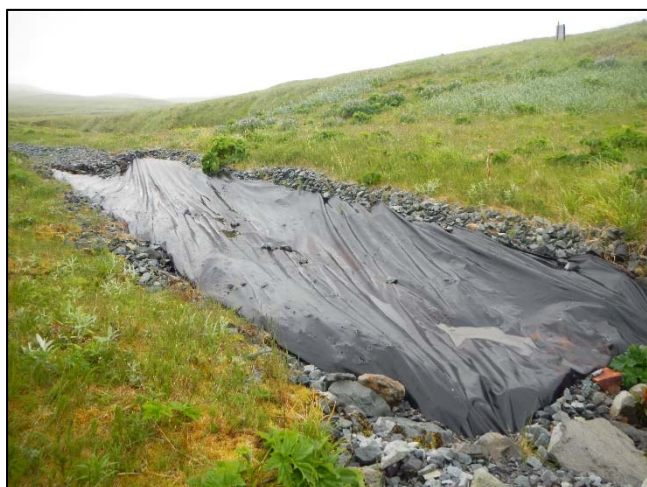
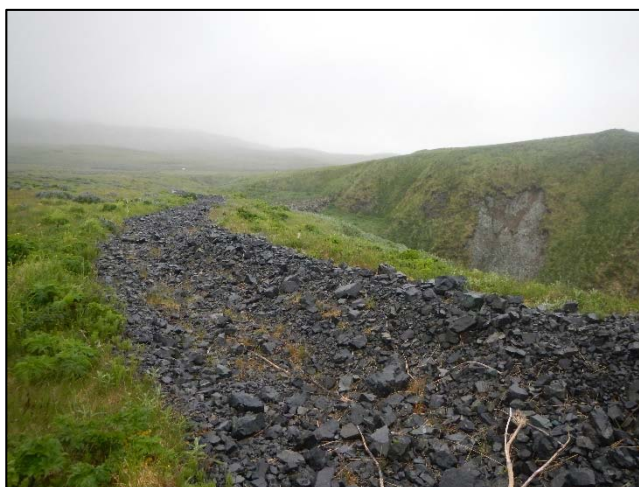
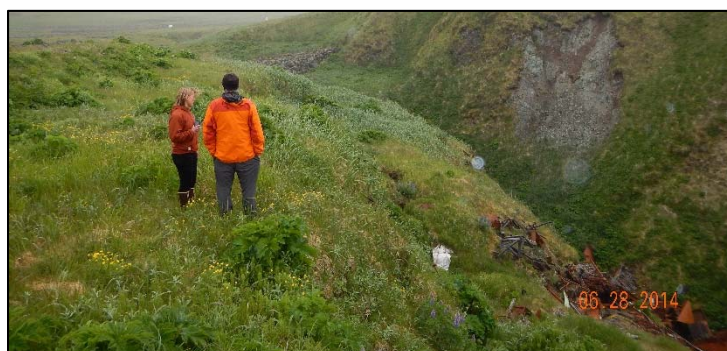
- **Naval Station Palisades Landfill, 51.906958/-176.613072 (Retired)** — The Palisades Landfill was used from the 1940s to early 1970s. Approximately 80,000 to 100,000 cubic yards of solid waste were deposited in the landfill. A wide variety of wastes were placed in the landfill, including waste petroleum, oils, and lubricants; chlorinated and non-chlorinated solvents; paint waste; municipal waste, scrap vehicles; lead and mercury batteries; construction waste; and mercury. The landfill was covered with local soils in the early 1970s after disposal had stopped. In 1996 the landfill was formally closed, which entailed construction of a proper landfill cover, surface water controls, vegetation, and institutional controls for the property. These items were considered to complete the remedial actions at the landfill. A ravine located next to the covered landfill contains uncovered metal wastes, including drums, building debris, and scrap metal. The debris in the ravine partially covers and dams the flow of Palisades Creek. There is no way to cover the exposed metals in the ravine. It is under long-term monitoring by the Contaminated Sites Program (File ID 2501.38.004.05) under the name *Adak SWMU 11 Palisades Landfill*. It has a status of ‘Cleanup Complete- Institutional Controls’. There is ongoing work at the site to build and maintain stormwater drains to reduce erosion to the landfill cap. The closest edge of the site is 350 feet northwest of Kuluk Bay.

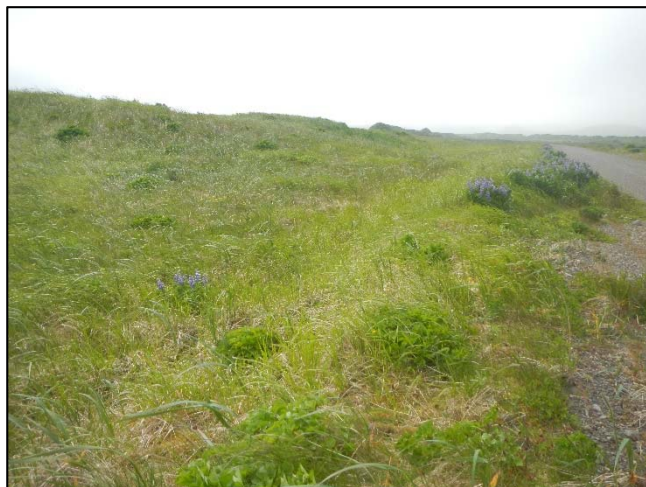
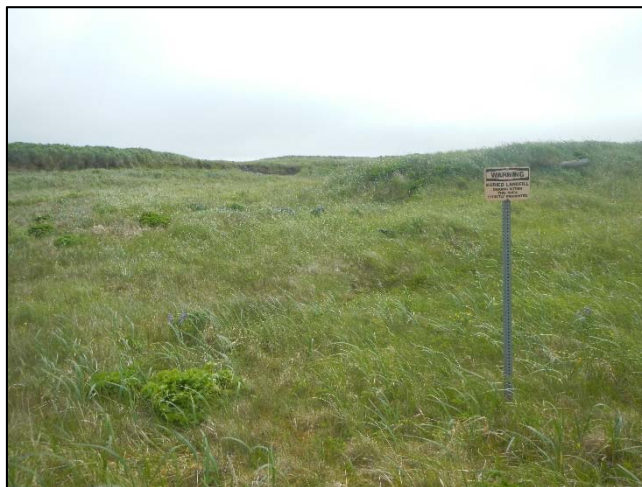
- **NSGA Causeway Landfill, 51.945053/-176.565361 (Retired)** – The Causeway Landfill is located on the eastern side of Clam Road on a narrow strip of land separating Clam Lagoon from Sitkin Sound. The landfill is 2-3 acres in area and 4 to 6 feet deep. The landfill appears to have been placed in a borrow pit along the causeway and was used for municipal trash and metal debris from Naval Security Group Activity (NSGA). It is monitored under the Contaminated Sites Program (File ID 2501.38.004) and has a status of ‘Cleanup Complete – Institutional Controls’. The landfill cap is inspected every other year to ensure that it remains intact and that no housing is developed on it. There was no exposed waste and the site was well-vegetated. The site is located 65 feet from Kuluk Bay.

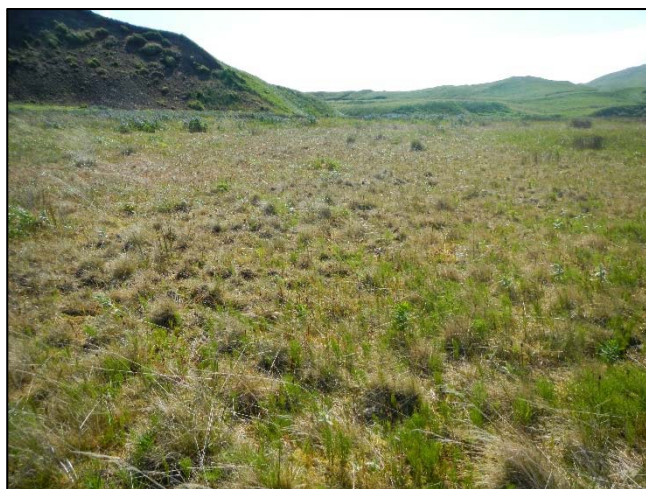
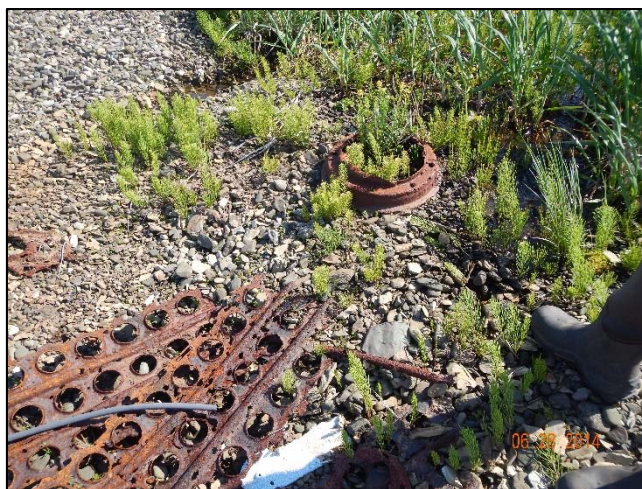
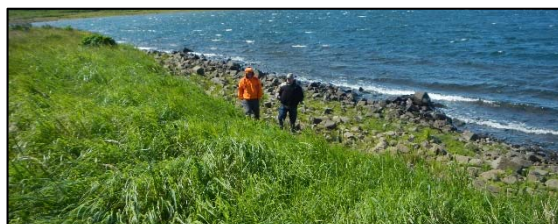
- **South Davis Road Landfill, 51.943139/-176.616458 (Retired)** – This is the site of a former 3-acre landfill that was operated from the early to late 1940s on the eastern shore of Andrew Lake. It is believed to be filled with construction generated by the construction and subsequent demolition of Albert Mitchell Airfield, which used to occupy the area between Andrew Lake and Clam Lagoon, and the seaplane base on Andrew Lake. It is believed to have been closed with a soil and rock cover in the late 1940s. The site is monitored under the Contaminated Sites Program (File ID 2501.38.004) with the status ‘Cleanup Complete – Institutional Controls’. It is under the name *Adak SWMU 04 South Davis Road Landfill*. The landfill is inspected every other year to ensure that it remains intact and that no housing is developed on it. The site is on the banks of Andrew Lake which has no reported erosion.

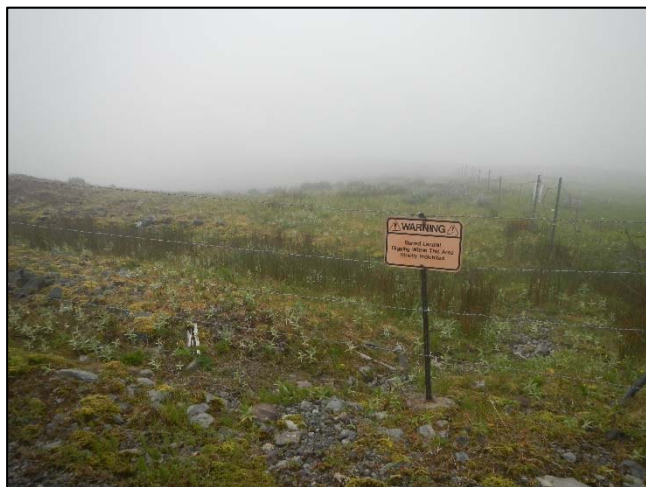
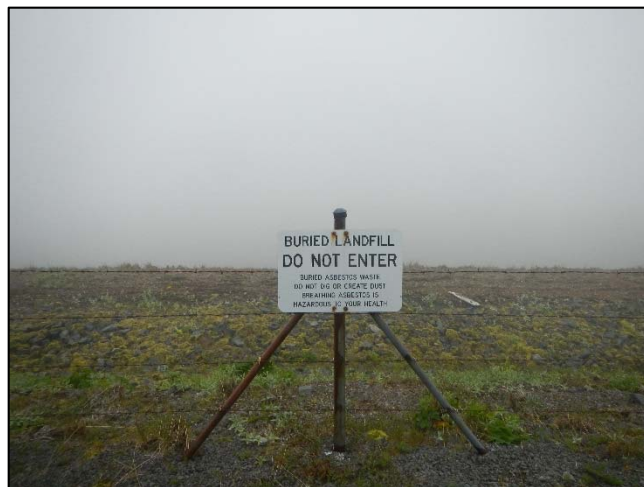
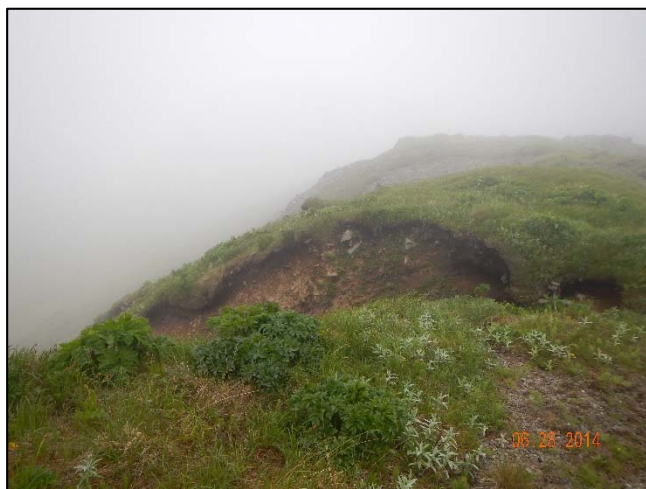
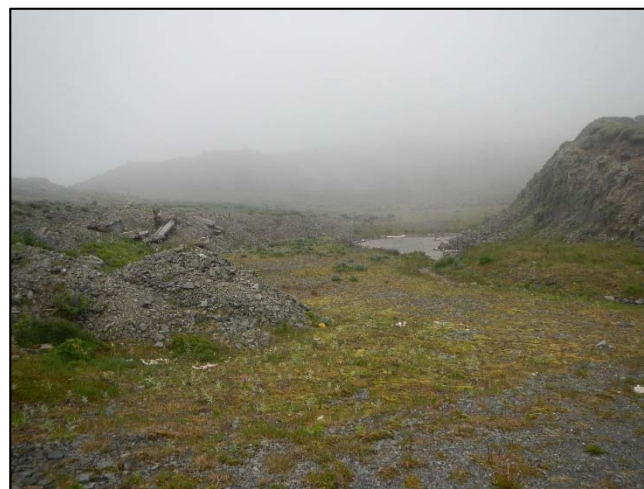
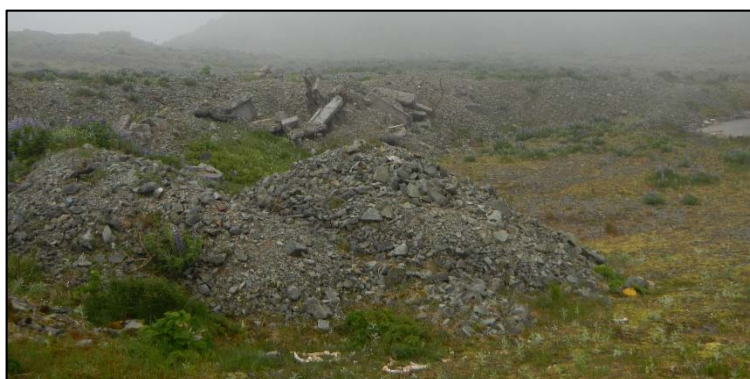
- **White Alice Site, 51.874553/-176.705489 (Closed)** – This is a group of sites managed under the Contaminated Sites Program that are part of the former White Alice installation. All of the sites have a status of ‘Cleanup Complete’ or ‘Cleanup Complete – Institutional Controls’. The hillside to the north of the quarry was used as a disposal area for drums and debris from 1980 to 1982. This is one of several possible locations where PCBs may have been disposed of from the White Alice station demolition. Approximately 100 55-gallon drums and soil with high PCB-contamination levels was removed from the site and an impermeable cover was set in place over the remaining contamination in 1992. Future land use has been restricted through deed restriction or restrictive covenants. Visual site inspections are conducted every other year to ensure the effectiveness of institutional controls. Site conditions are assessed at least every five years for the need to take additional action or reduce controls, as appropriate. During the inspection it was reported that wind and run-off erosion continue to be a problem. There is an exposed geotextile membrane that will be covered by the end of summer 2015. The area is on hillside, extremely exposed and very difficult to cap. This site is 5500 feet from Shagak Bay.

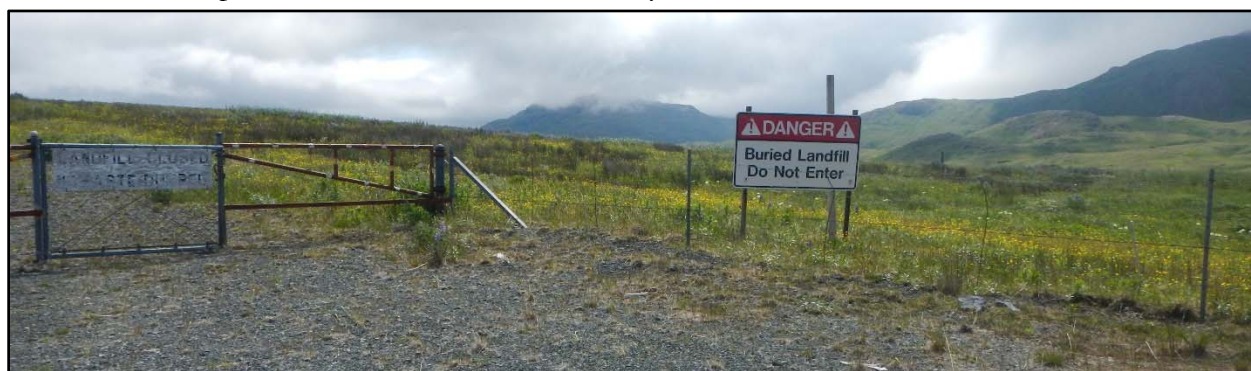
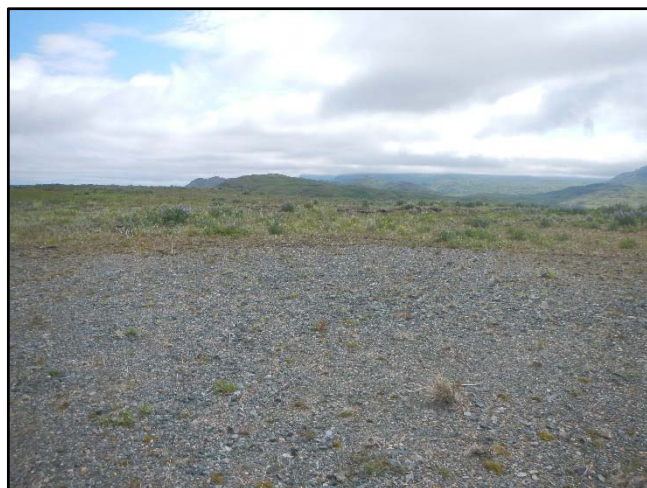
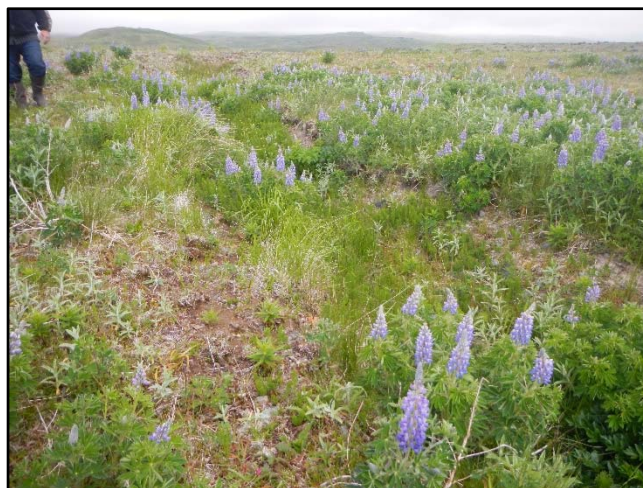
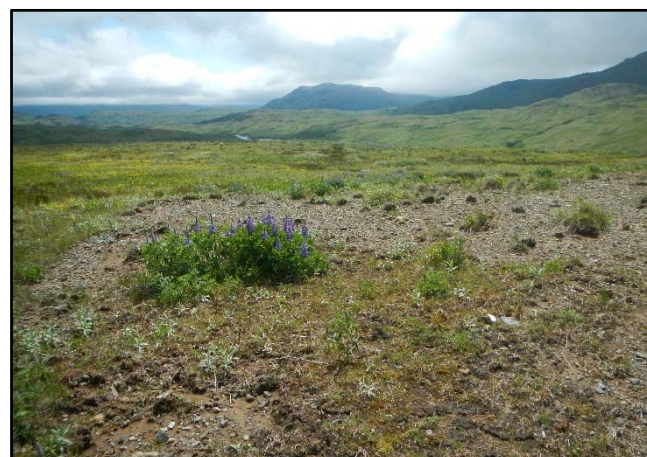
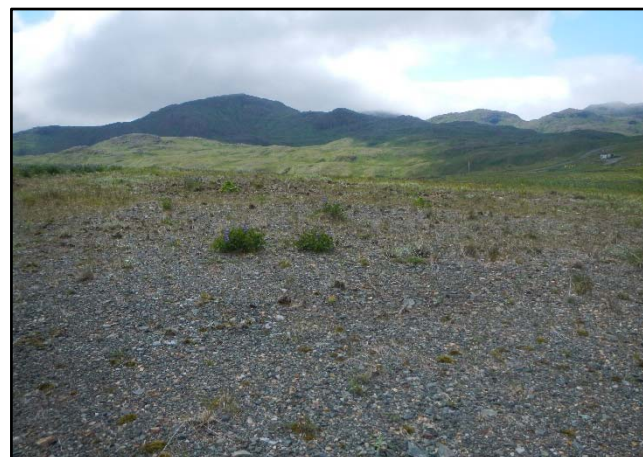
- **Roberts Landfill, 51.845696/-176.668946 (Retired)** – The Roberts Landfill is located south of downtown Adak. The landfill was run from 1950 until 1972 and from 1975 to 2002. During the initial operations, the landfill accepted municipal waste, metal debris, batteries, solvents, waste paints, and construction rubble. Since 1975, the landfill has only accepted municipal waste. The landfill is unlined. The landfill was closed in 2001 following ADEC Solid Waste regulations. Closure included placing a low-permeability soil covers over the landfill, grading and contouring, implementing access restrictions, installing surface water/erosion controls, placing vegetative cover, and securing bunkers used to store asbestos containing materials. A portion of the landfill was temporarily reopened in 2002 to allow for the disposal of metal debris from a cabin demolition project. The landfill was recapped and was closed in the fall of 2002. The landfill is currently in its post-closure care period and work on the stormwater drains and grading to reduce erosion on the cap is ongoing. Although it was closed under the Solid Waste Program, it is being monitored by the Contaminated Sites Program (File ID 2501.38.004.02) under the name *Adak SWMU 25 Roberts Landfill* with the status ‘Cleanup Complete – Institutional Controls’. It is inspected every other year. It is located 3,200 feet from Sweeper Cove, which is the nearest body of water.

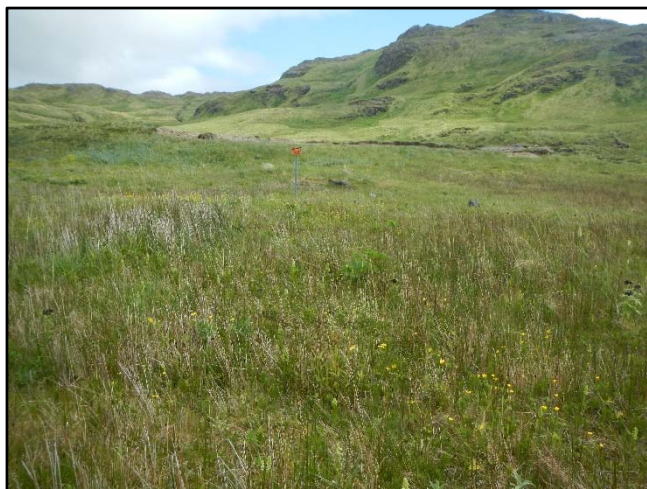
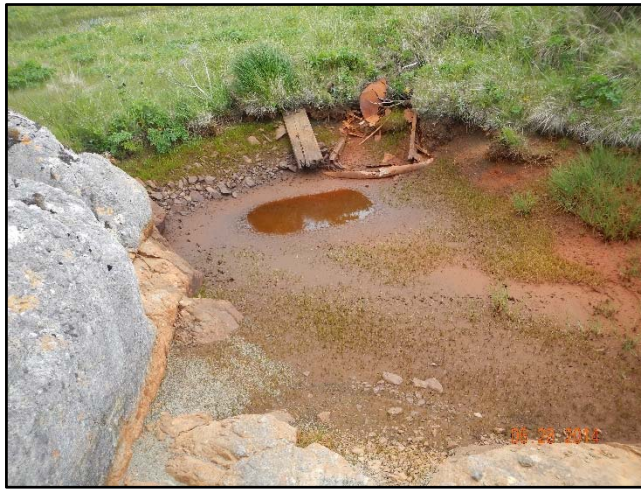
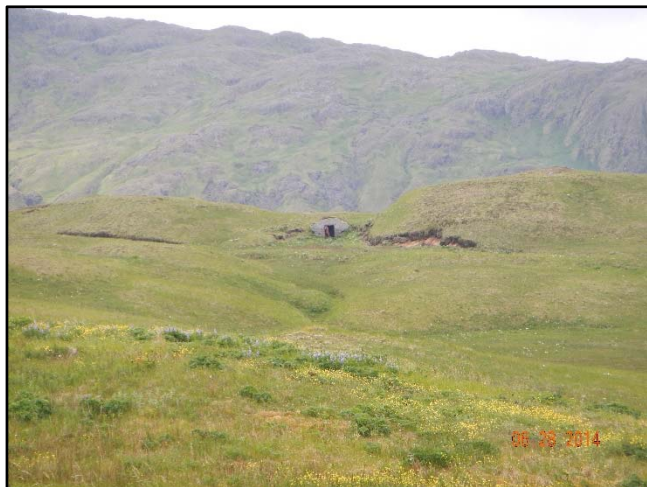
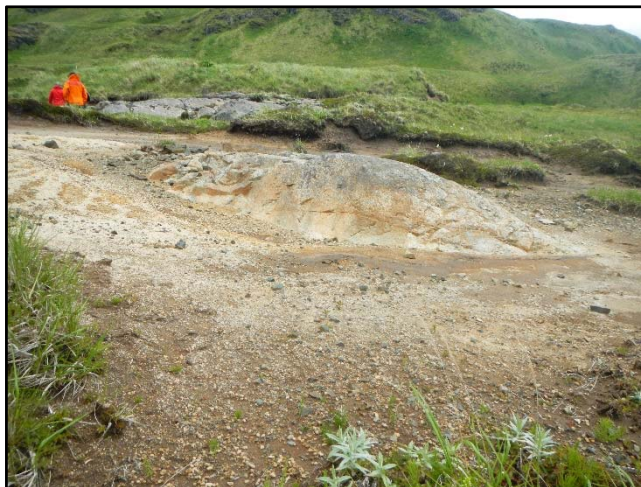
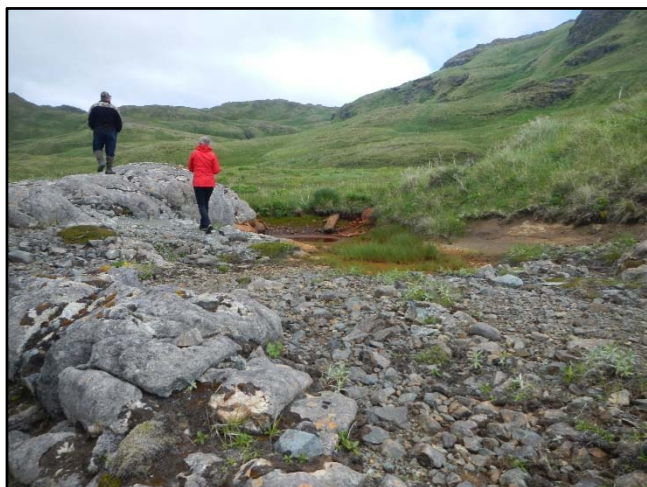
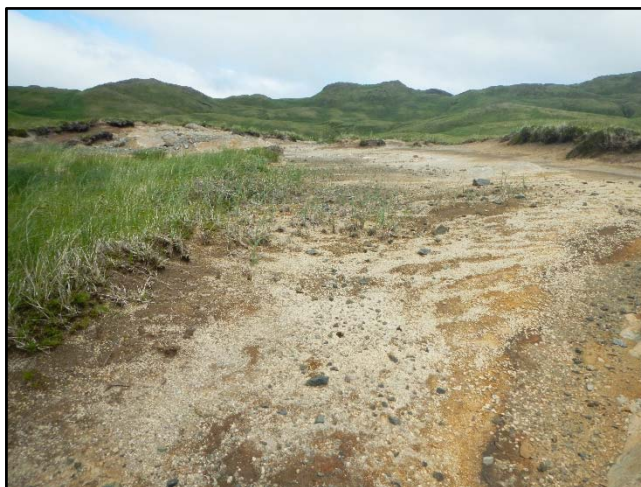
- **Finger Bay Landfill, 51.839806/-176.625433 (Retired)** – This site is managed by the Contaminated Sites Program (File ID 2501.38.004) under the status ‘Cleanup Complete – Institutional Controls’. The landfill was used for disposal of municipal waste, construction and demolition debris, and various ammunitions from the Finger Bay sub-post from 1972 through 1975. Drums were removed and landfill was covered and capped in 1996. Visual site inspections are conducted every other year to ensure the effectiveness of institutional controls and ensure that the cover at the site remains intact. Site conditions are assessed at least every five years for the need to take additional action or reduce controls, as appropriate. The site is 1,875 feet from Finger Bay, on a hillside. During the site visit, some metals were uncovered. There are plans to re-cover and grade the site in 2015.
