Alaska Department of Environmental Conservation (ADEC) Solid Waste Program (Doug Huntman and Rebecca Colvin) conducted a Coastal Impact Assistance Program (CIAP), Waste Erosion Assessment and Review (WEAR) site visit for Akiachak on May 8<sup>th</sup>, 2013. The IGAP Coordinator participated on the site visit. The following narrative is a brief description of our findings during the May inspection.

### WEAR Sites

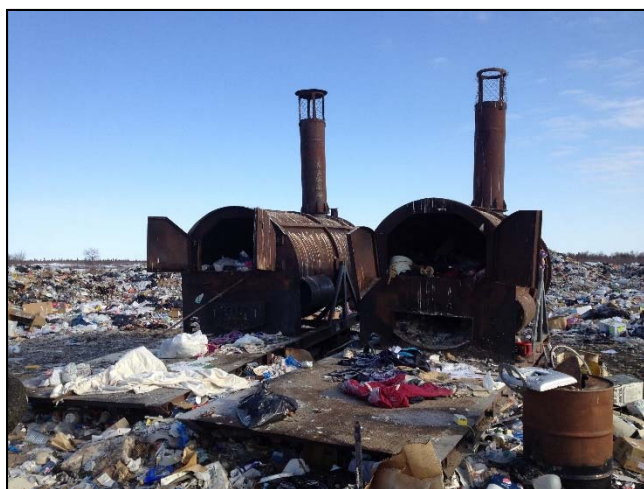
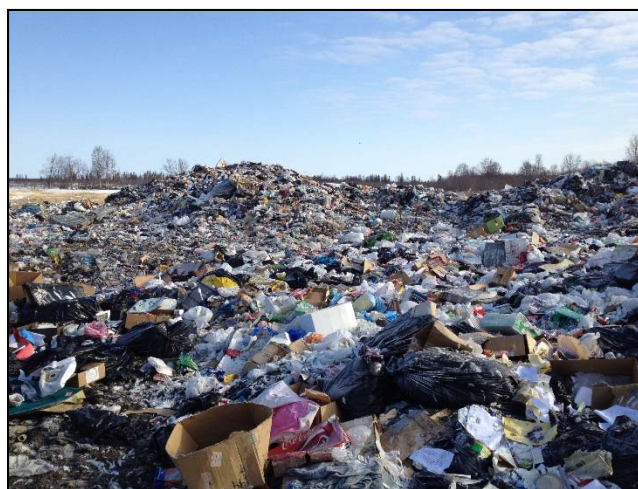
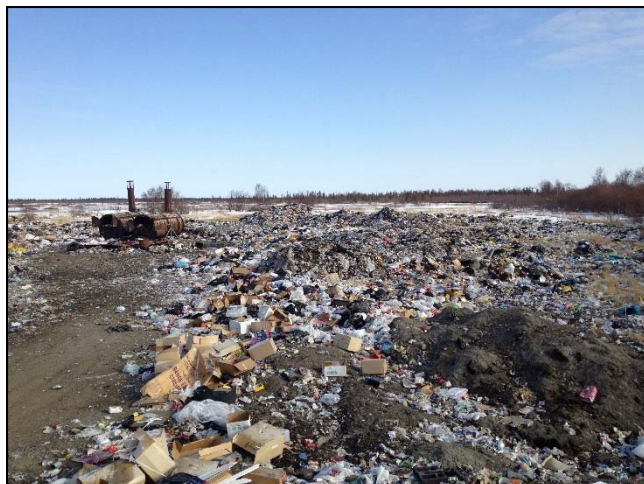
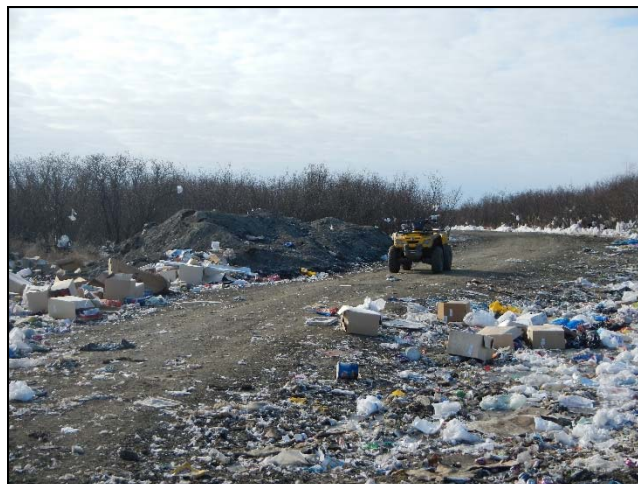
- **Landfill, 60.915733/-161.440198 (Active)** – This one acre unfenced landfill has waste spread throughout the site and litter along both sides of the landfill road. Small piles of cover material were staged at the site in preparation for summer 2013 landfill operations. The landfill has two functioning burn units onsite; these units however are only used during the summer months due to prevailing winds in the winter that blows smoke towards the community. Trash collection trailers are staged throughout the Village, and hauled to the landfill by sanitation workers when full. Some residents also self-haul trash to the landfill. The landfill is located ¼ mile north of the community and is 500 feet west of the cemetery. Due to the close location of the landfill and the wind direction in the winter, residents reported they could smell the landfill. It is located 2,550 feet from the Kuskokwim River.

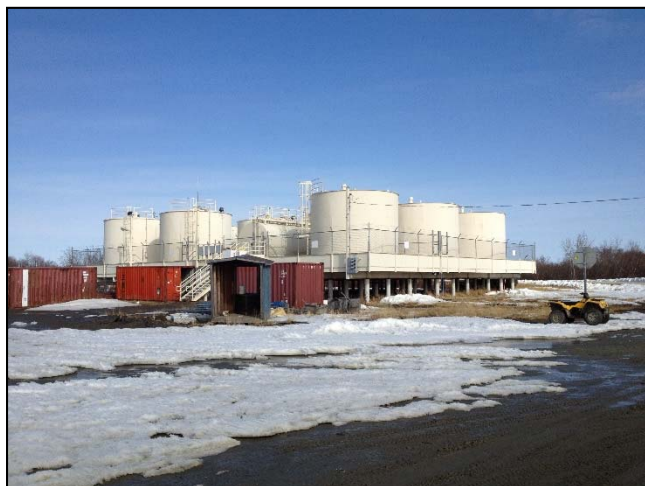
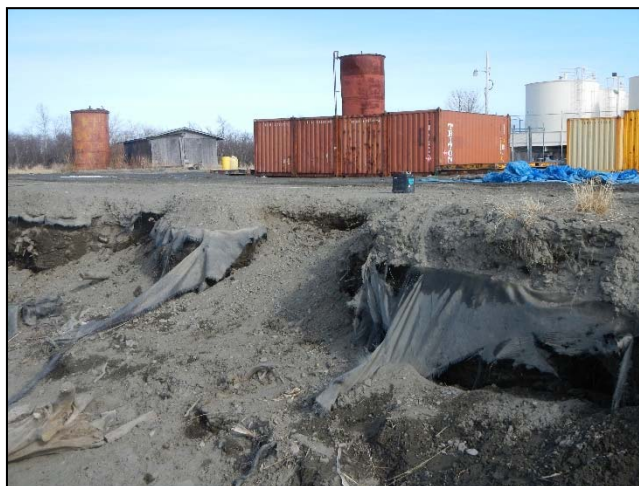
- **Tank Farm, 60.91138/-161.456936 (Active)** – This consolidated tank farm, located on the west side of the village, was completed in 2005 through the Denali Commission. It was constructed on a pile foundation approximately 5 feet above the normal grade at the site to keep the tank farm above potential flood elevations. It contains 11 vertical and one horizontal fuel tanks with a total capacity of 605,000 gallons. It is approximately 240 feet from the Kuskokwim River. Despite erosion mitigation measures of Geotextile fabric placed along the river bank, residents report the shoreline continues to erode at 10 feet per year.

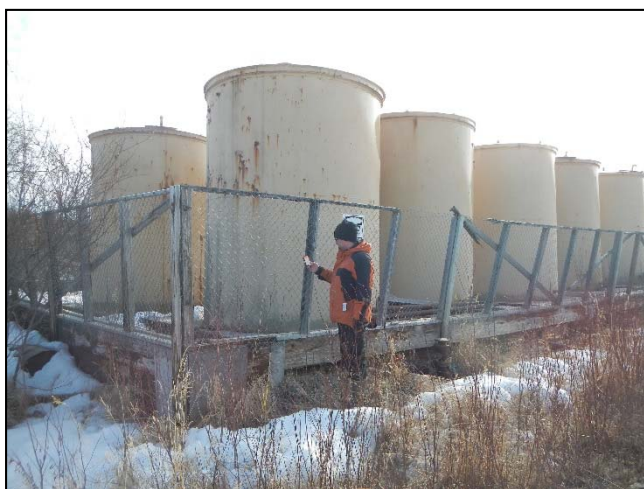
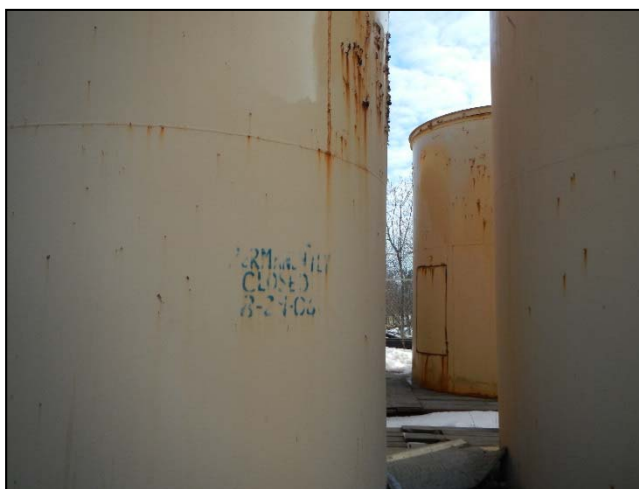
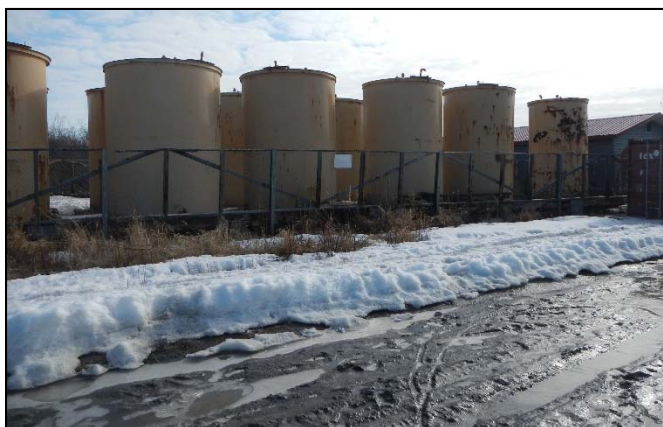
- **Old Elementary School Tank Farm, 60.909634/-161.437013 (Abandoned)** – This decommissioned tank farm is centrally located in the village. The site has a perimeter fence and secondary containment. The decommissioned tanks were used to store heating fuel and gasoline for the elementary school. A total of 14 vertical, single wall tanks sit on sturdy wooden piling within a fenced area. All tanks were marked 'Permanently Closed 8-24-2006' and were reported to be empty. The site is 223 feet from the Kuskokwim River.

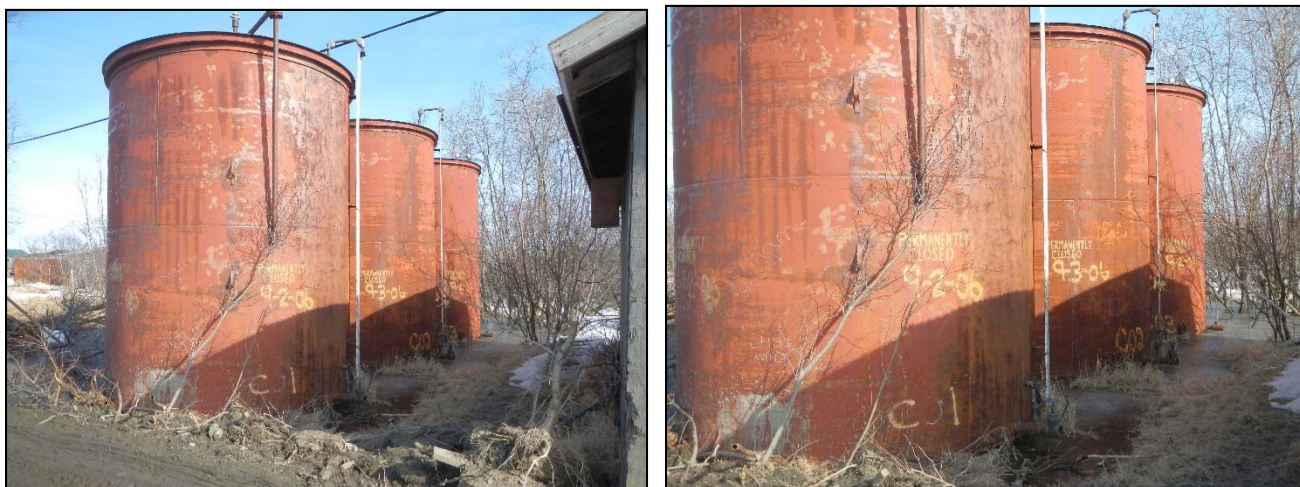
- **Water Plant Old Tank Farm, 60.911207/-161.441029 (Abandoned)** – This decommissioned tank farm is located on the north side of town and consists of three vertical single wall tanks. These tanks were used to store heating fuel for the water plant. There was no visible secondary containment and no perimeter fence. Tanks were disconnected, empty and inspection holes cut into the sides of each tank. All tanks were marked 'Permanently Closed 9-2-2006'. This site is located approximately 1,851 feet from the Kuskokwim River.

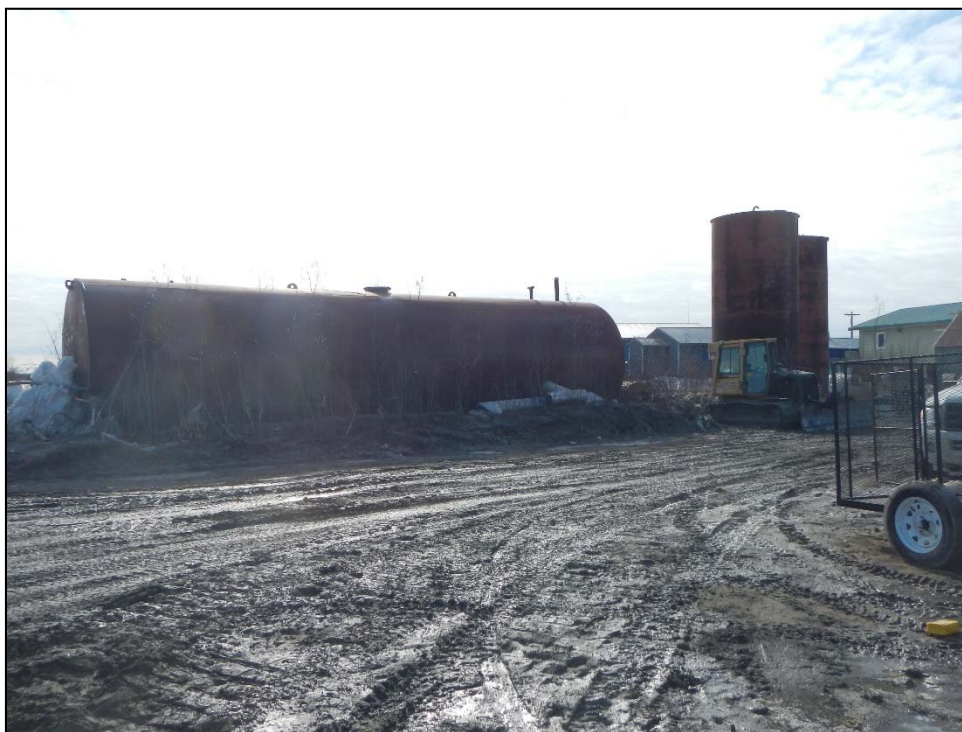
- **Old Power Plant Tank Farm, 60.910734/-161.440169 (Abandoned)** – This decommissioned tank farm is centrally located in town by the old power plant. The site consists of two vertical single wall tanks and one horizontal single wall tank used to store bulk heating fuel. The tanks have been out of service since the construction of the consolidated tank farm in 2005. The site is located approximately 700 feet from the Kuskokwim River.
