CIAP WEAR Trip Report
Chignik Lake (population 76)
August 19, 2014

Alaska Department of Environmental Conservation (ADEC) Solid Waste Program (Stephen Price and David Carlson) conducted a Coastal Impact Assistance Program (CIAP), Waste Erosion Assessment and Review (WEAR) site visit for Chignik Lake on August 19th, 2014. The following narrative is a brief description of our findings during the August inspection.

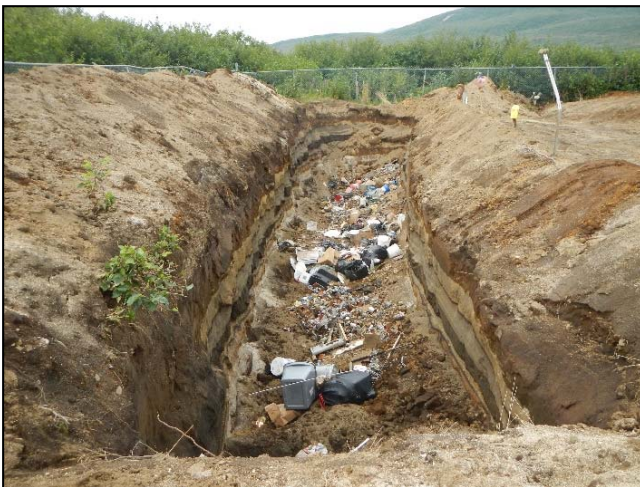
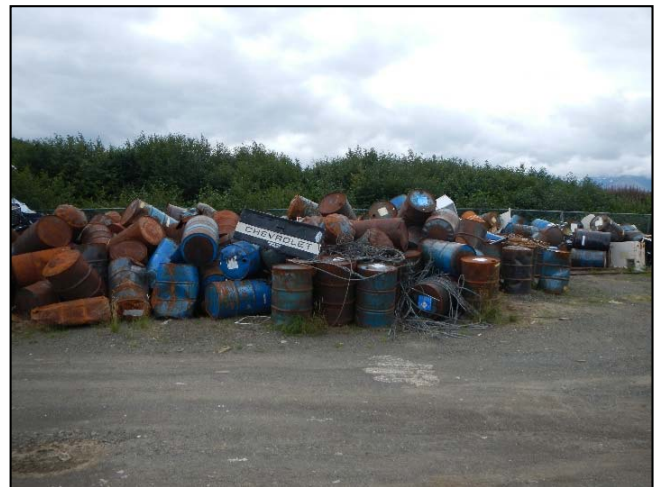
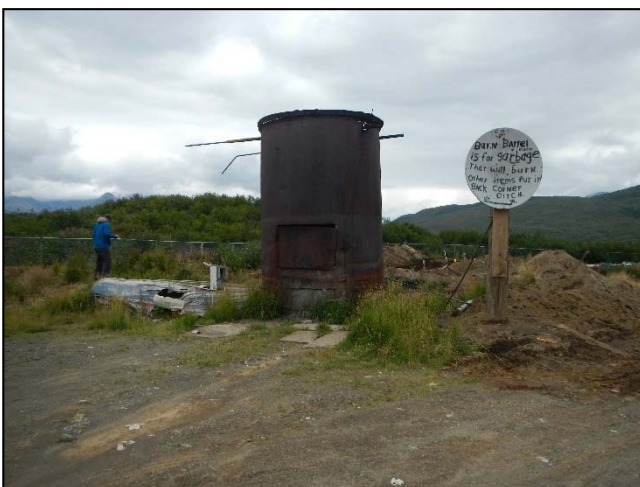
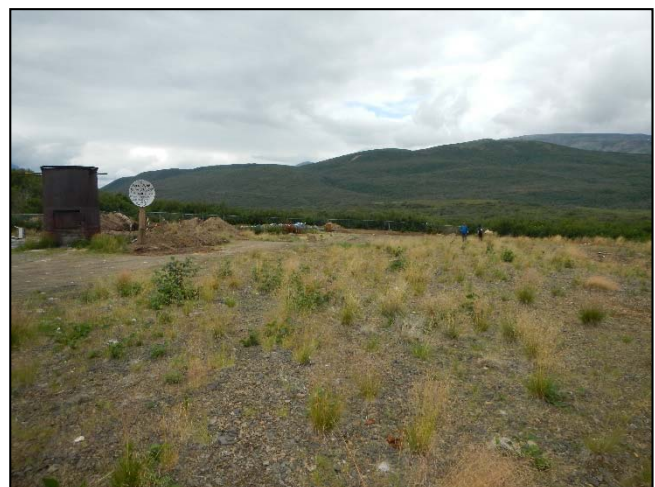
- **Landfill, 56.252987/-158.745201 (Active)** – This permitted landfill is designed as a trench and fill site and is operated by the Village of Chignik Lake. It accepts municipal waste, ash, inert waste and construction and demolition debris. It has been in operation since 1996 and is 1.6 acres. The landfill has an operator to maintain the site. This well-managed site is fully fenced and is only accessible by landfill staff. Waste is brought to the landfill through a collection program. There is a burn unit for burnable waste. Ash and other waste is disposed in the trenches. Metals, cars, drums, and propane tanks are placed in piles near the fence. Lead acid batteries are stored in a connex by the barge landing. The Chignik Lake Landfill is 440 feet from Chignik River and about a half mile east of the community. There was no erosion reported nearby.

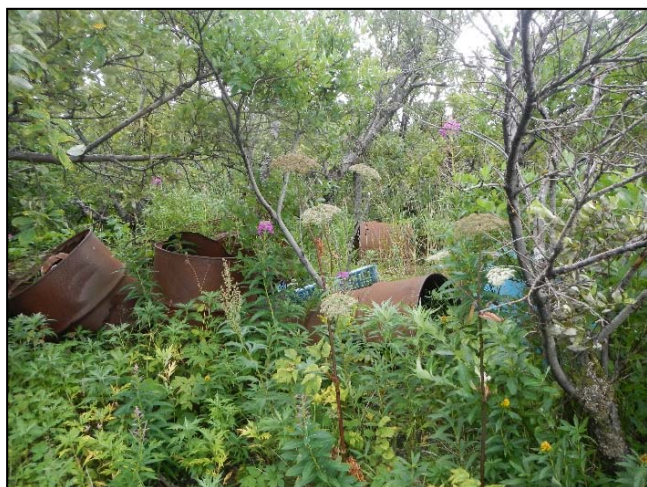
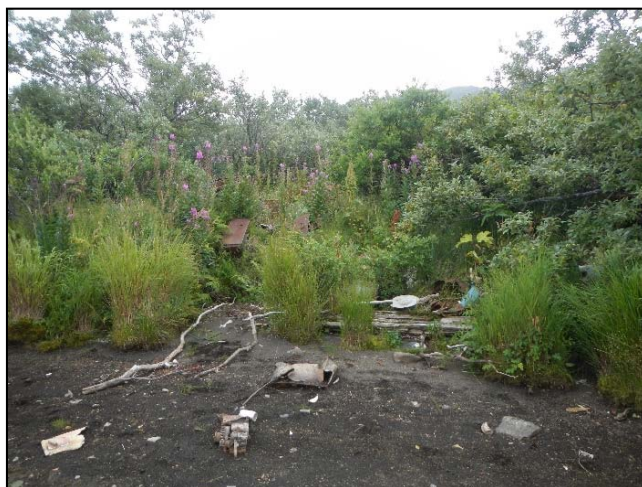
- **Old Landfill, 56.254698/-158.738863 (Retired)** — This historic landfill was discovered during the visit. It operated from the 1980s until the current landfill was constructed in 1996. It contains municipal waste and metals. It protrudes all the way to the riverbank; however, the riverbank is not eroding as of this 2014 site visit. The water level was actually reported to be decreasing. There were no signs of stressed vegetation. Plants have overgrown most of the landfill and only a few drums and scrap metal can still be seen. The site is less than a half-acre in size. This site is located 4,000 feet down river from the community.

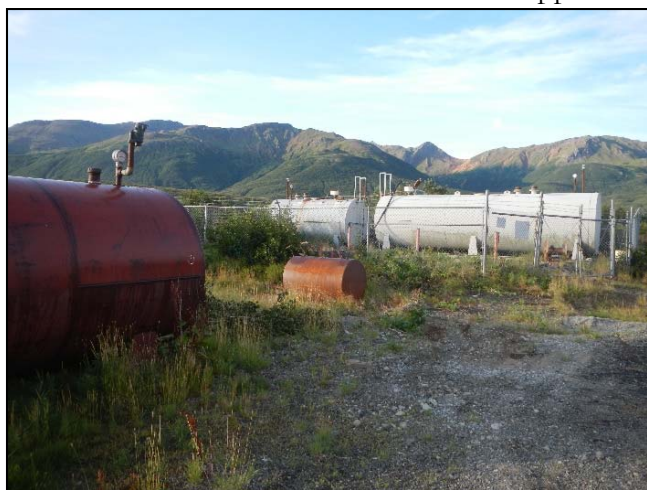
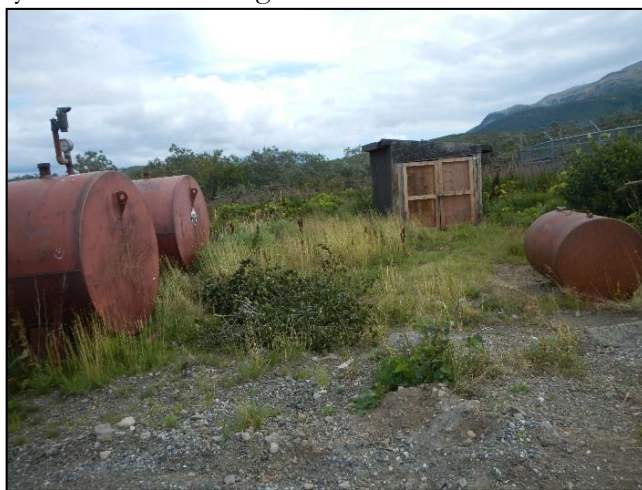
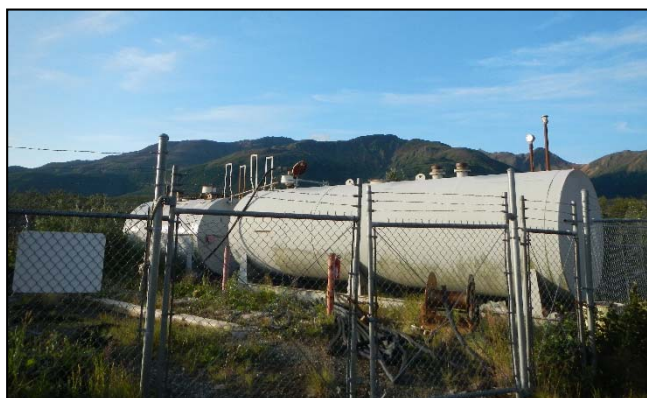
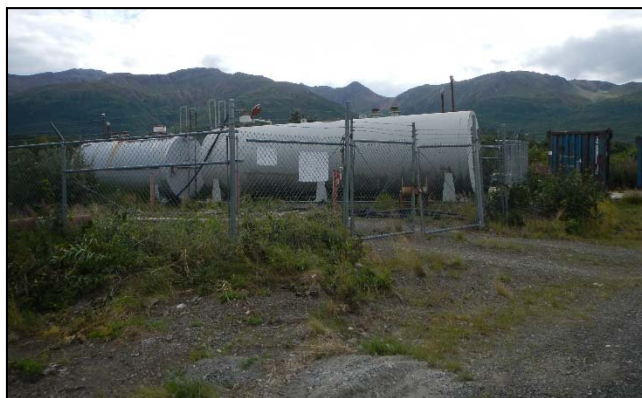
- **Barge Landing Tanks, 56.260797/-158.701719 (Active)** — The barge landing is at the end of Chignik Lake Road, which is over two miles east of the community. At this location, there are two horizontal fuel tanks within a fenced and locked area. The tanks are two different sizes with unknown capacity and contents. It is unknown if there is secondary containment. The tanks were reported to be owned by the Village of Chignik Lake and have been in this location since 1996. There are three other small tanks of various size that are outside the fenced area and are not in use. The tanks are approximately 200 feet from Chignik River.

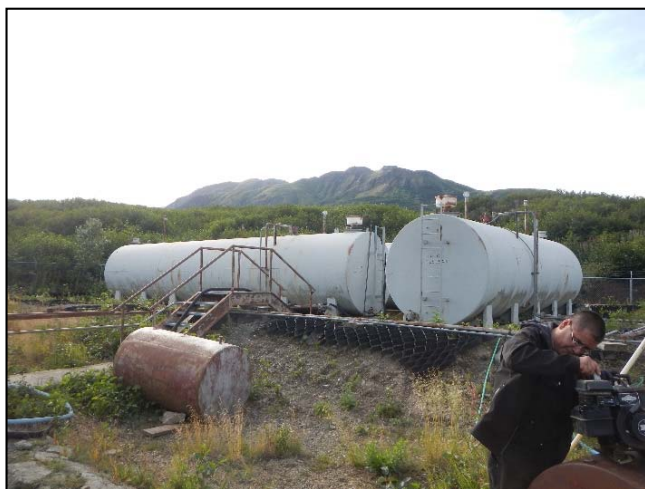
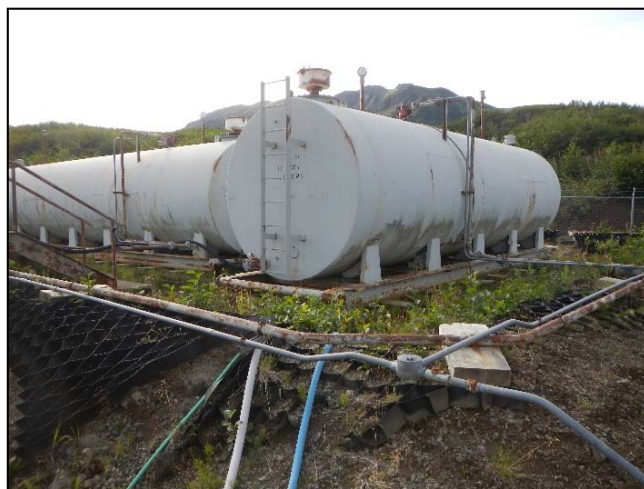
- **City Tank Farm, 56.25163/-158.76292 (Active)** – The city tank farm consists of three horizontal fuel tanks: two tanks with an estimated capacity of 20,000 gallons and a smaller 10,000 gallon tank. The tank farm is lined and fully fenced. The Village of Chignik Lake owns and operates the tank farm. The tanks have reportedly been here since 1996. There are a couple small disconnected tanks located within the fenced site. The tanks are 850 feet from Chignik Lake, but there is no erosion reported nearby.

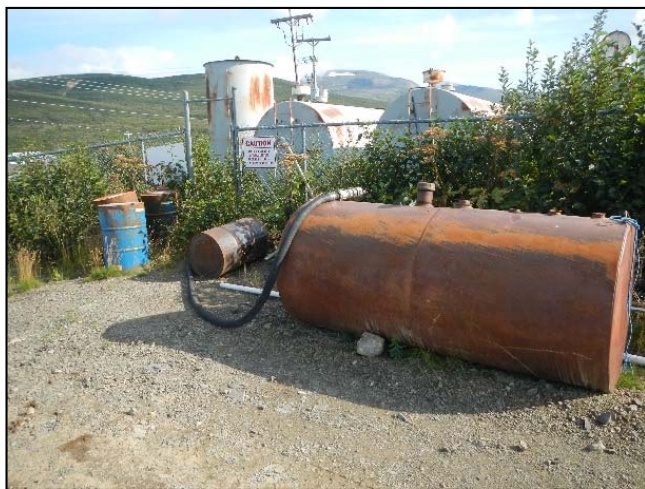
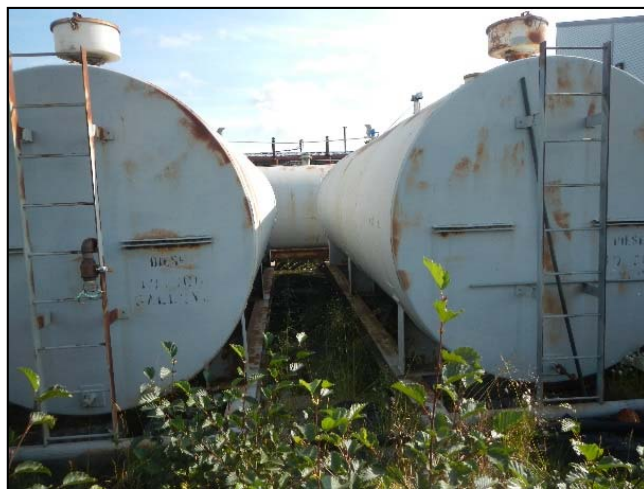
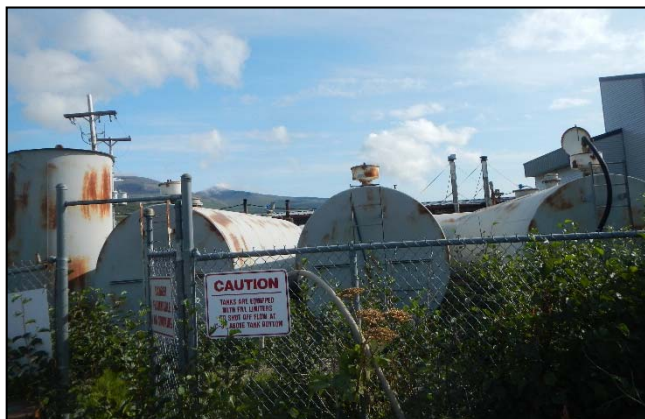
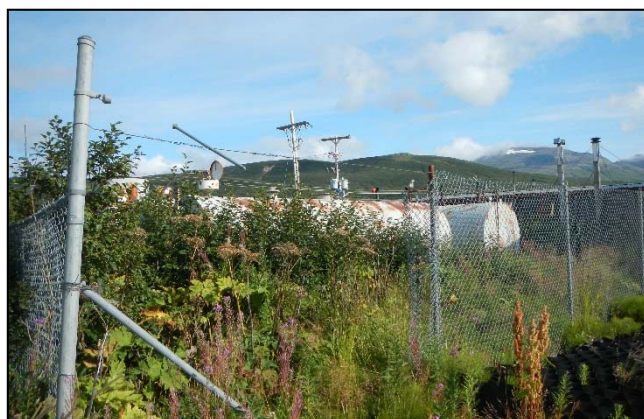
- **School Tank Farm, 56.25367/-158.76511 (Active)** – This tank farm is owned and operated by the Lake and Peninsula School District. This site has a total capacity of 50,000 gallons of diesel: 4 horizontal 10,000 gallon tanks and one vertical 10,000 gallon tank. There are a few small inactive tanks and drums in and around the site. It was recalled that the tank farm dated back to 1996. The tanks are fenced, but the fence is in need of repair. There are no signs of stressed vegetation. Vegetation is starting to grow thick around the tanks. The tanks are 440 feet from Chignik Lake, which has no erosion reported.
