CIAP WEAR Trip Report
Chevak (population 984)
July 8, 2014

Alaska Department of Environmental Conservation (ADEC) Solid Waste Program (Stephen Price and David Carlson) conducted a Coastal Impact Assistance Program (CIAP), Waste Erosion Assessment and Review (WEAR) site visit for Chevak on July 8th, 2014. The following narrative is a brief description of our findings during the July inspection.

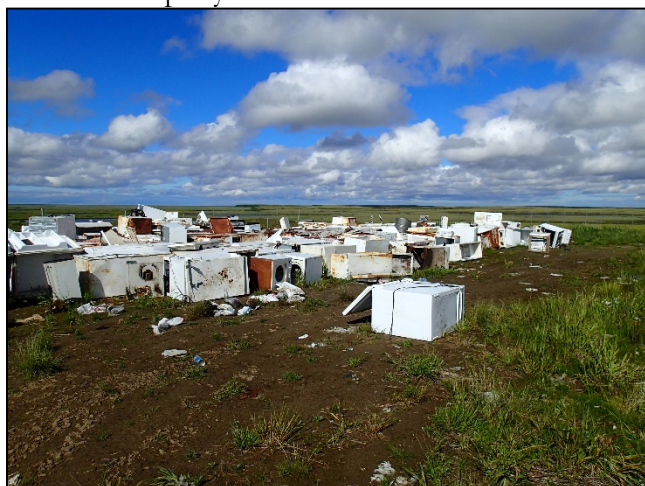
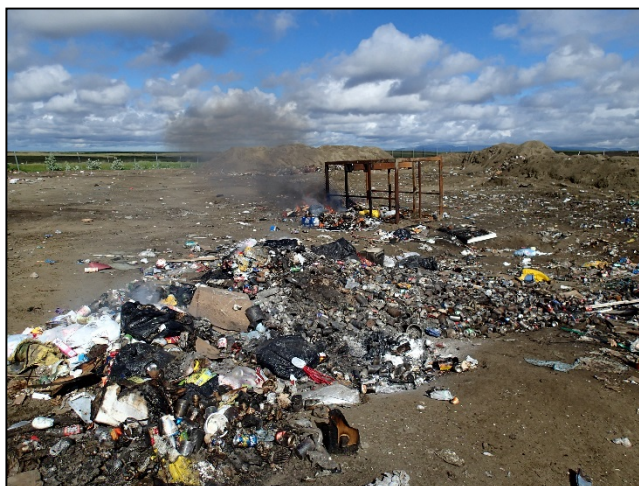
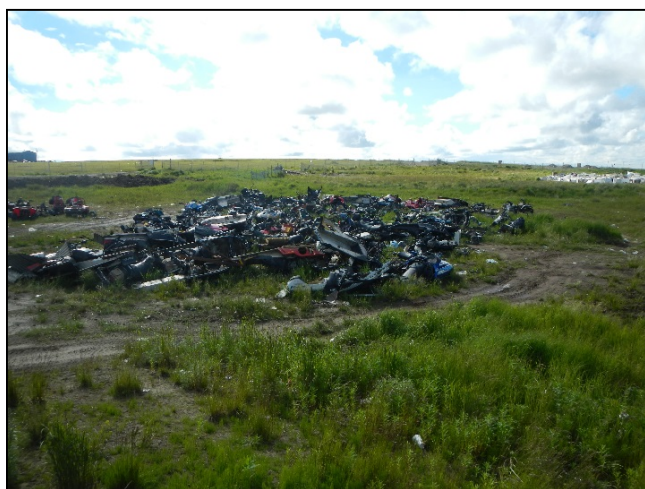
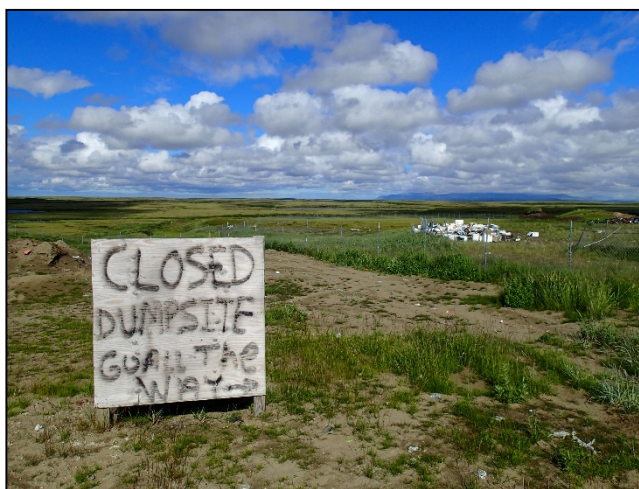
- **Landfill, 61.524117/-165.613004 (Active)** – This unpermitted landfill is operated by the City of Chevak and was constructed around 1997. The site is 8.7 acres and is a fully fenced area fill landfill. It contains at least one closed cell in the landfill. A landfill operator works part-time to manage the landfill. There is a homemade burn unit where waste is burned, but waste is also burned on the ground. Cover material stockpiled at the landfill, which is used to periodically cover the waste. There are separate areas designated for ATV's, metals, white goods, and construction and demolition debris. The landfill is about a mile south of the airport and a half mile west from the town. The Ninglikfak River is $\frac{3}{4}$ miles away from this landfill, where the Army Corps of Engineers 2009 Baseline Erosion Assessment (BEA) calculated erosion to be 5 feet per year.

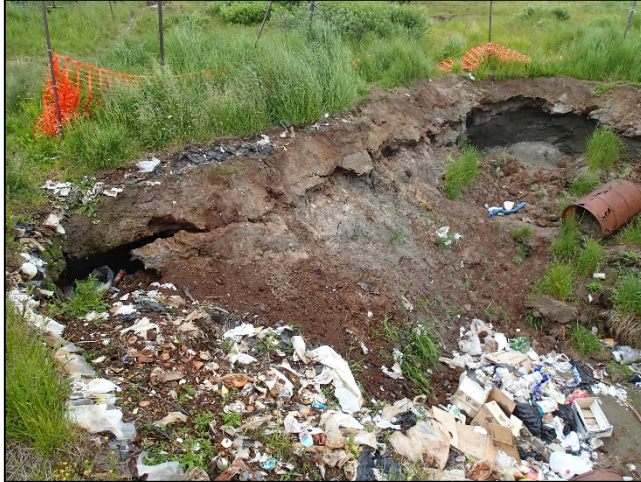
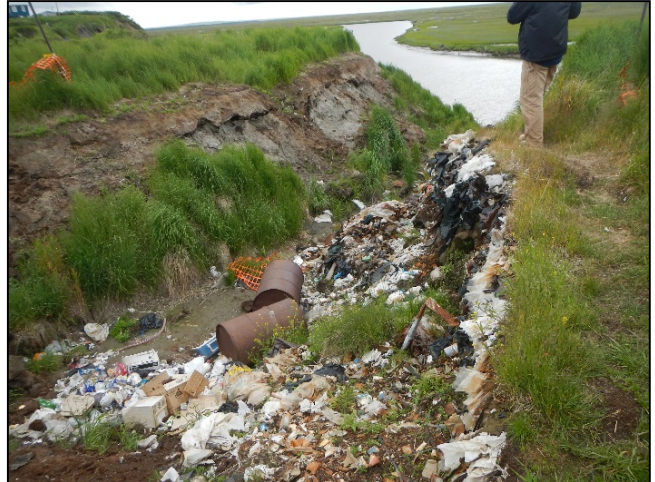
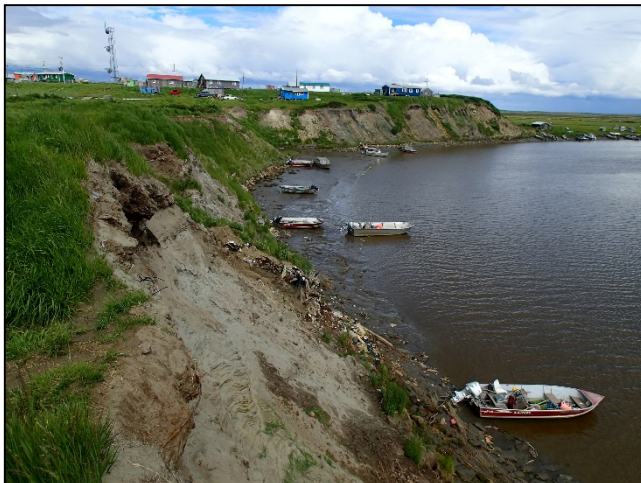
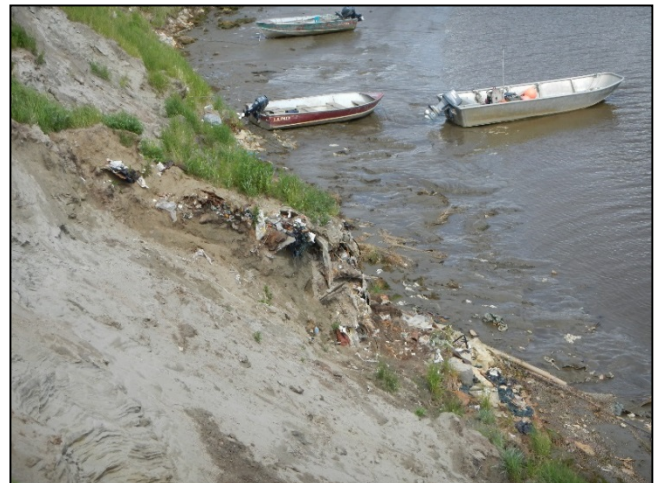
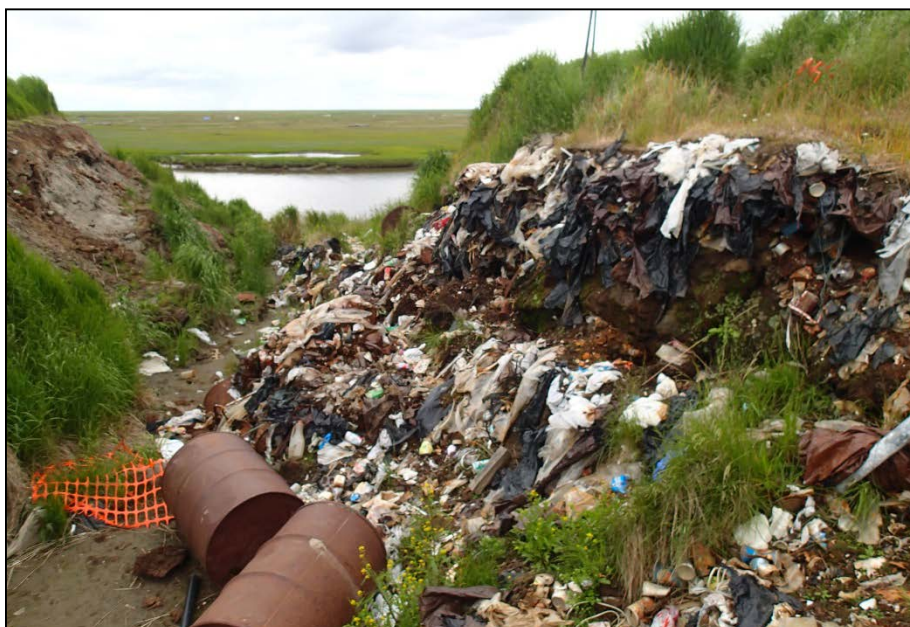
- **Chevak Old River Landfill, 61.528443/-165.584035 (Retired)** – This site accepted household waste back from the 1970's to around 1985. The waste had been covered for a several decades, but within the last ten years the river has been eroding this area. During the 2014 inspection waste was uncovered and falling into the river. The ground had caved in where the waste was previously buried. Locals placed posts to indicate where the ground drops, but no measures have been taken to move or clean this site. The waste is spread on the banks downstream of this eroding site.

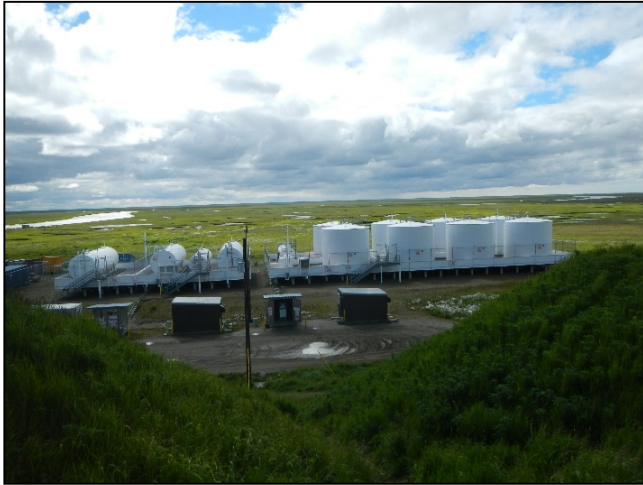
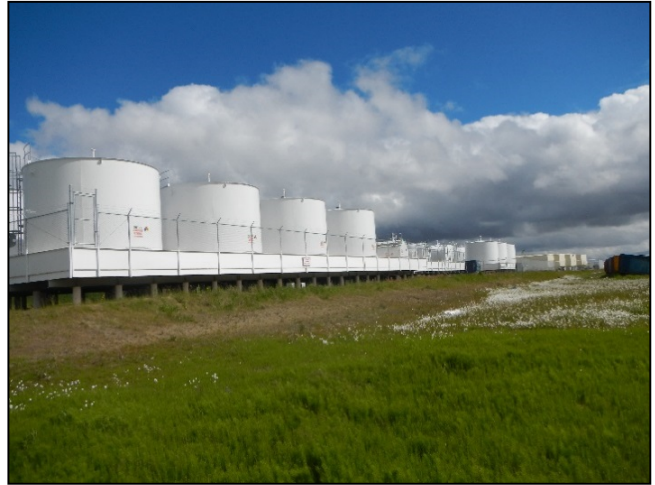
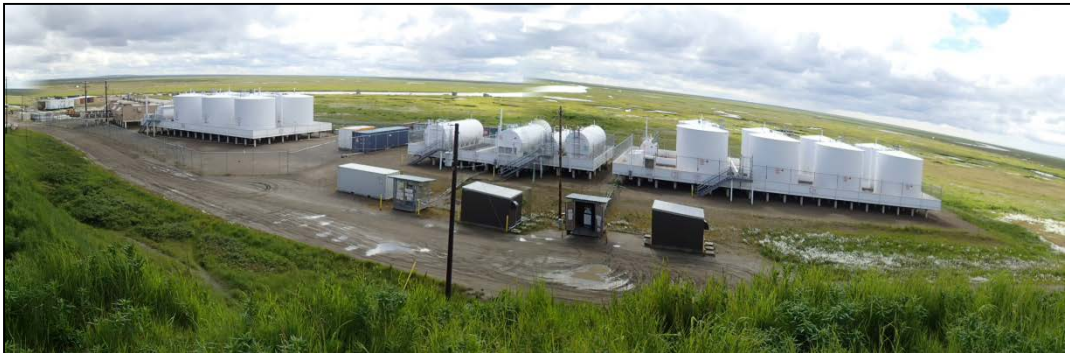
- **Consolidated Tank Farm, 61.525271/-165.591180 (Active)** – This consolidated tank farm was built in 2009 and 2010 through the Denali Commission. Per a 1994 map for Chevak, this tank farm was constructed on top of historic landfill sites which were used until the current landfill was constructed in 1997. It consists of three separate steel secondary containment decks supported on a foundation of steel pilings on a gravel pad. One deck contains AVEC tanks with a total capacity of 310,000 gallons. The other two decks contain 14 tanks with a total of 501,000 gallons for the Chevak Company Corporation and Wayne Hill Store, which both operate as fuel suppliers in Chevak. AVEC provides diesel to the adjacent community power plant. The site is 1,000 feet from the nearest source of erosion, the Ninglikfak River.

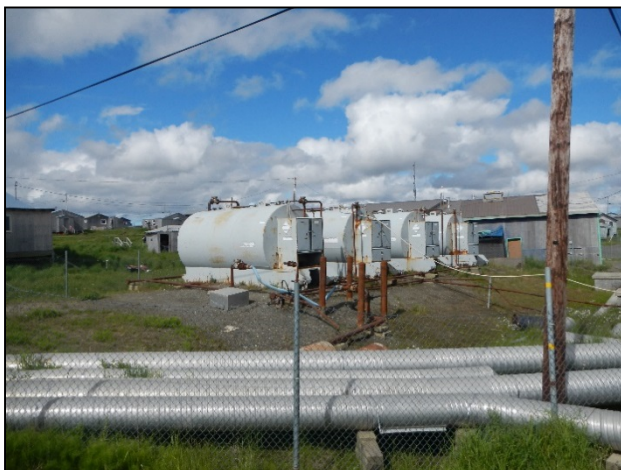
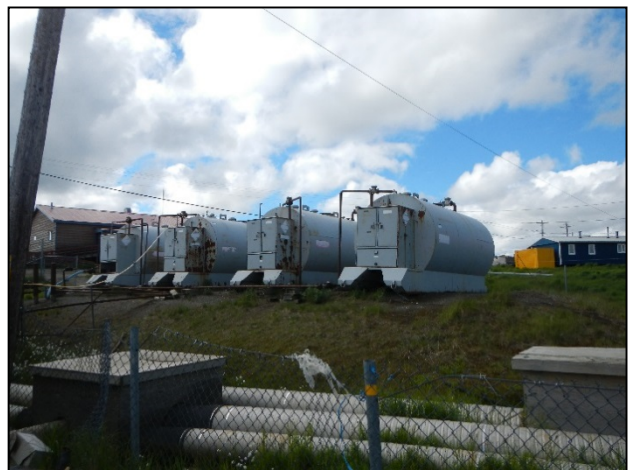
- **Water Treatment Plant Tanks, 61.527680/-165.589678 (Active)** – This site is centrally located in town next to Chevak Lake, across from the clinic. The site was constructed around 1997 and includes four tanks that are approximately 10,000 gallons in volume. The tank farm is fully fenced and the tanks are elevated on a gravel pad with no visible secondary containment. The nearest source of erosion is the Ninglikfak River 800 feet away.

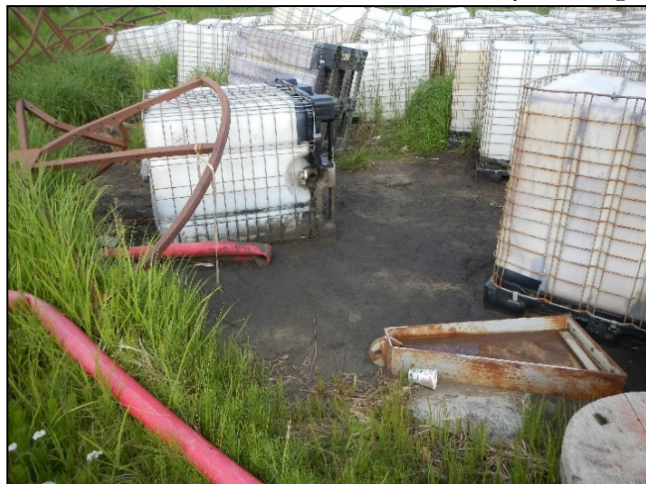
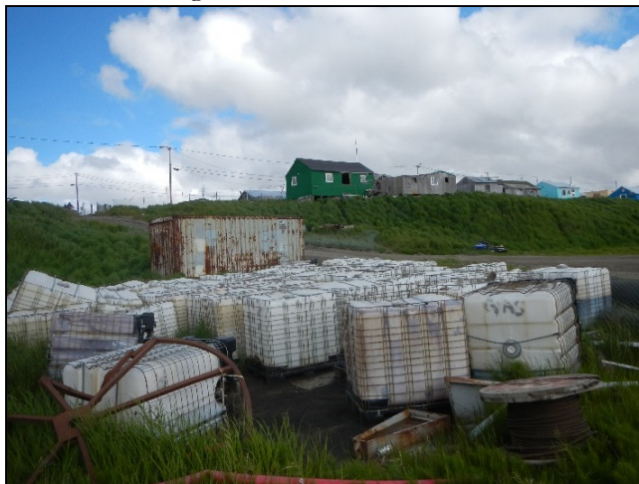
- **Gas/Oil Containers, 61.525976/-165.589571 (Active)** – This site is near the new Consolidated Tank Farm on the south edge of town. The containers are used dust control containers that the community appears to be reusing. They are approximately a cubic yard in volume. There are over 30 of these containers gathered together, some empty and some with liquid in them. One of the containers was labeled “gas”, although there appeared to be oil on the ground as well. The soil was darkened and no vegetation was growing between the containers. Per imagery review, the containers have been stored here prior to 2009. It is located 900 feet from the actively eroding section of the Ninglikfak River.

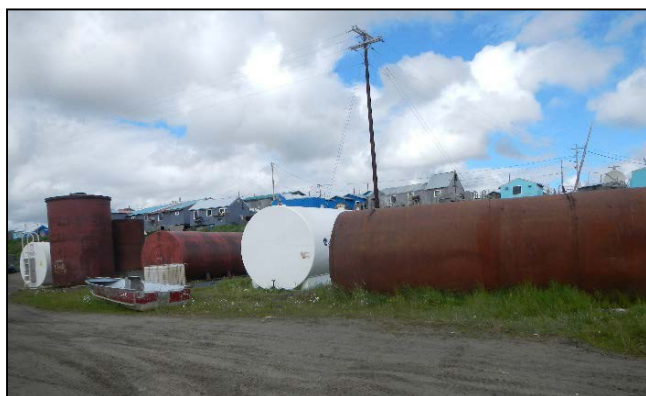
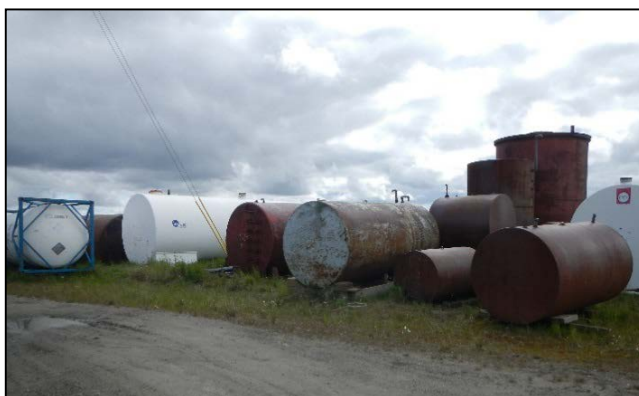
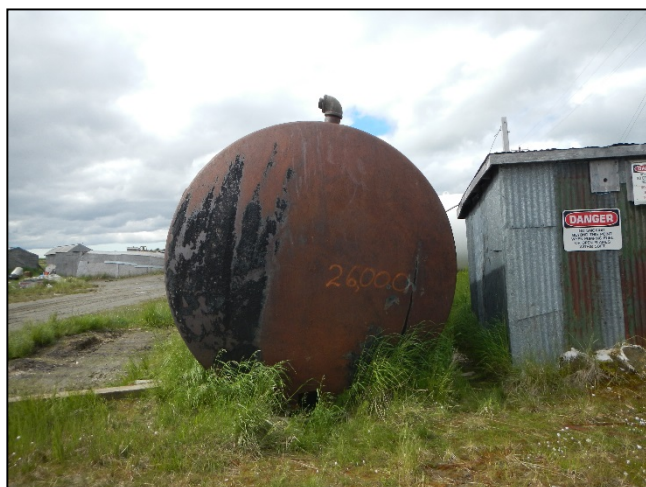
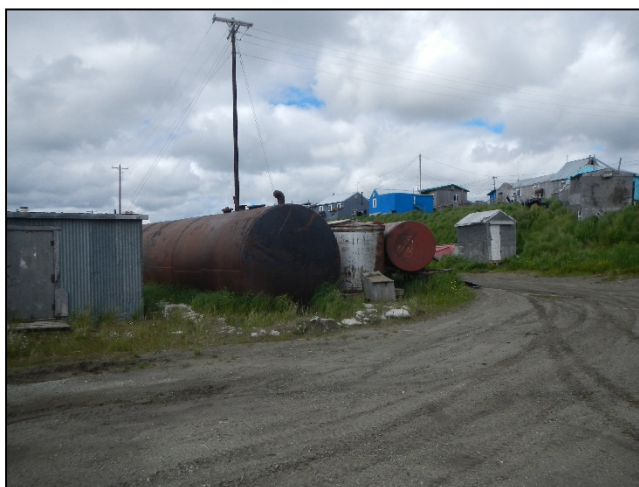
- **Chevak Company Tanks, 61.526782/-165.586047 (Abandoned)** – This site includes a various assortment of empty tanks that were reported to be owned by the Chevak Company. The tanks range in size from just a few hundred gallons to 26,000 gallons. There are upwards of 12 tanks at this location. Most of the tanks were used from around the 1990s until 2010 when the Consolidated Tank Farm was constructed. The tanks are located at the barge landing and are 200 feet from the closest eroding part of the Ninglikfak River.

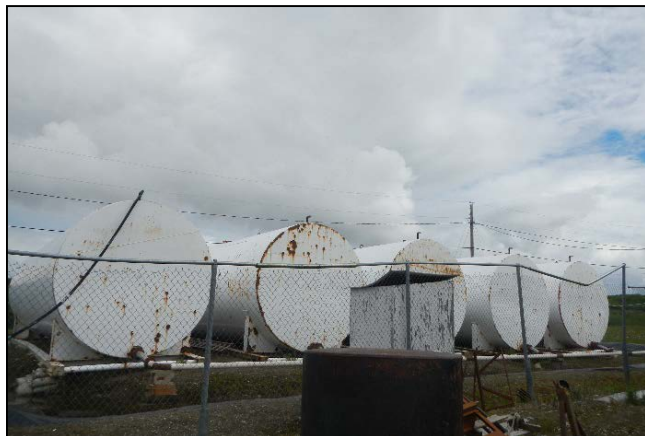
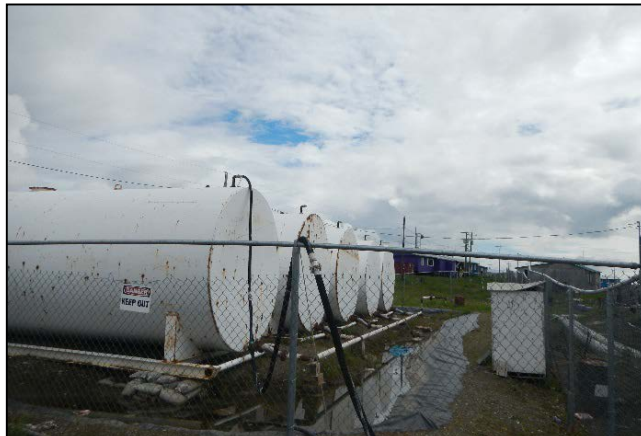
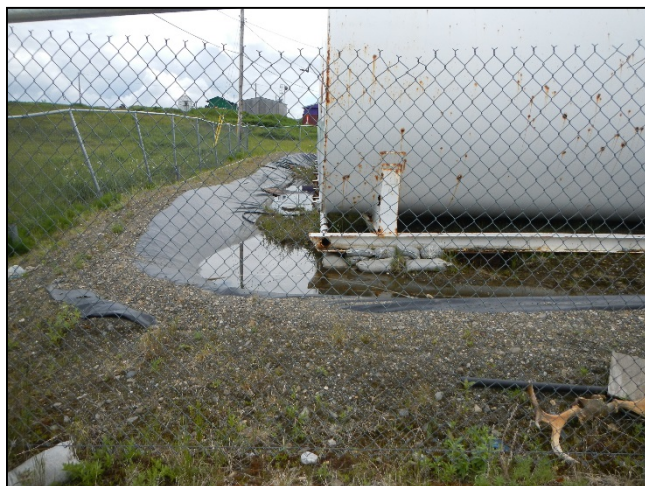
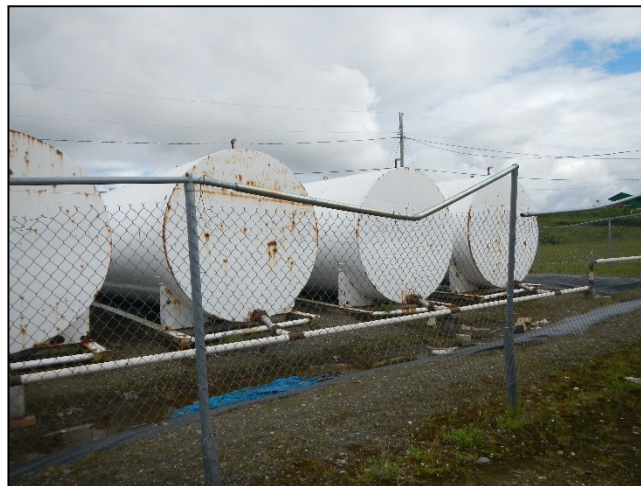
- **School Tank Farm, 61.532168/-165.584593 (Active)** – This site contains five, 27,000 gallon tanks that supply the new high school. The tanks are fully fenced and have secondary containment consisting of a liner and earthen berms. The site was constructed around 2003 and is owned and operated by the Kashunamiut School District. The school tank farm is located 1,300 feet from the closest eroding part of the Ninglikfak River.

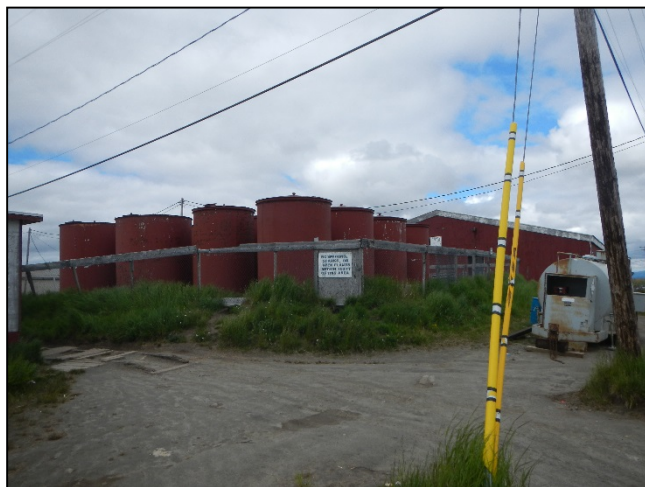
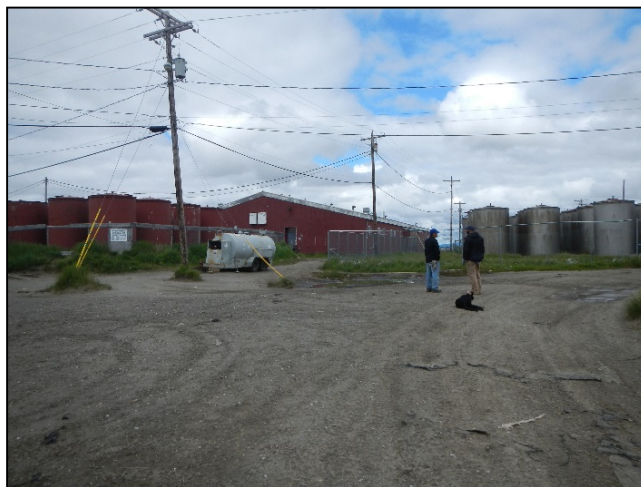
- **Former City Tank Farm, 61.528139/-165.585886 (Abandoned)** – This tank farm is located 60 feet south of the old high school building and directly west of the Former AVEC Tank Farm. It consists of 16 red, single-walled vertical fuel tanks within a fenced area. They were originally owned by the school and were reportedly given to the City of Chevak. The tanks were in operation from around the 1970s-2010 when the new Consolidated Tank Farm was constructed. The tanks are no longer in use and are reported to be empty. This site is 215 feet from an eroding part of the Ninglikfak River.

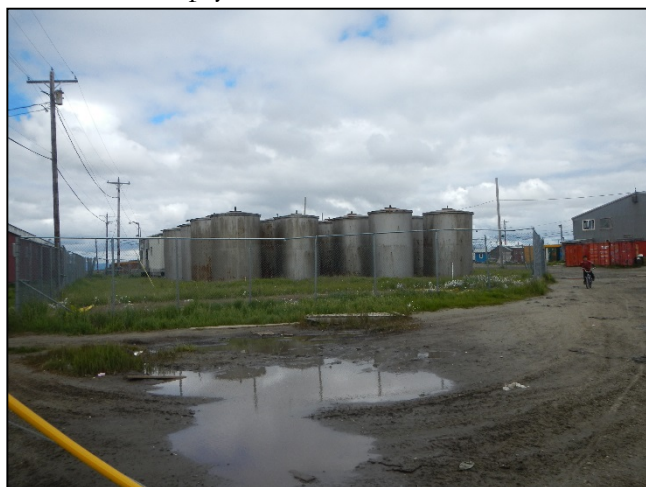
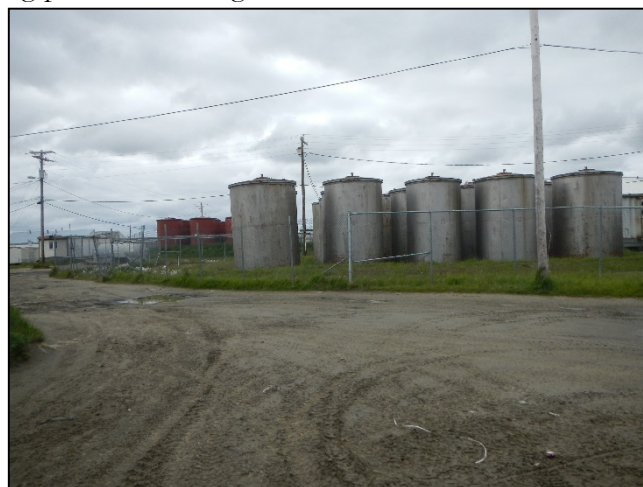
- **Former AVEC Tank Farm, 61.528480/-165.585547 (Abandoned)** – This tank farm was owned and operated by AVEC from around the 1970s-2009 when the new Consolidated Tank Farm was constructed across town. It is located 38 feet from the old high school and is between the Former City Tank Farm and the Former Corporation Tank Farm. It consists of 18 grey, single-walled, vertical, diesel fuel tanks within a fenced area. The tanks are reported to be empty. It is located 225 feet from an eroding part of the Ninglikfak River.

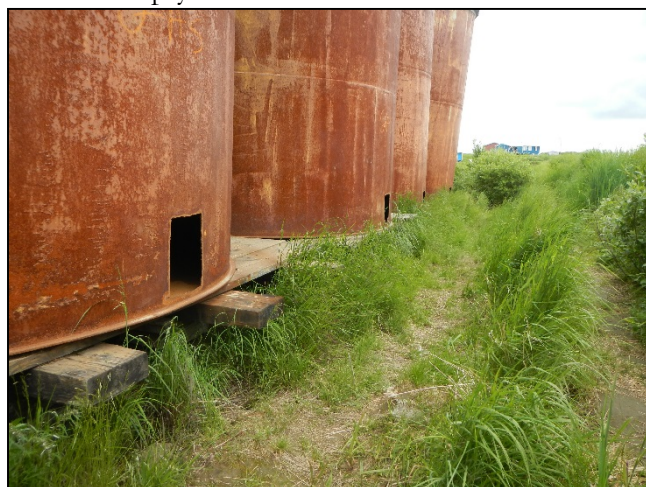
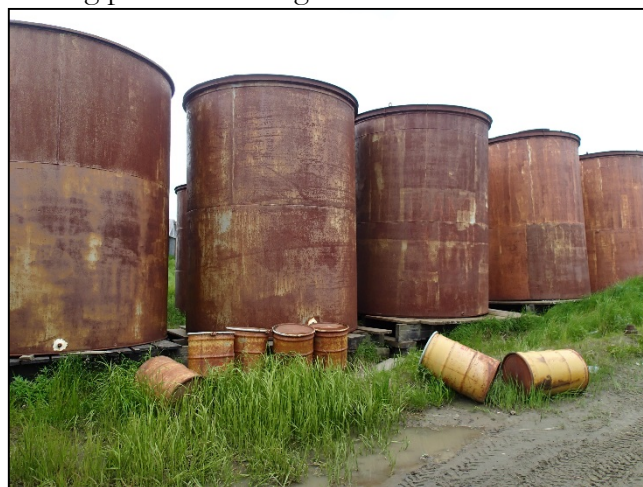
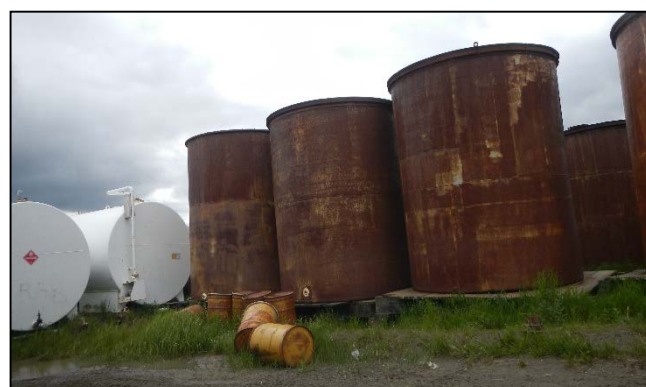
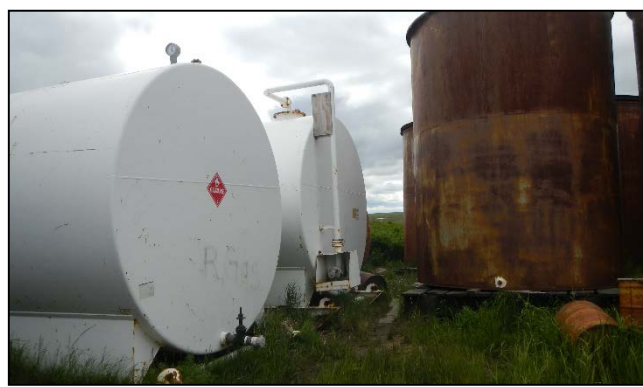
- **Company Corporation Tank Farm, 61.528517/-165.584802 (Active)** – This tank farm is owned by the Chevak Company, which is the village corporation. It has been in this location since around the 1970s and was in operation until 2010 when the new Consolidated Tank Farm was constructed. It is a Contaminated Site (File ID 2409.38.001) due to an adjacent fuel spill that leaked under the liner into the soil in 2002. Site characterization work was completed in 2003, but no further remediation work has been done. The site contains 10 vertical fuel tanks that are sitting on pallets with large holes cut into the side of each tank and 4 horizontal fuel tanks which are disconnected. The site is not fenced; however, all tanks are reported to be empty of fuels. It is located 135 feet from an eroding part of the Ninglikfak River.

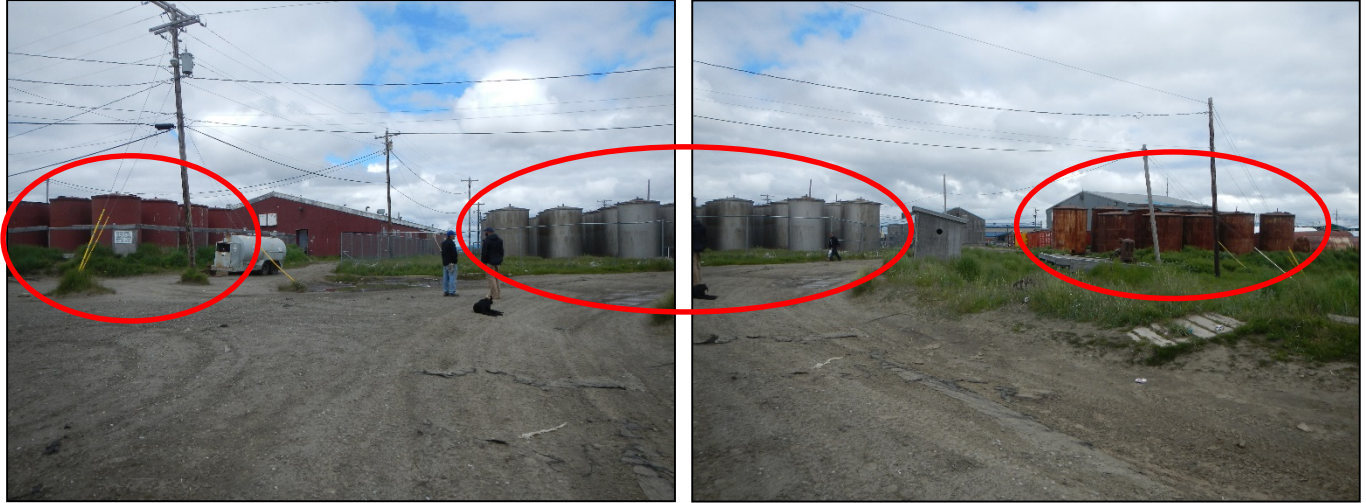
View of three adjacent tank farms located by the old high school building.

From left to right: Former City Tank Farm, Former AVEC Tank Farm and
Company Corporation Tank Farm
