**CIAP WEAR Trip Report
Dillingham (population 2,406)
June 27-28, 2013**

Alaska Department Environmental Conservation (ADEC) Solid Waste Program (Kit Persson and Jamie Gorman) conducted a Coastal Impact Assistance Program (CIAP), Waste Erosion Assessment and Review (WEAR) site visit for the City of Dillingham, June 27th – 28th, 2013. The following narrative is a brief description of our findings during the June inspection.

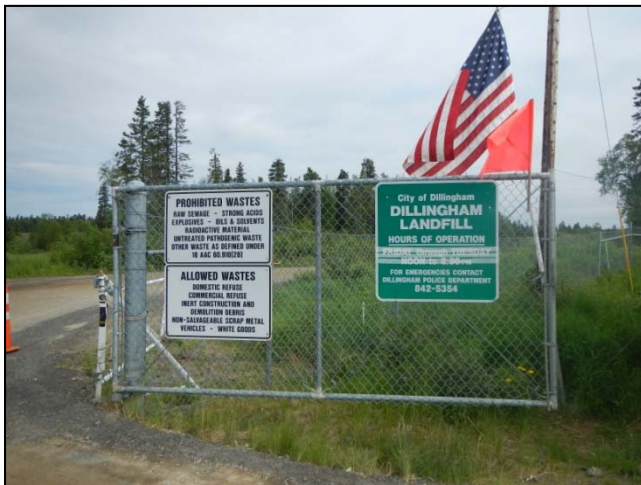
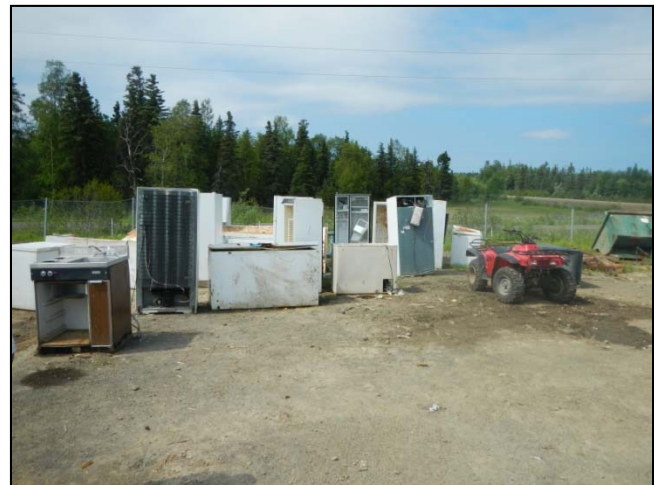
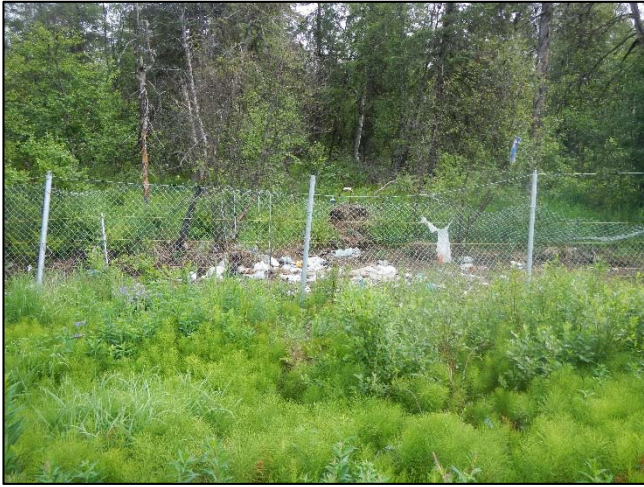
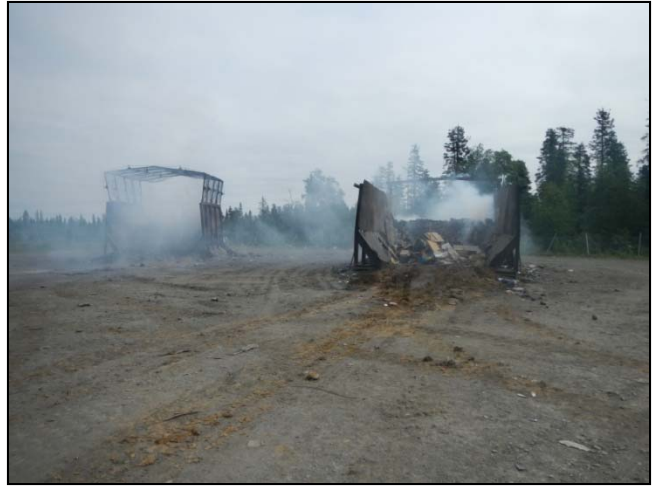
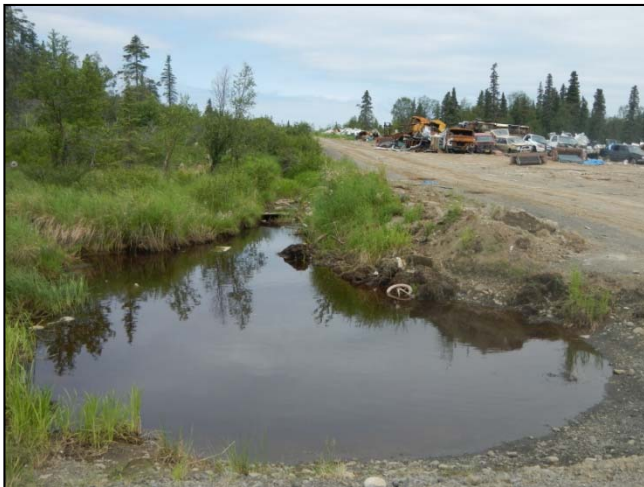
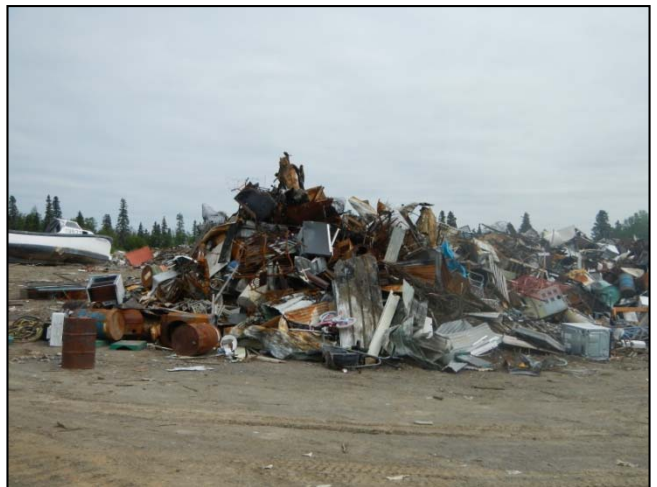
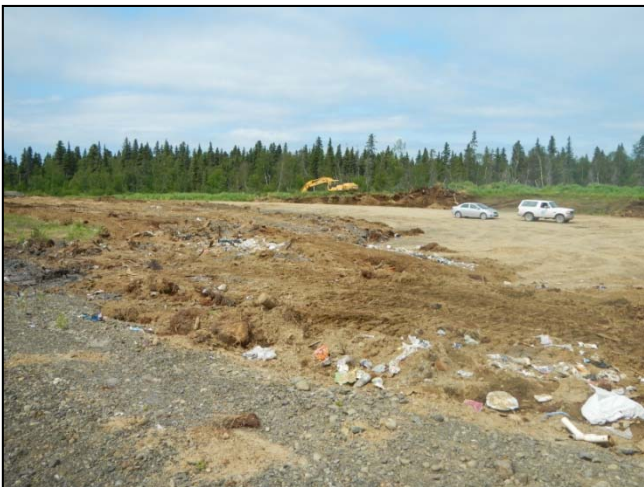
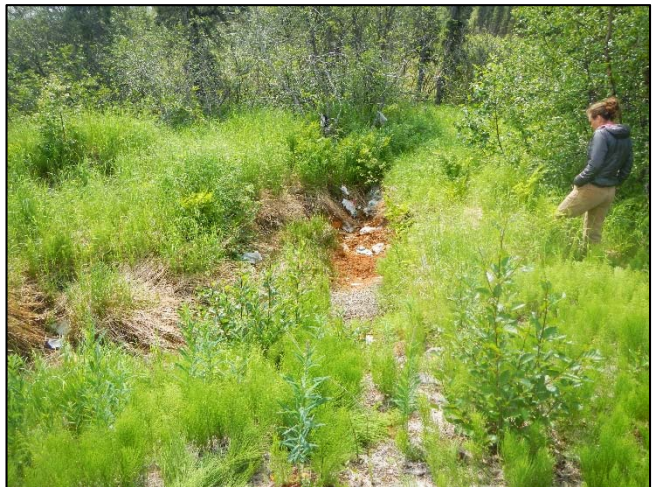
- **Landfill, 59.097498/-158.547821 (Active)** – This is a permitted Class II Landfill that is owned and operated by the City of Dillingham and has been in use since August of 1979. The landfill is located 3.75 miles northwest of the Dillingham Airport and is roughly 15 acres in size. It accepts municipal waste, construction and demolition debris, and regulated asbestos containing materials (RACM). Semi-annual groundwater monitoring has been conducted since 2009 due to a November 2007 Notice of Violation. Public access is controlled at multiple points along the access road through a series of locking gates. The waste transfer area includes an office, shipping crates used for special waste separation and storage, an area for white goods waiting for Freon removal, a dumpster for waste transfer, and a garage for heavy equipment storage. At the time of inspection, the electric fence surrounding the transfer area was documented to have been damaged by bears. The landfill burns most of its waste within a Summit burn unit until June 1, 2014 when it will no longer be allowed through their solid waste permit. There is a gargantuan, unsorted metals pile which has no soil cover and has been the site of an unintended fire. The cell where ash is placed and covered borders a wetland. South of this cell's berm, on the wetland side, there was noted to be distressed vegetation, litter, and discolored water. The landfill operators did not have hazardous waste recognition training or Rural Alaska Landfill Operator training at the time of the inspection. The site is 8,350 feet west of the Wood River.

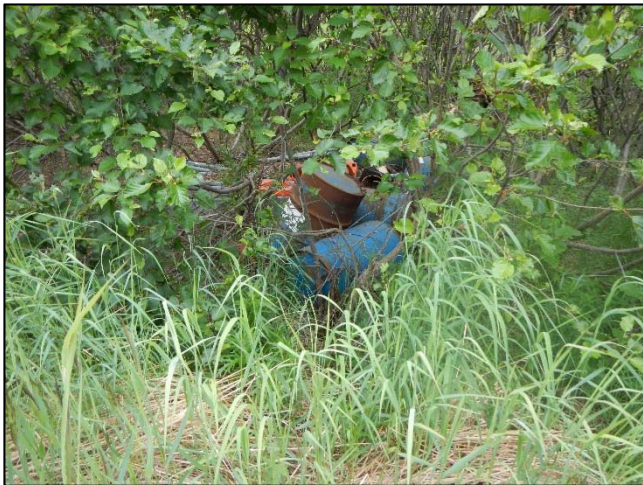
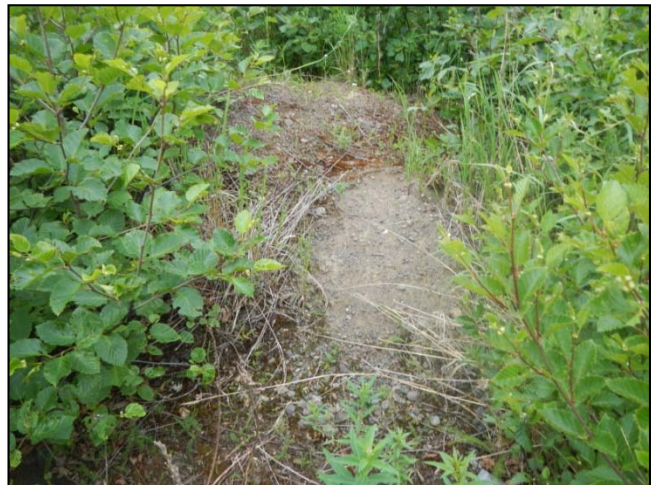
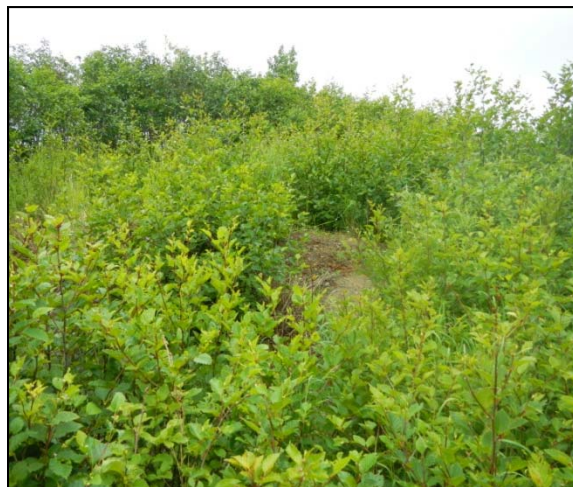
- **ADOT&PF, 59.041307/-158.468814 (Closed)** – This Contaminated Site (File ID 2540.26.002) is located at the Alaska Department of Transportation and Public Facilities (ADOT&PF) Vehicle Maintenance Facility off of Kenny Wren Road. The site's status is listed as 'Cleanup Complete – Institutional Controls' in the Contaminated Sites database. The site was documented in September of 1999 after three underground storage tanks were removed from the site, resulting in the discovery of petroleum hydrocarbons exceeding ADEC cleanup levels. Approximately 35 cubic yards of contaminated soil were stockpiled about 125 feet south of the maintenance building. During the time of inspection, these stockpiles were investigated and noted to be revegetated. Also, near the soil, several 55-gallon drums with unknown contents and various traffic cones and metal poles were discarded amongst the trees. The relation of these items to the Contaminated Site is unknown. The site is 1,500 feet north of the Nushagak River.

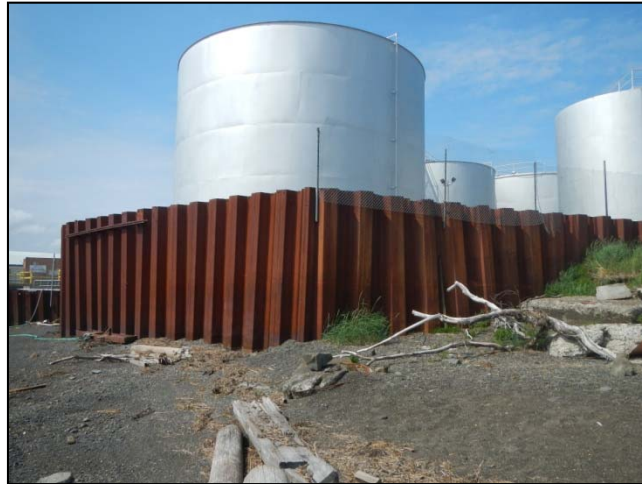
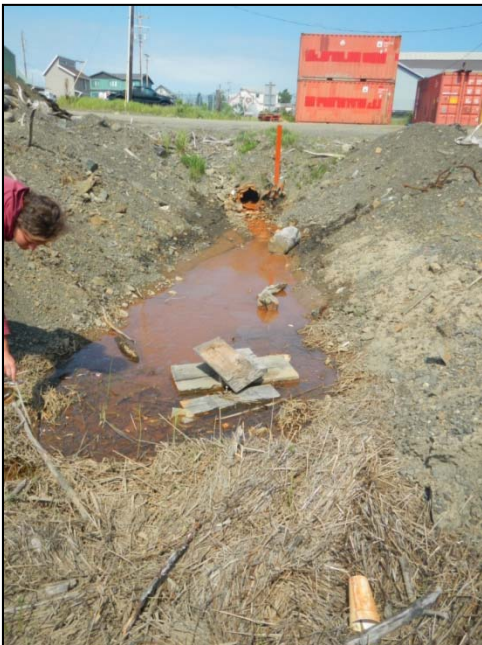
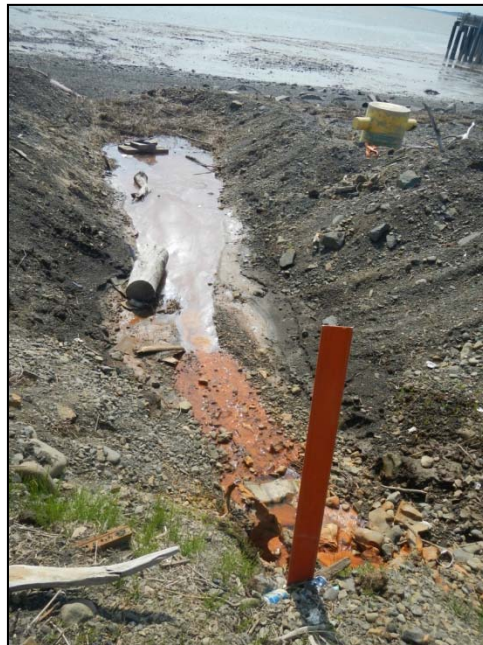
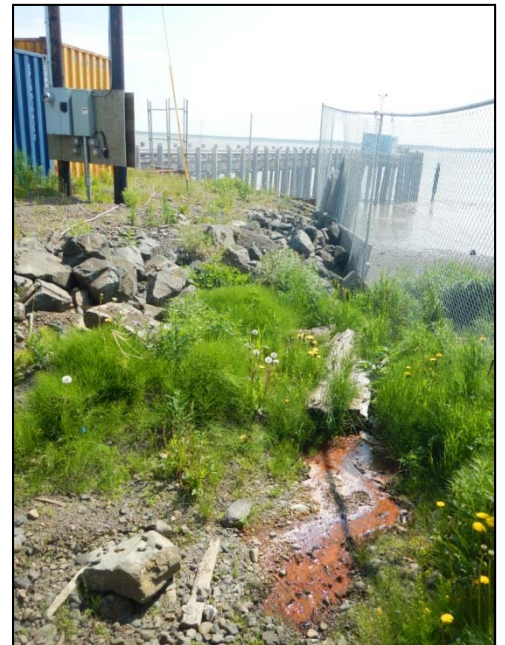
- **Delta Western Tank Farm, 59.037962/-158.467063 (Active)** – This tank farm is situated on the shores of the Nushagak River and is listed as an active Contaminated Site (CS) (File ID 2540.38.017). There were 11 tanks onsite located within a sheet pile containment wall that had attached fencing. The site covered half an acre and had a total capacity of 2.23 million gallons. The facility is owned and operated by Delta Western and there was an administrative building and gas station in front of the tank farm along Dillingham’s Main Street. The tank farm itself has been around since the 1940s. However, the CS status was granted much later, in 2011. The CS description details that a “seep was observed in June of 2011 near the shoreline in the rock outcrop along the southwest property boundary.” That seep contained several petroleum contaminants and was observed during inspection to have an oily sheen and a rusty orange hue. Also, at a culvert outfall 100 feet east of the tank farm enclosure, the exiting water was observed to be the same rusty orange hue and had a noticeable sheen to it. The vegetation surrounding the outfall was disturbed.

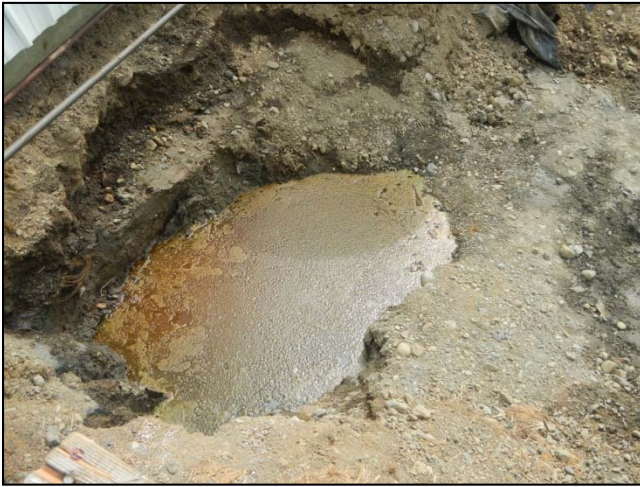
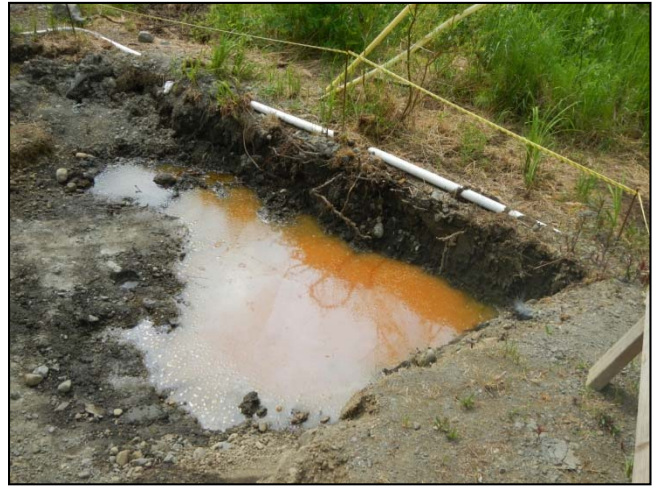
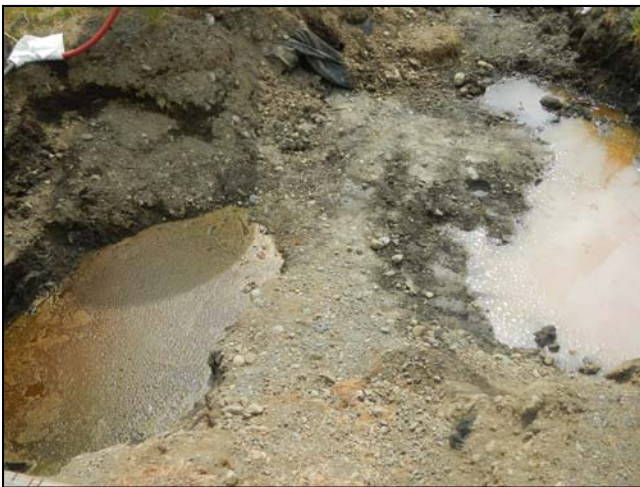
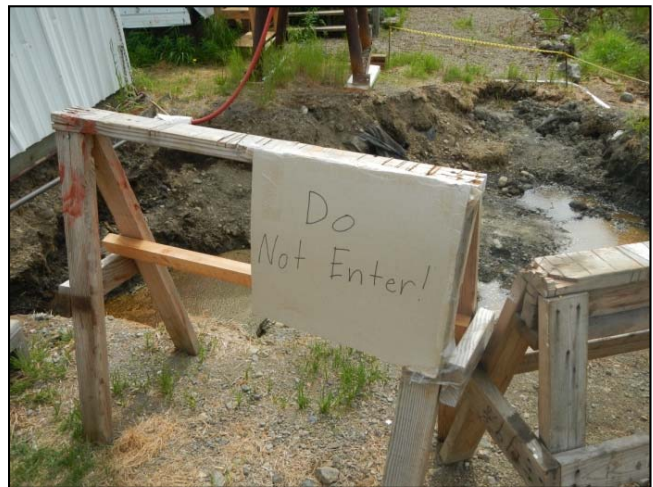
- **Icicle Seafoods Wood River Facility, 59.067637/-158.438682 (Active)** – This active Contaminated Site (File ID 2540.38.019) was reported to the CS Program on May 15th, 2013, a little over a month before the time of WEAR inspection. The site was located beside a housing connex at Icicle Seafoods approximately 280 feet from active erosion along the banks of the Wood River. The site is described within the CS Database as a release of about 150 gallons of diesel fuel from an aboveground heating oil tank. The area of concern was noted to be dug out at the time of inspection and groundwater had begun to pool. The 0.001 acre area was roped off and found to have above ADEC cleanup levels of contamination in the soil and groundwater. The pooled water had an orange-brown hue with a foamy surface texture. There was also piping surrounding the site which was in place to reroute utilities from the bunkhouse which had initially been buried in the contaminated soil. Groundwater in the area was found to occur at a depth of three to five feet.

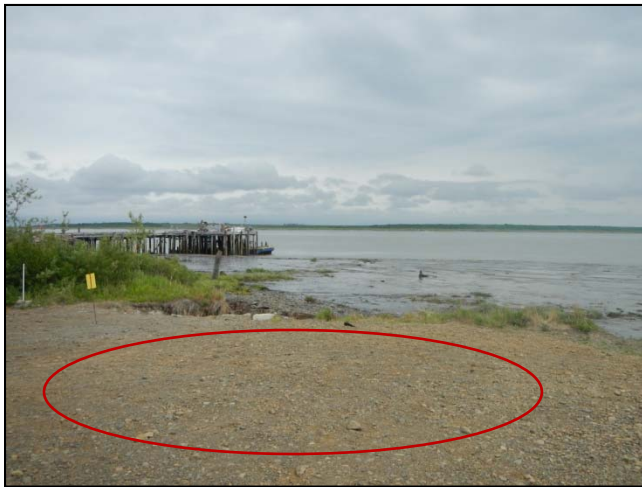
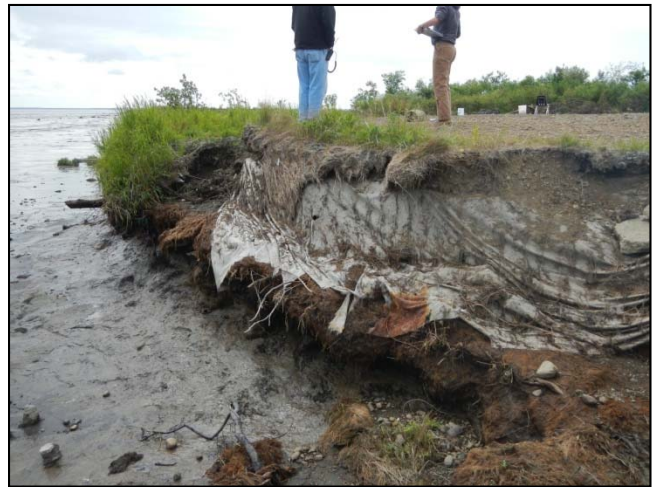
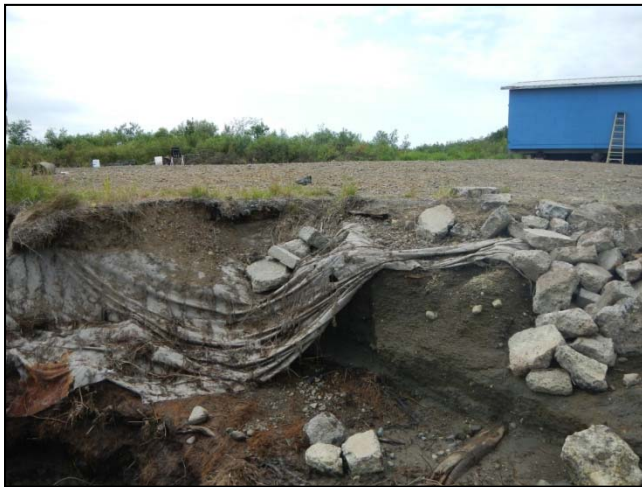
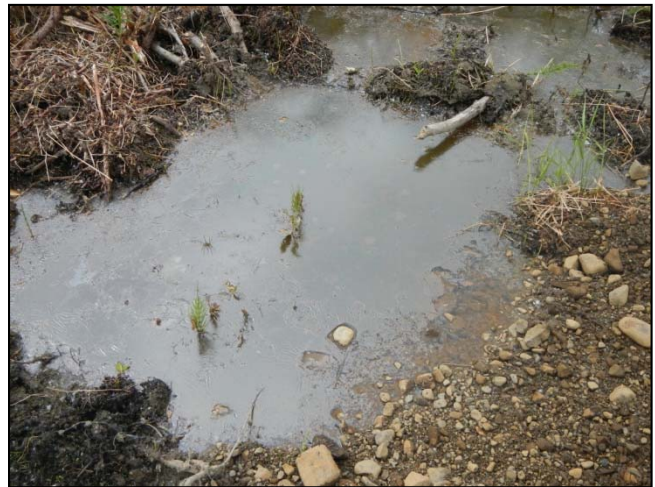
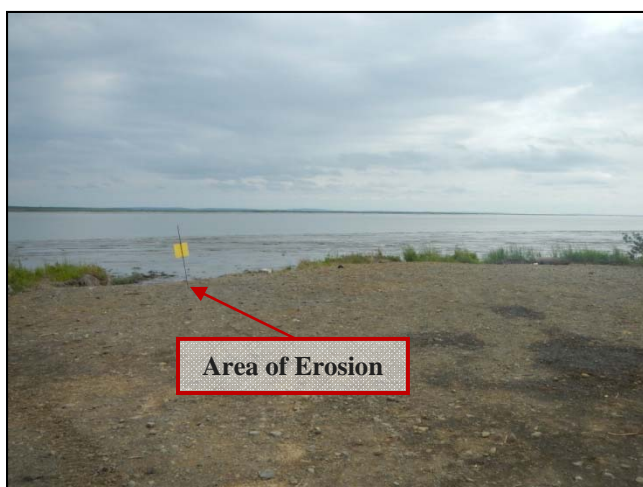
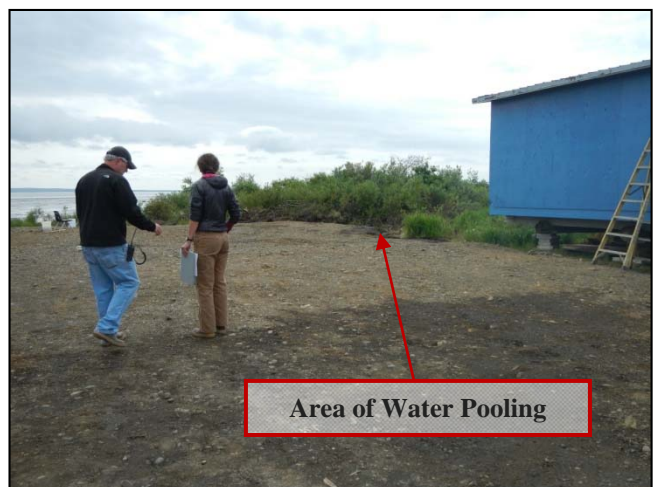
- **Former Snopac Seafood Processing Facility, 59.067898/-158.437803 (Active)** – This is another active Contaminated Site (File ID 2540.38.018) located on Icicle Seafoods property. An Environmental Site Assessment dated November 2011 documented the presence of petroleum contamination in the areas of concern: a gravel clearing previously used for waste burning operations, former fuel tank locations, and stained areas. The site was documented during the time that the property was owned and operated as a Snopac Seafood Processing facility. Icicle Seafoods bought the processing plant from Snopac on April 1st, 2013. The site is located right on the edge of Wood River. During the inspection, it was noted that the river bank was actively eroding, despite the implementation of various erosion mitigation measures, such as the placement of concrete blocks and geotextile fabric. This erosion was on the east side of the site; on the southwest side, there was witnessed pooling water with a visible sheen. This site is located 205 feet northeast of the Icicle Seafoods Wood River Facility CS.

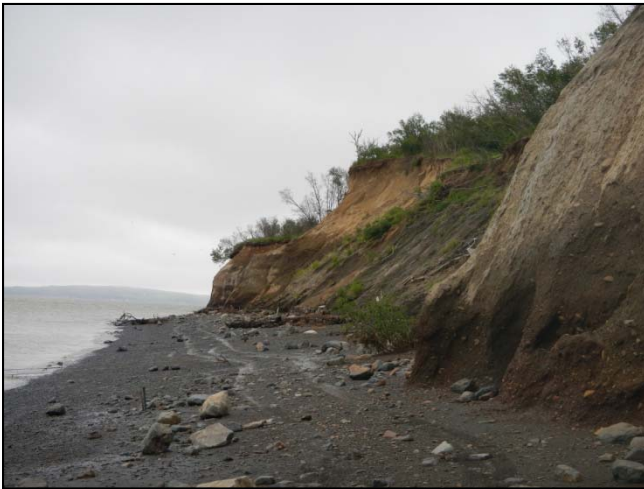
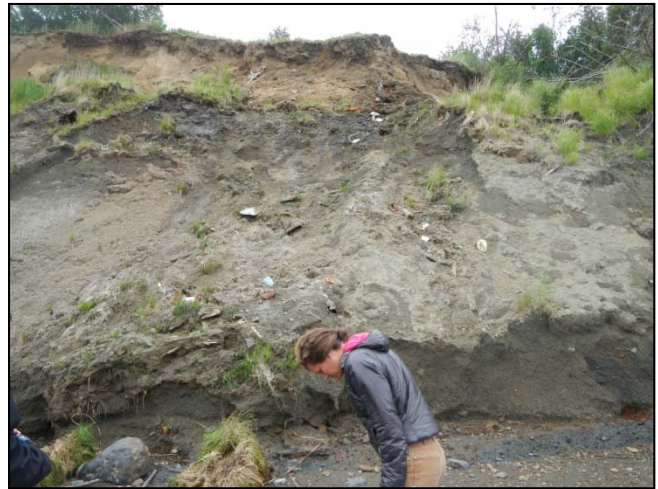
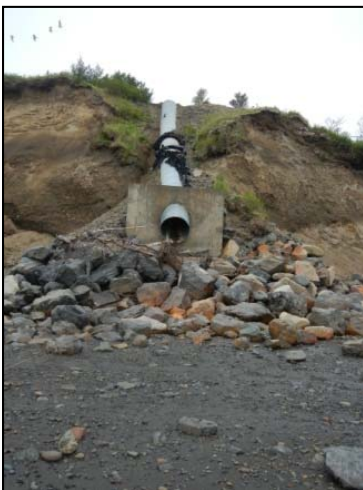
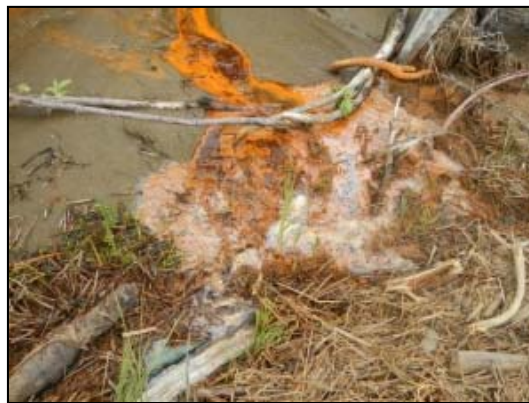
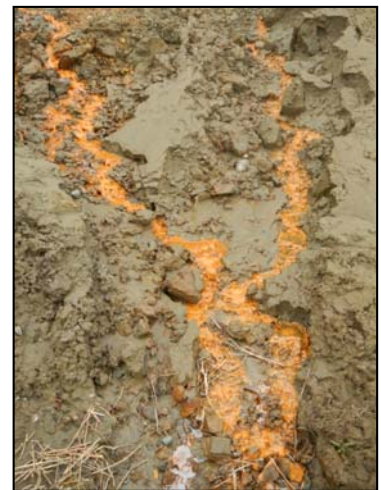
- **IHS Hospital Sites, 59.000154/-158.531449 (Active)** – The US Indian Health Service (IHS) Kananak Hospital has several active areas of petroleum contamination documented within the Contaminated Sites Database (File ID 2540.38.005). The edge of the IHS property boundary runs up against a steep bluff that is eroding into the Nushagak River. A historic hospital landfill was discovered several years ago when garbage began surfacing along the face of the bluff. The landfill was dug up in 2005 and transferred to the Dillingham Landfill. Also along the beach, there were witnessed seeps of bright orange sheened water originating from the bluff. These seeps were noted to have a sulfurous odor. Erosion along the bluff was most noticeable at an outfall culvert that had become completely exposed, despite the placement of heavy riprap at its base and geotextile coverage along its body. This site covers an area of about 10 acres and is located along the anadromous Nushagak River.
