CIAP WEAR Trip Report  
Emmonak (population 755)  
July 9, 2012

Alaska Department of Environmental Conservation (ADEC) Solid Waste Program and Contaminated Sites Program (Doug Huntman and Grant Lidren) conducted a Coastal Impact Assistance Program (CIAP) , Waste Erosion Assessment and Review (WEAR) site visit for the Village of Emmonak, July 9<sup>th</sup>, 2012. John Murphy, City Administrator, participated on the site visits. The following narrative is a brief description of our findings during the July inspection.

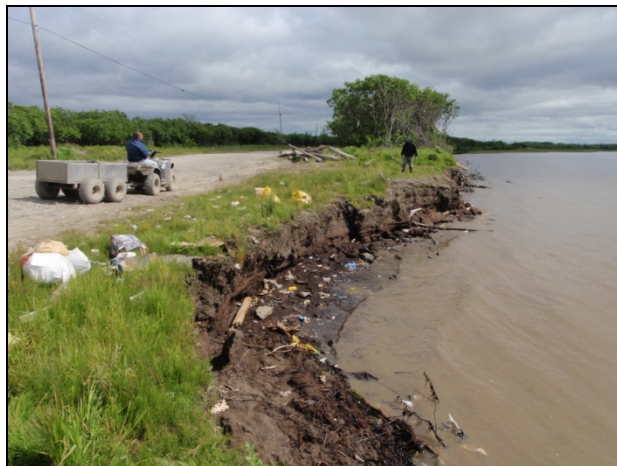
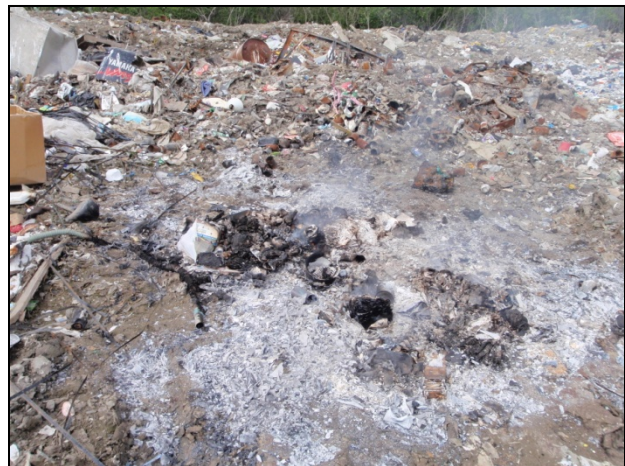
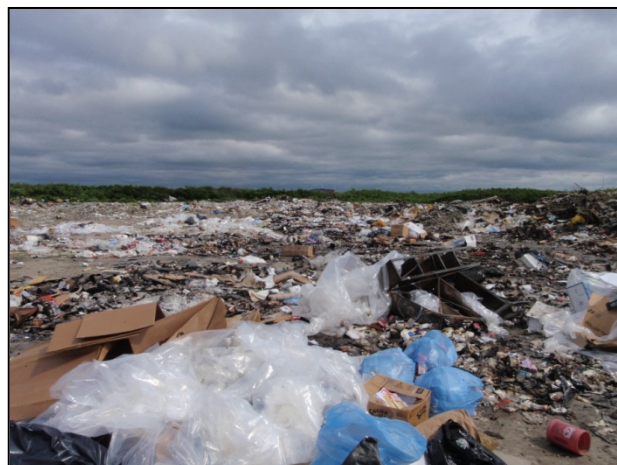
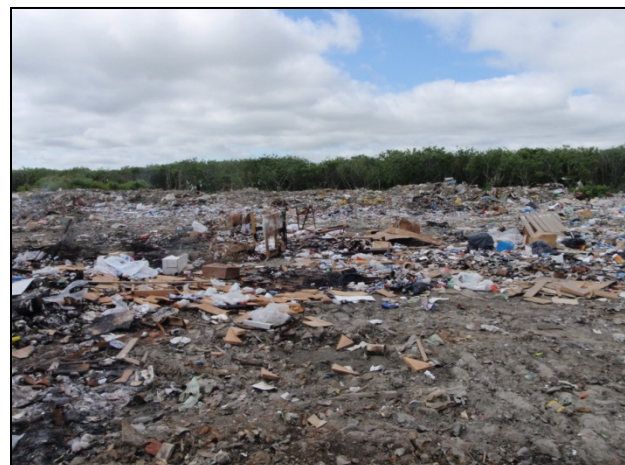
- **Landfill, 62.775086/-164.505094 (Active)** – The landfill is a self-haul site with a part-time operator. The site is approximately 5 acres with waste spread out throughout the site. Problems with the site include: no cover material available to place on waste, open burning was observed, no wastes are prohibited from dumping, and no fence is around the perimeter. The landfill is located approximately 380 feet from an actively eroding bank along the Yukon River. Trash was observed along the bank for about 100 yards. Some of the waste appeared to be new, and the result of either windblown litter, or illegal dumping. Other waste appeared to be historical waste, eroding directly from the bank. This waste is probably attributed to landfill expansion away from the bank in a NNE direction. The landfill is located approximately 4,500 feet upstream of the village water supply. It is reported that the majority of erosion occurs in the spring when the river breaks up and ice scours the banks.

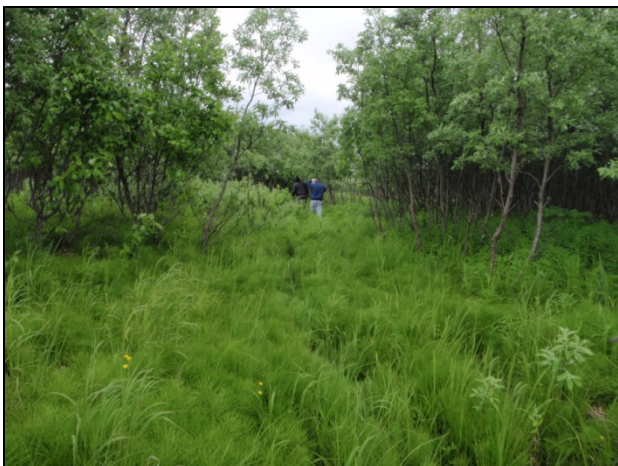
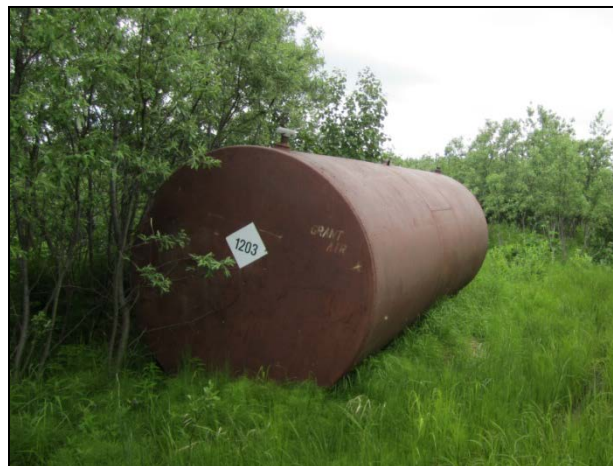
- **Old Emmonak Corp Tank Farm, 62.770248/-164.492964 (Active)** – This is the site of the Emmonak Corporation’s old tank farm. It is an active Contaminated Site (File ID 2413.38.005). The tank farm was decommissioned when the new consolidated tank farm was completed in 2000. The tank farm consisted of seven of the eight tanks located within two adjacent bermed, lined areas. The eighth tank was situated outside the berm on the south side. There was an approximately 300-foot piping run from the former tank farm to the dispenser/pump house located adjacent to the Yukon River. The only remaining tank is an empty 12,000 gallon tank that had been moved from its original location. Soil sampling was completed on this site in 2012 and work is ongoing. It is less than 100 feet from Kaoledoly Slough and is approximately 320 feet from the Yukon River. Marshy lowlands extended out from the bank by about 100 yards.

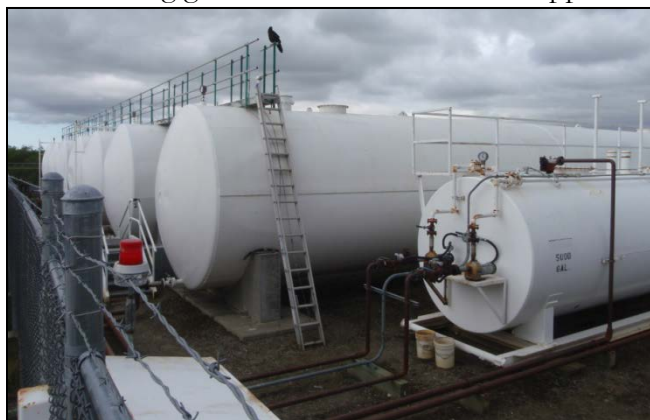
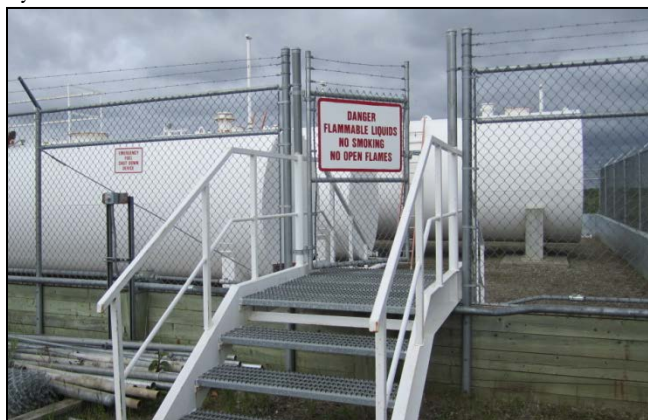
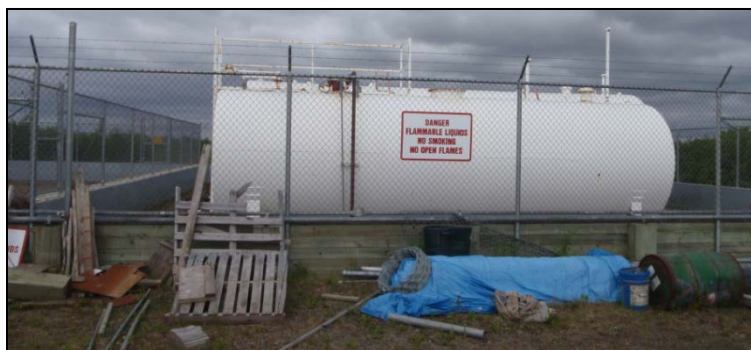
- **Consolidated Tank Farm, 62.776195/-164.517239 (Active)** – The City of Emmonak and the Emmonak Corporation individually own and operate separate storage tanks and distribution systems within this tank farm. It was completed in 2000 and contains a partitioned tank farm with three cells containing eight Corporation tanks and one cell containing three City tanks. It was built on a raised gravel pad above flood level and contains a liner system. A fence with a locking gate was in use. It is located approximately 560 feet from the Yukon River.

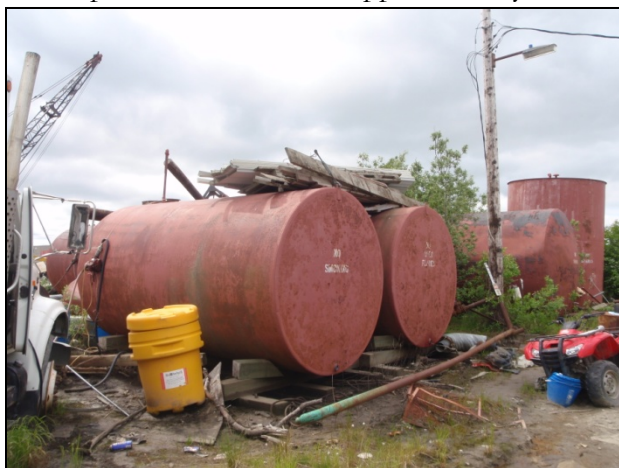
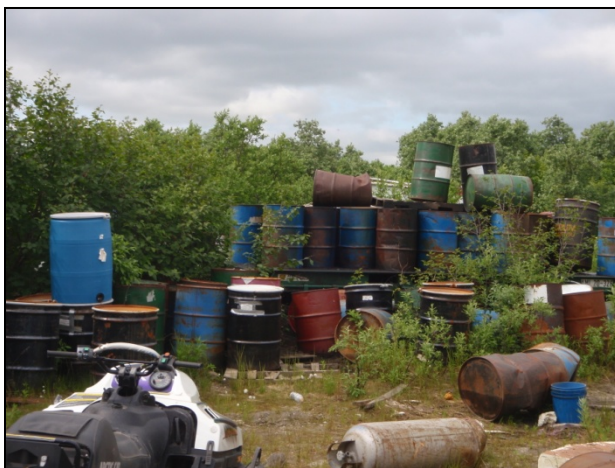
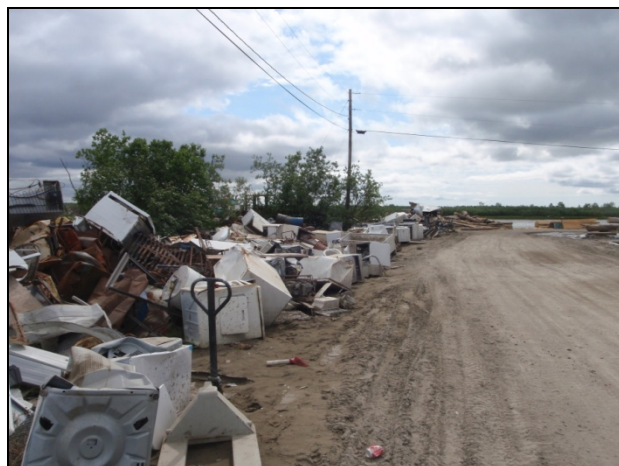
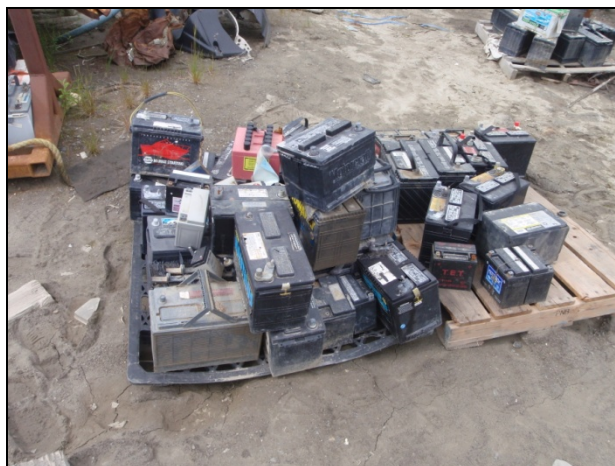
- **City Shop Tank Farm & Boneyard, 62.775457/-164.517608 (Active)** – This active Contaminated Site (File ID 2413.38.008) is the historic City tank farm. The tanks are still present, but not in use due to the new consolidated tank farm completed in 2000. This site is located between the airport and the village. The boneyard portion of the site is approximately two acres and contains: vehicles, old tanks, broken heavy equipment, lead acid batteries, appliances, and drums. Leaking oil and distressed vegetation was witnessed during the inspection. It is located approximately 125 feet from the Yukon River.

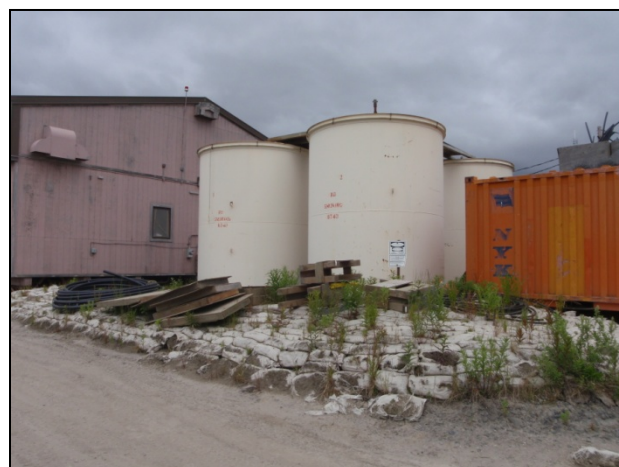
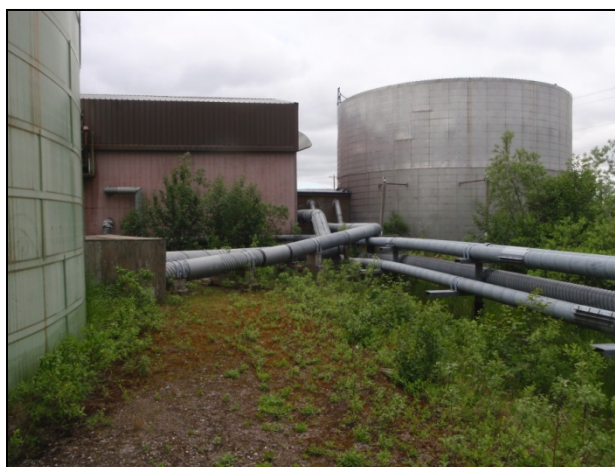
- **City Tank Farm, 62.777583/-164.531303 (Active)** – The tanks appeared in good condition with secondary containment and no evidence of leaks or spills. There are four large fuel tanks and two very large, water tanks located on the site. This site is adjacent to the AVEC tank farm. The City Tank Farm is located approximately 650 feet from the bank of the Yukon River.

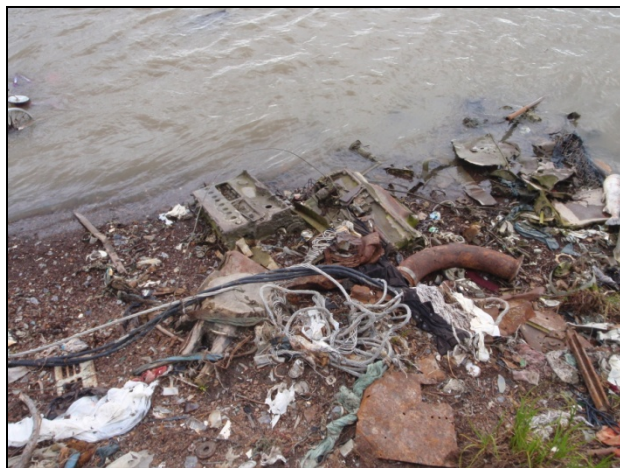
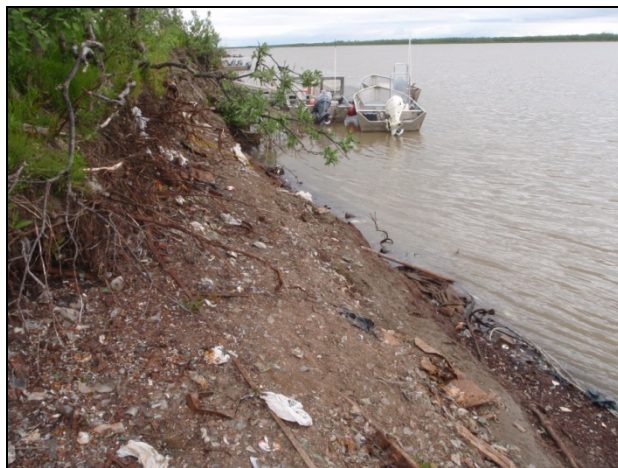
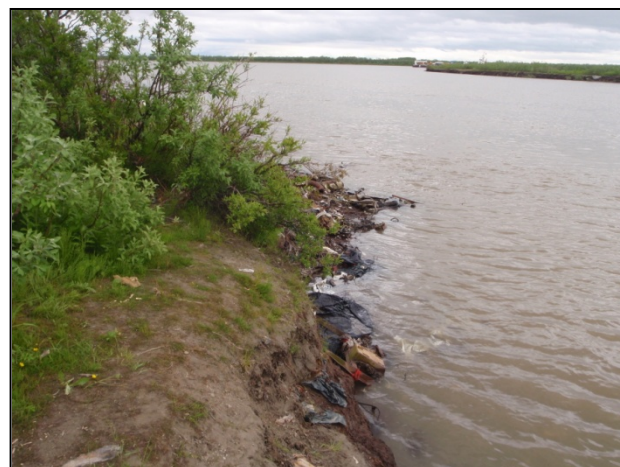
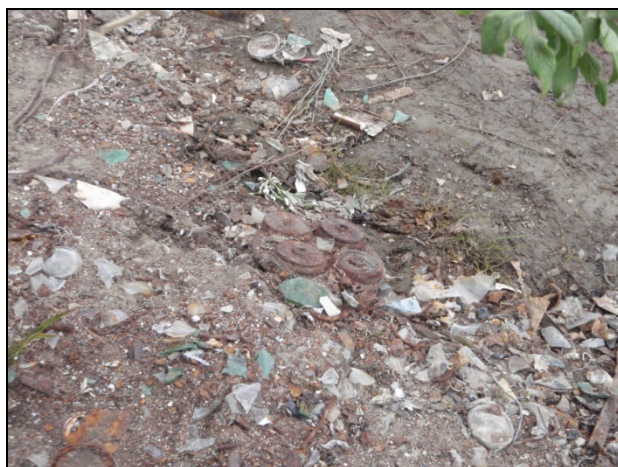
- **Old AC Dump, 62.777500/-164.546800 (Abandoned)** – This site is located directly behind the old AC Store. It appears to be historic and consists of trash buried from the AC store over a period of years. Historic scrap metal and plastics noted as well as recent dumping evident by a fish carcass and a bicycle. This site is an active boat launch area and is actively eroding into the Yukon River.

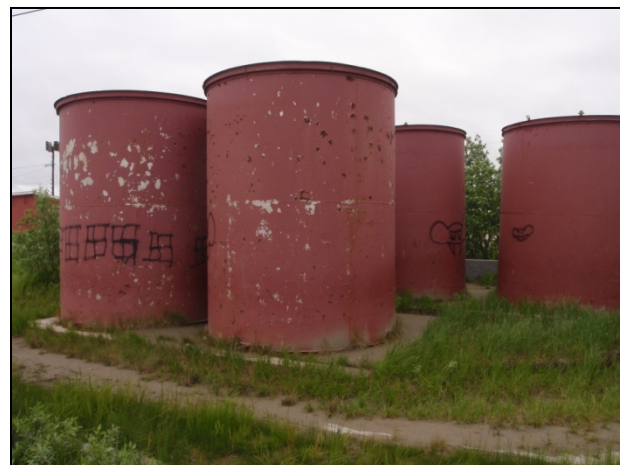
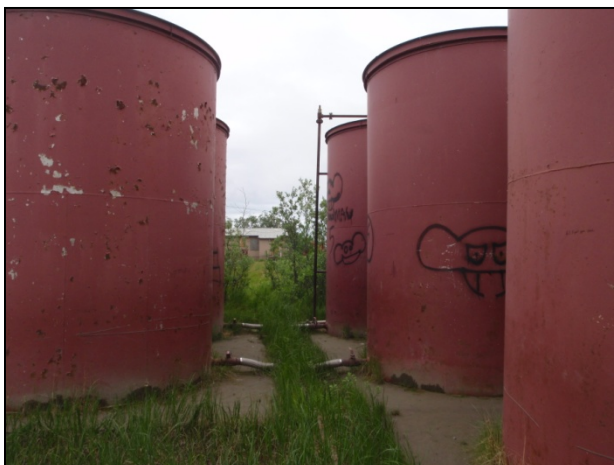
- **Old BIA School Tank Farm, 62.777268/-164.530568 (Active)** – This old BIA school tank farm is an active Contaminated Site (File ID 2413.38.006). It consists of five vertical fuel tanks on wooden platforms in an unfenced area. The tanks are still in use by the new school. The tanks are located in the middle of the village and are frequented by village youths as they are 20 feet from the village basketball court. This site is located approximately 550 feet from the banks of the Yukon River.

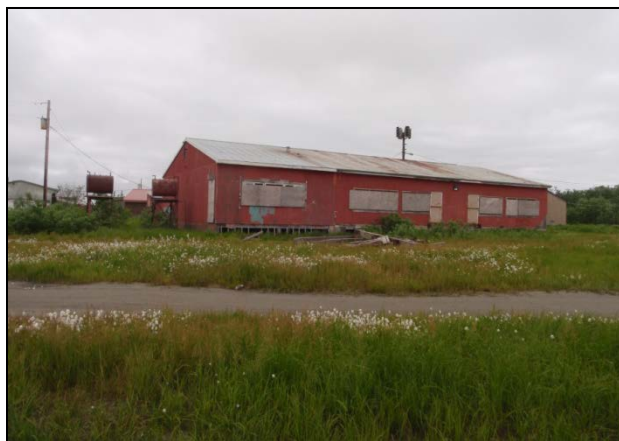
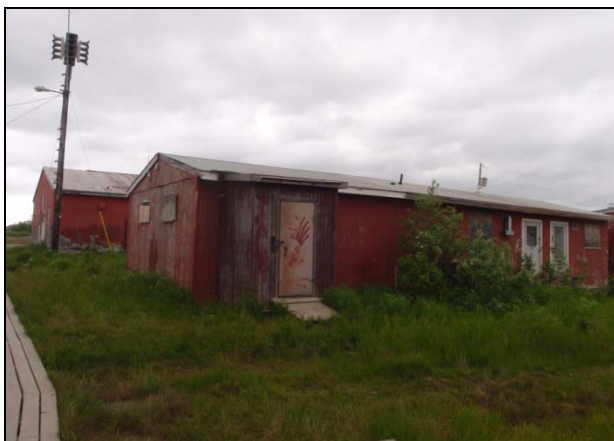
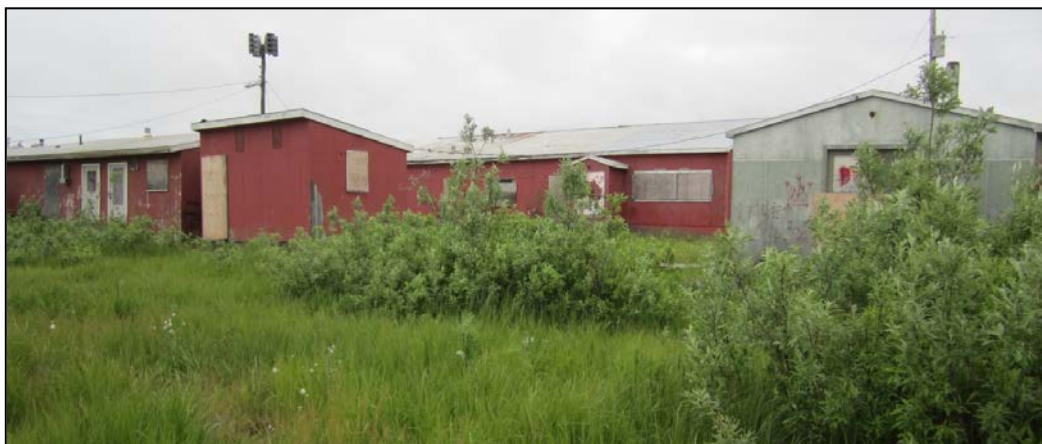
- **Old BIA School, 62.776944/-164.531111 (Active)** – The old BIA school is a Brownfield site under the Contaminated Sites Program (File ID 2413.57.001). An Environmental Management Plan was completed in 2011. Limited testing of the buildings indicated there was asbestos in some structures, but no lead-based paint was found in the samples collected. However, this testing was not intended as a full hazardous materials inspection. This site is located approximately 350 feet from the banks of the Yukon River.

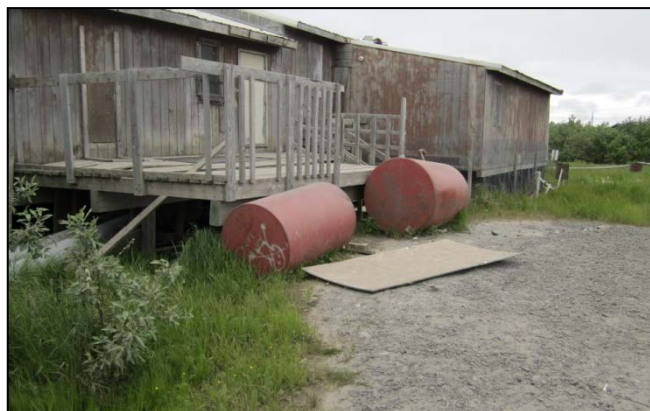
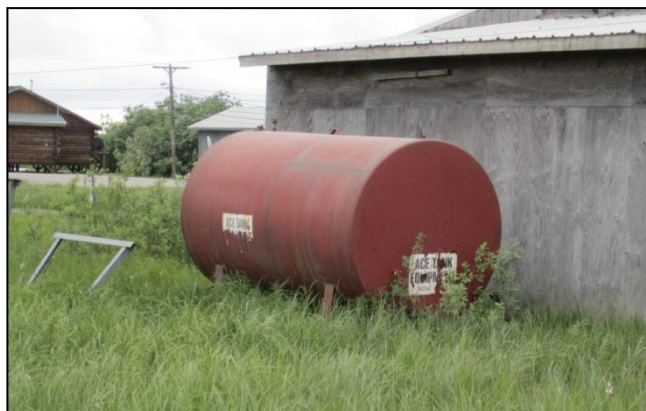
- **Washeteria, 62.777269/-164.528573 (Active)** – The Washeteria is an active Contaminated Site (File ID 2413.38.001). In 1994 a pipeline spill at the washeteria tank farm was first identified and reported. During a 2000 limited site investigation, only one of two tanks was observed at the site. As of July 9, 2012, the washeteria building appeared abandoned. Two unknown tanks were observed leaning against the front porch and one of the original tanks (observed in 2000) remains on the side of the building at the former tank farm area. This site is located approximately 530 feet from the banks of the Yukon River.

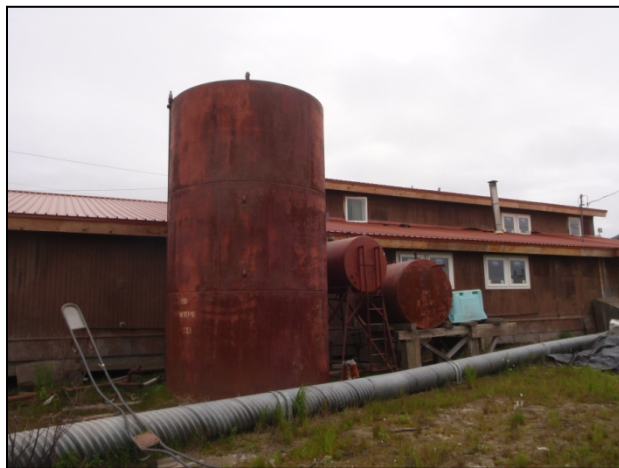
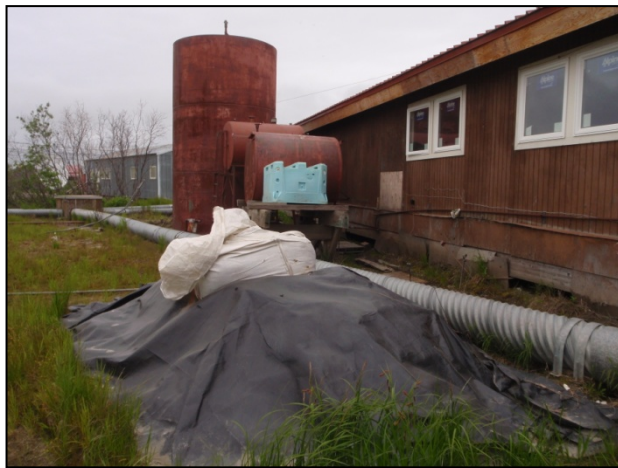
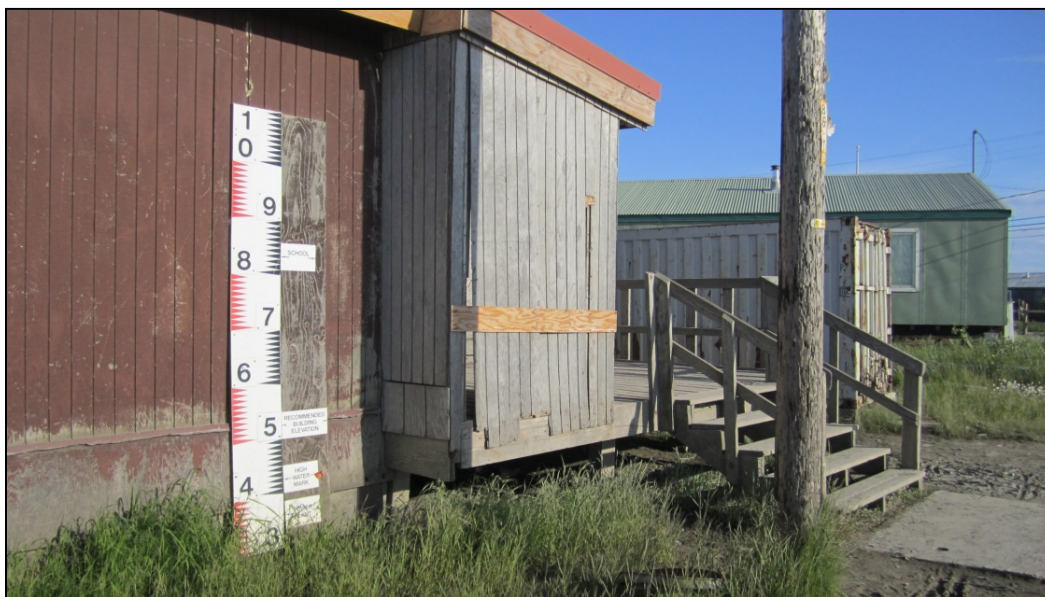
- **City Hotel/Office Tank Farm, 62.776933/-164.530038 (Active)** – The City Hotel/Office is an active Contaminated Site (File ID 2413.38.007) due to petroleum releases first encountered in 1997. In 2000, a soil sample collected contained petroleum contamination above ADEC cleanup levels. As of July 9, 2012, fuel tanks were present and appeared to be in use. A high water spring flooding mark of 4 feet above ground surface was noted marked on the side of the office building. Additionally, a new covered stockpile was noted on site. The stockpile was generated during cleanup of a separate 2011 spill event that is currently being managed by the ADEC Prevention and Emergency Response Program (PERP) known as: Emmonak Office Complex 2011. This site is located approximately 350 feet from the banks of the Yukon River.
