Alaska Department of Environmental Conservation (ADEC) Solid Waste Program (Stephen Price and David Carlson) conducted a Coastal Impact Assistance Program (CIAP), Waste Erosion Assessment and Review (WEAR) site visit for Hooper Bay on July 7th, 2014. The following narrative is a brief description of our findings during the July inspection.

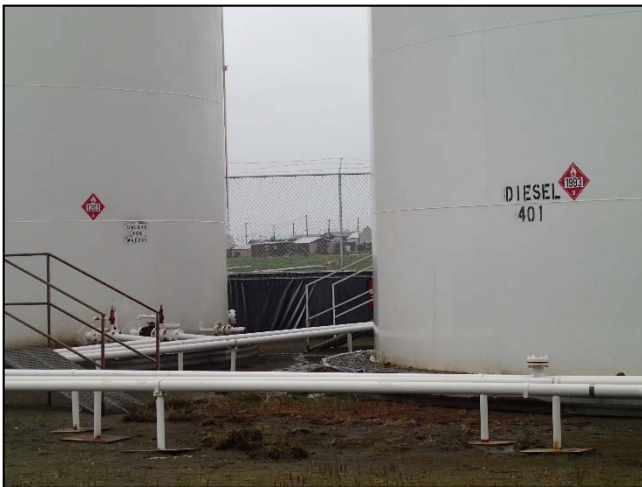
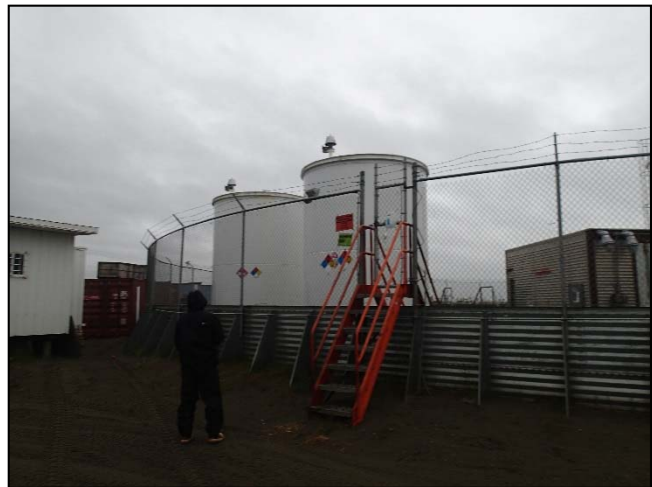
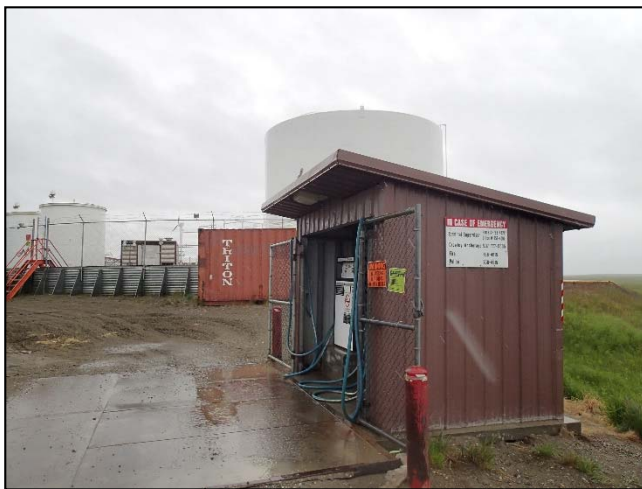
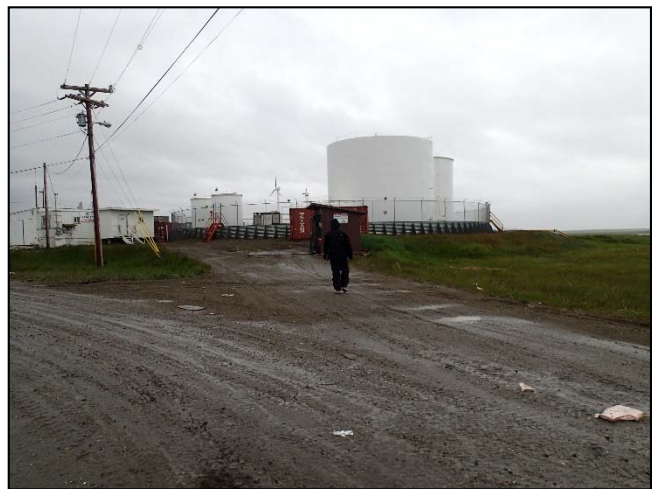
- **Crowley Tank Farm, 61.533954/-166.100955 (Active)** – This site is located just before the entrance to the landfill and sewage lagoon. It is operated by Crowley Fuel Services and is owned by the City of Dillingham. There are a total of 5 fuel tanks with diesel and gasoline with a total capacity of 406,000 gallons. These tanks have been in service since the early 2000's. The tank farm is fully fenced inside a round, steel corrugated secondary containment wall. There were no signs of leaks or stressed vegetation. There is also a community fueling station located outside the fenced tank farm area. The tanks are located 300 feet from the landfill and 1,800 feet from the nearest river.

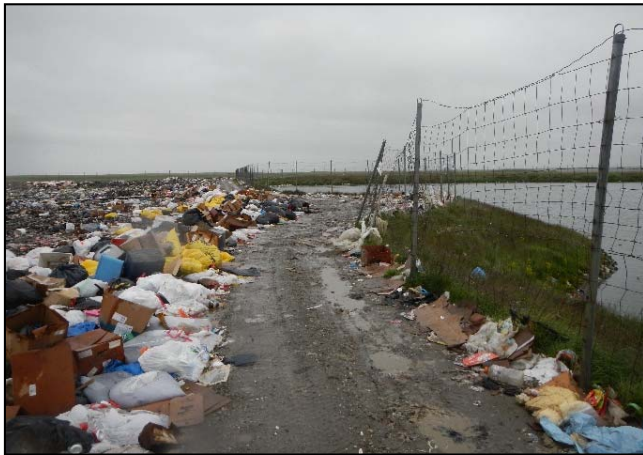
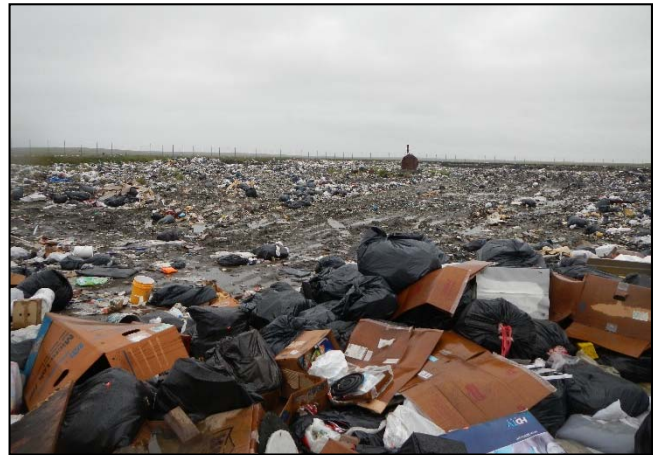
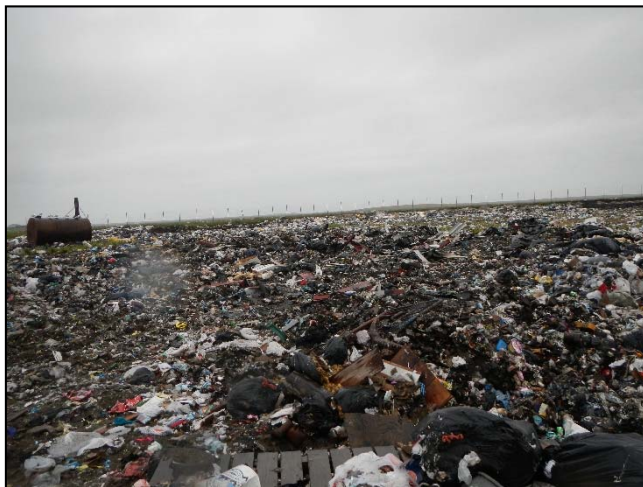
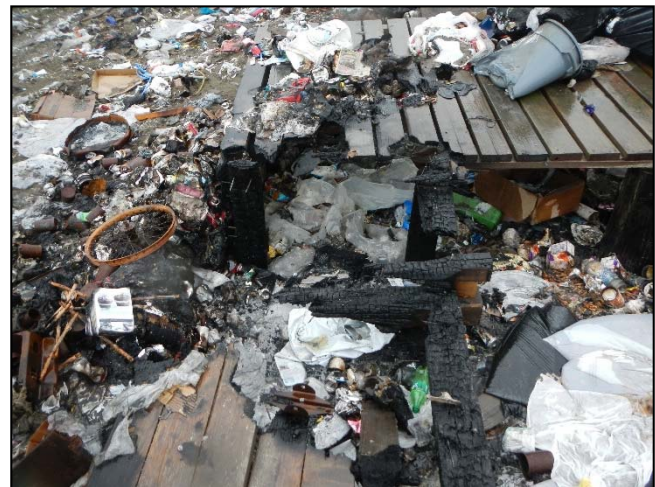
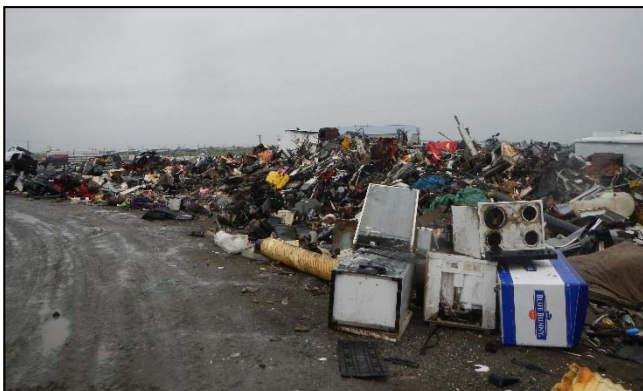
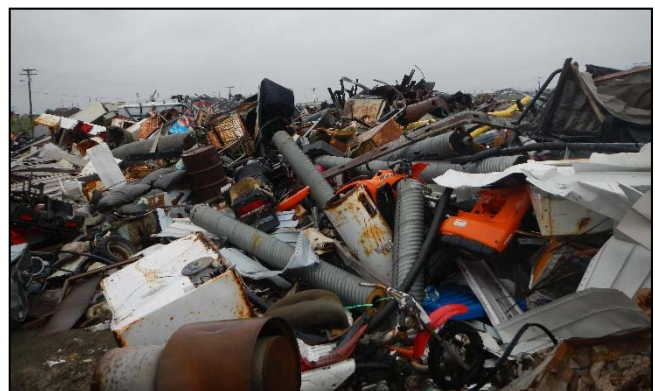
- **Landfill, 61.53553/-166.10176 (Active)** — The landfill is located next to the sewage lagoon at the north end of town. This unpermitted, 5 acre landfill is operated as an area-fill by the City of Hooper Bay. It accepts municipal waste, honeybucket waste, and construction and demolition debris. The landfill is fully fenced, but the gates remain open for self-haul. Half of the town is not connected to water or sewer, so the landfill receives honeybucket waste. Honeybucket waste is self-hauled to the landfill and disposed of wherever is most convenient. This waste is intermingled with other wastes. Birds and dogs rummage through the landfill. The burn unit is not used because intermingled waste blocks all paths to it. Open burning occurs at the landfill, and the boardwalk within the landfill has caught on fire previously. There is currently a Landfill Operator hired for waste collection and managing the landfill; however there is no heavy equipment to manage it. There is a 1.4 acre metals pile located outside the landfill fencing. The landfill is located approximately 1,000 feet from a subsistence area and 2,200 feet from the closest river.

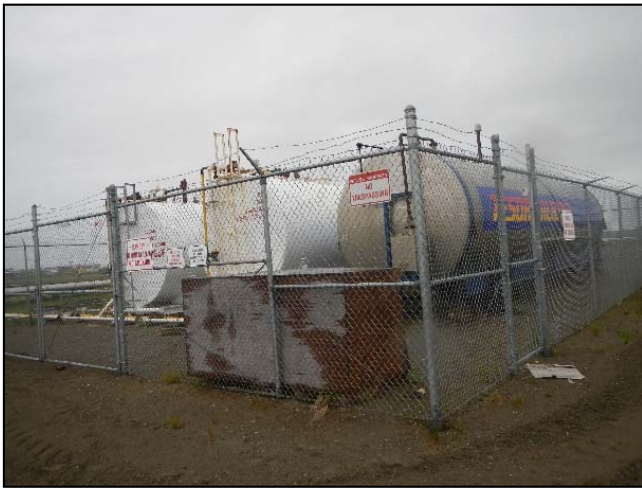
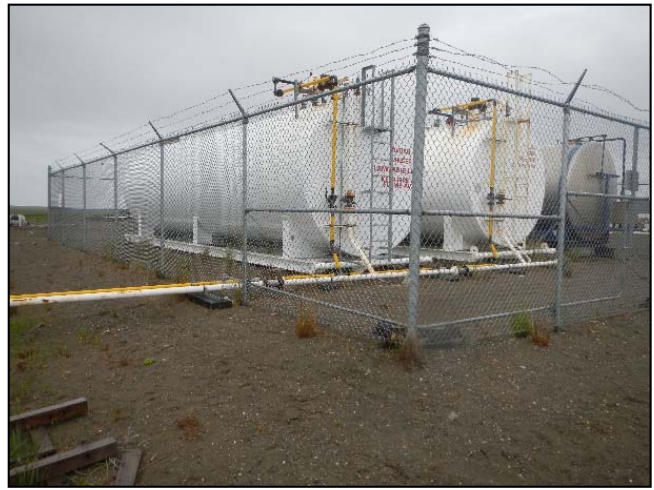
- **City Tank Farm, 61.533116/-166.102427 (Active)** – This site is located adjacent from Crowley Tank Farm. The tank farm was constructed in 2010 and is owned by the City of Dillingham. There are three tanks in total each with a capacity of 27,000 gallons. There is no visible secondary containment for the site. Each tank is mounted on skids which are supported on wooden blocks within a fenced area. There were no signs of leaks or stressed vegetation. The tanks are 2,000 feet from the closest river.

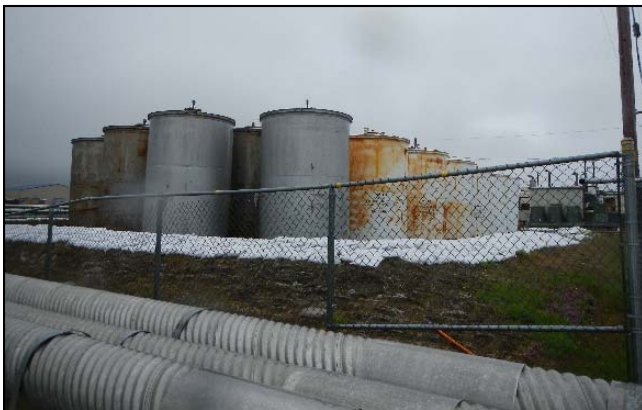
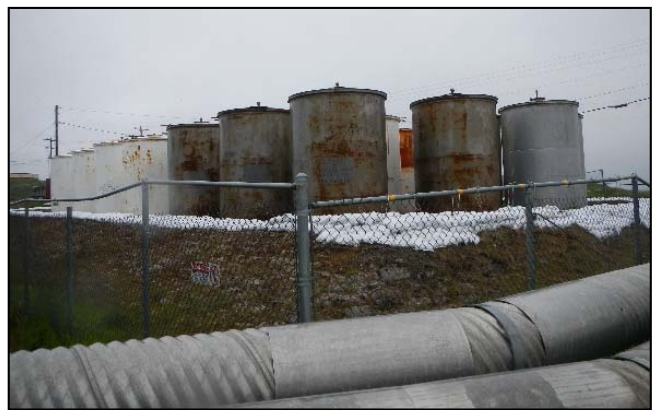
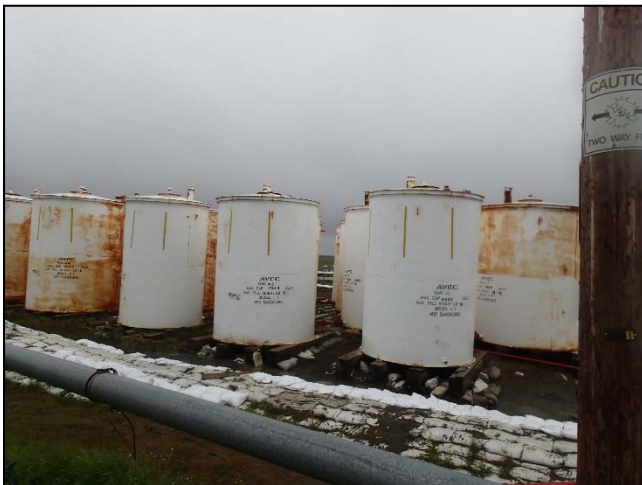
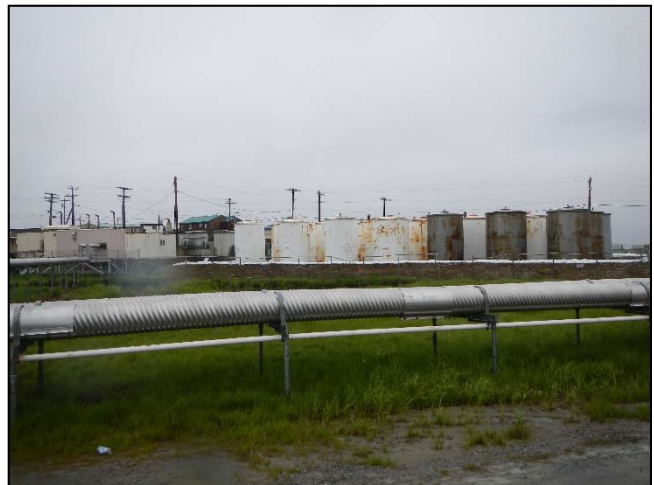
- **AVEC Tank Farm, 61.530657/-166.102344 (Active)** – This site is centrally located within the town. The AVEC tank farm has been in use since the 1970s. This site includes 27 vertical tanks with a total capacity of 211,644 gallons of diesel. Each tank is supported on timbers. The tank farm is fully fenced and has an earthen berm of sandbags surrounding the tanks. New sandbags had recently been added to the berm. It was reported that flooding reaches all the way to the tank farm, but has not exceeded the berm around the tanks. It is 8,400 feet from an eroding area.

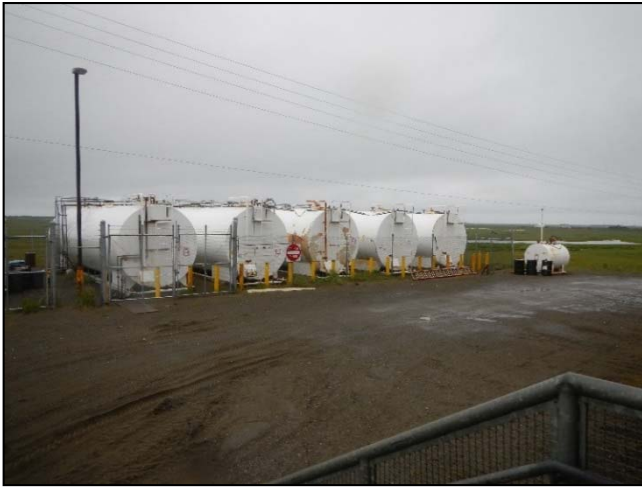
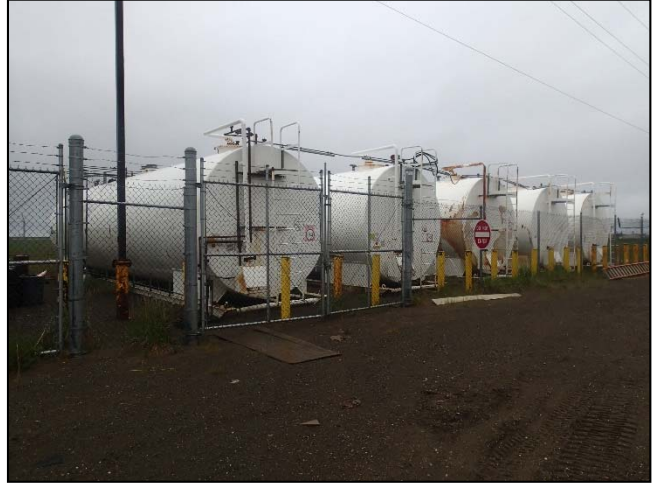
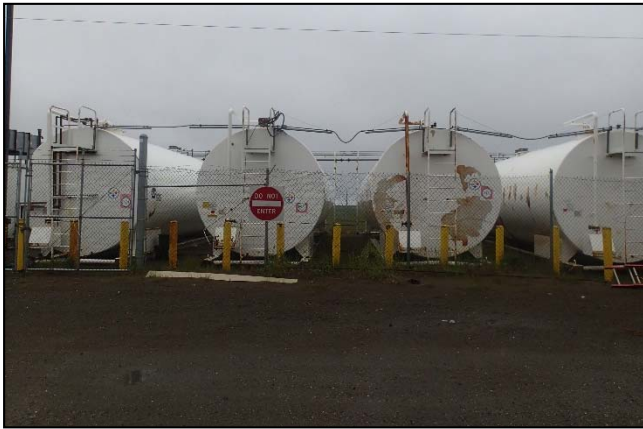
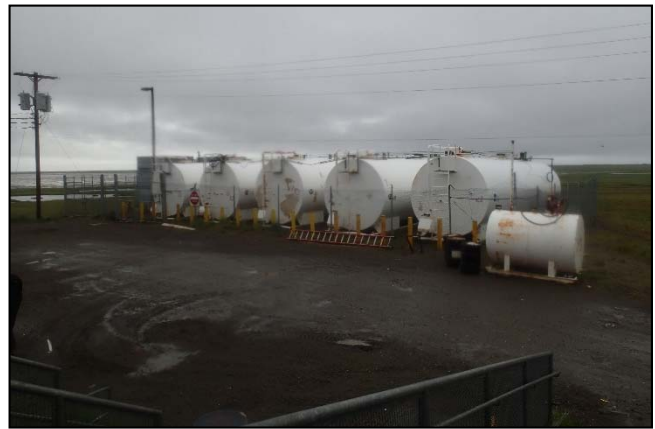
- **School Tank Farm, 61.521347/-166.097495 (Active)** – This site is located at the southernmost point in town, just off of Hooper Bay. The new school and tanks were built in 2005. The tank farm is fully fenced and is owned by the Lower Yukon School District. It consists of five, 27,000 gallon tanks for a total capacity of 135,000 gallons. There is no visible secondary containment for this site. The school tanks are located 55 feet from the school and 900 feet from Hooper Bay.

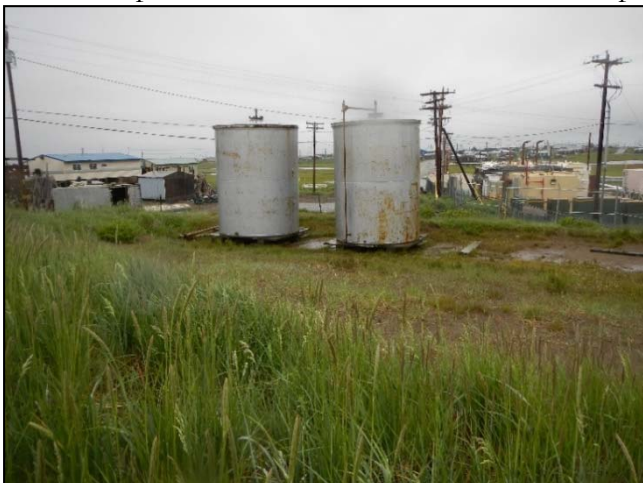
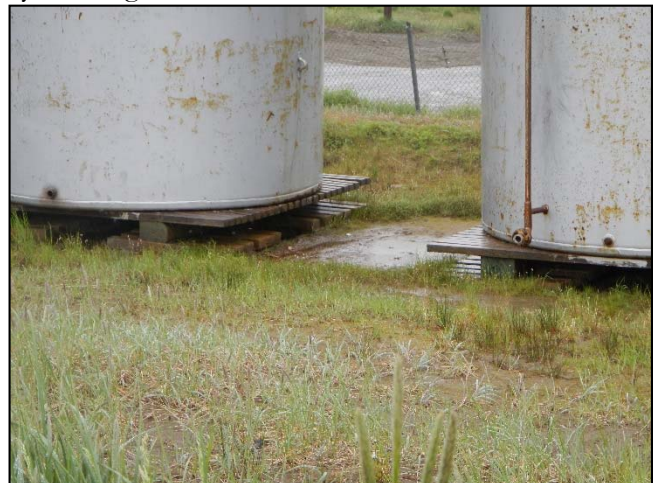
- **Former School Tank Farm, 61.531217/-166.100971 (Abandoned)** – This former tank farm is located across from the AVEC tank farm in the parking lot near the store. It is the tank farm for the old school and was in operation from the 1970s-2005 when the new school and new tank farm were constructed. It originally contained 12 fuel tanks. This site currently contains two inactive fuel tanks. Each tank is approximately 8,000 gallon capacity. The tanks have no fence and are in the open. The tanks are disconnected, empty and are raised off of the ground on wooden pallets. There is no visible secondary containment; however, a small earthen berm is present. This site is 1,100 feet from Napareayak Slough.
