# PEDERSON HILL CREEK WATER QUALITY MONITORING

JULY 2, 2012 – JUNE 30, 2013

This Final Report was prepared for the Alaska Department of Environmental Conservation as part of the Alaska Clean Water Actions Grant # ACWA 13-07 (FY13).

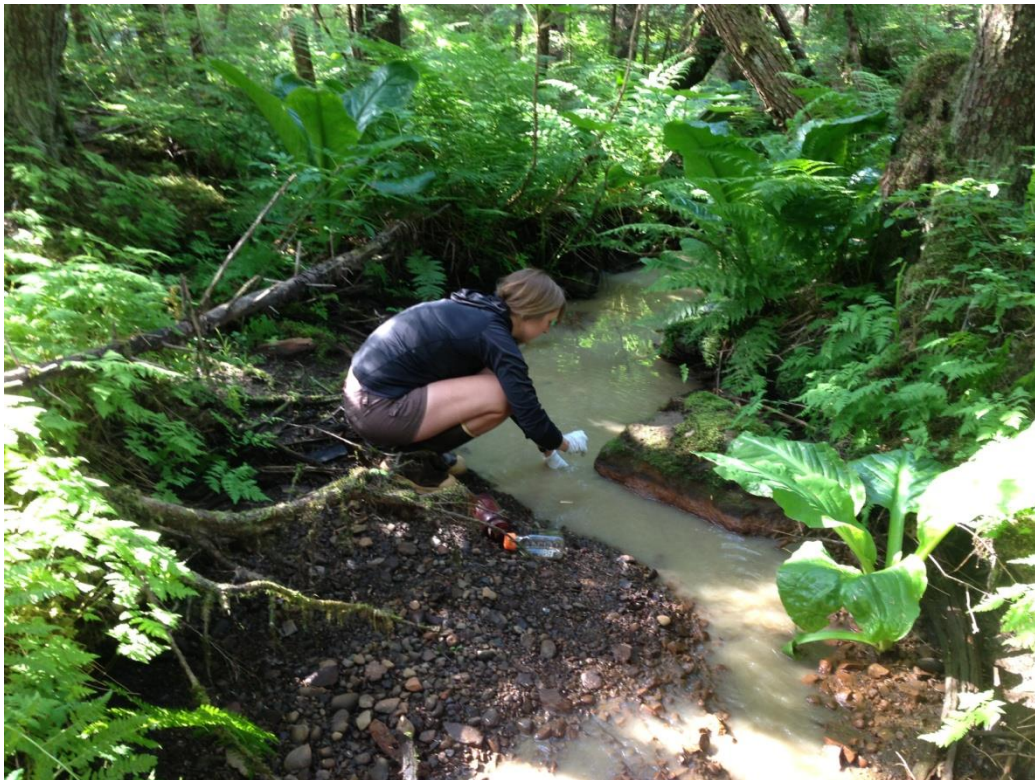
Solids values for Pederson Hill Creek generally stayed consistently low throughout the sampling project, with the exception of one outlying sampling event. During the sample collection on June 24, 2013 the water at site PHC-2 was visibly turbid and cloudy with sediment, which was not the normal condition of the stream. The turbid water can be seen in Figure 2 below.

*Figure 2: Abnormally turbid water present during sample collection at site PHC-2.*

This visual observation was later confirmed with the turbidity and TSS results, which were both significantly higher than their normal values. These anomalies can be seen in Figure 5 and 6 of the appendix. After a discussion of these results with the DEC project manager and her communication with

several other DEC departments, it was later determined that a water truck had been brought in to a large construction site that was immediately upstream of and adjacent to Pederson Hill Creek. The water truck was increasing water flow as well as the amount of solids that were eroding and discharging into the stream. Two days later during the next sample collection on June 26, 2013 the turbidity and TSS values were back to normal background levels.

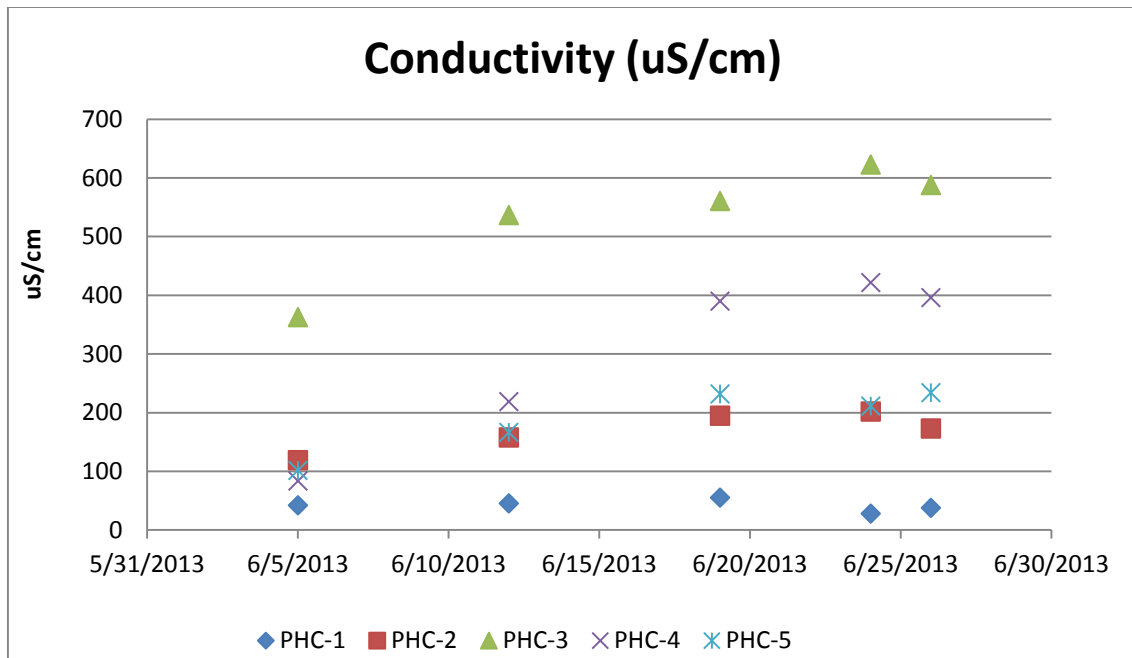
Figure 3: Conductivity values from Pederson Hill Creek water quality monitoring during June 2013.

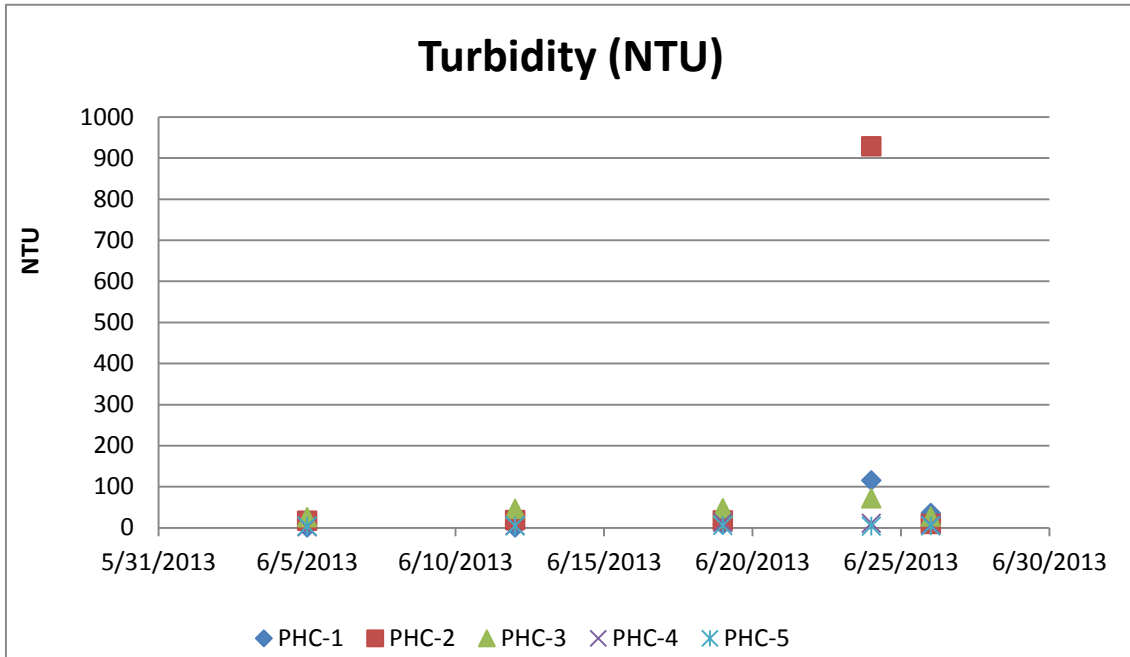
Figure 5: Turbidity values from Pederson Hill Creek water quality monitoring during June 2013, with outlying turbidity value displayed from site PHC-2.

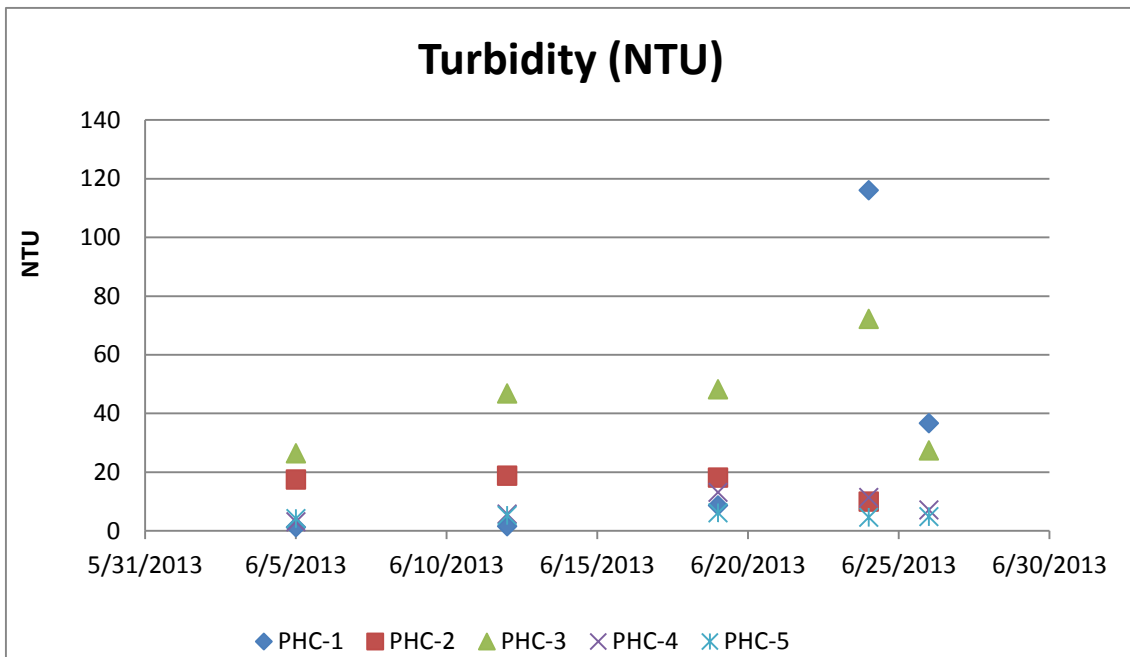
Figure 6: Turbidity values from Pederson Hill Creek water quality monitoring during June 2013, with outlying turbidity value from PHC-2 sampled 6/24/13 removed.

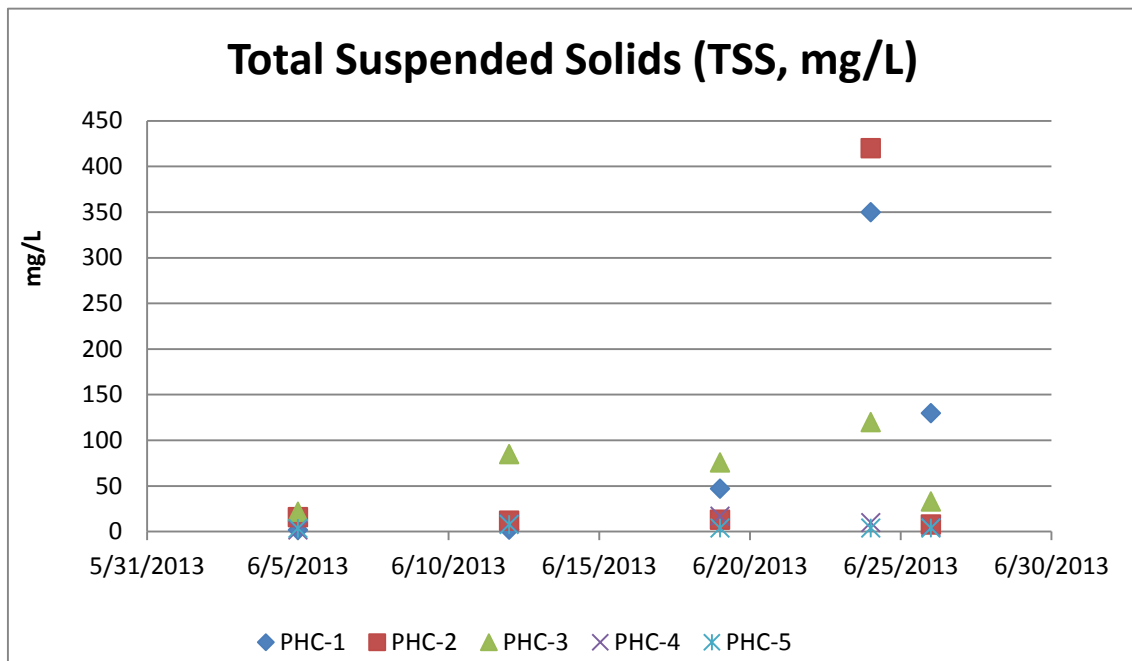
Figure 7: Total Suspended Solids (TSS) values from Pederson Hill Creek water quality monitoring during June 2013, with outlying turbidity values displayed from site PHC-1 and PHC-2 sampled 6/24/13.

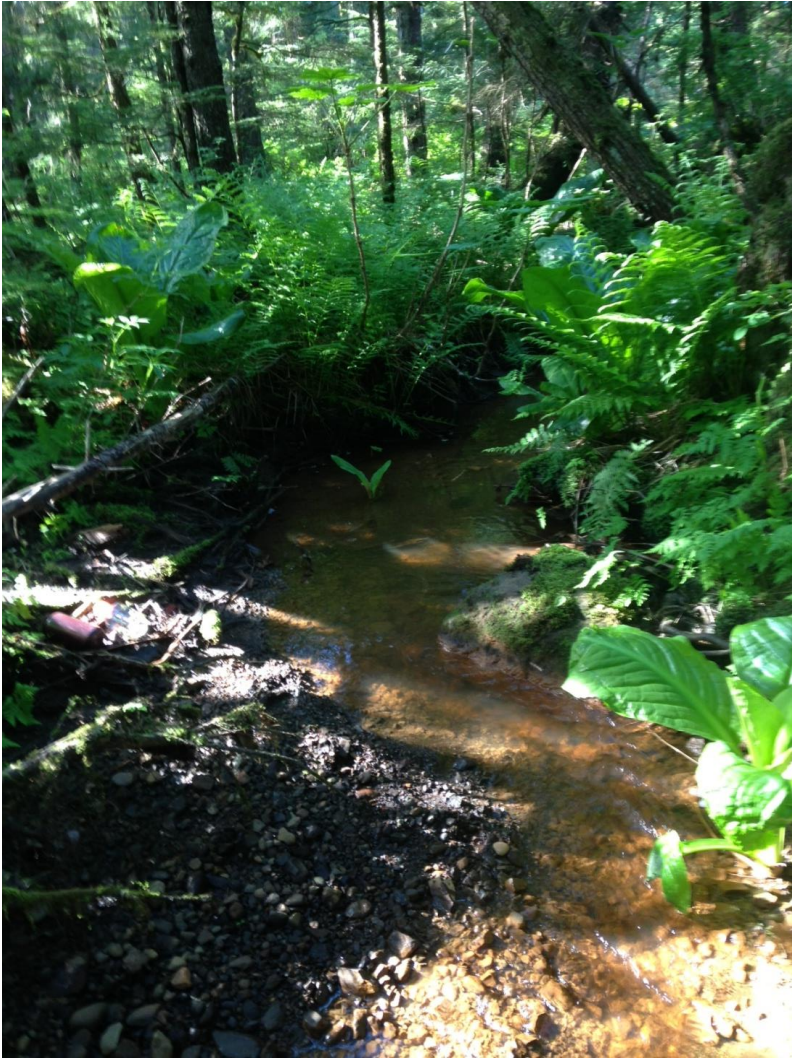
*Photo 1: Site PHC-2 of the Pederson Hill Creek water quality monitoring project during June 2013, looking downstream from the sampling site.*

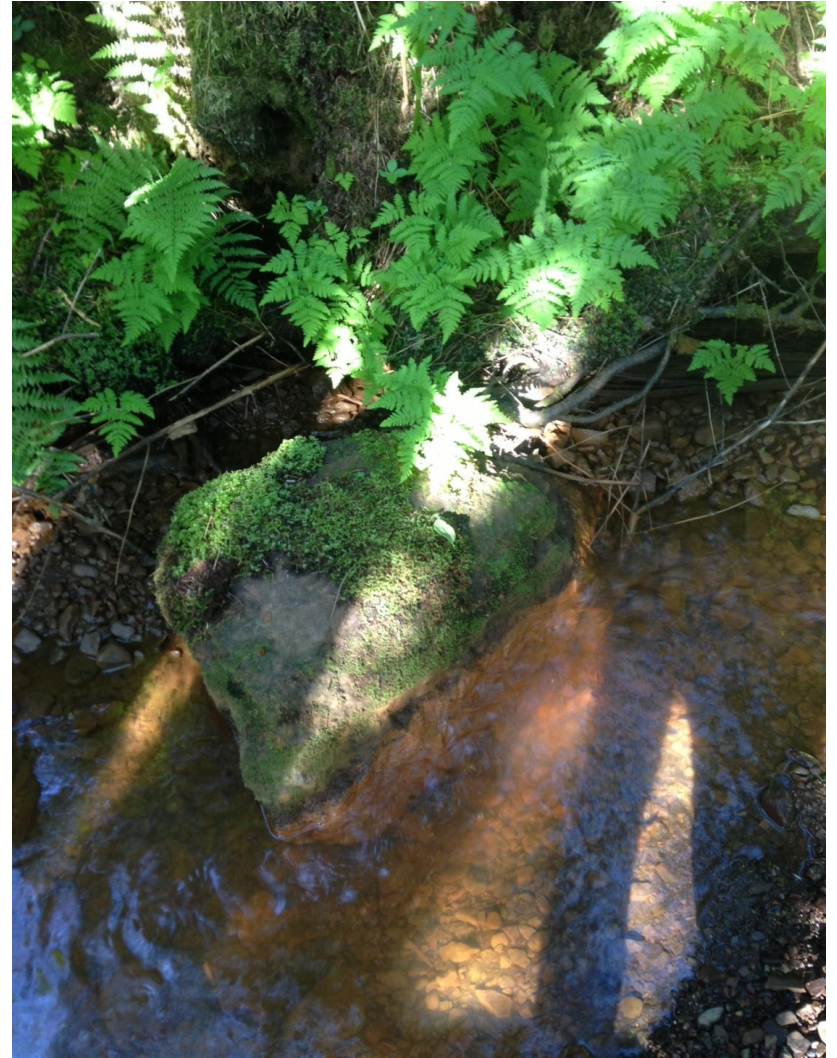
*Photo 2: Site PHC-2 of the Pederson Hill Creek water quality monitoring project during June 2013, looking directly at sampling site.*

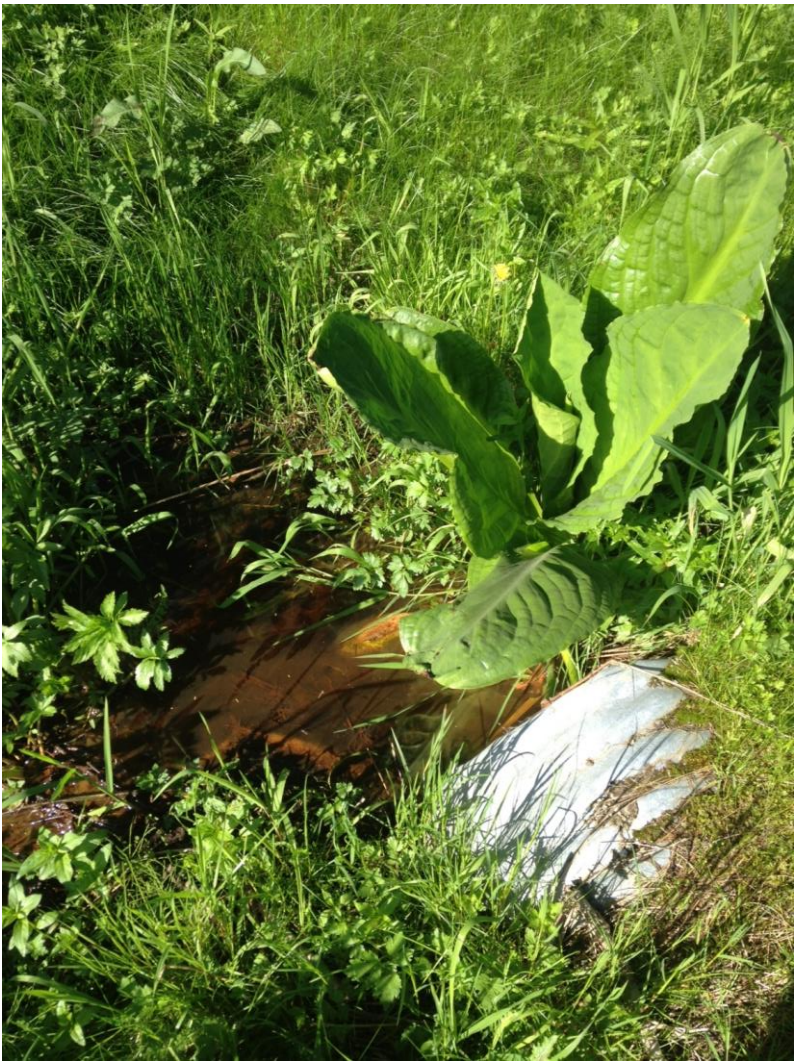
*Photo 3: Site PHC-3 of the Pederson Hill Creek water quality monitoring project during June 2013, looking directly at sampling site.*

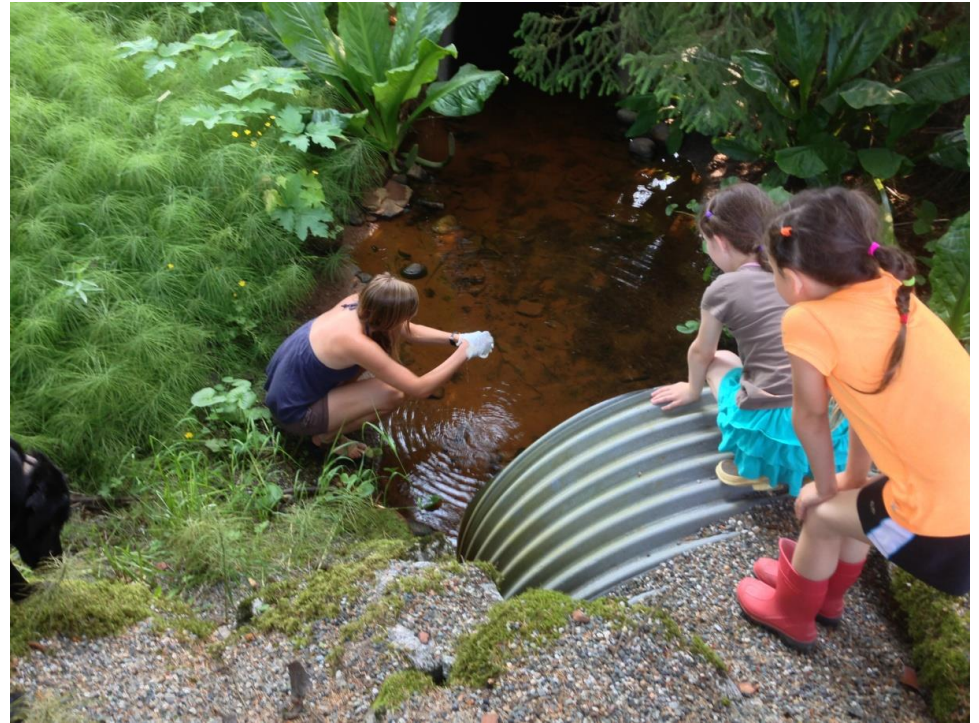
*Photo 4: Site PHC-4 of the Pederson Hill Creek water quality monitoring project during June 2013.*

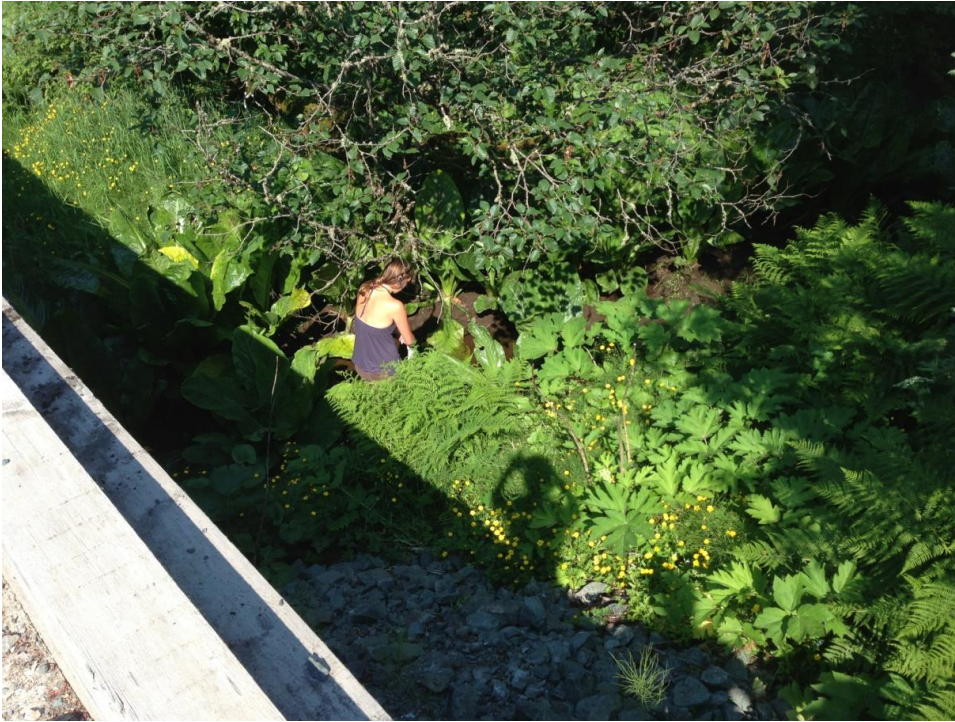
*Photo 5: Site PHC-5 of the Pederson Hill Creek water quality monitoring project during June 2013.*

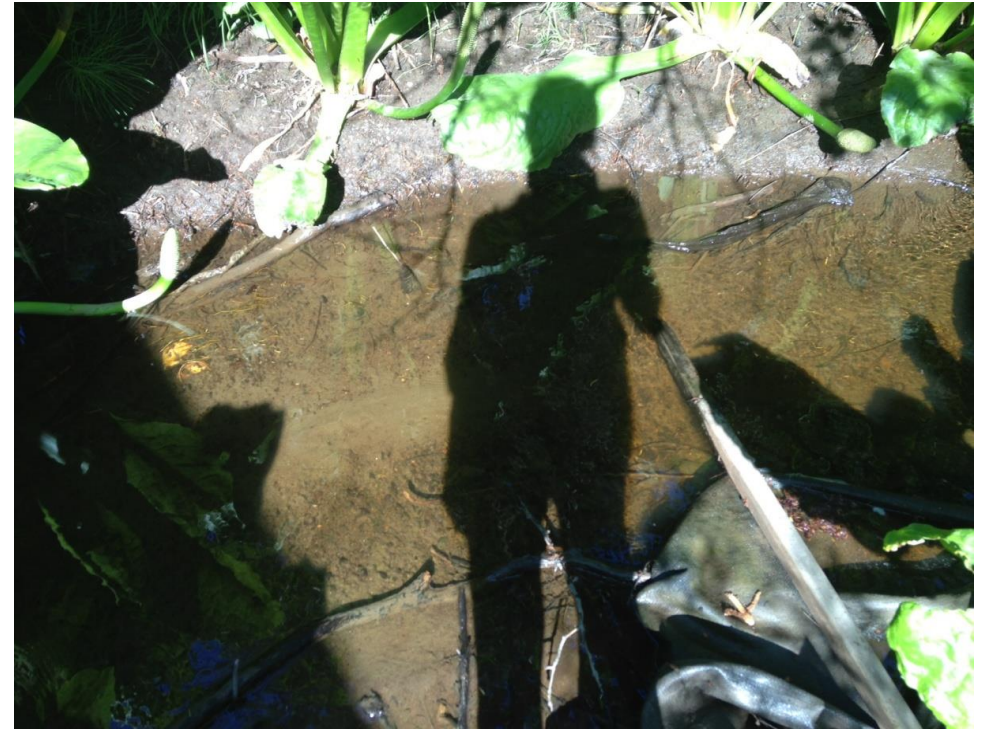
*Photo 6: Site PHC-5 of the Pederson Hill Creek water quality monitoring project during June 2013, looking directly at the sampling location.*
