CIAP WEAR Trip Report
King Cove (population 934)
August 6, 2014

Alaska Department of Environmental Conservation (ADEC) Solid Waste Program (Doug Huntman and Kym Bronson) conducted a Coastal Impact Assistance Program (CIAP), Waste Erosion Assessment and Review (WEAR) site visit for King Cove on August 6th, 2014. The following narrative is a brief description of our findings during the August inspection.

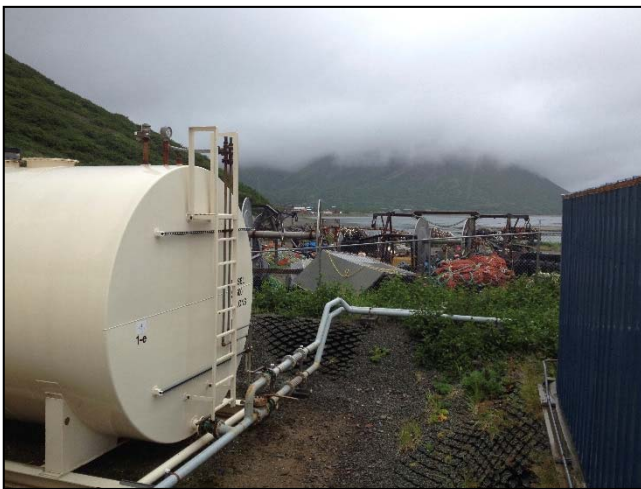
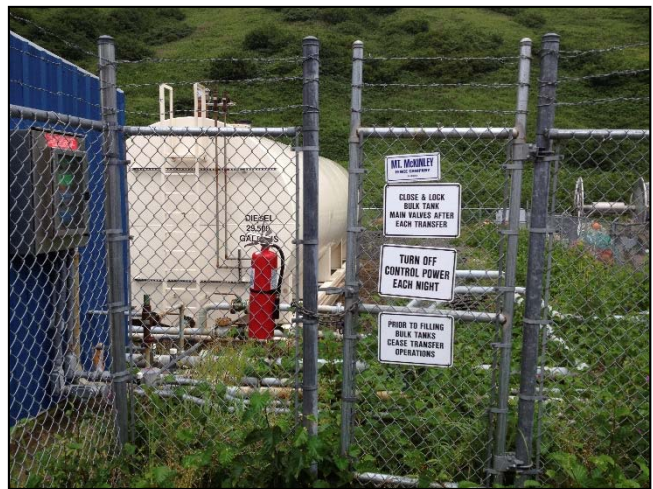
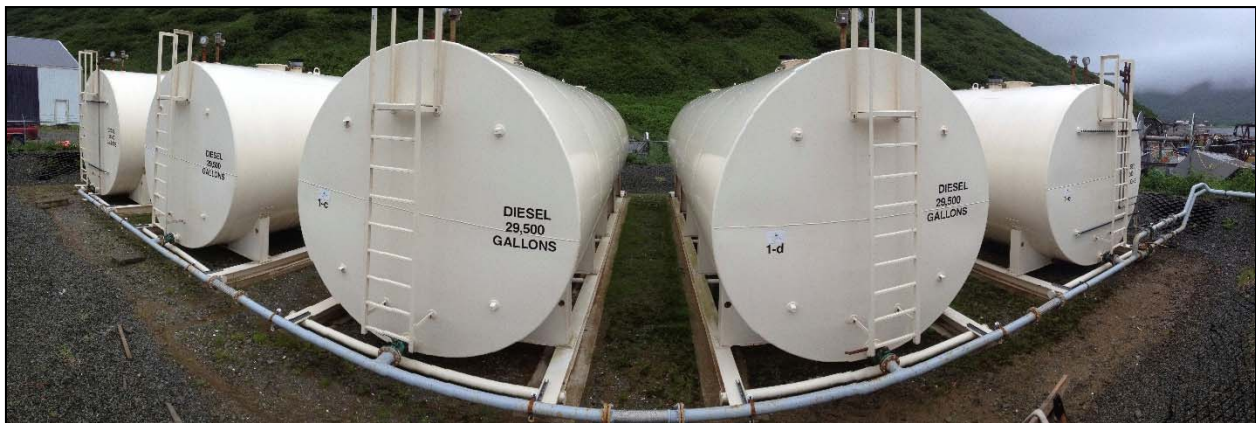
- **City Tank Farm, 55.060258/-162.329035 (Active)** – This tank farm is owned and operated by the City of King Cove. This tank farm has been in place since around the 1990s, but it was upgraded in 2007 through a Denali Commission project. The site includes five horizontal diesel tanks with a 29,500 gallon capacity for a total of 147,500 gallons. The tanks had secondary containment and a geotextile fabric liner. The tank area was fully fenced and had locked gates. There were no signs of stressed vegetation nearby. This site is 150 feet from King Cove Lagoon, which is not eroding. There was not a significant source of erosion nearby, but the tanks are at risk of tsunamis.

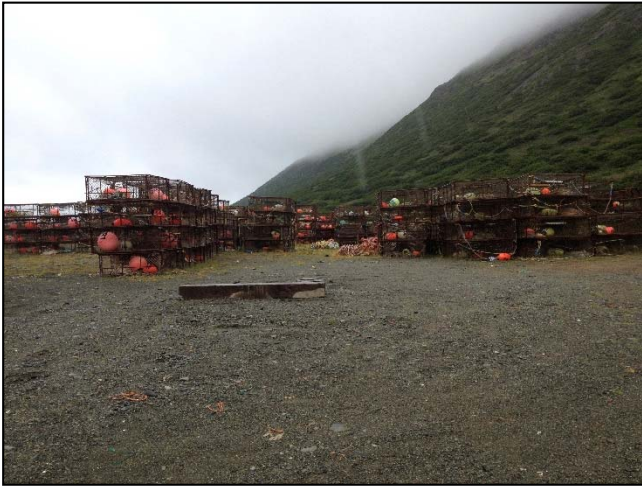
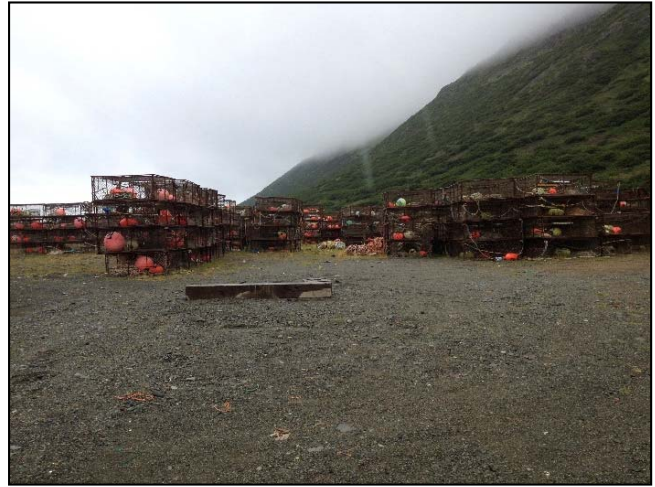
- **Old Landfill, 55.056079/-162.328445 (Retired)** – This site is located just over 100 feet from the King Cove small boat harbor. The landfill was used throughout the 1970’s – 1988. It accepted municipal waste and construction and demolition debris. It is currently covered with no exposed waste. The old landfill area is now owned by Peter Pan Seafood and used as a crab pot storage area. There were no signs of stressed vegetation or erosion. This area is 250 feet from King Cove water body and is at risk of tsunamis.

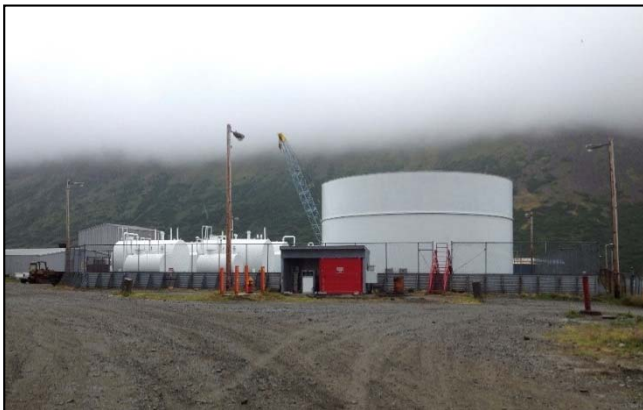
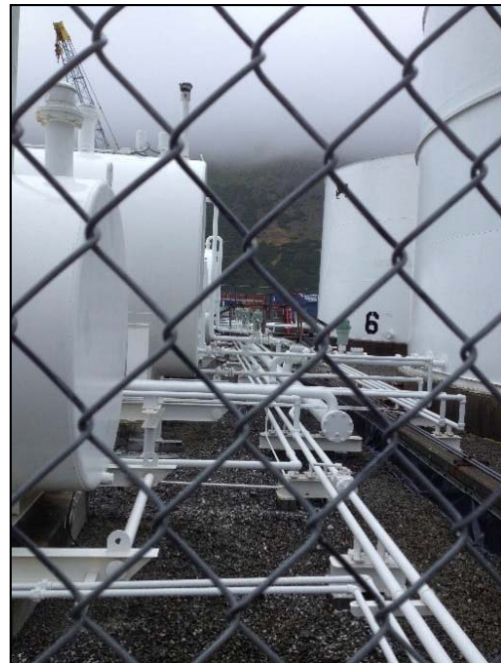
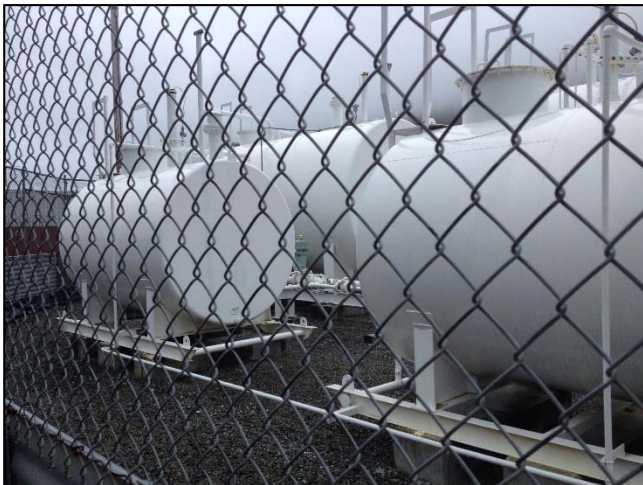
- **Peter Pan Tank Farm, 55.061370/-162.319840 (Active)** — This site is the Peter Pan Seafood Tank Farm. The tank farm is fully fenced with secondary containment, and a steel dike enclosing the perimeter. It includes two very large vertical tanks and eight medium size horizontal tanks comparable to the City Tank Farm. It has unknown capacity of diesel and gasoline and serves as the community fueling station. This tank farm was reported to have opened around fifteen years ago in 2000 and can be seen per DCRA imagery in 2002. There were no signs of stressed vegetation or erosion nearby. It is 200 feet from King Cove Lagoon.

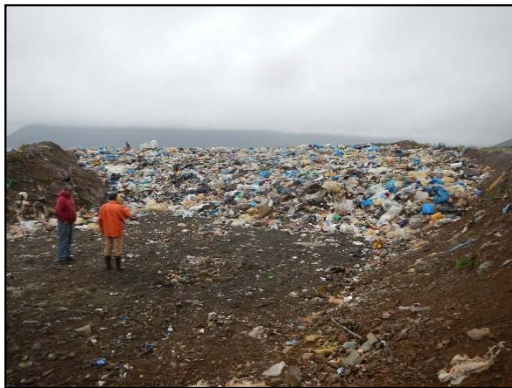
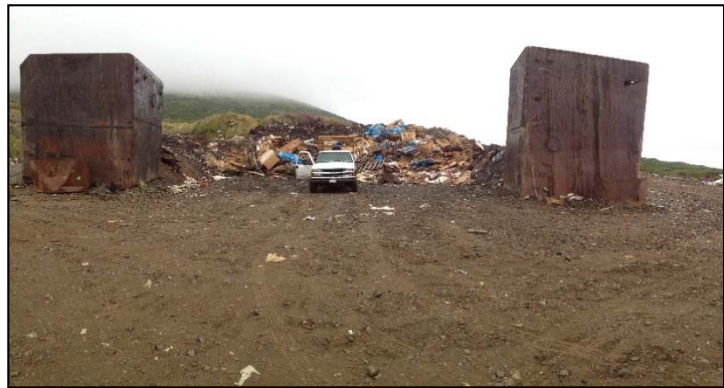
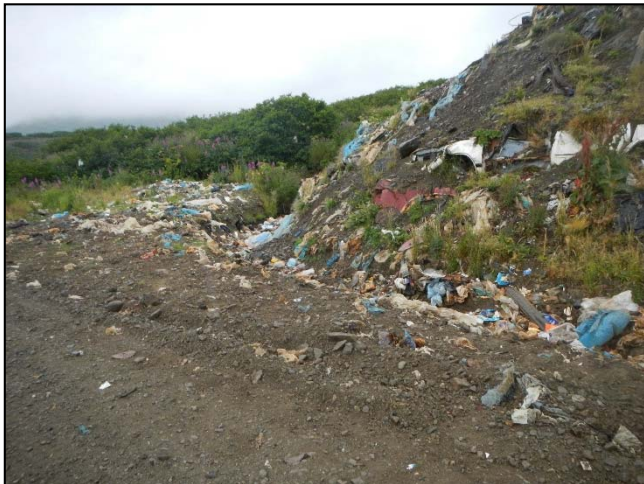
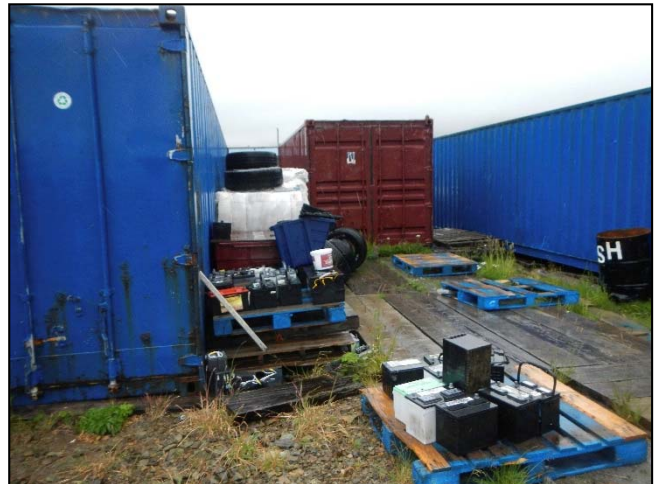
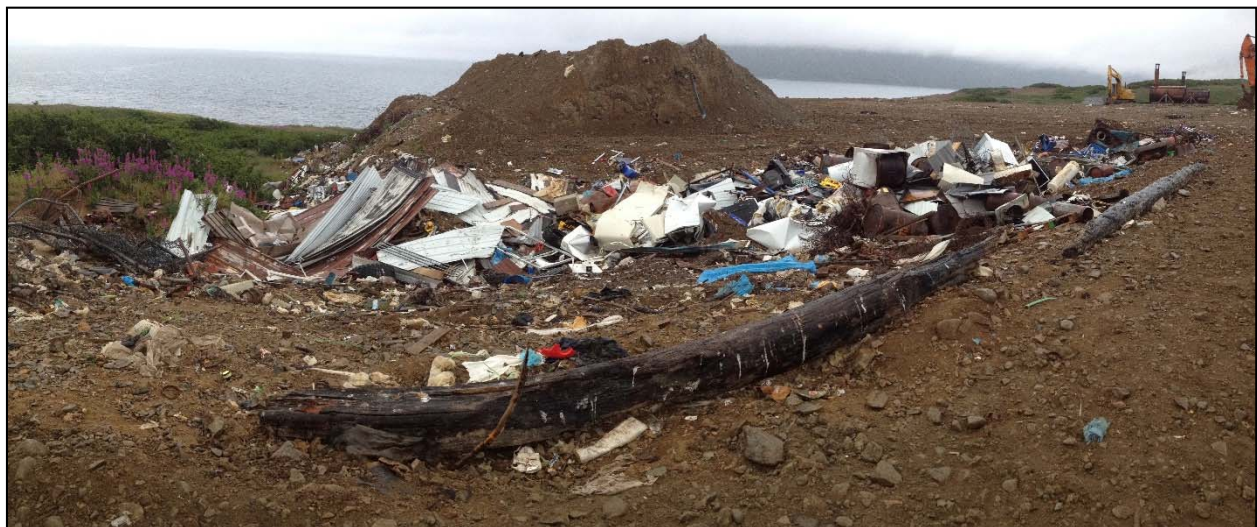
- **Landfill, 55.034878/-162.293065 (Active)** – The landfill is 11,000 feet south of the main town area. This permitted landfill has been in operation since 1988 and is operated as an area fill design. It is approximately 7.5 acres in size. It accepts municipal waste, construction and demolition debris (C&D), ash and septage. The City of King Cove employs an operator for the site. Waste was spread throughout the large, open cell. It is planned to be closed when a new cell opens in 2015. Clean wood, cardboard, and paper is burned on the ground in an area separate from the active cell. There is a separate C&D cell that is regularly compacted and covered. The city has a used oil burner and lead acid battery collection. The landfill is located 520 feet from the King Cove water body. There is no reported erosion of the shoreline near the landfill.
