Alaska Department of Environmental Conservation (ADEC) Solid Waste Program (Trisha Bower and Rebecca Colvin) conducted a Coastal Impact Assistance Program (CIAP), Waste Erosion Assessment and Review (WEAR) site visit for Koyuk on September 26th, 2013. Tracey Kimoktoak, City Administrator, participated in the site visit. A follow-up visit was conducted on August 12, 2014 by Trisha Bower, Rebecca Colvin and Jacob Timmons. The following narrative is a brief description of our findings during the inspections.

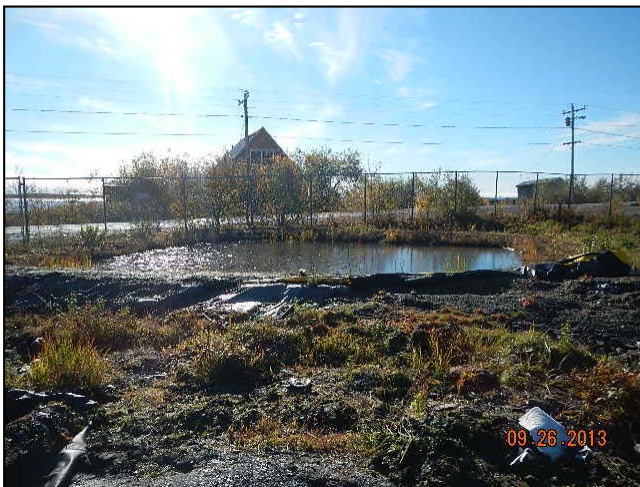
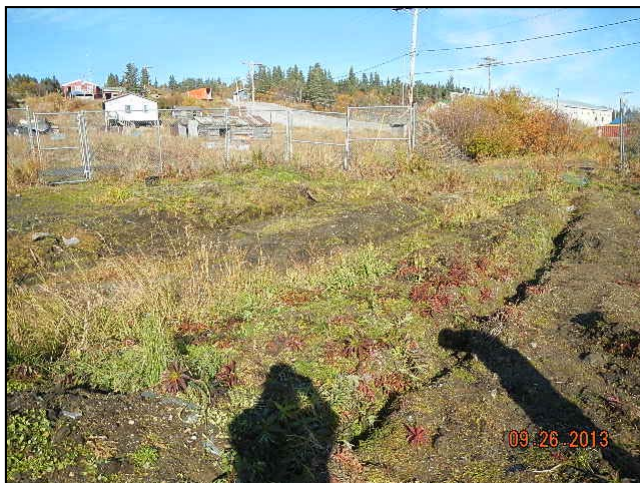
2013 Photos

- **Old AVEC Tank Farm, 64.931028/-161.159092 (Active)** – This former tank farm was operated by AVEC from around 1969 – 2005 until the construction of the new tank farm. It is an active Contaminated Site (File ID 610.57.001) due to petroleum contamination. The tanks and other associated buildings were removed from the site in 2012, and a Phase I Assessment was completed in February 2013. As of this site visit, the site was fully fenced; however the fence had fallen down and was accessible from the adjacent preschool building. There was a large pond of water in the remaining liner, but it had dried up by the 2014 visit. No visible changes occurred between the visits except for heavier vegetation growth. It is located 270 feet from the Koyuk River.

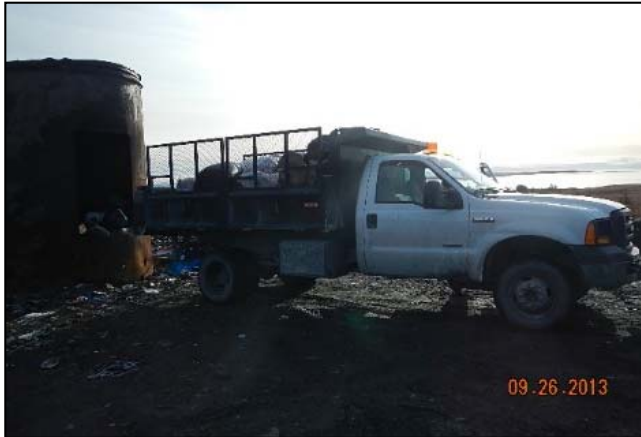
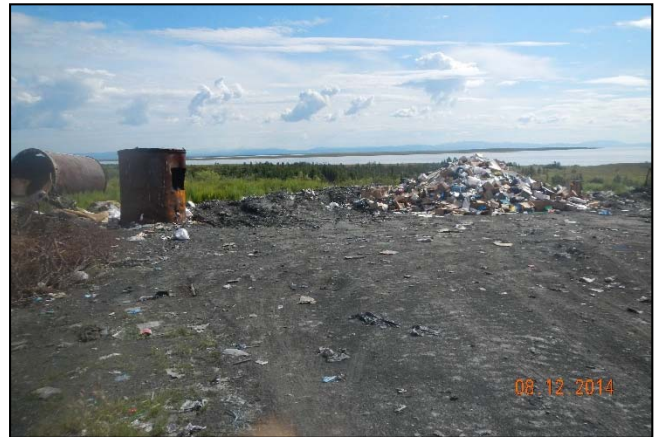
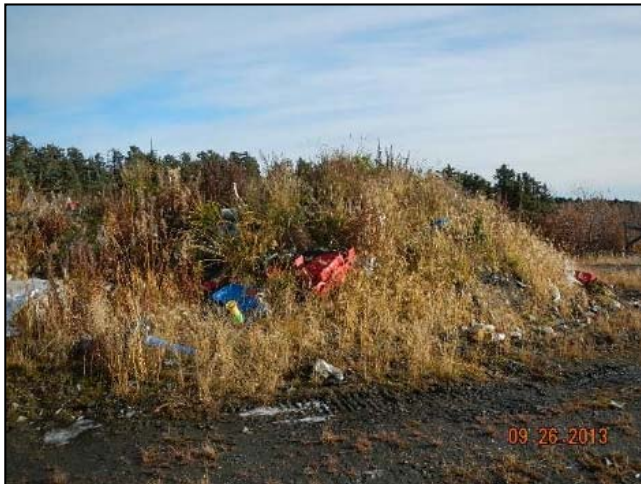
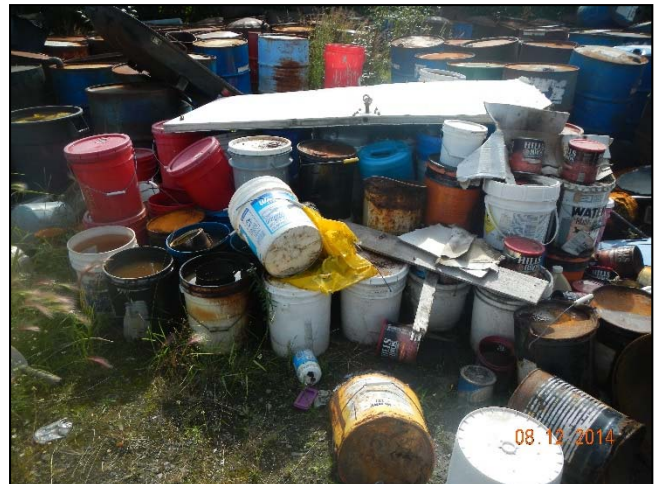
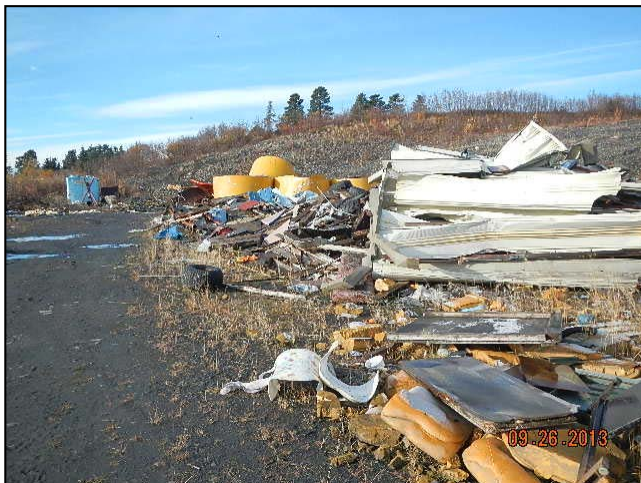
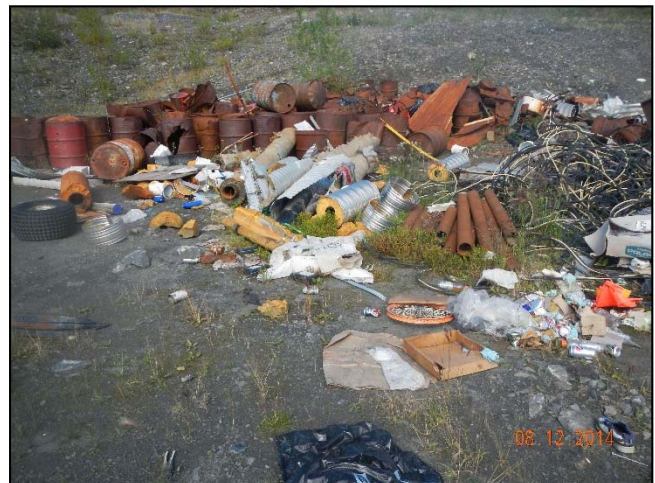
- **Landfill, 64.929877/-161.188885 (Active)** – This Class III landfill was constructed around 1995 and is located more than half a mile east of the community along a maintained gravel road. It is operated by the City of Koyuk as an area fill landfill that accepts municipal waste and construction and demolition debris. A homemade burn unit is used by two part-time operators, who also run a waste collection program with a fee structure. Since the previous inspection in 2011, a large portion of the landfill was consolidated, compacted, and covered. This resolved the leachate problem that was created by water seeping through the exposed waste. A separate, large salvage area is located outside the landfill boundaries that contains metals, white goods, drums and various other materials. A large amount of construction and demolition debris from a housing improvement project was noted in the salvage area in the 2014 inspection. This site was permitted for the first time in 2014. The landfill is located 1,665 feet from the Koyuk River.

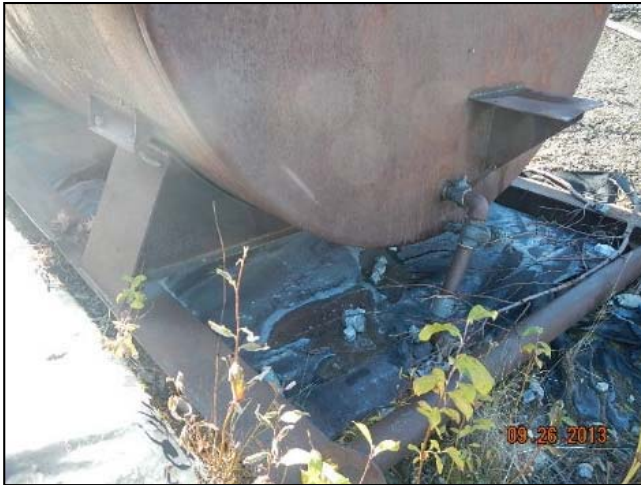
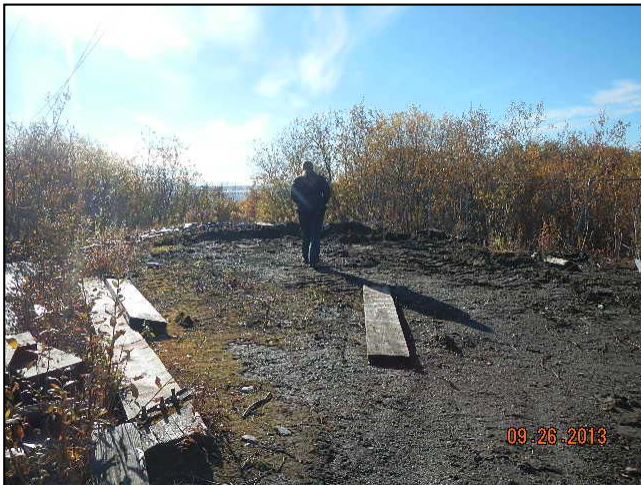
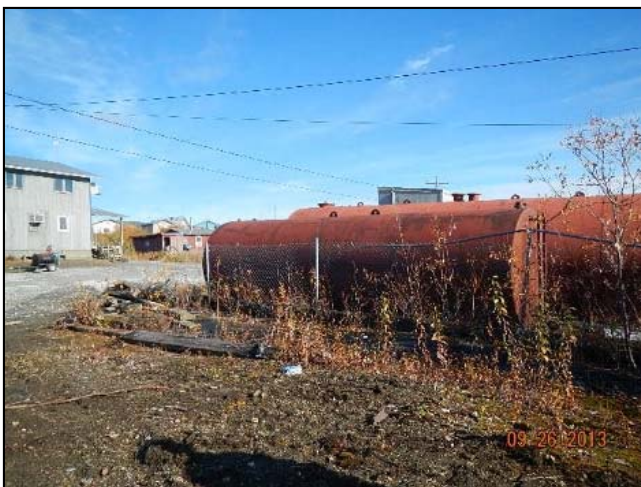
2013 Photos

- **Koyuk Native Corporation Tank Farm, 64.929930/-161.163340 (Active)** – This tank farm is owned by the Koyuk Native Corporation. It has not been in service since 2005 when the new consolidated tank farm was constructed. It is an active Contaminated Site (File ID 610.38.003) due to petroleum contamination. It consisted of three vertical tanks and two horizontal tanks. The three vertical tanks had been removed as of our visit, but the two horizontal tanks remained. The horizontal tanks were situated on black plastic directly on the ground and the plastic was torn in multiple places. This site remained unchanged between the 2013 and 2014 inspections. The site is located 250 feet from the Koyuk River.

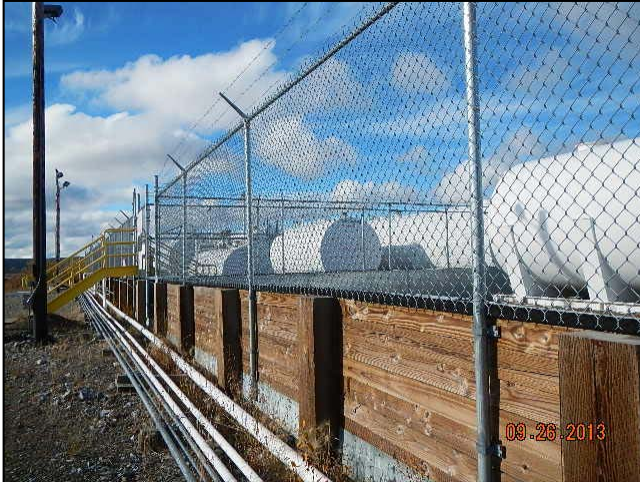
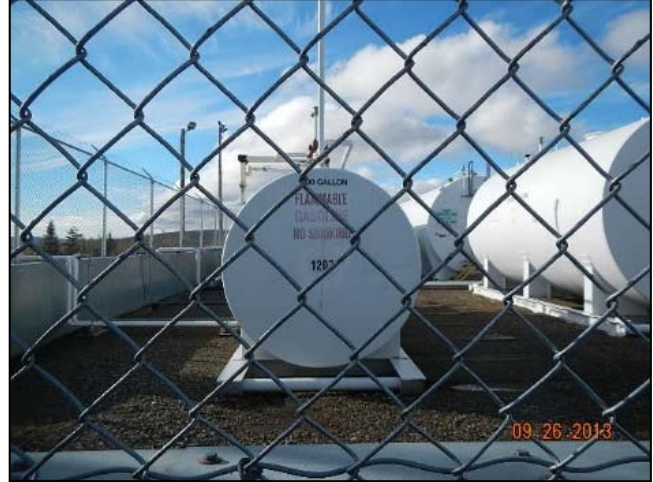
- **Tank Farm, 64.931867/-161.167939 (Active)** – This consolidated tank farm was constructed in 2005 through a Denali Commission project. It contains tanks for the City of Koyuk, AVEC, and the Bering Strait School District with the Koyuk Native Corporation as the operator. It contains a total of 18 fuel tanks with a total capacity of 83,700 gallons of gasoline and 213,400 gallons of diesel. The site consists of three separate lined wooden cells within a fully fenced and locked area. It is located in an elevated area above the community between the sewage lagoon and the power plant. The Koyuk River is approximately 990 feet south.

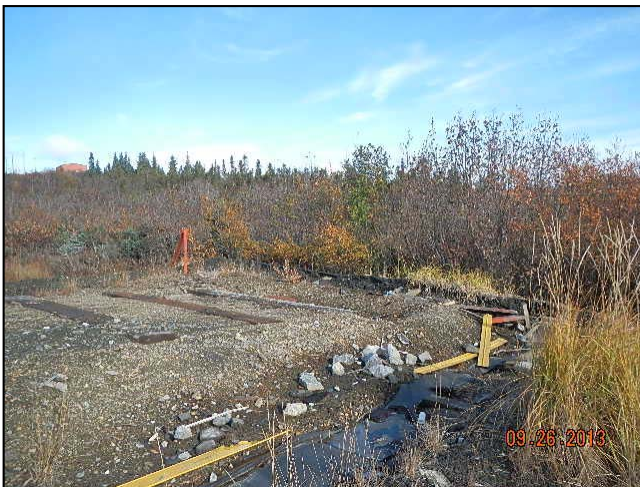
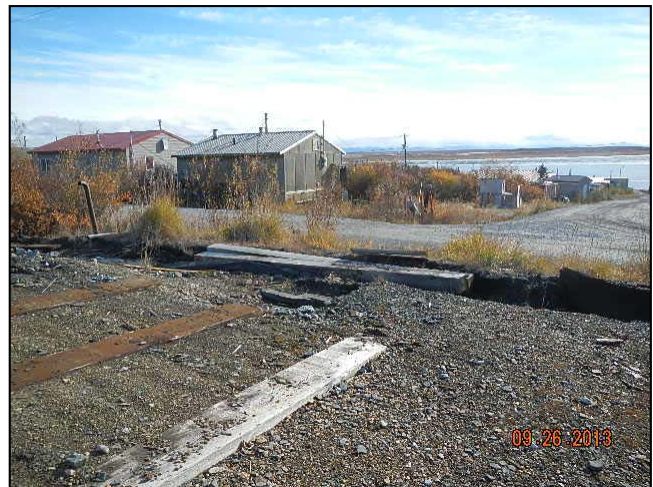
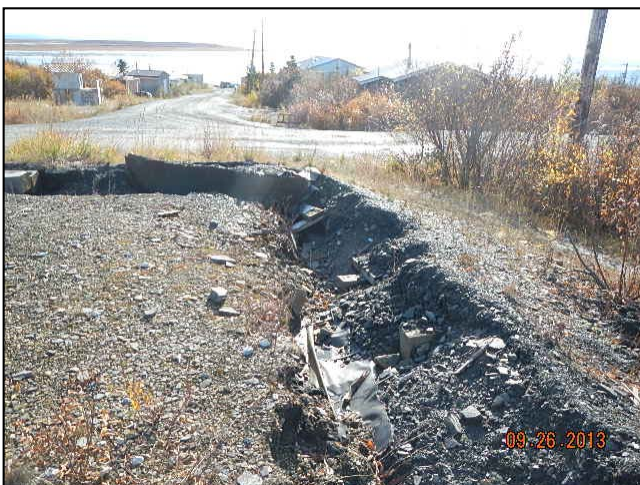
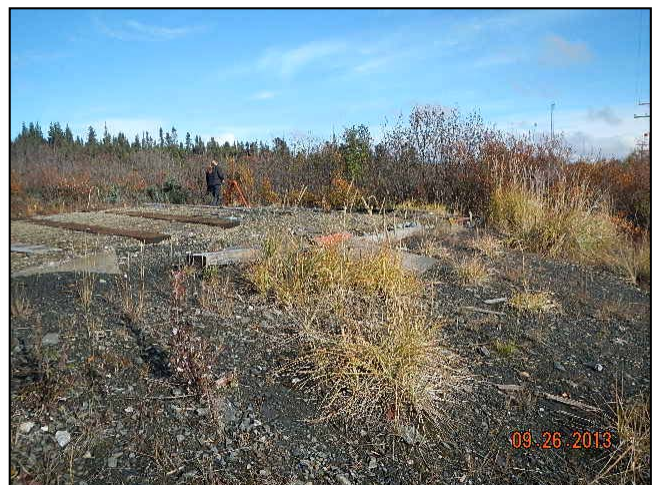
- **Old City Tank Farm, 64.931986/-161.164451 (Abandoned)** – This is the location of the former City of Koyuk tank farm. It contained two vertical fuel tanks within an earthen bermed area on the north end of the community. As of our visit, the tanks had been removed, but the plastic liner and wooden boards remained in place. It is 980 feet from the Koyuk River.

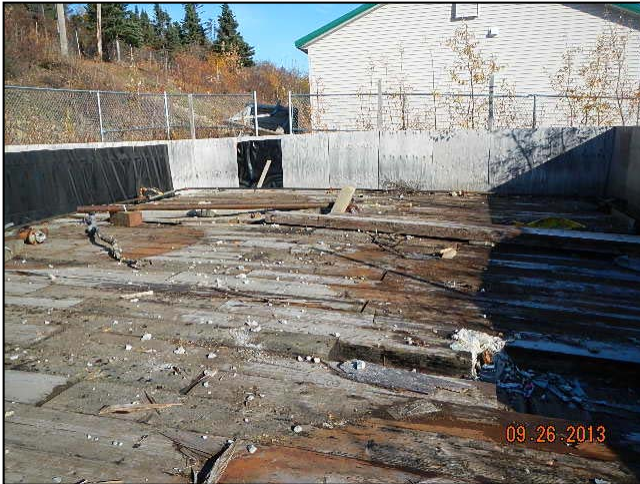
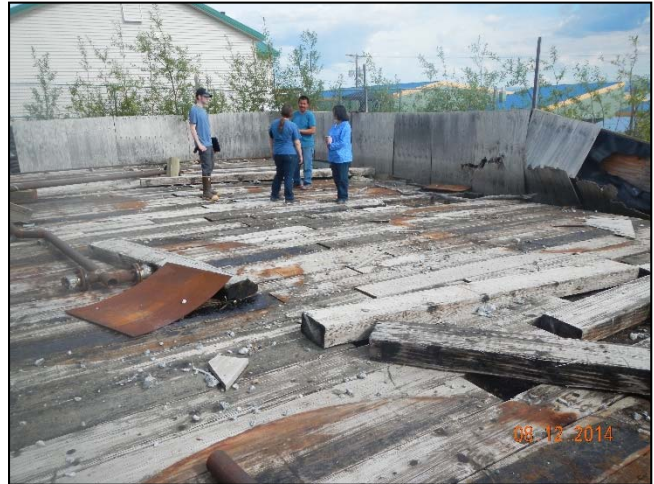
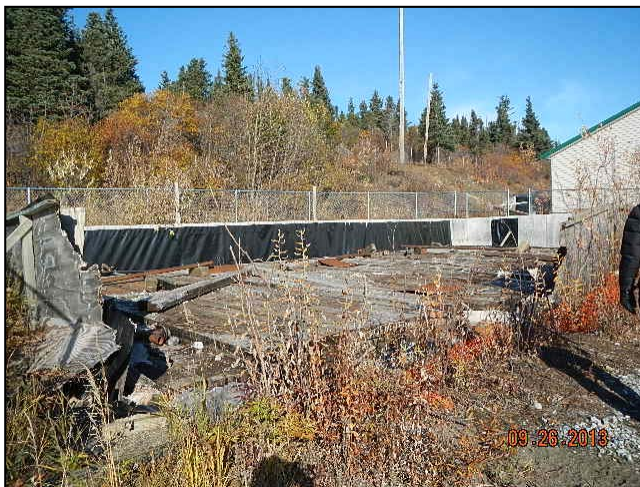
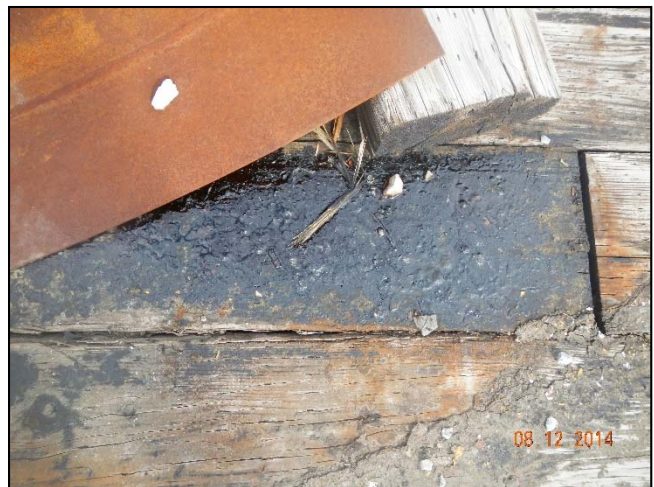
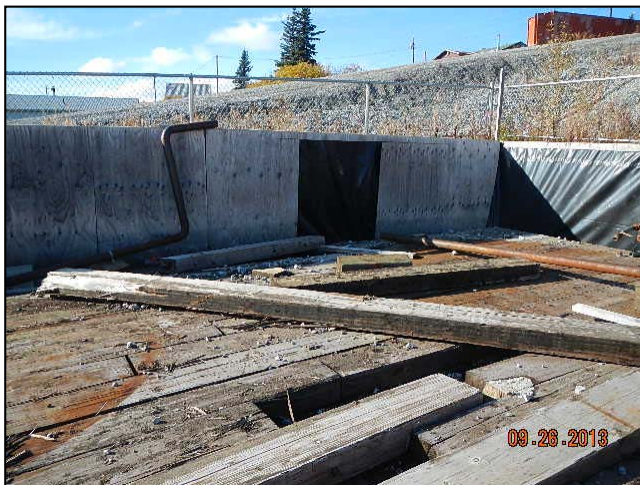
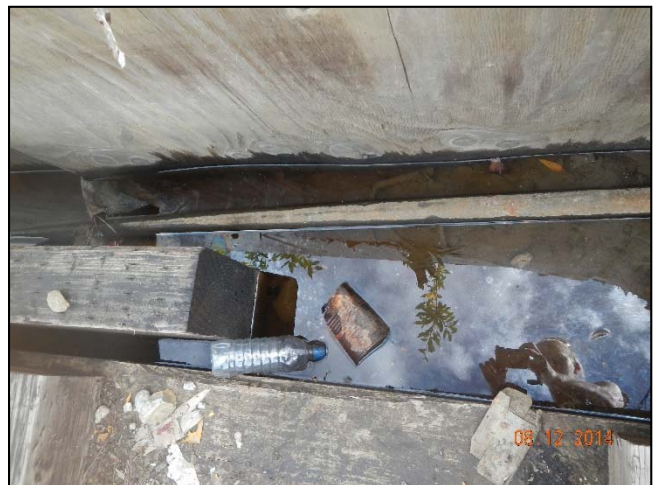
- **School Old Tank Farm, 64.932104/-161.159016 (Abandoned)** – This tank farm was owned and operated by the Bering Strait School District. It originally consisted of eight vertical fuel tanks on a raised, lined wooden platform within a fenced area. The wooden platform consisted of boards more than 4 inches in height. At the time of the site visit, the tanks had been removed and some of the wooden platform had been pulled up. The area had such an extreme fuel odor that inspectors had to leave the area. This site also remained unchanged between inspections. A strong fuel odor was still present in the 2014 inspection with sheening in collected water. This site was reported to ADEC Prevention and Emergency Response Program. It is located 30 feet from teacher housing and 145 feet from the school. The Koyuk River is approximately 670 feet to the south.
