Alaska Department of Environmental Conservation (ADEC) Solid Waste Program and Contaminated Sites Program (Kitrina Persson and Katrina Chambon) conducted a Coastal Impact Assistance Program (CIAP), Waste Erosion Assessment and Review (WEAR) site visit for the Village of Levelock on September 10<sup>th</sup>, 2012. Greg Andrew, the Village Council Administrator, and Shirley Andrew, IGAP Coordinator, helped coordinate our visit. The following narrative is a brief description of our findings during the September inspection.

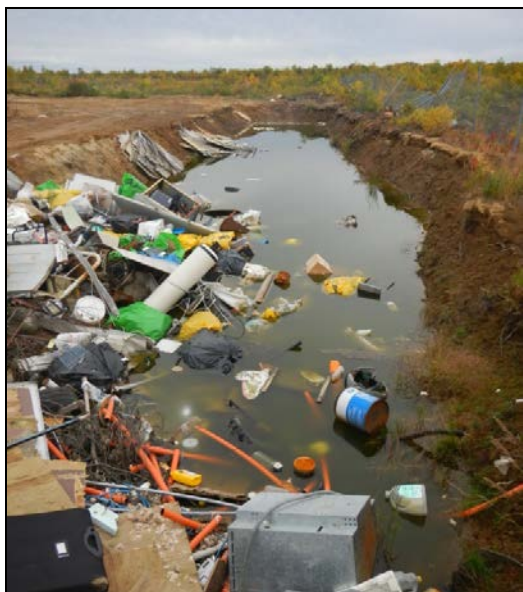
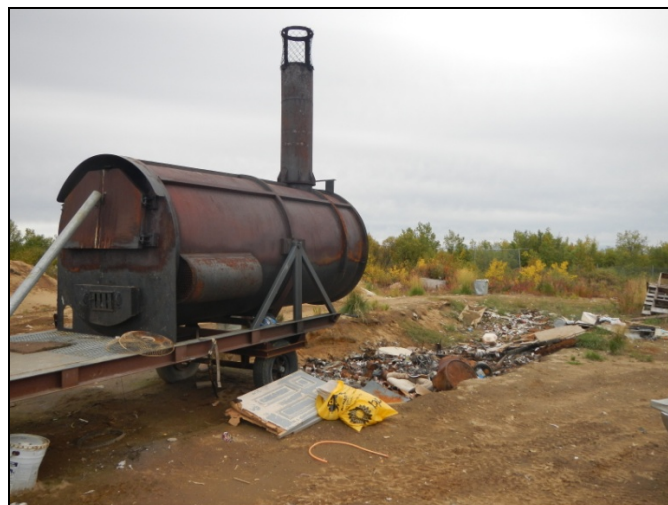
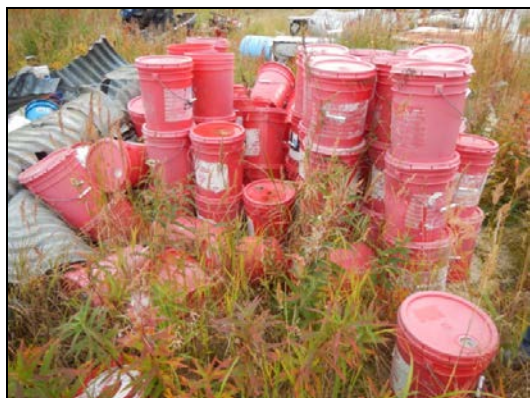
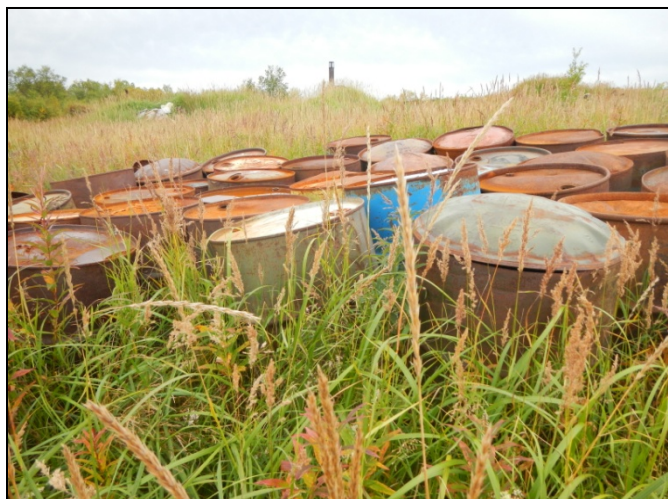
- **Landfill, 59.111382/-156.883063 (Active)** – This fenced landfill is a large site with two designated trenches for waste disposal: one burnable and one not. The non-burnable trench is full of water, with waste floating in it. Drums, vehicles, buckets of paint, appliances, fishing web, and other non-burnable items are collected and stored at the landfill as well. The area is quite large and waste is not very consolidated. It is fenced and there is a designated landfill operator that collects and burns waste in a Tok Burn Unit. There is a shipping container available for batteries and electronics; however, it does not appear to be well used. The landfill is over 4,000 feet inland from the Kvichak River.

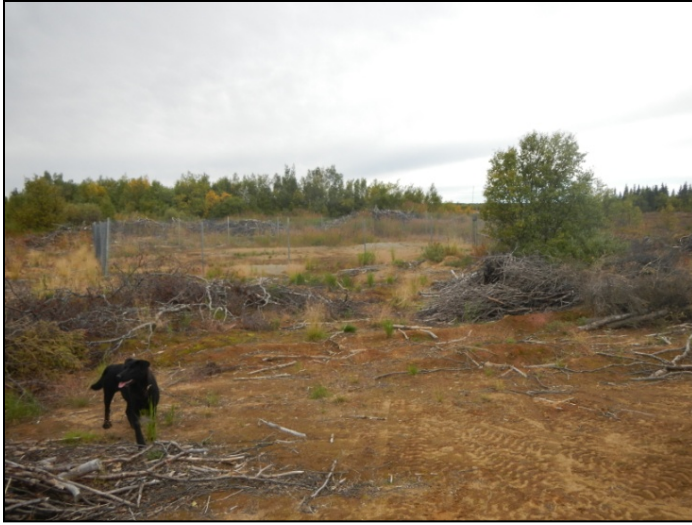
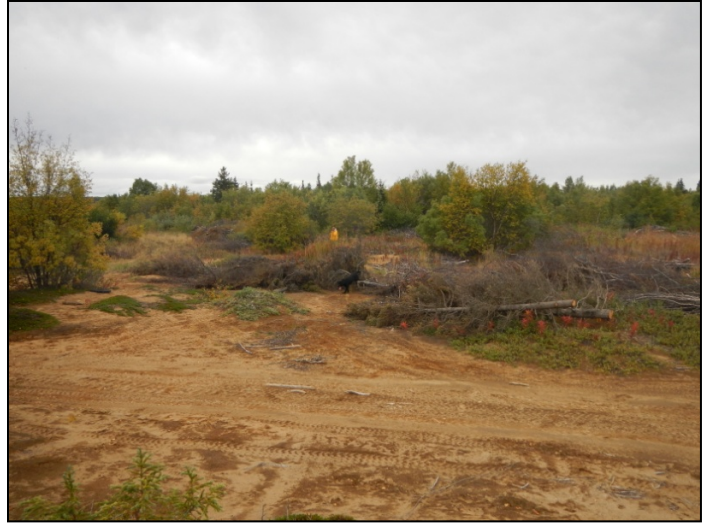
- **Closed Landfill, 59.102493/-156.876064 (Closed)** – The closed landfill is about 1,000 feet from the Kvichak River. Soil is sandy. The area is being used to dispose of trees and brush that are cleared from other areas of the community. The landfill cover is in good condition and re-vegetation is naturally occurring over the site.

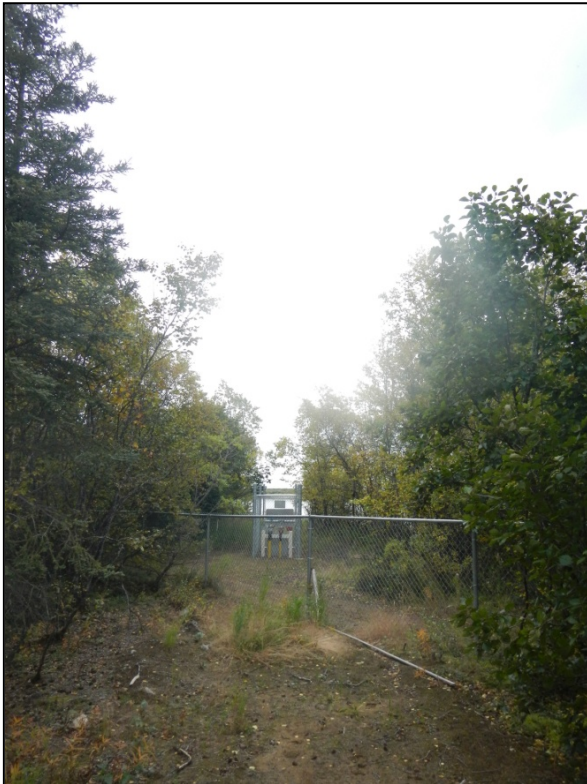
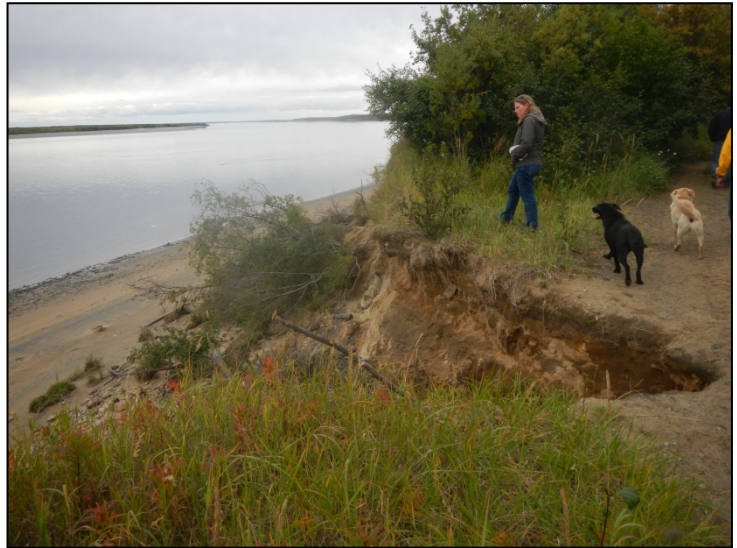
- **Fuel Header, 59.112092/-156.856052 (Active)** – The fuel header is approximately 50 feet from the actively eroding shoreline of the Kvichak River. The site is fully fenced and well maintained. Community leaders reported rapid loss of the bluff over the last year. During storm events wind and rain cause the sandy soil to slough. We observed that several trees had fallen off the banks onto the beach within the last month. There is no erosion mitigation at this site.

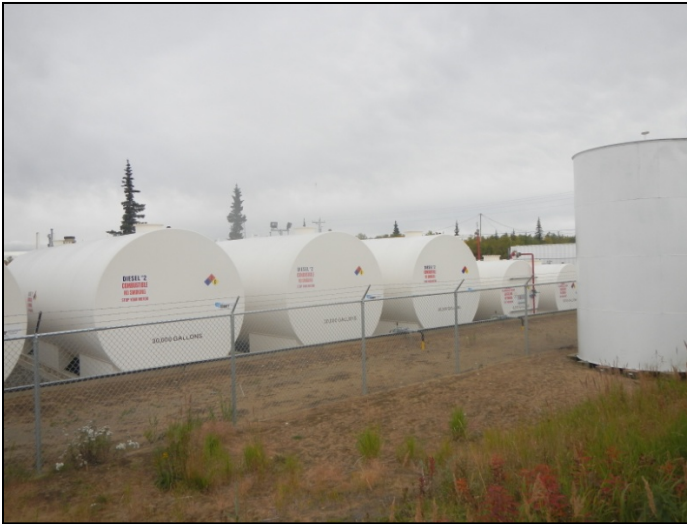
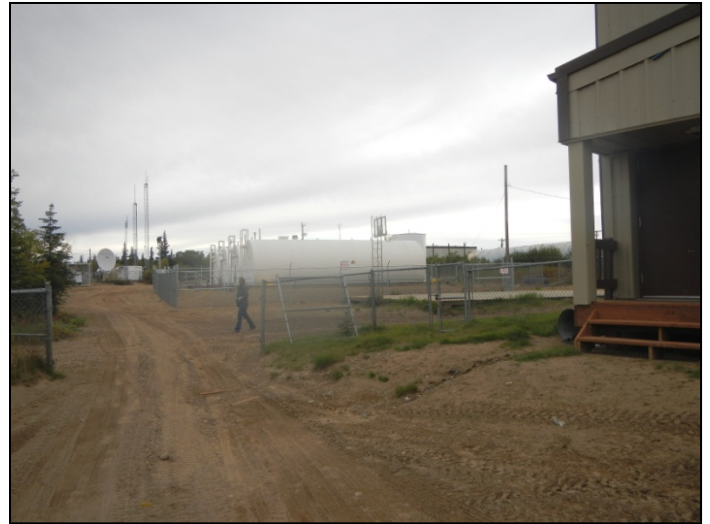
- **Tank Farm, 59.112198/-156.857392 (Active)** – This fully fenced, bulk fuel facility was completed in 2010. It consists of 4-30,000 gallon diesel tanks, 1-6,000 gallon gasoline tank, and 1-12,000 gallon gasoline tank. The facility is located about 60 feet from the school. The tanks are approximately 195 feet from the eroding shoreline of the Kvichak River.

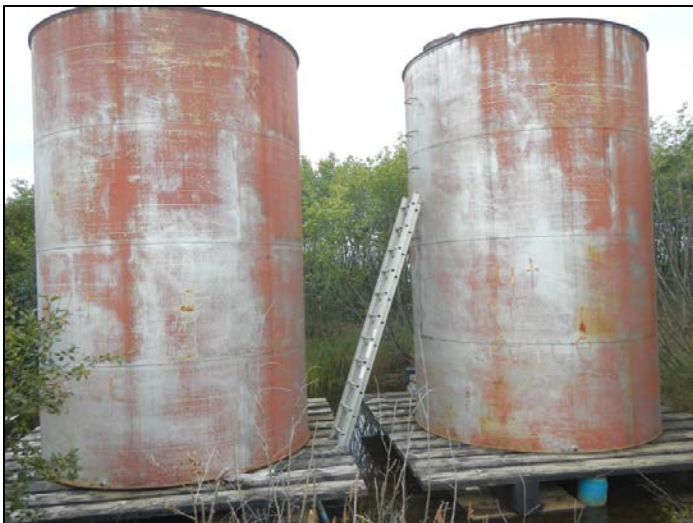
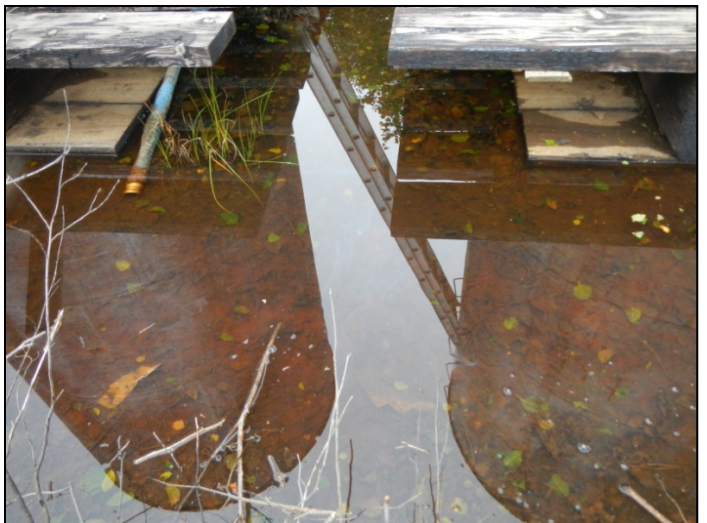
- **Two Old Tanks, 59.109889/-156.859458 (Inactive)** – This site consisted of two vertical, BIA-style tanks used for gasoline storage. It is no longer in use since the new tank farm was constructed in 2010. During the site visit a fuel odor was observed. Standing water within the secondary containment produced sheen when mixed. Tanks were labeled 'Out of Service'. This site is located approximately 65 feet from the eroding bluff of the Kvichak River.

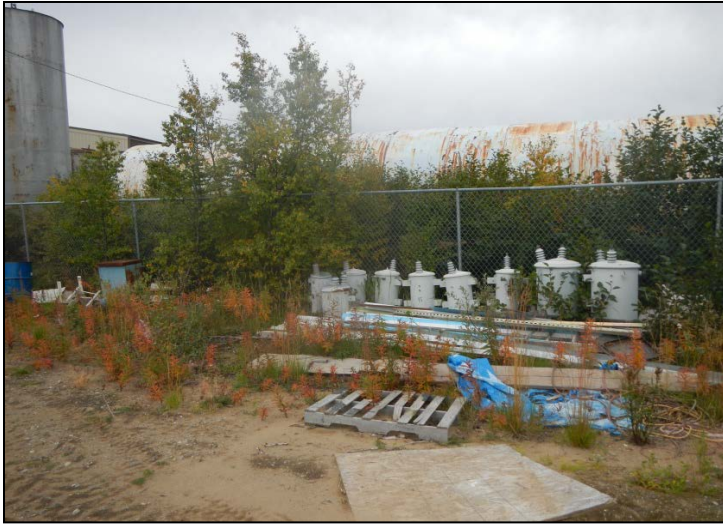
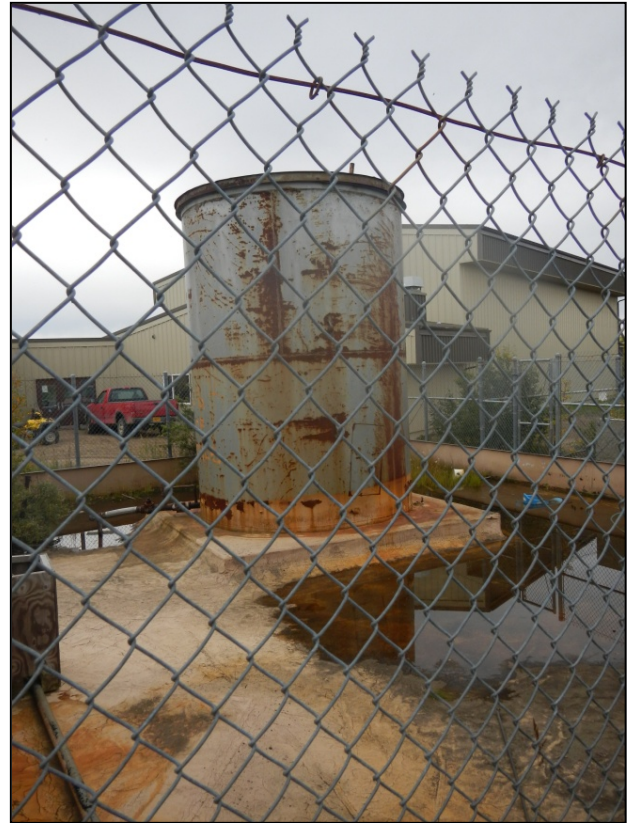
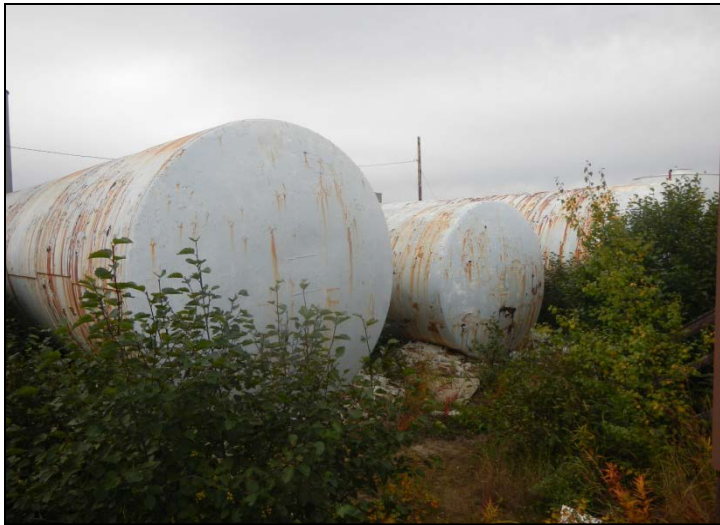
- **Old Tank Farm, 59.112769/-156.858183 (Inactive)** – This site consists of two adjacent tank farms: the old village tank farm and the old school tank farm. Each of these tank farms are no longer in use since the new tank farm was constructed in 2010. The village tanks consist of three horizontal tanks and the school tanks consist of two vertical tanks. All tanks were used for diesel storage. The site is located approximately 500 feet from the eroding bluff of the Kvichak River and 70 feet from the school. Transformers are stored outside the fence of the old village tank farm on the ground.
