CIAP WEAR Trip Report Manokotak (population 449) July 11th, 2012

Alaska Department of Environmental Conservation (ADEC) Solid Waste Program and Contaminated Sites Program (Kitrina Persson, Bill O'Connell, and Jamie Gorman) conducted a Coastal Impact Assistance Program (CIAP), Waste Erosion Assessment and Review (WEAR) site visit for the Village of Manokotak on July 11th, 2012. Nancy George, City Administrator, Bibiana Gloko, IGAP Coordinator, and the mayor all helped coordinate our visit. We were given a ride to the landfill by Ferdinand Sharp and were accompanied by Trinity, the landfill operator. The following narrative is a brief description of our findings during the July inspection.

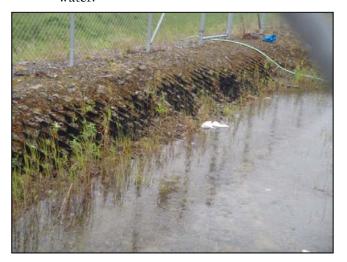
➤ Tank Farm, 58.981060/-159.058000 (Active) — This fenced, raised site housed several fuel tanks. The tanks were well-maintained and structure enhancement features for the ground had been installed in the form of black plastic honeycomb sheets. About an inch of water had built up around the tanks (it was raining) but there was no sheen or nearby dead vegetation. There was some oil boom observed in the wetland northeast of the fuel tanks. The site was approximately 190 feet from the Igushik River. The Igushik River is a meandering, flat, slow river, bordered on all sides by swampy wetland which absorbs high water.

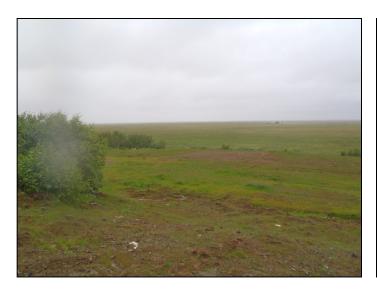
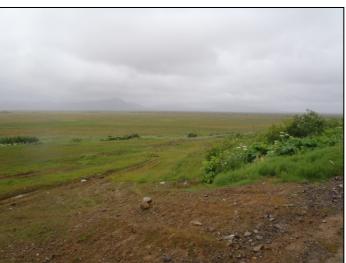
➤ Landfill, 58.975291/-159.051158 (Closed) – This landfill was closed in 2011 and is already covered with the early stages of grass growth. Some trash is visible at the site due to ground settlement. Since there is an uphill slope on the other side of the road across from the site, care should be taken to divert water from flooding over the area during spring melt or any high precipitation events. It is located along on Manokotak Heights Road about 1,200 feet southeast of town and 2,300 feet from the Igushik River.

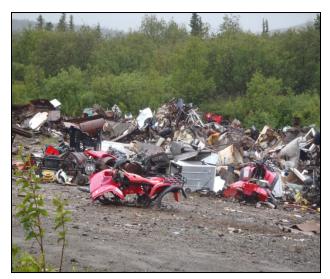
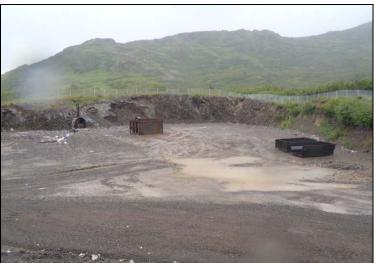
➤ Heights Landfill, 58.975130/-159.011113 (Active) — This permitted landfill is located at the base of a mountain. The majority of the refuse is incinerated by means of a Tok Burn Box. The entirety of the landfill is fenced with restricted gate access and ample sign postings. There is a salvage area down the road which is open to the public and only partially sorted. Within this section, there is a shipping crate that is used for the collection and storage of e-waste and batteries. It is located 1.75 miles from the Igushik River and 1.5 miles from town.
