CIAP WEAR Trip Report Noatak (population 568) July 26, 2012 & September 20, 2013 & July 11, 2014

WEAR Sites

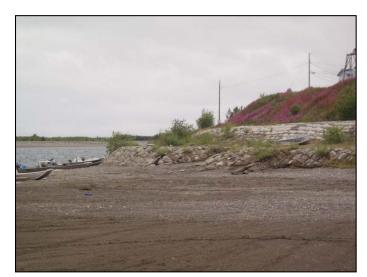
2012 Photos

➤ AVEC Tank Farm, 67.570675/-162.966236 (Active) – The AVEC tank farm is centrally located in Noatak and is the largest tank farm. It has been in place since the 1970s and contains 12 vertical diesel tanks with a total capacity of 95,254 gallons. The tanks are within a lined secondary containment area with no fencing to block public access. Concrete blocks have been installed for erosion control as the Noatak River is approximately 85 feet away.

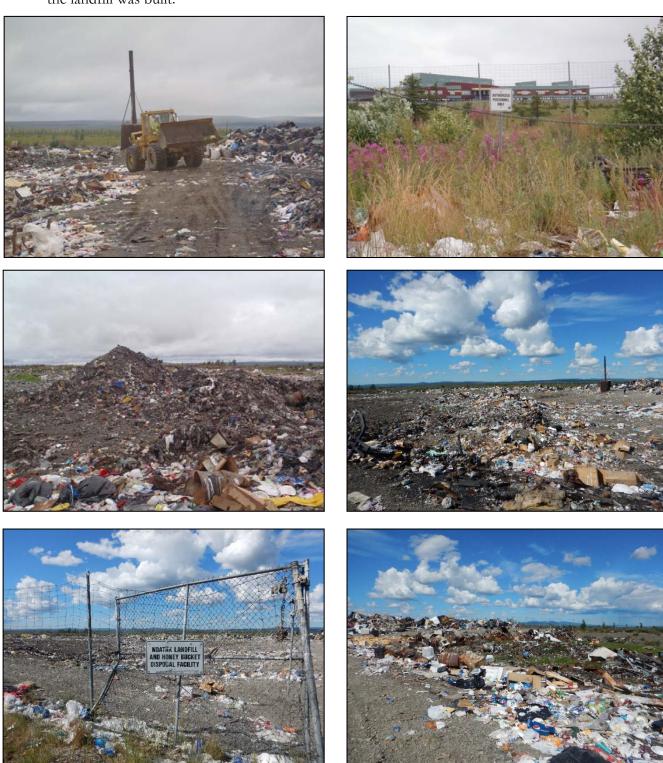
➤ Landfill, 67.566083/-162.992597 (Active) – This unpermitted landfill is a fenced area fill that has operated since 1995. It is a 3.4 acre site that has accepted municipal waste, honeybucket waste, special waste, and construction and demolition waste. There is no waste separation and the burn unit is in disrepair and not used. Waste is brought to the site by residents as there is no collection program. It is located inland approximately 2,800 feet from the Noatak River. It is located approximately 1,830 feet from the school, which was constructed around 2 years after the landfill was built.

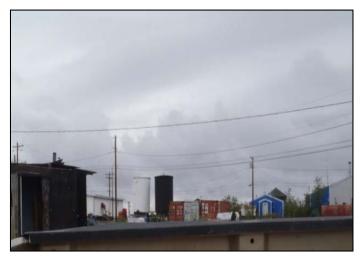
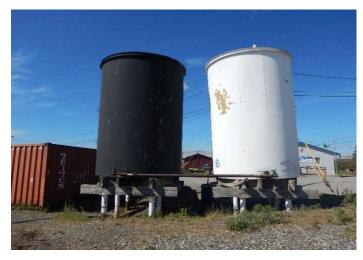
2012 Photo 2014 Photo

➤ IRA Tanks, 67.570611/-162.968067 (Active) – This site consists of two vertical fuel tanks in the middle of Noatak that are directly west of the AVEC Tank Farm. The tanks belong to the IRA and although they are empty at this time they are actively used from time to time for fuel storage and have planned future use. The tanks are on wooden platforms atop metal pilings several feet above ground level. They are located 370 feet from Noatak River.
