Alaska Department of Environmental Conservation (ADEC) Solid Waste Program and Contaminated Sites Program (Doug Huntman and Grant Lidren) conducted a Coastal Impact Assistance Program (CIAP), Waste Erosion Assessment and Review (WEAR) site visit for Oscarville on September 17th, 2012. Michael Stevens, Tribal Administrator participated on the site visit. The following narrative is a brief description of our findings during the September inspection.

WEAR Sites

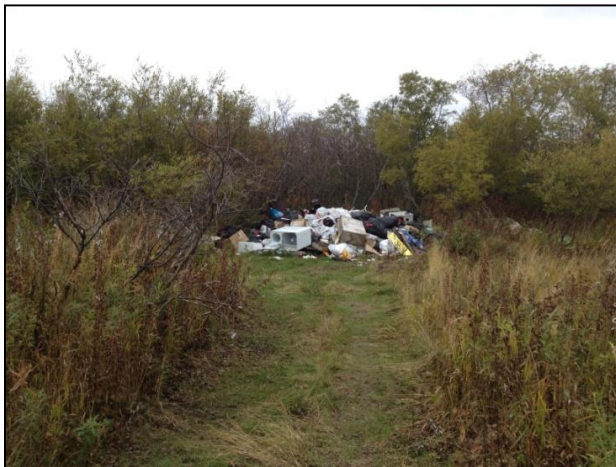
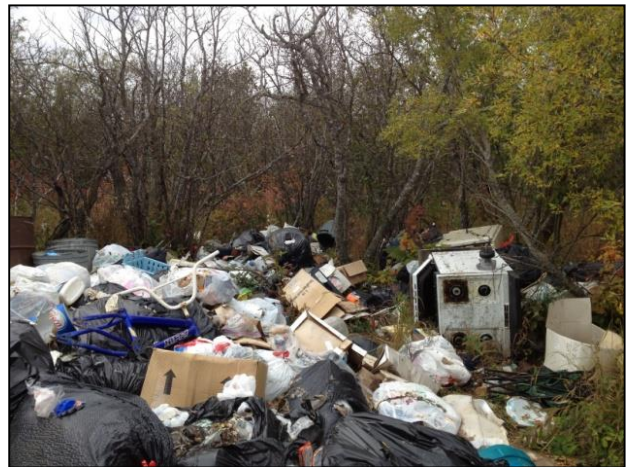
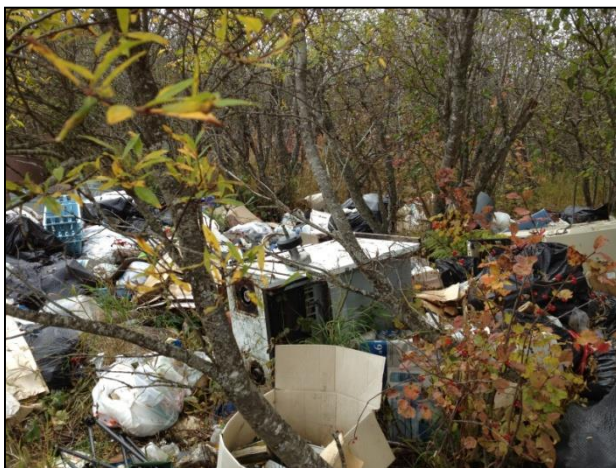
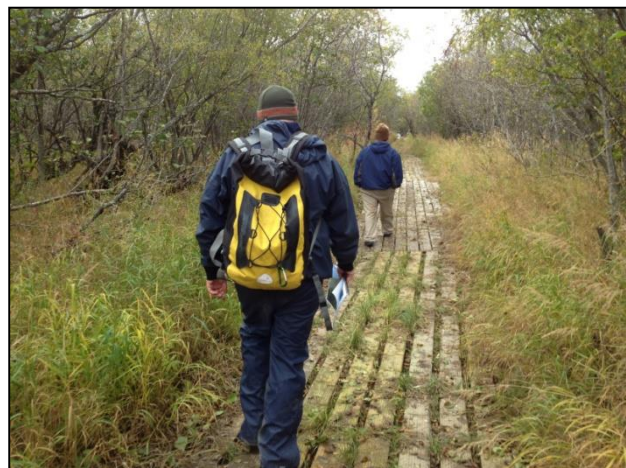
- **Substitute Landfill, 60.722303/-161.77567 (Active)** – This landfill is not managed and is part of two sites connected by a trail. It was established by users not wanting to take waste down the boardwalk to the Landfill. It is roughly 0.05 acres in size and is approximately 500 feet from the village. The site is situated on discontinuous permafrost. The landfill is a self-haul landfill with no operator or dedicated equipment for the landfill. This landfill has been in operations since the early 2000's and has waste spread throughout the site. It is prone to flooding and as a consequence had a large area of waste mixed in water at the time of the inspection. Uncovered waste flows out of the site during spring and fall storms and is deposited in the tundra and nearby wetlands. The site is approximately 935 feet from the banks of the Kuskokwim River.

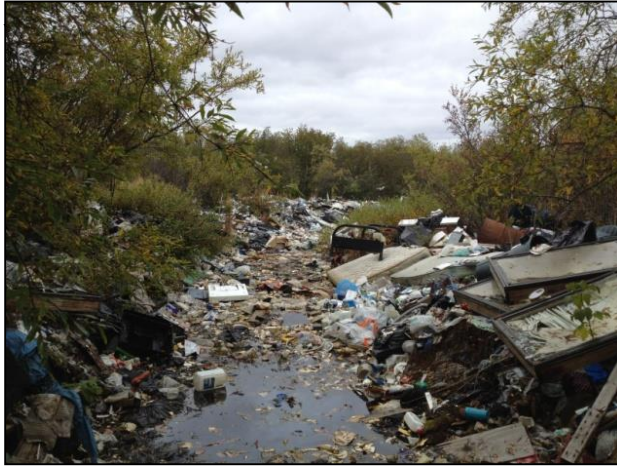
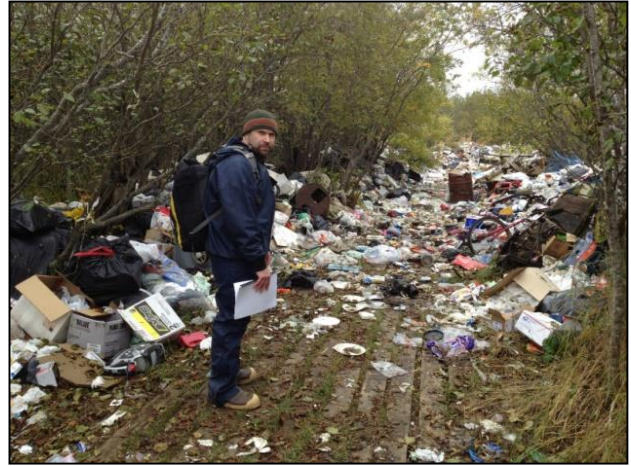
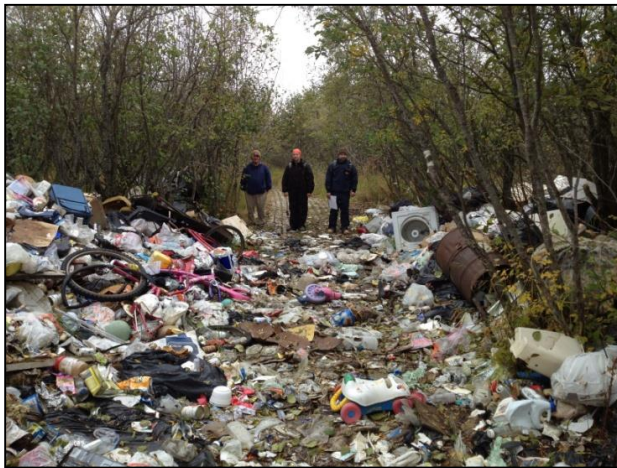
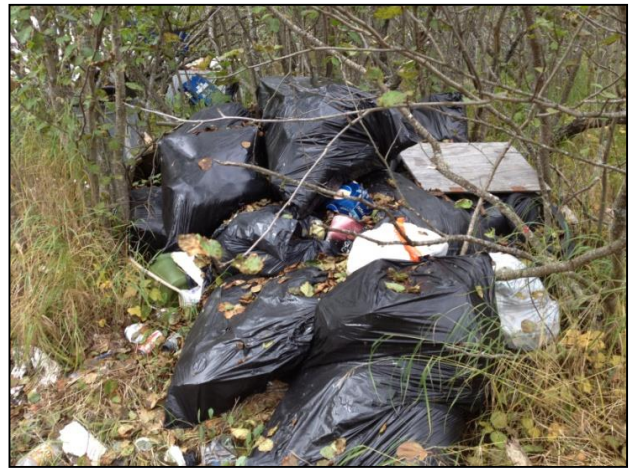
- **Landfill, 60.721137/-161.776381 (Active)** – This landfill appears to be the primary disposal site. It is located 400 feet directly behind the Substitute Landfill and is 0.3 acres in size. The primary concerns at the site include: no fencing, open dumping and no wastes prohibited from the site. There were large areas of ponding observed in the site. This site is located 598 feet from the Kuskokwim River.

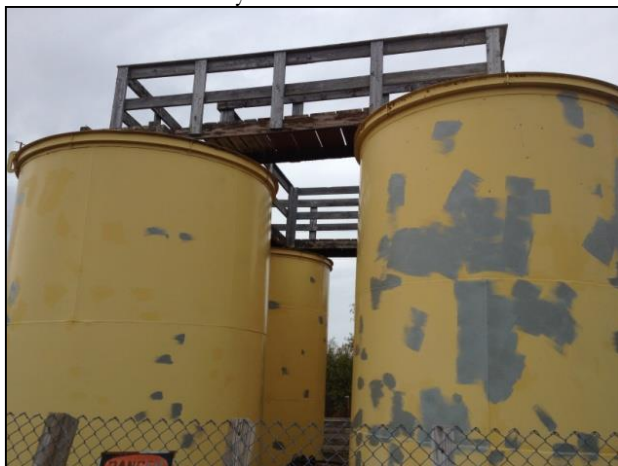
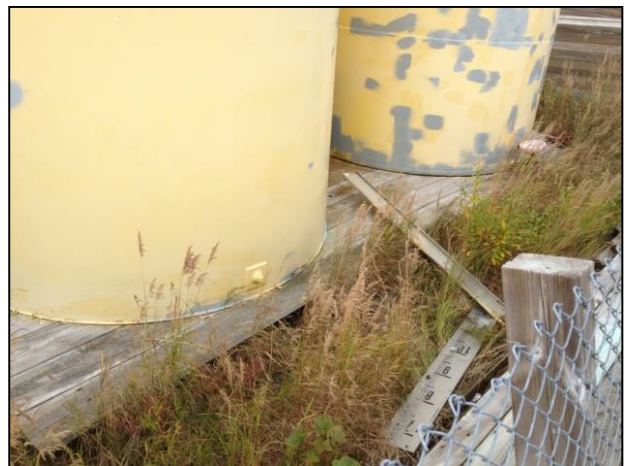
- **School Tank Farm, 60.722953/-161.772458 (Active)** – This school tank farm is owned and operated by the Lower Kuskokwim School District. There are five vertical fuel tanks for heating oil (diesel) on site within a wooden fenced area. The tanks have been active since the mid 1980's. The site is located 145 feet from Oscarville Slough that connects to the Kuskokwim River. The banks along the slough were observed to be eroding at an unknown rate. The bank consists of silty material.

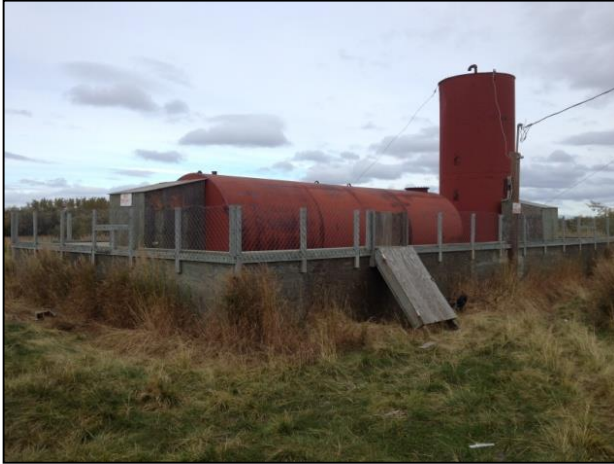
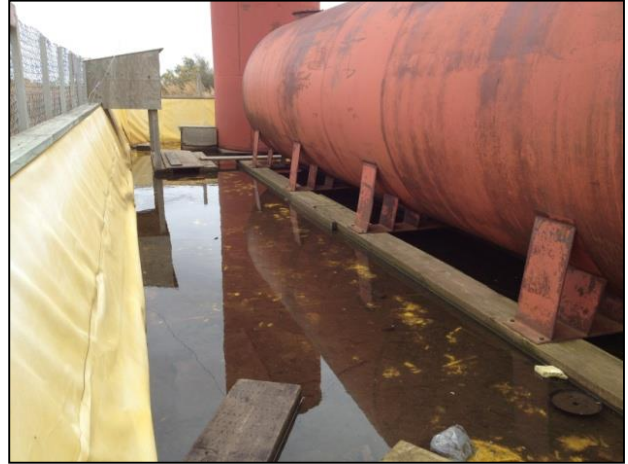
- **Native Corp. Tank Farm, 60.722814/-161.769627 (Active)** – This tank farm is operated by the Oscarville Native Corporation and contains one horizontal and one vertical fuel tank. The tanks contain gasoline and diesel. The site is located less than 40 feet from Oscarville Slough that connects with the Kuskokwim River. The banks along the slough were observed to be eroding. The bank consisted of silty material.
