CIAP WEAR Trip Report
Napakiak (population 354)
June 21, 2013

Alaska Department of Environmental Conservation (ADEC) Solid Waste Program (Doug Huntman, Trisha Bower and Jacob Timmons) conducted a Coastal Impact Assistance Program (CIAP), Waste Erosion Assessment and Review (WEAR) site visit for Napakiak on June 21st, 2013. Harold Ilmar, Landfill Operator, participated in the site visit. The following narrative is a brief description of our findings during the June inspection.

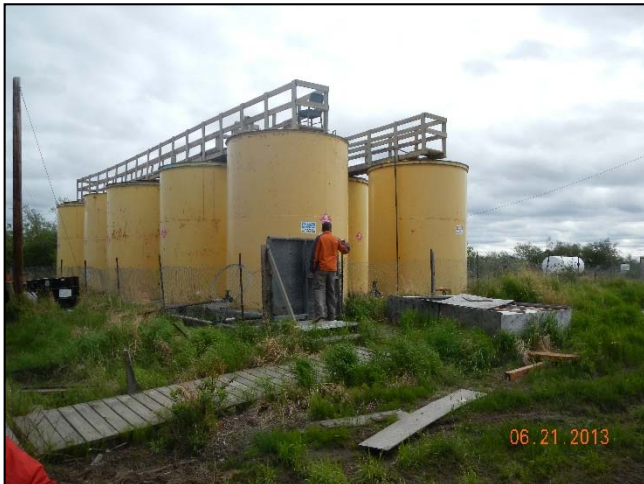
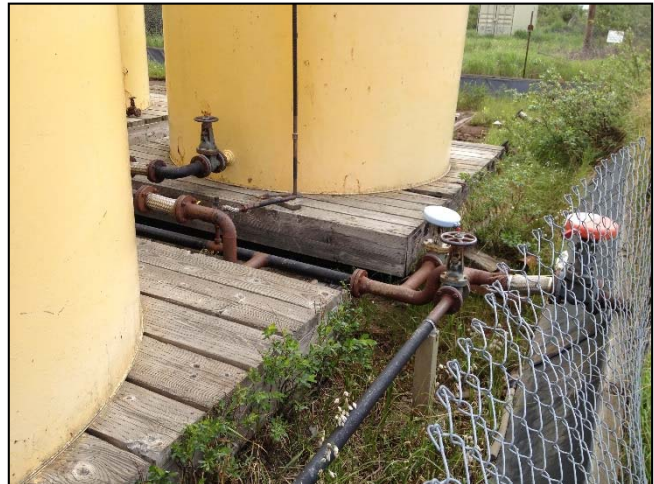
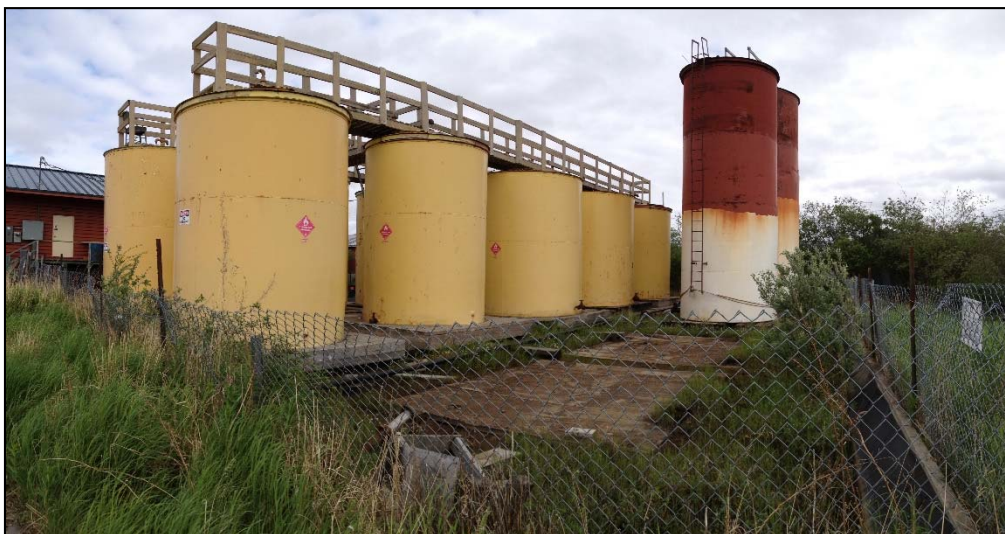
- **School Tank Farm, 60.694347/-161.969874 (Active)** – The school tank farm consists of 10 yellow single-walled vertical tanks. They are owned and operated by the Lower Kuskokwim School District (LKSD). The site serves as the fuel source for the school. The tanks were installed sometime during the 1970's are resting on a sturdy timber foundation, bolt on tops. The tanks are in a fenced area within a lined timber dike impoundment for secondary containment. The total capacity of the tank farm is approximately 140,000 gallons of diesel. The site also contains two disconnected vertical tanks that are owned by the Corporation. These two tanks have not been in use since a new Corporation Tank Farm was constructed in 2009. The tanks are located on school grounds near the northeast corner of the school. The site is approximately 420 feet from the banks of the Kuskokwim River. Erosion rates were reported by locals as over 5 feet a year; however, the Army Corps of Engineers 2009 *Baseline Erosion Assessment* (BEA) reports an average erosion rate of 35 feet a year.

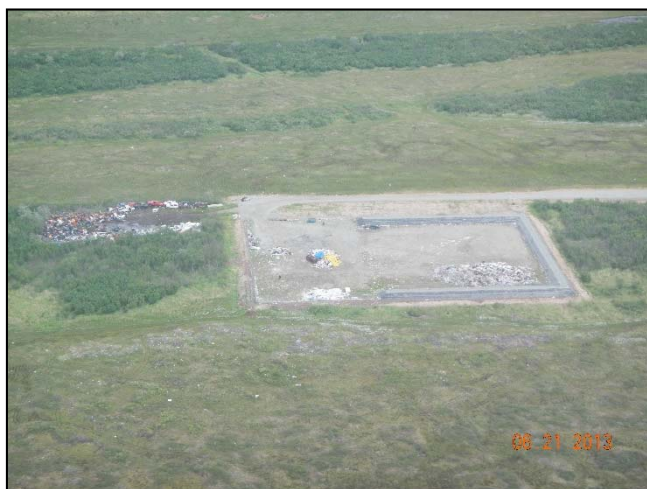
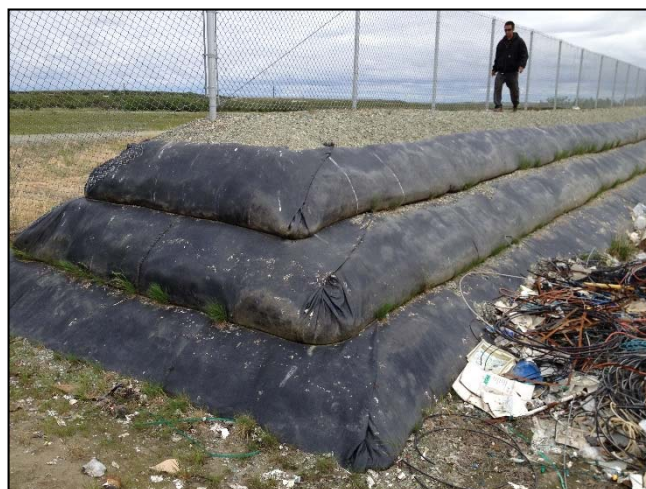
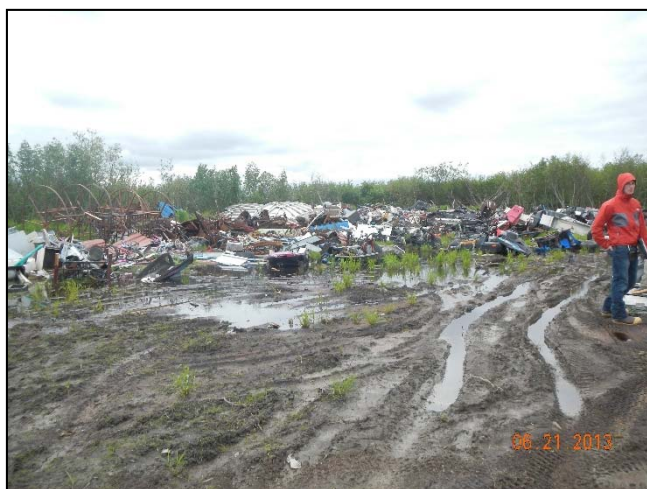
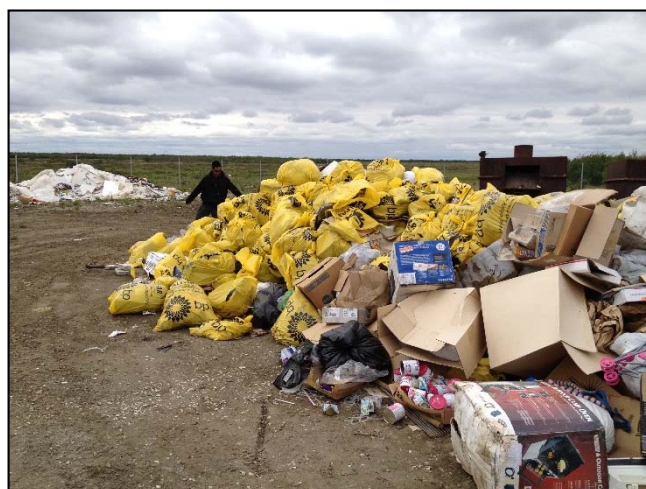
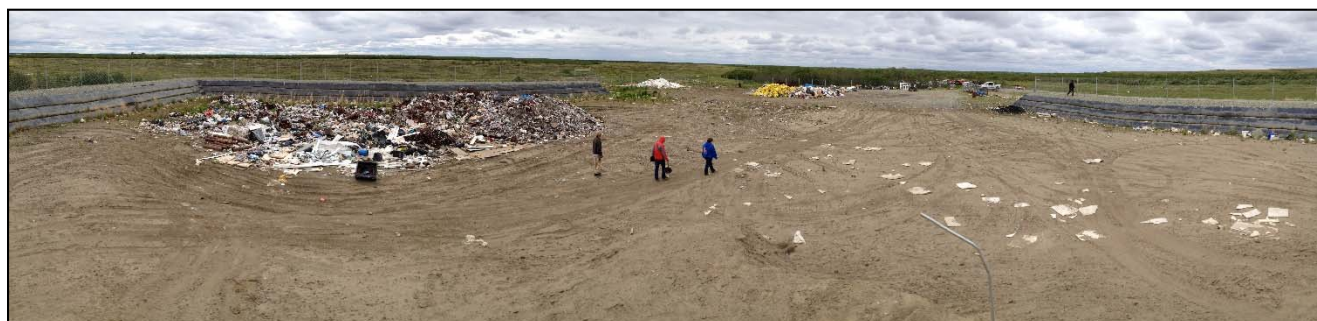
- **Landfill, 60.690734/-161.997748 (Active)** – This landfill was constructed in 2010 and is engineered as an above grade fill landfill that is completely fenced. It is roughly 3 acres in size and approximately ½ mile from the village. A waste collection program is available for residents; however self-hauling waste to the site is also allowed. A part-time landfill operator is employed for day-to-day landfill operations. There are two homemade burn units designed to minimize the volume of waste disposed of at the landfill. Both units were functioning and emptied of ash on a regular basis by the landfill operator. Waste and ash are disposed of in several locations throughout the landfill. Although a stockpile of cover material was available, it had not been applied to either the active or inactive areas of the landfill. There is a separate metals area outside the entrance to the landfill which had large ponds of water mixed with metals in it. The metals area of the landfill does not have a perimeter fence or signs indicating where to dump and what items are prohibited from the site. It is located 4,900 feet from the Kuskokwim River, which is eroding at 35 feet per year according to the BEA study.

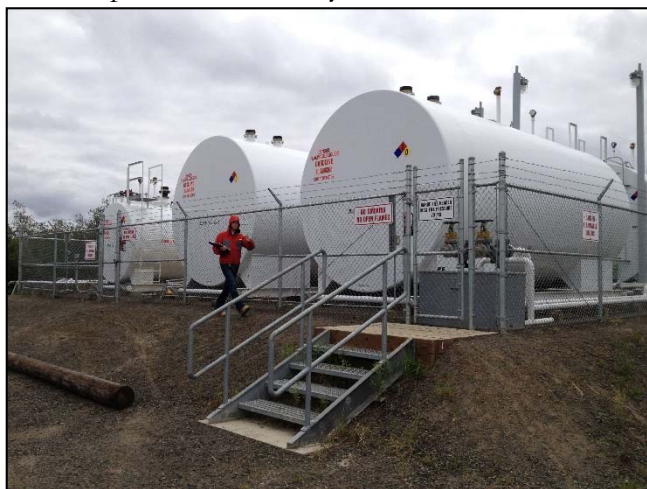
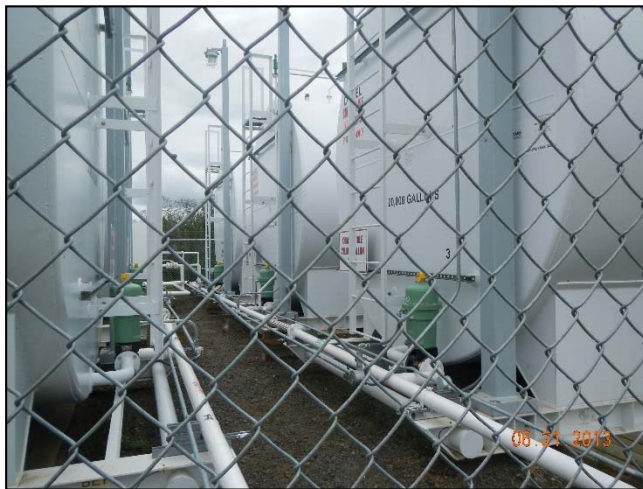
- **Corporation Tank Farm, 60.693014/-161.976297 (Active)** – This tank farm is the new community tank farm that is owned and operated by the Napakiak Corporation. It was completed in 2010 and is fully fenced with a locking gate. The site has secondary containment with a liner and dike and is built above the surrounding area by several feet. The total capacity for the site is 103,000 gallons of fuel oil, diesel and gasoline. The facility is on the east side of the runway apron and 1500 feet from the Kuskokwim River, which is eroding at 35 feet a year per the BEA study.

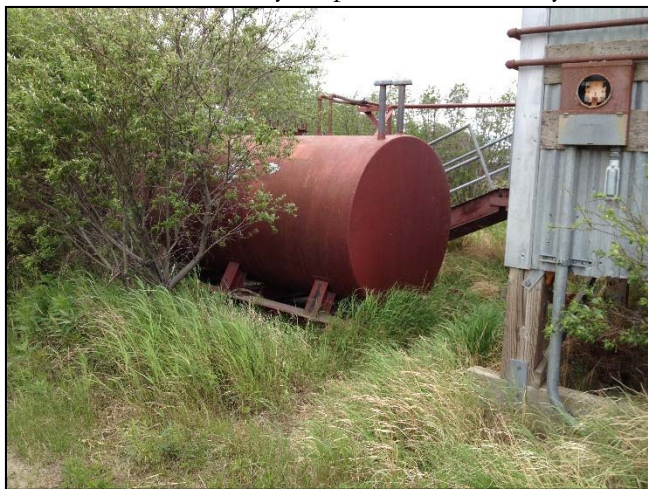
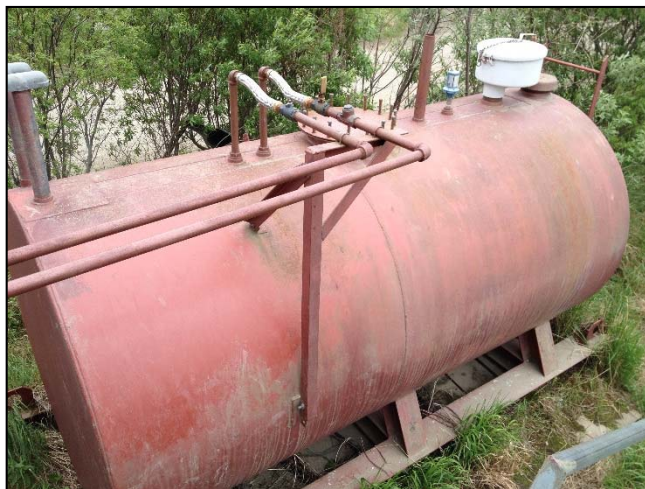
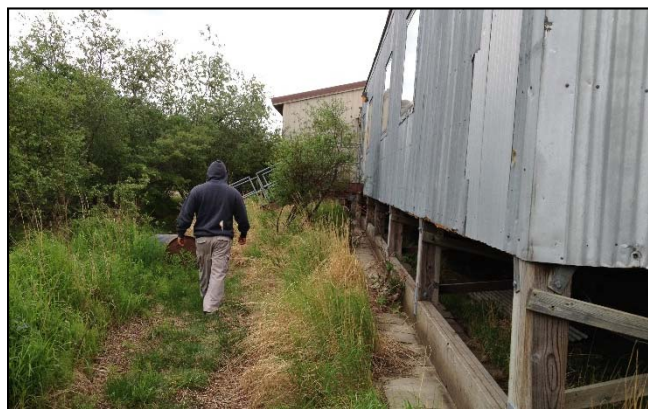
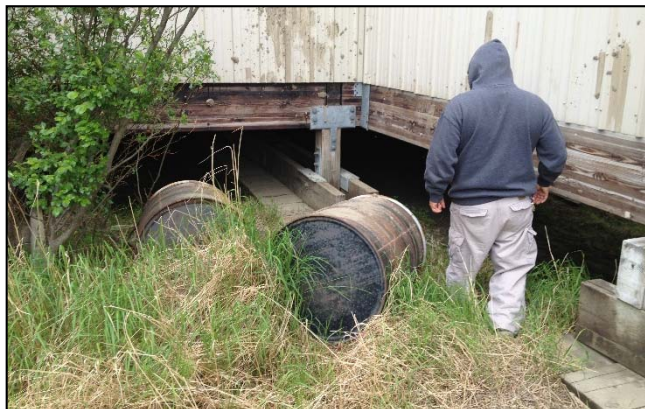
- **AKARNG Armory, 60.694642/-161.969280 (Active)** – This site is the Alaska Army National Guard (AKARNG) armory. It is an active Contaminated Site (File ID 2431.38.002) due to petroleum contamination, which was documented in 1996. It is located across the street from the school's tank farm. Contaminated soil has been removed as part of cleanup actions for this site in the past. A day tank is next to the building and is connected. There was no sign of stressed vegetation. The site is located 250 feet from the Kuskokwim River, which is eroding at 35 feet a year per the BEA study.

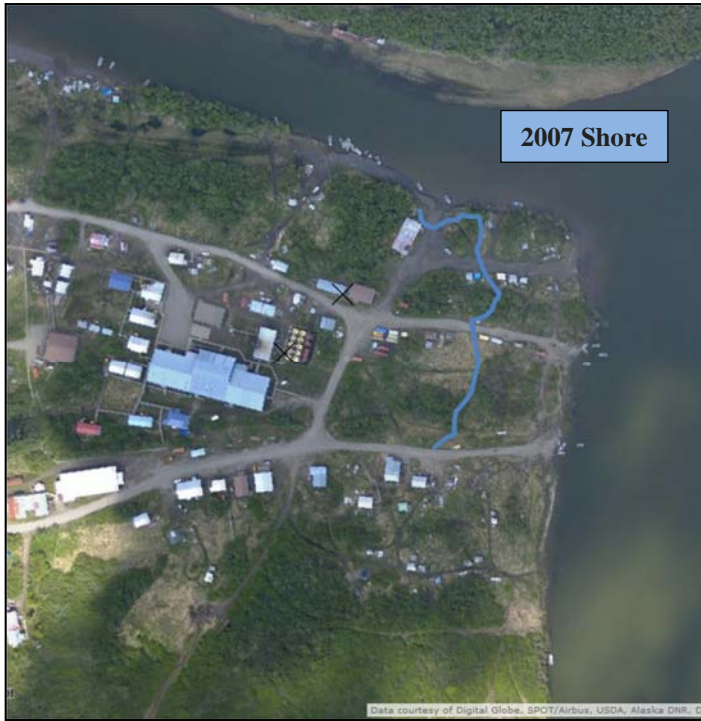
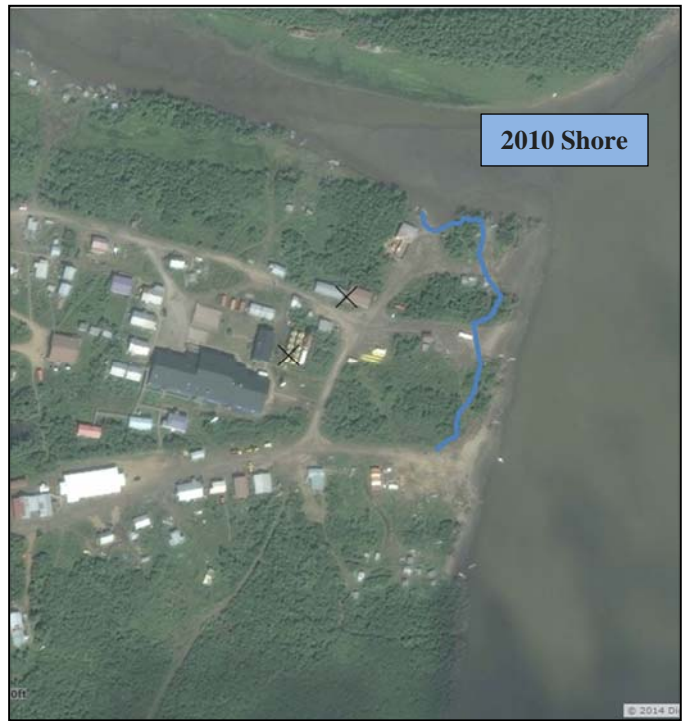
Napakiak is experiencing active erosion along its entire eastern shoreline of the Kuskokwim River. The **Blue Line** in the imagery below indicates the shoreline during our site visit in 2013. Roughly 200 feet have eroded in six years. The Xs are the School Tank Farm and the Armory.
