CIAP WEAR Trip Report Quinhagak (population 690) July 12, 2013

Alaska Department Environmental Conservation (ADEC) Solid Waste Program (Doug Huntman and Jacob Timmons) conducted a Coastal Impact Assistance Program (CIAP), Waste Erosion Assessment and Review (WEAR) site visit for Quinhagak, July 12th, 2013. The following narrative is a brief description of our findings during our July inspection.

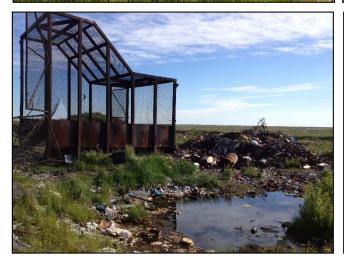
Landfill, 59.709378/-161.885449 (Active) – This permitted landfill is operated as an area fill design and was constructed around 2006. The site is fully fenced, but the gate was broken. There is a collection program available with large yellow dumpsters in town which an operator brings to the landfill. Residents also self-haul waste to the landfill. The landfill has a Summit style burn unit, but it appeared to not be in use as it was in disrepair with broken doors and partially burned waste in it. Waste was spread throughout portions of the site, and there was evidence of open burning of the waste on the ground. Several large ponds of water mixed with waste was observed along with evidence of leachate from these actions. A separate salvage and metals area is available outside the entrance to the landfill, which was piled over 8 feet high in places creating a safety hazard. The landfill is located about 2.5 miles south of the village on a gravel road. It is approximately 730 feet from Kuskokwim Bay.

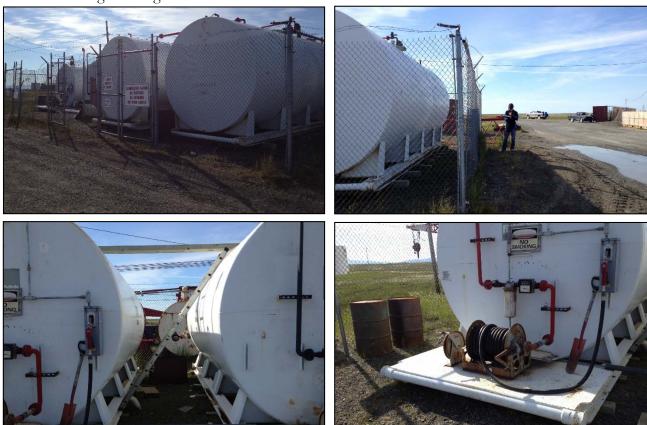
NVK/City Tank Farm, 59.745314/-161.917575 (Active) – This tank farm is located at the barge landing and is owned by the Native Village of Kwinhagak (NVK) and the City of Quinhagak. The site includes two 12,000 gallon storage tanks and two 5,000 gallon dispensing tanks as well as two smaller tanks that are not in use. The four tanks in use are double-walled and were installed in the late 1990s. The tank farm is on a gravel pad and its' perimeter is fenced. The Kanektok River is 190 feet away with a corrugated metal wall installed to protect the barge landing from erosion.
