CIAP WEAR Trip Report Shishmaref (population 598) September 11, 2012 and September 11, 2014

Alaska Department Environmental Conservation (ADEC) Solid Waste Program (Trisha Bower, Sandra Woods, and Rebecca Colvin) and Kawerak, Inc. (Anahma Shannon) conducted a Coastal Impact Assistance Program (CIAP), Waste Erosion Assessment and Review (WEAR) site visit for the Village of Shishmaref, September 11th, 2012. Sharon Nayopuk, IGAP Coordinator, Richard Kuzuguk, IGAP Assistant and Stanley Tocktoo, Mayor helped coordinate our visit. An additional inspection was conducted on September 11th, 2014. The following narrative is a brief description of our findings during the inspections.

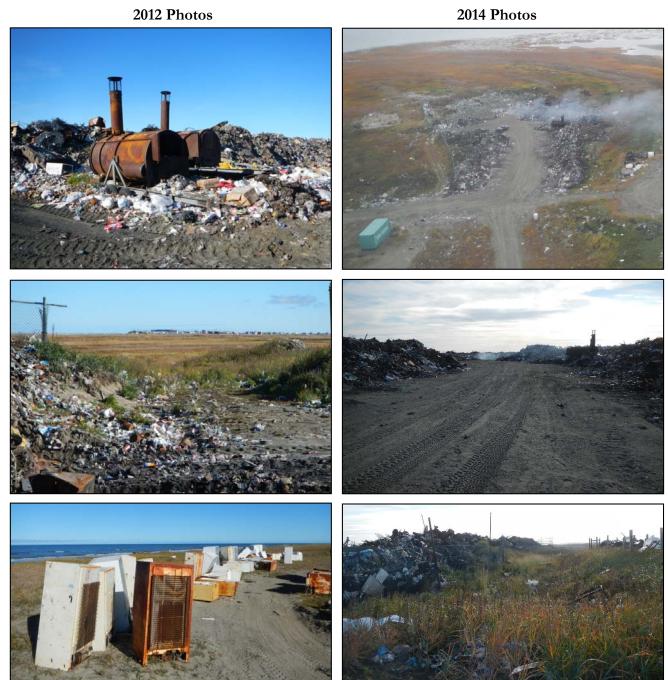
➤ Landfill, 66.243132/-166.114655 (Active) — This 2 acre, permitted landfill is a fenced area fill design located 1.5 miles southwest of the community. It is operated on an as needed basis by the City of Shishmaref. There is waste separation and diversion by the IGAP Program, who collects and recycles/backhauls fluorescent lights, lead acid batteries, household batteries, some scrap metal, and aluminum cans. There is not a collection program, so the community self-hauls to the landfill. It has accepted special waste and construction and demolition waste and does not receive honeybucket waste. The site is partially fenced with the existing fencing in poor condition. There are two Tok burn units in the landfill that are not used. Waste is open burned by residents. Waste has been consolidated into large, unstable mounds. A metals/salvage area is located outside the landfill. It was reported that storm surges impact the landfill as there are no erosion control measures in place at this location. The Chukchi Sea is located approximately 517 feet north from the landfill.

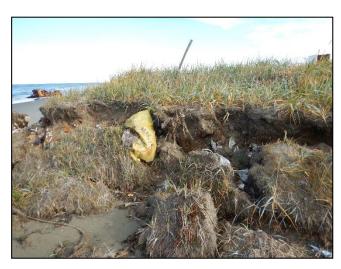
➤ Closed Landfill, 66.244553/-166.114609 (Closed) – This landfill was covered and closed in the 1990s when the new landfill was opened. This site was operated as a trench and fill in the sand. It contains primarily municipal waste. The current metals/salvage area is located on top of this site. This landfill is eroding when the south wind causes high wave action and during the increasingly frequent fall storms. These pictures were taken in 2014, the landfill was not eroding in 2012. It is located at the high tide line of the Chukchi Sea and is not protected by the riprap wall installed by the Army Corp of Engineers located more than 1 mile away in the community.

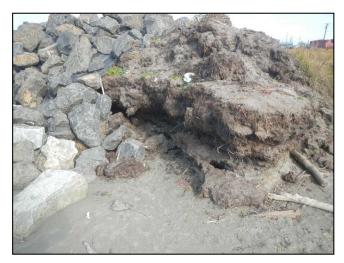
➤ AVEC Tank Farm, 66.254926/-166.072631 (Active) — This tank farm is located in between the school and the sewage treatment lagoons on the west end of the village. It is owned and operated by AVEC for power generation in the community. There are 16 white tanks in one cell and 4 grey tanks in an adjacent cell. This site has an approximate capacity of 176,000 gallons. The tanks are not within a fenced area and a secondary containment system was not visible. There has been a tank farm in this location since the 1970s per imagery review. The tank farm is approximately 570 feet from the Chukchi Sea. A riprap wall was installed by the Army Corps of Engineers in 2013, which helps provide erosion control for this site.

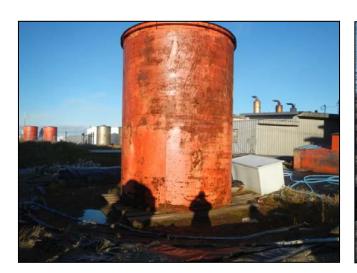
➤ Lone Tank, 66.254953/-166.071058 (Active) – This tank is located on the southwestern side of the community and is adjacent to a water storage tank. It is resting on a wooden pallet within a depression in the ground that is lined. The area contained standing water. The tank was hooked up to a hose line, indicting it was in use. The owner and contents of the tank are unknown. It has been in this location since the 1990s per imagery review. It is 600 feet from the Chukchi Sea. A riprap wall was installed by the Army Corps of Engineers in 2013, which helps provide erosion control for this site.
