CIAP WEAR Trip Report  
Togiak (population 871)  
July 10<sup>th</sup>, 2012

Alaska Department of Environmental Conservation (ADEC) Solid Waste Program and Contaminated Sites Program (Kitrina Persson, Bill O'Connell, and Jamie Gorman) conducted a Coastal Impact Assistance Program (CIAP), Waste Erosion Assessment and Review (WEAR) site visit for the Village of Togiak on July 10<sup>th</sup>, 2012. Anita Atakitlig, IGAP Coordinator, and Joseph Johnston, the landfill operator, participated on the site visits. The following narrative is a brief description of our findings during the July inspection.

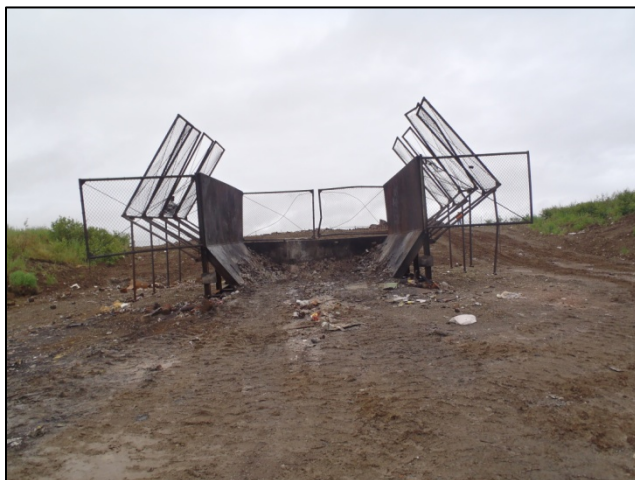
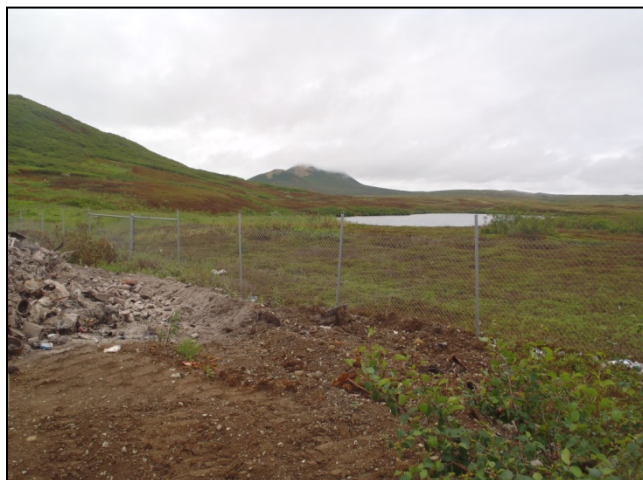
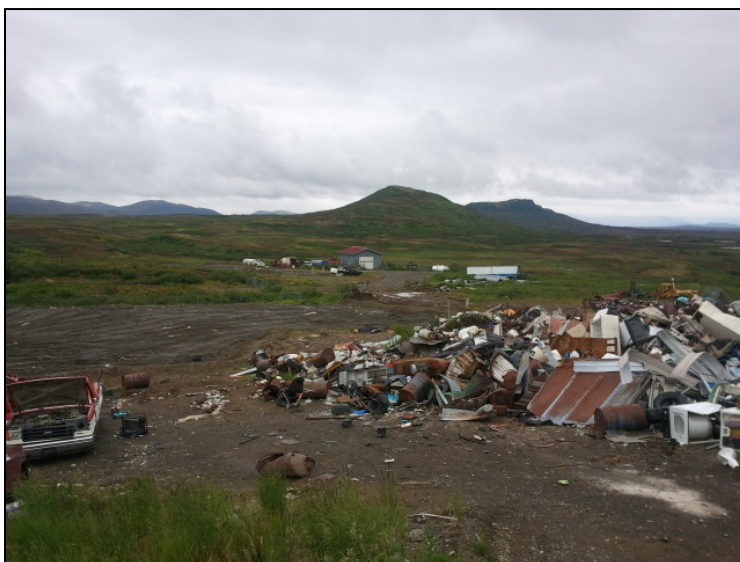
- **Heights Road Landfill, 59.063253/-160.474691 (Active)** – This unpermitted landfill is located at the base of a mining operation, approximately 1.5 miles west of Togiak Heights Subdivision and 3.2 miles west of downtown Togiak. The facility incinerates the majority of waste within a fenced site that has controlled gate access. Salvageable and non-burnable materials are left outside of the fence, unsorted and with open access for the public. Refuse reaches the landfill by means of a trash collection service run by the city. The landfill is located within 200 feet of a water body with fishing and berry-picking areas nearby. The site is located at a higher elevation about 2.1 miles northwest of Togiak Bay.

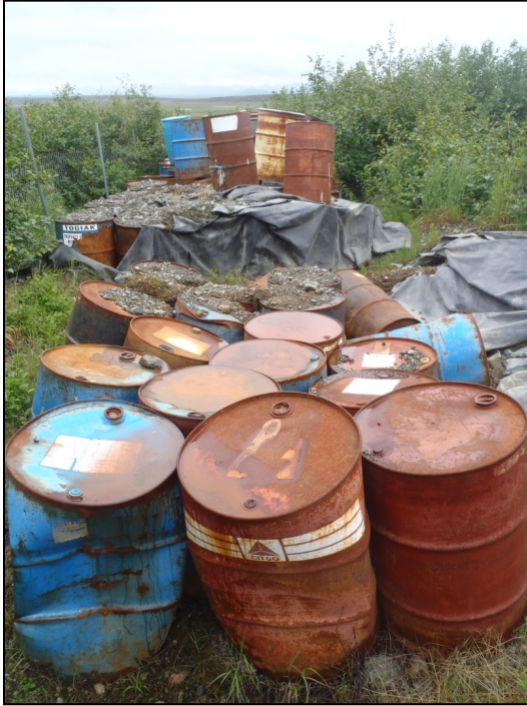
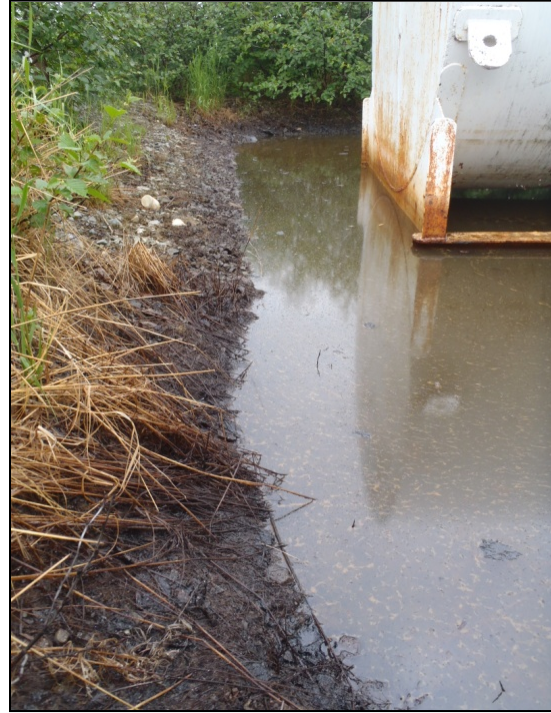
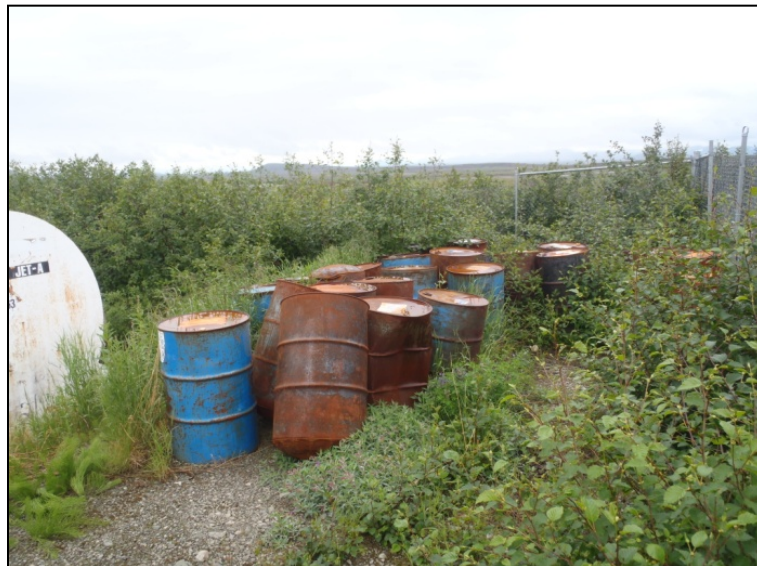
- **Landfill Drum Storage, 59.063923/-160.473782 (Active)** – This fenced area located near the landfill, next to the equipment garage, contains dozens of 55-gallon drums and a large Jet-A fuel tank. About half of the drums, reported to contain contaminated soil, are stored in a lined corner of the fenced site. The rest of the drums are in another unlined corner of the site. Between the two clusters of drums sits the Jet-A fuel tank, which is in a depression that has filled with 8-12 inches of water. Surrounding this depression, the soil is stained and the vegetation is distressed. It is located approximately 700 feet from a small lake and 2.2 miles northwest of Togiak Bay.

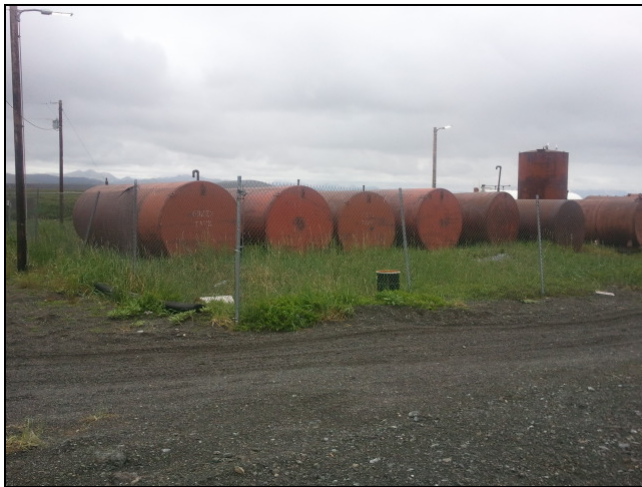
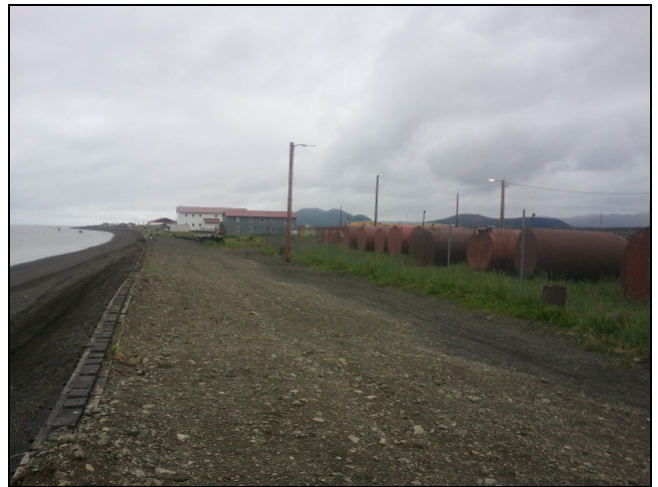
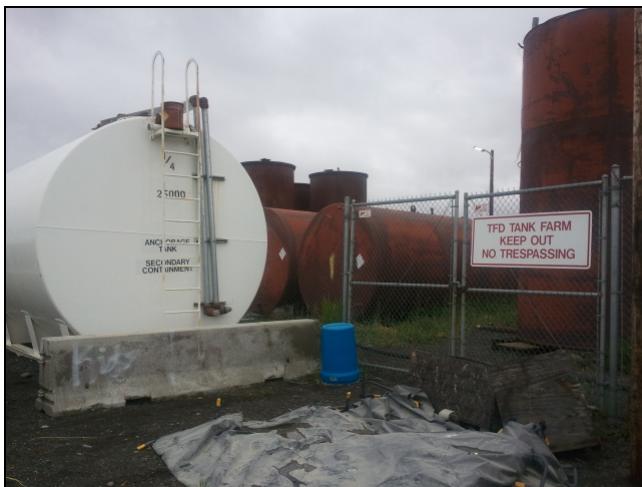
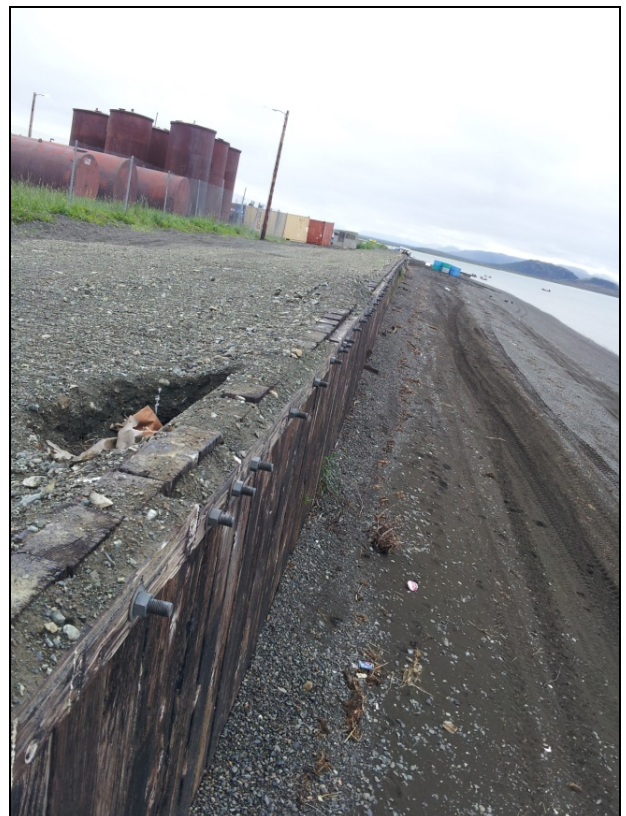
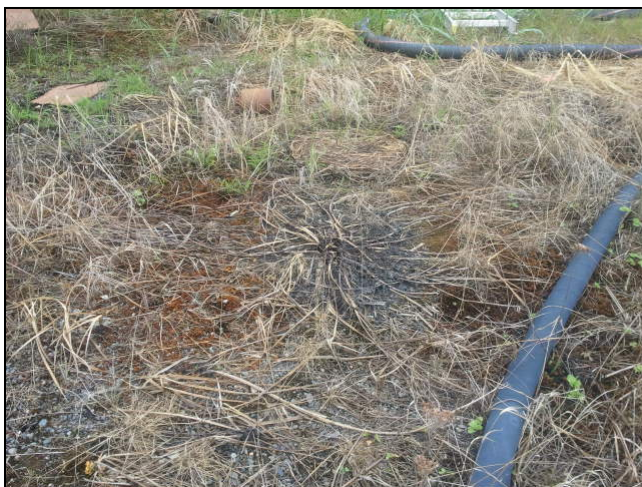
- **TFD Tank Farm, 59.063635/-160.368398 (Active)** – This fenced tank farm contains around 20 vertical and horizontal fuel tanks. There is stressed vegetation around several of the tanks (dead and blackened grass) and the northeast corner has a significant amount of stained soil and dead vegetation. Water Bodies are approximately 110 feet away on either side of the tank farm. Togiak Bay is to the south and a bay-fed slough is to the north. A sea wall has been put between the site and the bay.

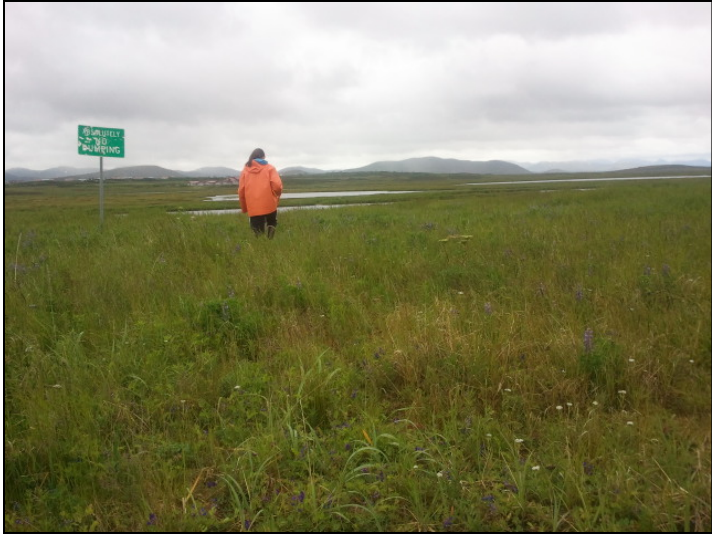
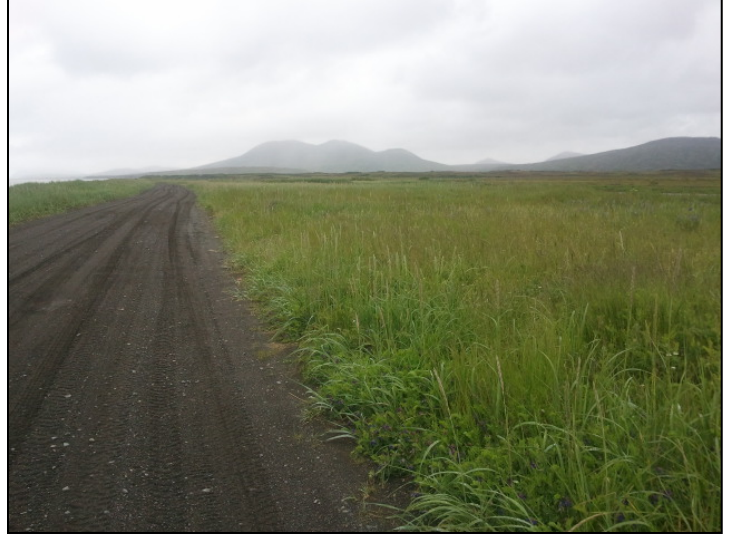
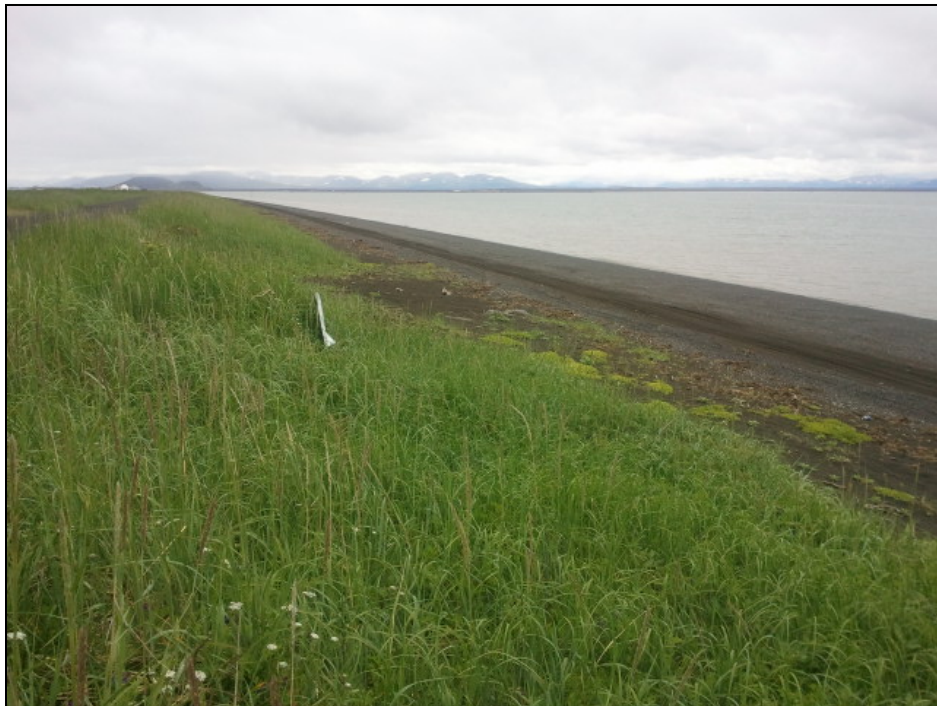
- **Airstrip Landfill, 59.044020/-160.419146 (Closed)** – Located at the end of the runway, between Togiak Bay and a small lake, this landfill operated for 20 years from around 1980 until it was closed between 2000 and 2001. It is completely covered with full vegetative re-growth. The waste at this site was moved to the current landfill when the site closed. Togiak Bay is 140 feet to the south and the lake is 50 feet to the north. The lake contains pike and is sometimes used for fishing. There are many berry-picking areas in the vicinity.
