## CIAP WEAR Trip Report Toksook Bay (population 630) July 8, 2014

Alaska Department of Environmental Conservation (ADEC) Solid Waste Program (Doug Huntman and Jacob Timmons) conducted a Coastal Impact Assistance Program (CIAP), Waste Erosion Assessment and Review (WEAR) site visit for Toksook Bay on July 8<sup>th</sup>, 2014. The following narrative is a brief description of our findings during the July inspection.

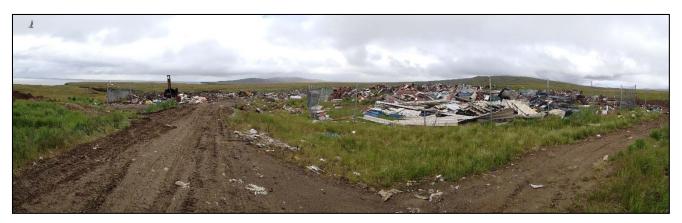
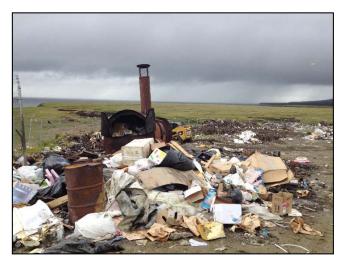
➤ Landfill, 60.525545/-165.120412 (Active) – This approximately 4 acre site is located half of a mile southwest of town and is operated by the City of Toksook Bay. It was constructed around 1986. The unpermitted landfill features two adjacent areas: the area for the landfill is 2 acres and a metals/salvage area that is also 2 acres. The landfill is operated as an area fill landfill and is fully fenced, but it does not have a gate and is open to public access. A part-time operator runs a collection program and residents also self-haul waste. The operator burns the municipal waste in the Tok burn unit located in the landfill. A skid steer is used to consolidate waste and ash; however it is not well consolidated. It is also not covered or is inadequately covered after consolidation. The 2 acre salvage area is not well managed. It contains metals, construction and demolition debris and items for reuse mixed together. The most serious issues this landfill faces are unconsolidated waste, poor burn box operations, little to no waste separation or sorting, and poor management of the salvage area. The nearest source of erosion, Kangirrluar Bay, lies 870 feet away.

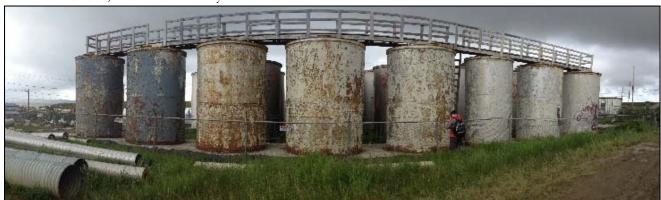
Former AVEC Tank Farm, 60.530249/-165.109105 (Abandoned) – This site is the old AVEC tank farm operated from the 1980s until the new tank farm was completed in 2004. It includes 19 tanks vertical fuel tanks that are all on wooden structures within an earthen berm. The berm is lined, but it is torn in multiple places. A fence surrounds the site limiting public access. All tanks are disconnected and no longer in use. This site is located just north of the consolidated tank farm, about 1,000 feet south of the school. Kangirrluar Bay, the nearest source of erosion, sits 960 feet away.

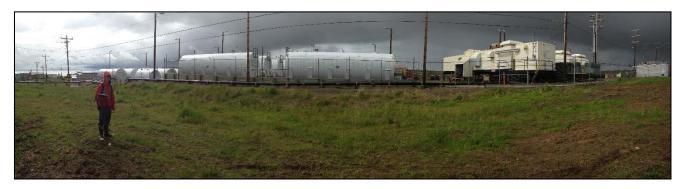
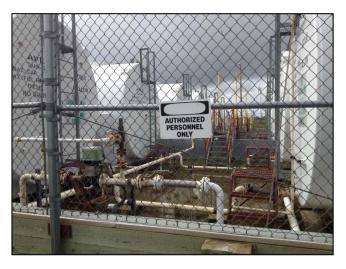
Consolidated Tank Farm, 60.529736/-165.109063 (Active) – This site was constructed in 2002-2004 through a Denali Commission project and is the community's consolidated tank farm. Nunakauiak Yupik Corporation (NYC), AVEC, City of Toksook Bay, and the Lower Kuskokwim School District (LKSD) are the owners of the tanks. Each entity operates its' own tanks except for NYC who also operates the City tanks. The site contains 27 horizontal tanks in two separately fenced, adjacent tank farms connected to a pump house. The western AVEC tank farm contains twelve 27,000 gallon tanks for a total capacity of 324,000 gallons of diesel. The eastern tank farm contains ten 27,000 gallon tanks and five 10,000 gallon fuel oil tanks. Both sites are within a timber dike containment system with multiple cells in each. This site can be found approximately 1,200 feet south of the school. The nearest source of erosion, Kangirrluar Bay, is 800 feet away.

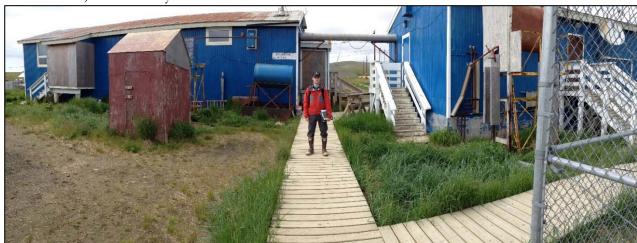
➤ Toksook Bay School, 60.53061/-165.109034 (Closed) – This is a Contaminated Site (File ID 2450.38.002) with the status "cleanup complete – institutional controls" as of 2006. A 4,500 gallon fuel leak in the old elementary school maintenance crawlspace was the cause of contamination in 1990. Contamination remains under the building, but there are no indications of surface water or ecological impacts as of 2006. Natural attenuation is expected to degrade the remaining contamination over time. Institutional controls consist of that ADEC must approve any excavation, transport, remediation and/or disposal of soil from the school site. No indication of contamination was found during the 2014 site visit. This site is located on the west side of town, about 600 feet south of the school. Kangirrluar Bay, the nearest source of erosion, lies over 1,000 feet away.

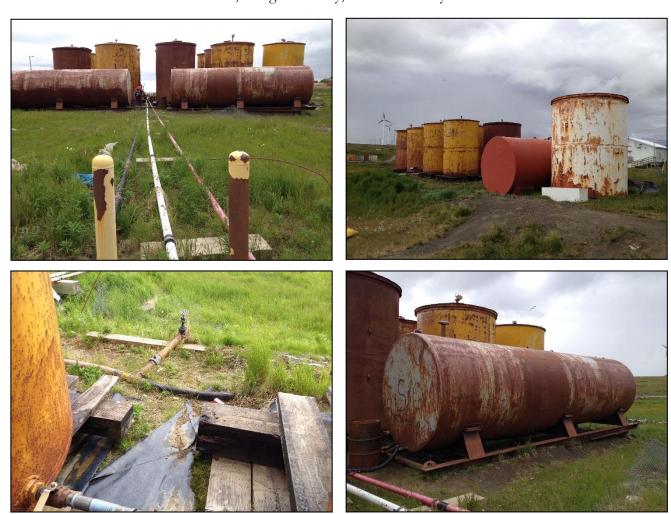
➤ South Tank Farm, 60.528621/-165.10618 (Abandoned) – This site consists of sixteen old fuel tanks, both vertical and horizontal. All of the tanks appear to be empty and disconnected, without secondary containment and not in use for many years. The site is located on the southeast side of town, 1,600 feet southeast of the school. The owner of the site is unknown. The nearest source of erosion, Kangirrluar Bay, is 180 feet away.

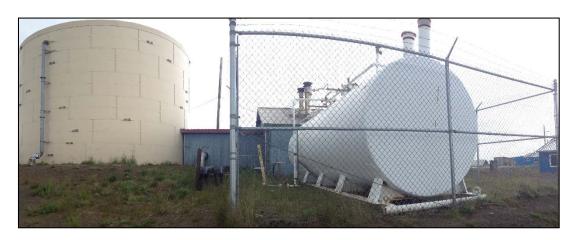
➤ Water Plant Fuel Tank, 60.53011/-165.107838 (Active) – This site is located about 1,000 feet south of the school by the city water tank. It includes one approximately 18,000 gallon fuel tank for the water plant. Public access is restricted by a fence. It is owned by the City of Toksook Bay. The nearest source of erosion, Kangirrluar Bay, sits 800 feet away.
