Controlling Urban Runoff to Cottonwood Creek Final Report Phase 1 & 2

2.28.2021

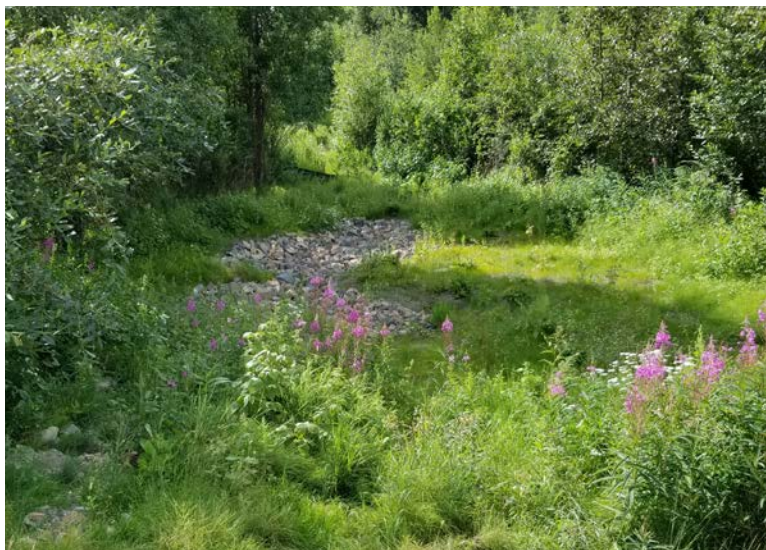
Low Impact Development (LID) and Green Infrastructure (GI) are at work in these projects, helping to improve water quality and controlling storm flows.

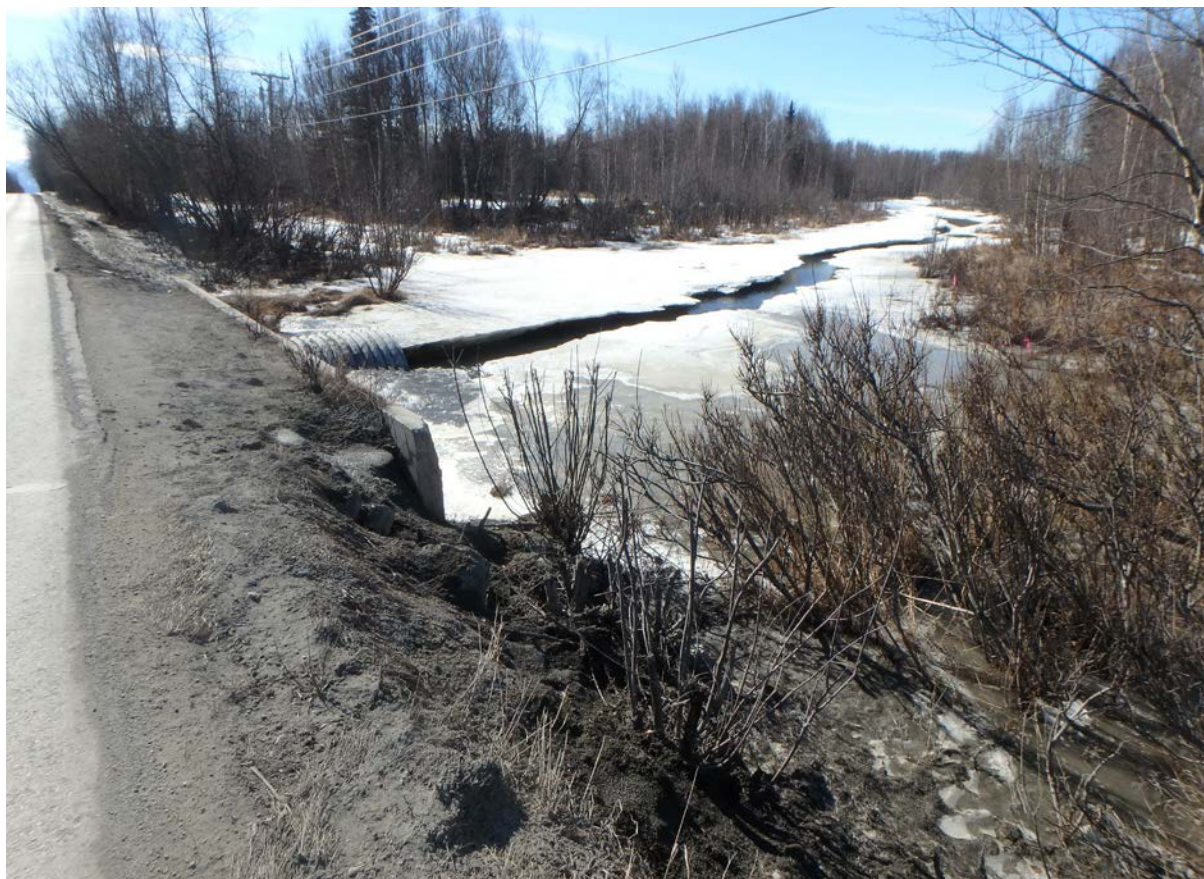
2018: Water collection in spring runoff adjacent to Fern Street contains sediment and pollutants from Knik Goose Bay Road, Palmer-Wasilla Highway, and Fern Street. The sediment and pollutants smothered native vegetation and created a sediment plume within Cottonwood Creek.

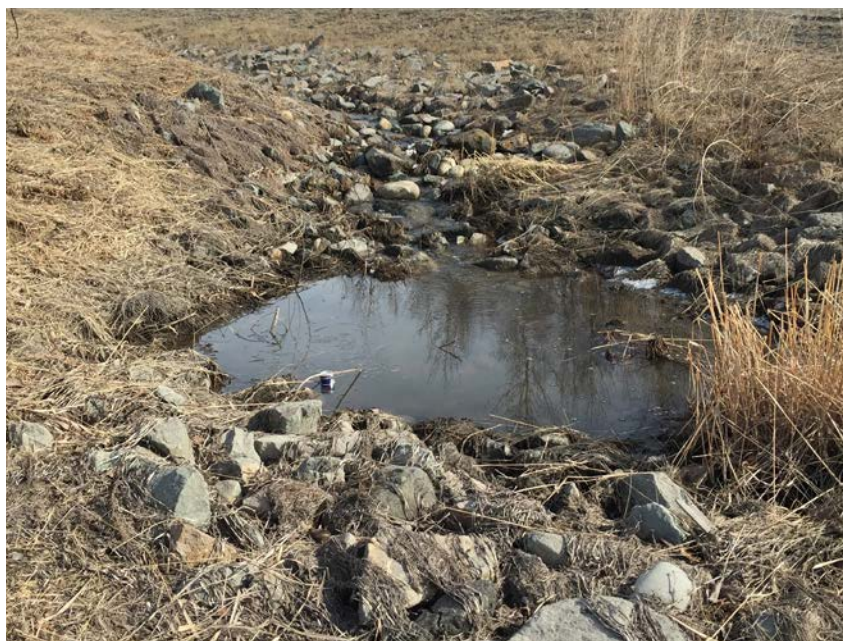
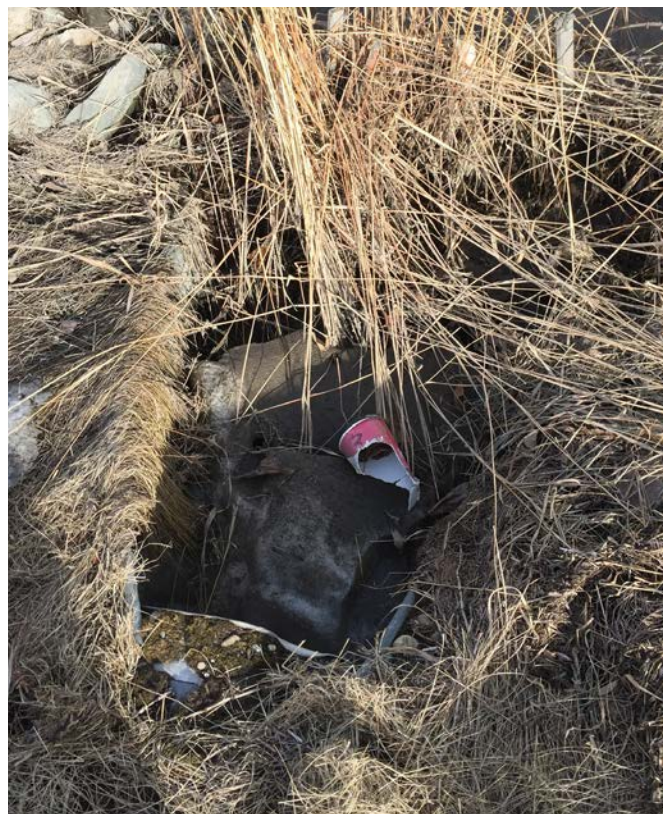
Based on site reconnaissance, drainage through the Fern Street site contains sediment and pollutants* collected from Knik Goose Bay Road (KGB) by the ATV track rather than the rock lined ditch. Sediment load of sand and salt is intensified from Fern Street, KGB, the Palmer-Wasilla Highway, and side streets adjoining the major collectors. Fern Street roadside ditches contain decaying organic matter, predominately composed of invasive plants. Trash and weed seeds are trapped by rock-lined ditches that provide minimal filtration of sediment and pollutants and few collection areas.

**Pollutants may include oil and petroleum hydrocarbons, heavy metals such as zinc, copper, and lead, nitrogen and phosphorus from pesticides and herbicides, along with coliform and bacteria.*

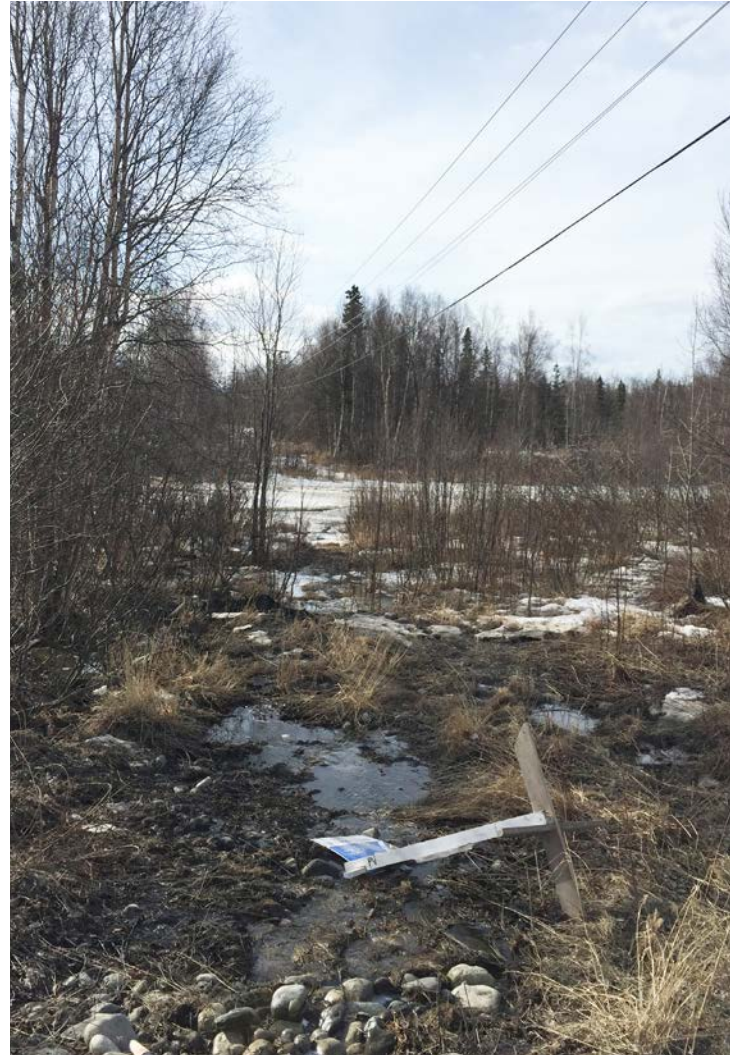
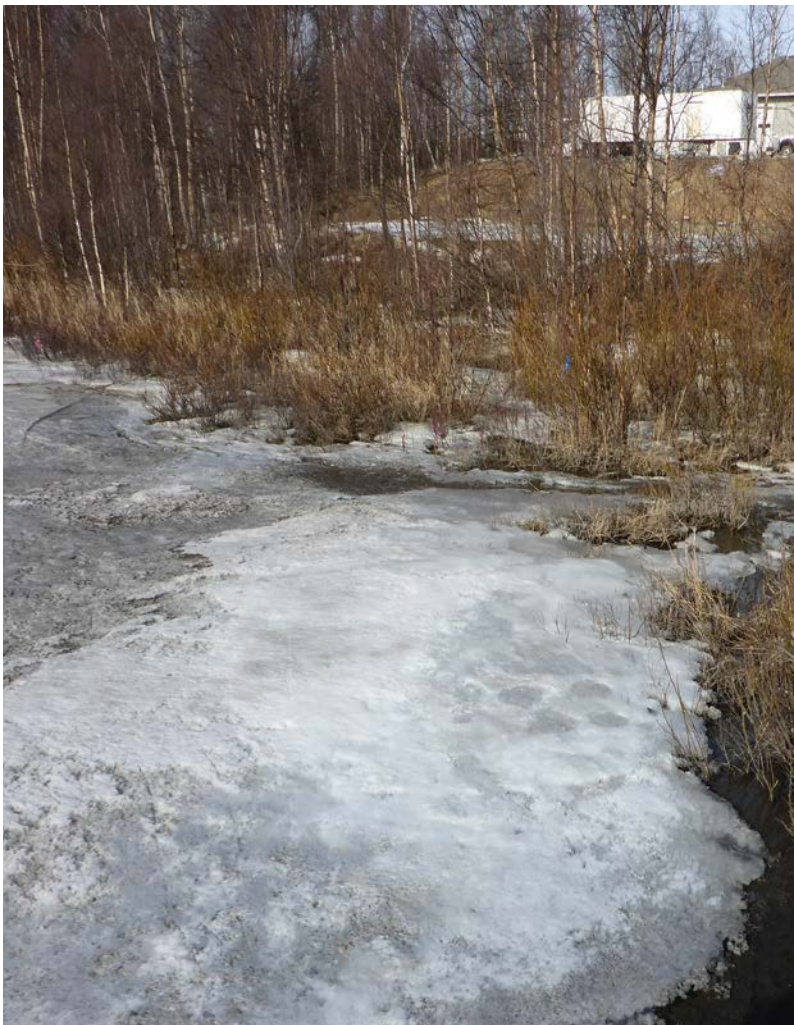
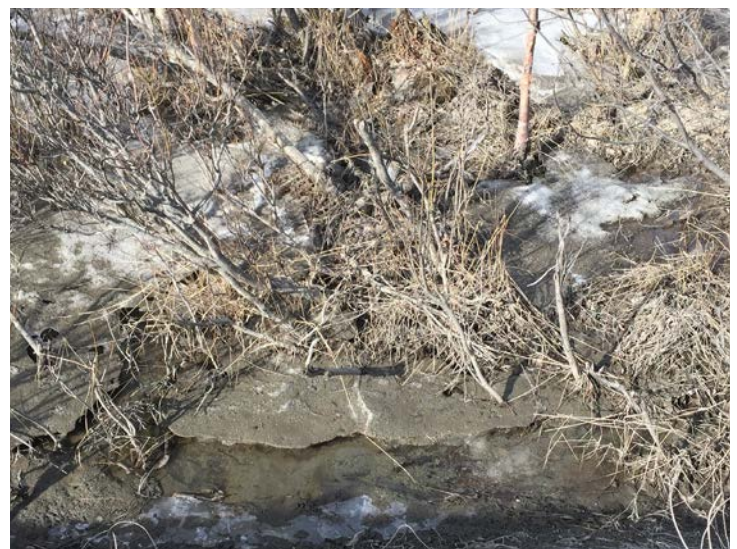
On the Phase 2 site, high volumes of stormwater flood native vegetation adjacent to Fern Street and Cottonwood Creek. This concentrated stormwater runoff contains large amounts of silt, gravel, sand, and pollutants. Water velocity flattens existing vegetation diminishing any filtration qualities it may have provided. The drainage area widens after leaving the driveway culvert, slowing runoff and allowing silt, gravel, sand, and pollutants to settle out. Debris and trash are deposited as the flow channel winds around a semi-buried silt fence. The runoff enters Cottonwood Creek as a drainage plume extending over the remaining creek ice to empty directly into open waters.

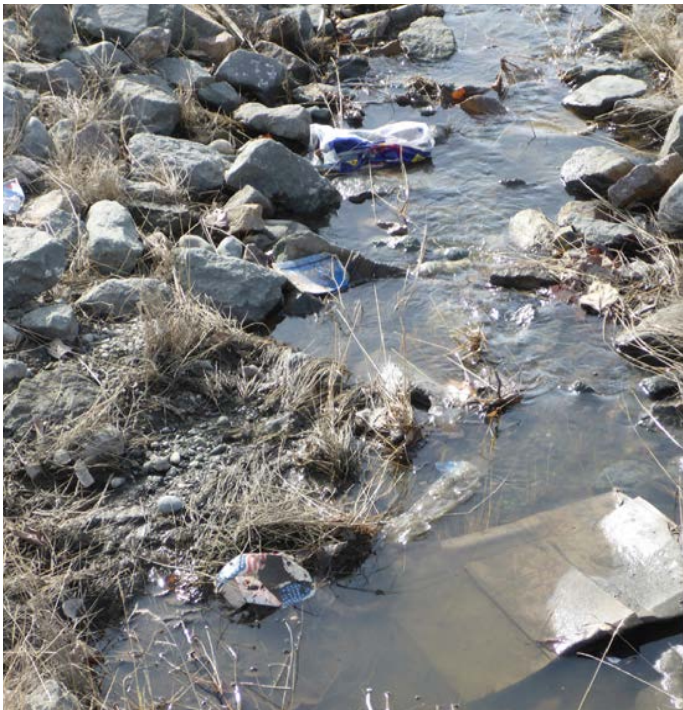
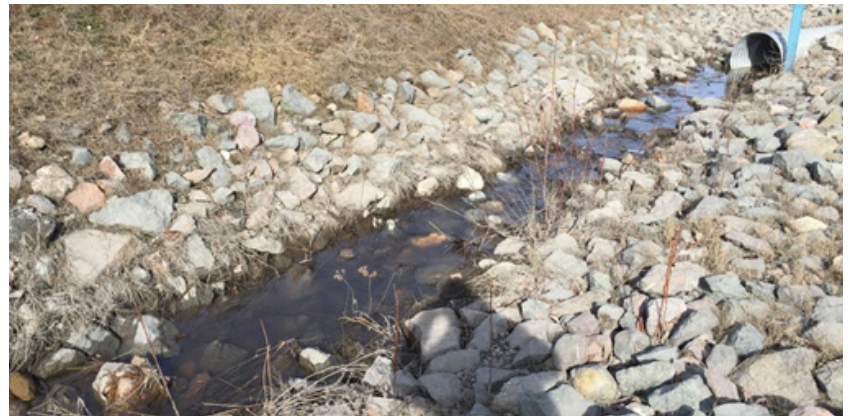
High volumes of runoff during spring breakup and from summer storms erode soils above the rock-lined ditches. Yet, as the runoff amounts are recede, silt, debris, and pollutants are deposited along the Fern Street ditches. In some locations, invasive weeds have taken root in the depositional materials, spreading to surrounding areas.

Trash and debris collect in rock-lined ditches as runoff slows. Siltation creates an ideal growing medium for invasive weeds that, without maintenance, choke off water channels forcing runoff waters outside of ditches where erosion, flooding, and glaciation can occur.

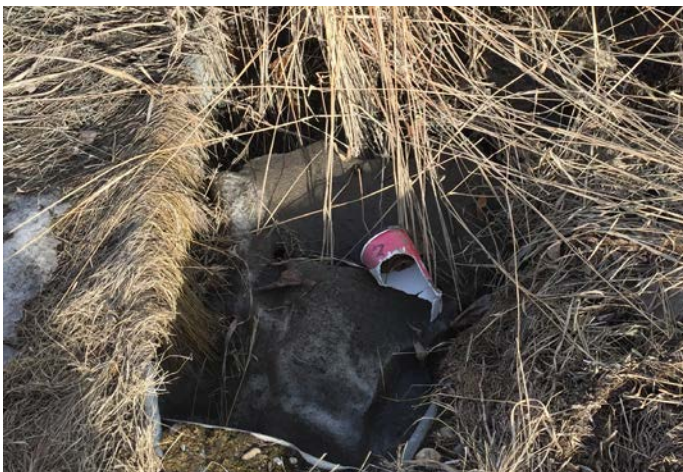
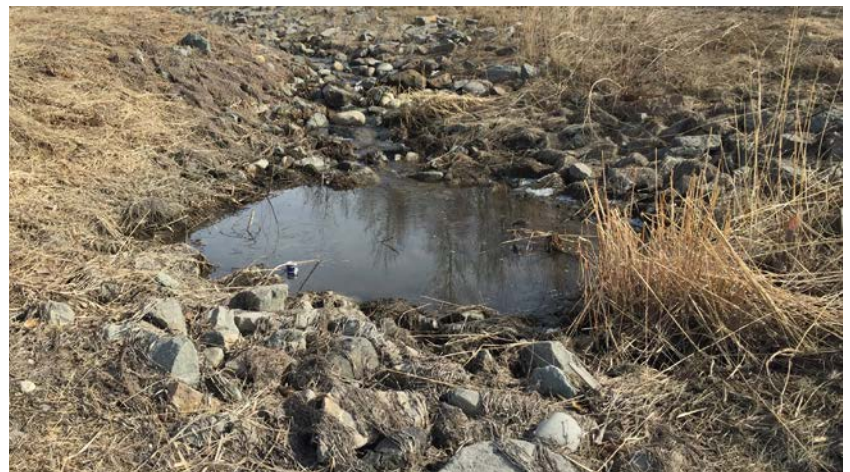
Stagnant water collecting in pond areas contains a high level of pollutants. Open stagnant water encourages mosquito breeding conditions.

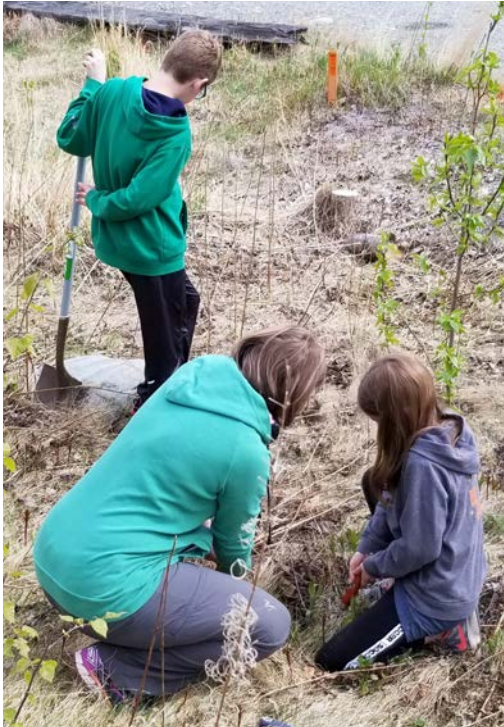
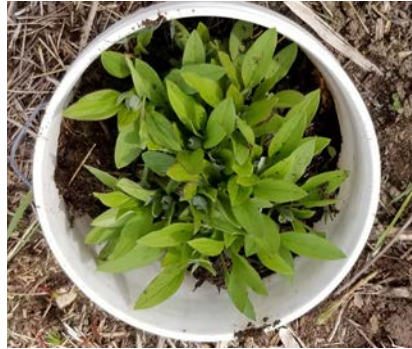
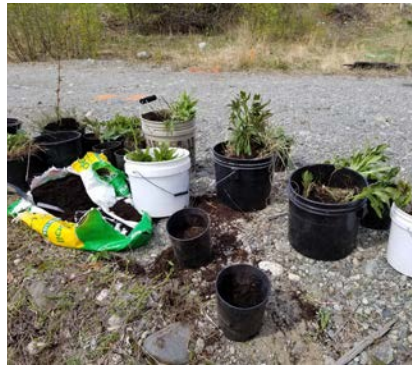
Volunteers assisted with harvesting native plants from the site. These plants were replanted as part of Phase 1 remediation.

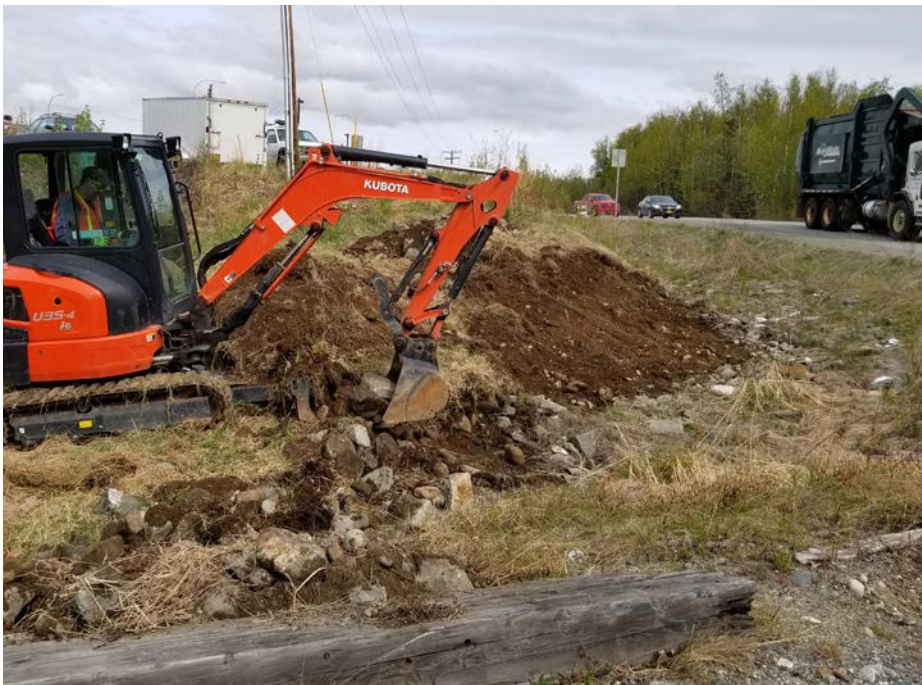
Trees were removed from under the utility lines. Riprap and stones were collected by volunteers and as part of excavation for reuse during construction of bio-infiltration cells and protecting channels from erosion.

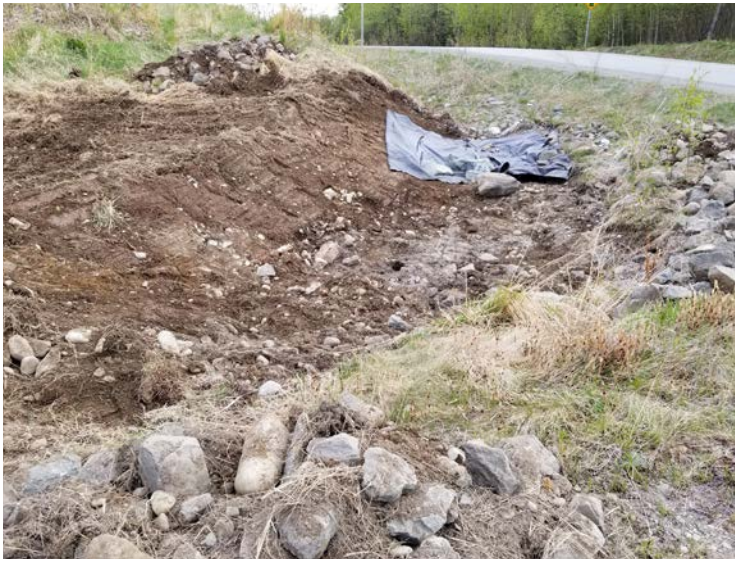
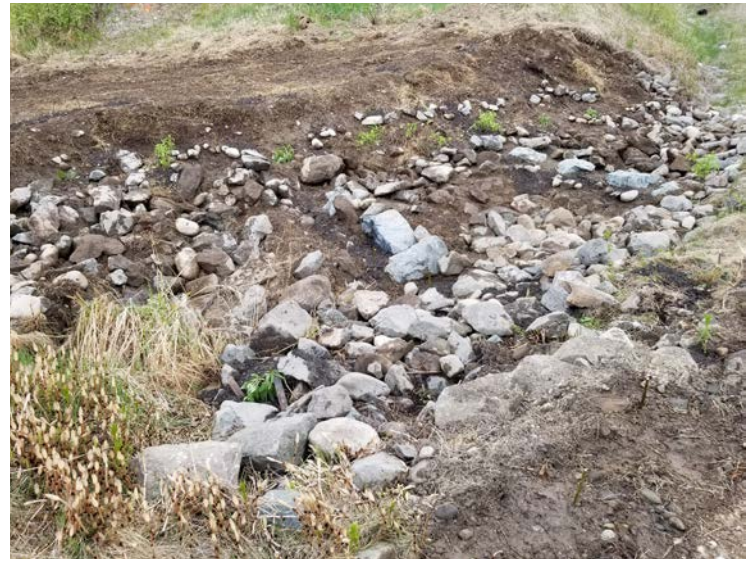
During construction, each bio-infiltration cell was created by lining the area with geotextile fabric covered with a base layer of 8" minus stone and riprap to create large, water-holding voids. The base was then covered by additional geotextile fabric with a layer of infiltration soil (equal mix of native soils high in organic matter and sand) placed over the fabric. Stabilization vegetation, including the harvested plants, was installed in the infiltration soils. Exposed stone weirs help to dissipate runoff flows; stabilized vegetation now holds soils and filters contaminants; infiltration soils collect runoff allowing it to soak in; native vegetation is used as phytoremediation, removing pollutants from the stormwater entering the site.

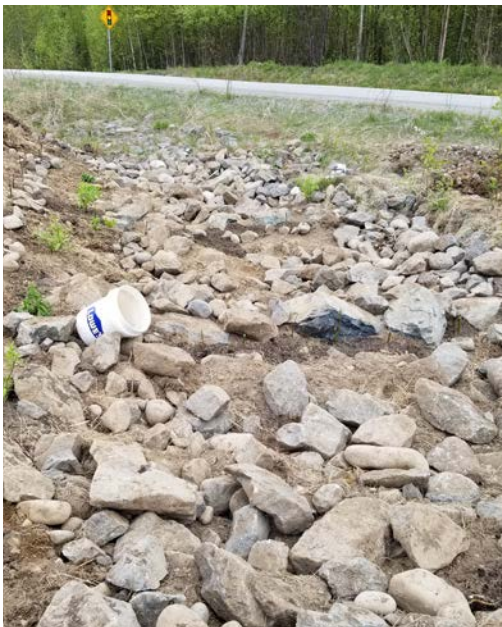
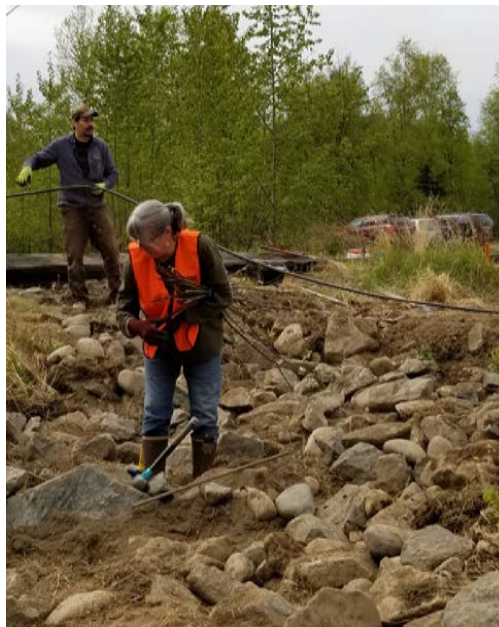
Stabilization used harvested riprap, geotextile, and infiltration soils to create bio-infiltration cells, spillways, and filtration strips as part of the Natural Drainage System construction. Harvested site plants were reestablished along with native plantings that would tolerate flooding and deposition. Depth of bio-infiltration cells was increased to maximize water infiltration. Spillways with exposed rock and native shrubs will slow runoff. Removal of trees from under utility lines will decrease maintenance requirements.

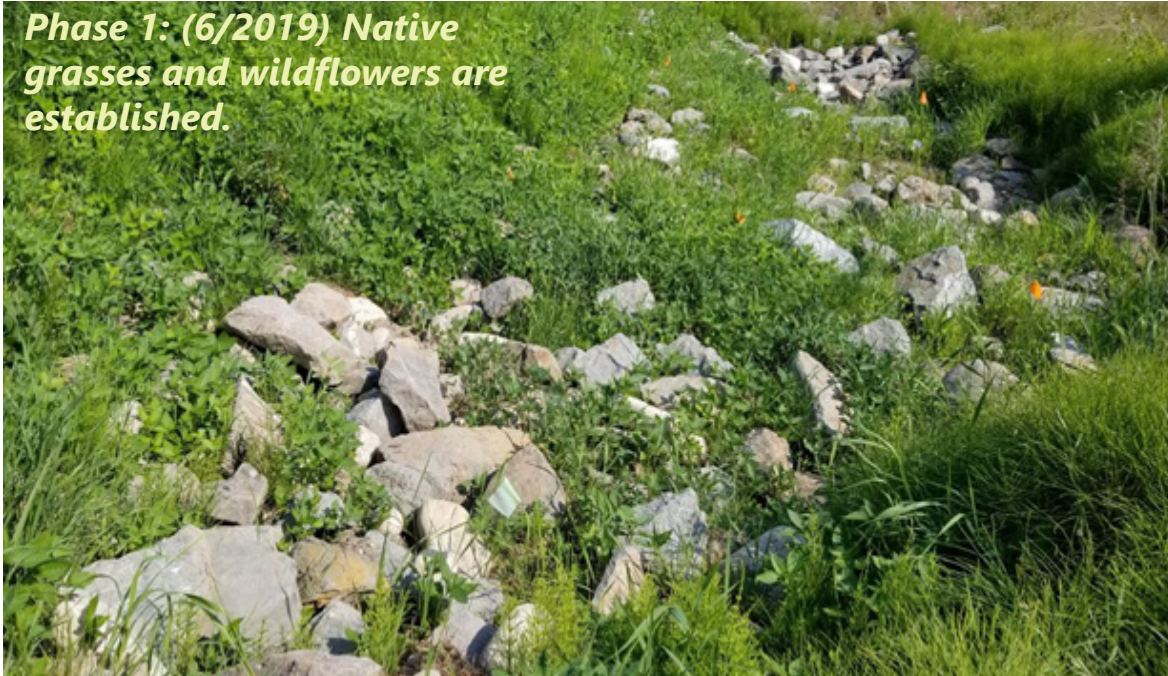
Phase 1: (6/2019) Native grasses and wildflowers are established.

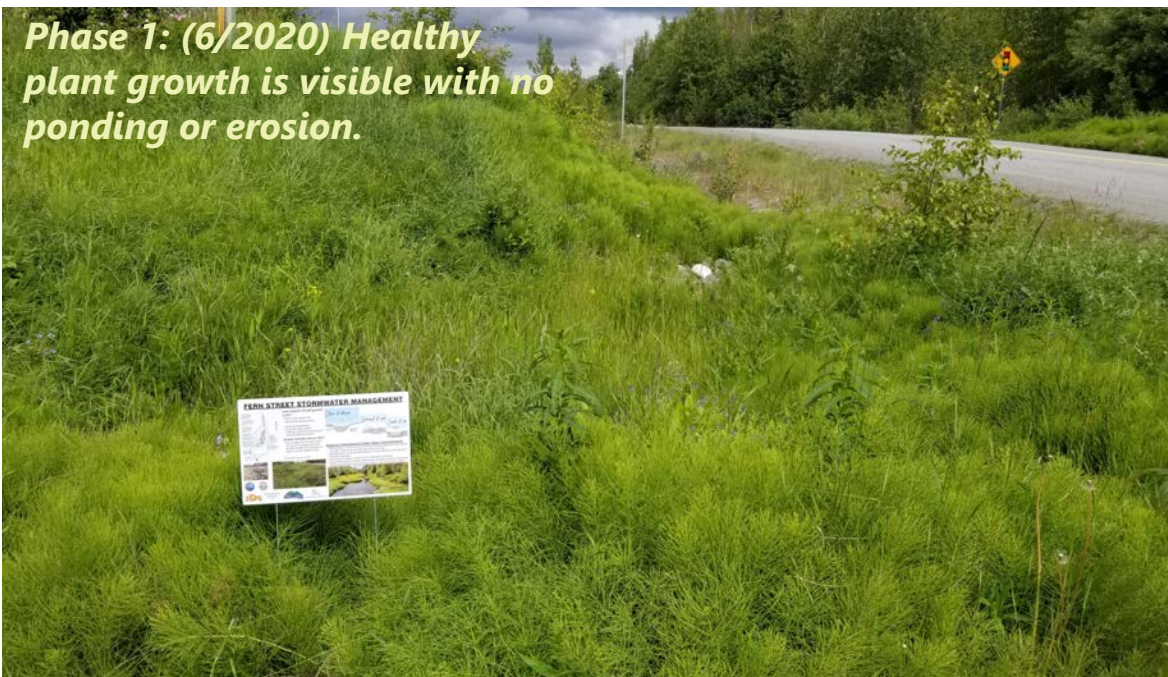
Phase 1: (6/2020) Healthy plant growth is visible with no ponding or erosion.

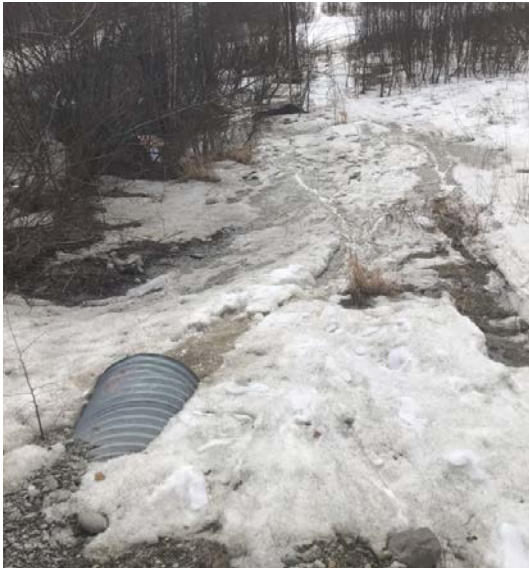
PROJECT WATERSHED VOLUMES

Volumes passing through culverts may be severely underestimated due to limitations of data provided and unavailable Knik Goose Bay Road redesign plans.

*FSS Watershed volumes fail to include significant collection areas to the west of the project.

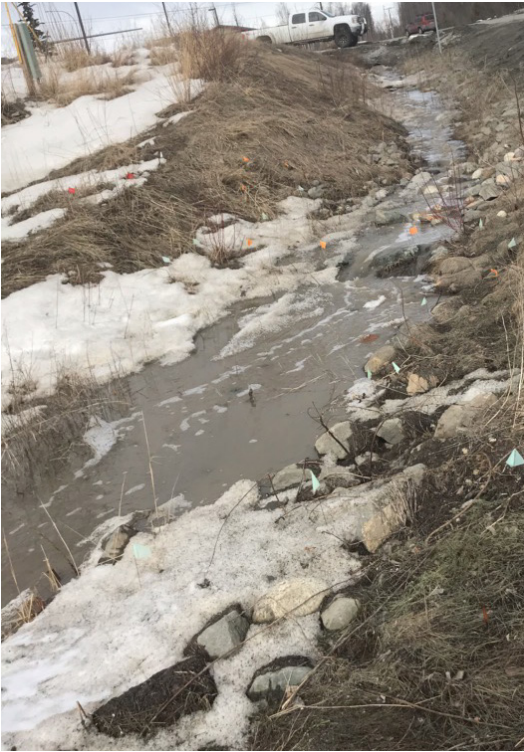
In spring of 2020, runoff entering Phase 1 treatment areas contain high amounts of pollutants such as heavy metals, hydrocarbons, bacteria, and silt. Weirs and other stabilization used to slow runoff are visible in the channel.

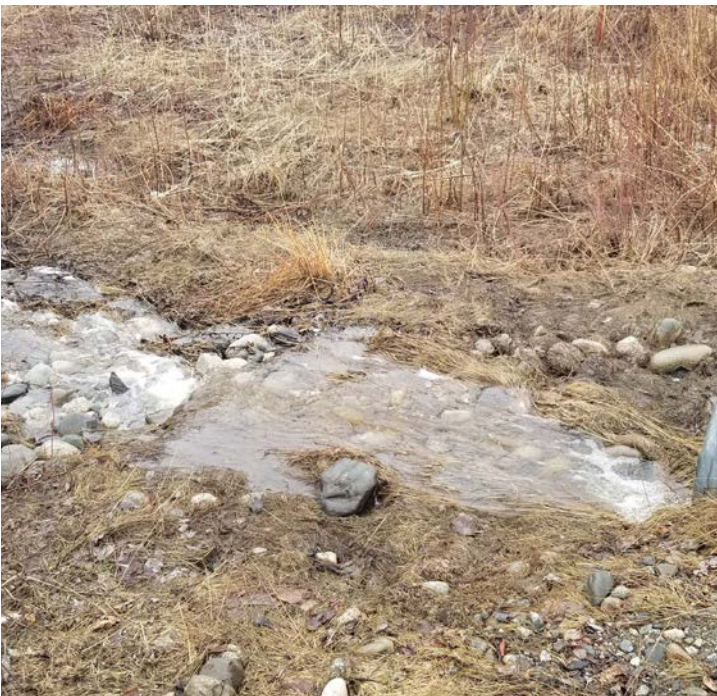
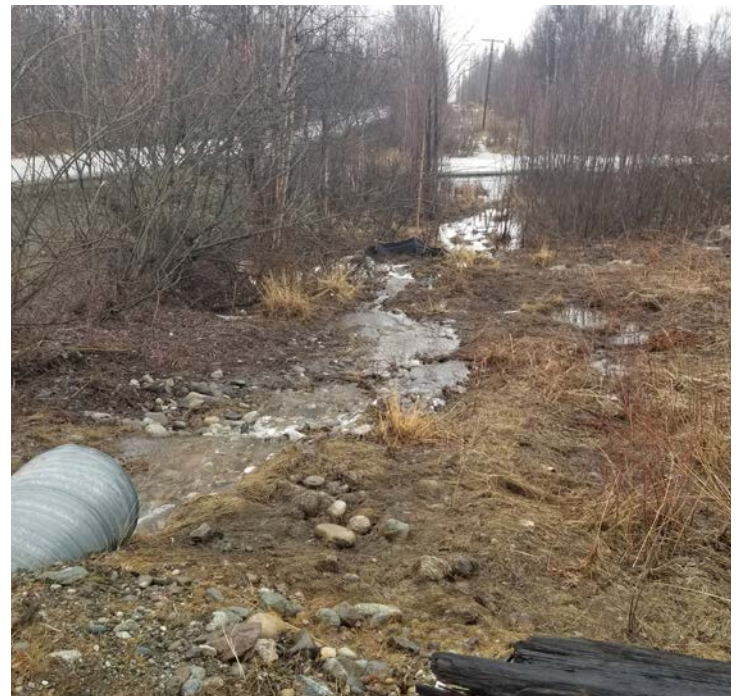
In spring of 2020, stormwater entering Phase 2 remains significant yet appears much clearer after exiting the existing culvert. For the Phase 2 site, the concentrated runoff is highly prone to causing erosion as it moves through the site and exits into Cottonwood Creek.

Assessment options for Phase 2 remediation focused on erosion, removal of contaminants, and filtration. The design approach would undertake removal of pollutants not captured in Phase 1, erosion and siltation occurring in Phase 2, and reducing turbidity and high water volumes entering Cottonwood Creek.

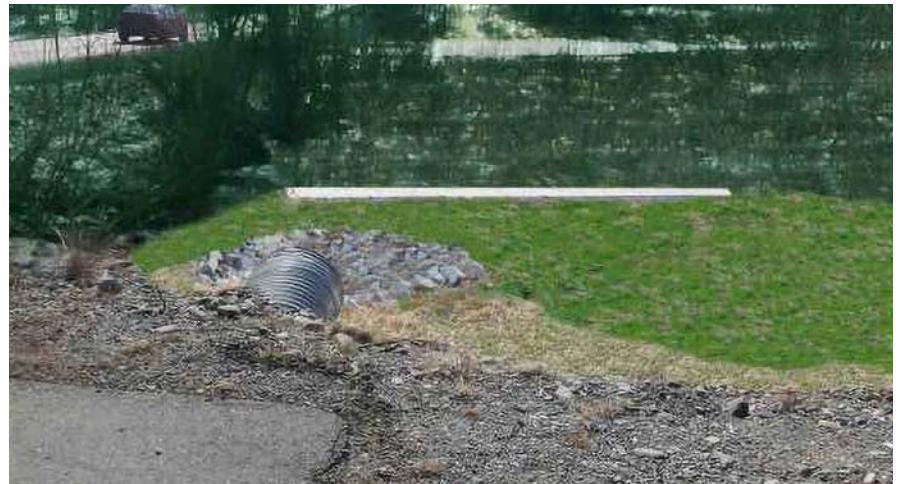
Phase 2 is a natural bowl shape, collecting water from all sides that exits into Cottonwood Creek, to the south. Recommendations from Cottonwood Creek Stormwater Analysis (2017) recognized the importance of using the Phase 2 site for stormwater treatment. “Flow Spreader” concepts from this report show construction in the Phase 2 site.

A flow spreading device could be installed to spread out the concentrated flow and reduce channelization. As evident in the spring breakup photos, the runoff flows under the snow pack, indicating that the flow spreading device may function in spring, as well, as long as the flow spreading trench was not completely frozen. A conceptual rendering is shown in Figure 8 and the layout of a conceptual flow spreader is shown in Figure 15. Alternatively an OGS device in the piped system under Knik-Goose Bay Road could be considered to reduce the total sediment load, but sediment could still be picked up along the ditch system downstream of the OGS and reach Cottonwood Creek.

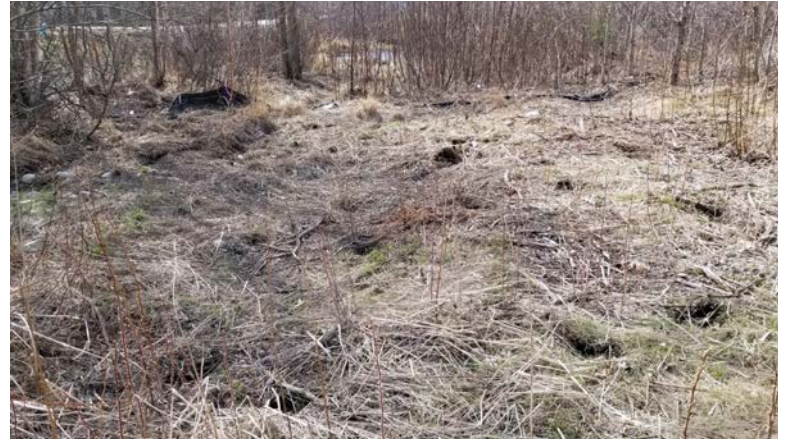
In spring of 2020, runoff entering Phase 2 areas shows impacts of spring runoff containing high amounts of pollutants and silt. LID and GI techniques will address stabilization, infiltration, collection, filtration, and dissipation when installed. Natural vegetation is flattened by runoff allowing polluted stormwater to drain directly into Cottonwood Creek.

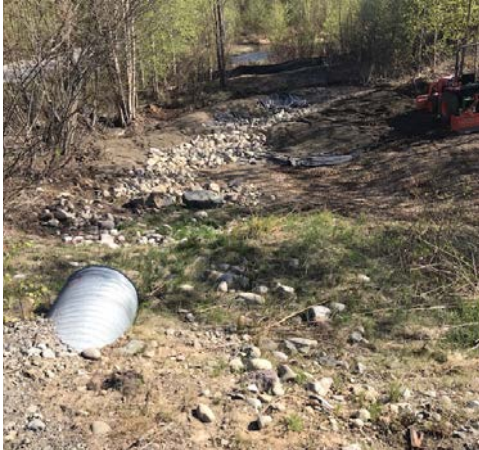
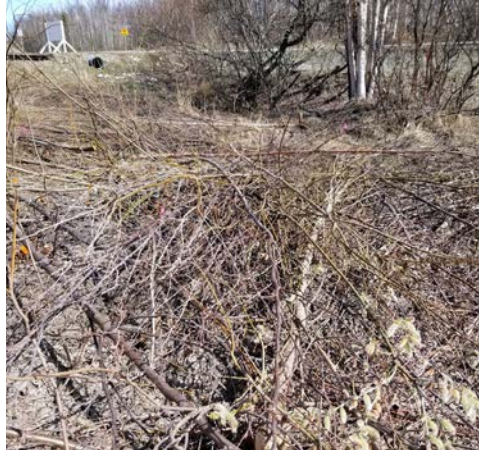
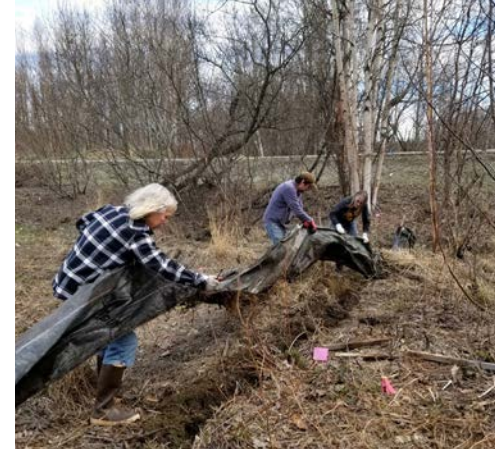
On-site, the project was constructed within Fern Street's right-of-way (ROW). Existing vegetation along the Fern Street was retained for filtration of road runoff. Tall willows were removed to eliminate continued maintenance by Matanuska Electric Association (MEA) to avoid conflict with their overhead utility lines. Existing native plants were harvested for relocation and the half-buried, old silt fence was removed.

Stormwater channels were constructed and stabilized along with dissipation weirs and filter strips. Collection areas, the bioinfiltration ponds, were lined with geotextile fabric and constructed with a base layer of 8" minus stone. Over this are of large voids, additional geotextile fabric was installed. The geotextile was covered with infiltration soil (an equal mix of native soils high in organic matter and sand) where stabilization vegetation was planted. Exposed rock areas will collect depositional fill over time, creating voids for native plants.

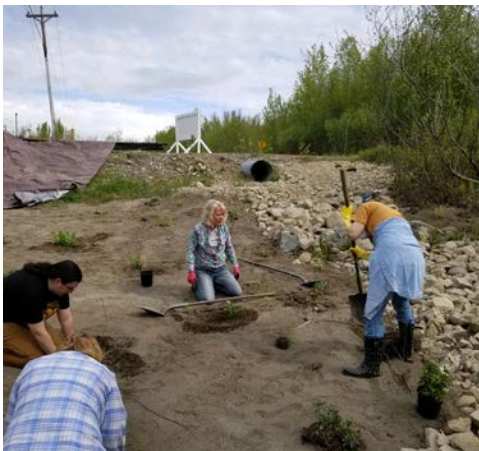
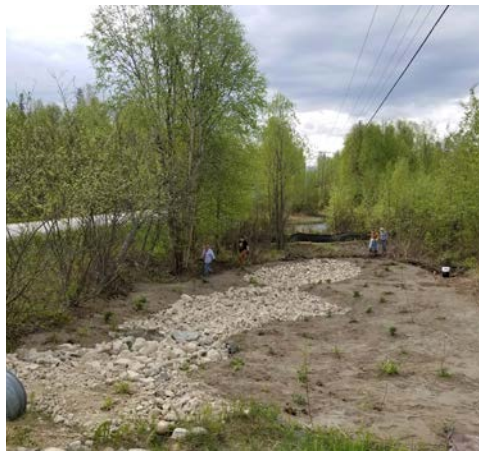
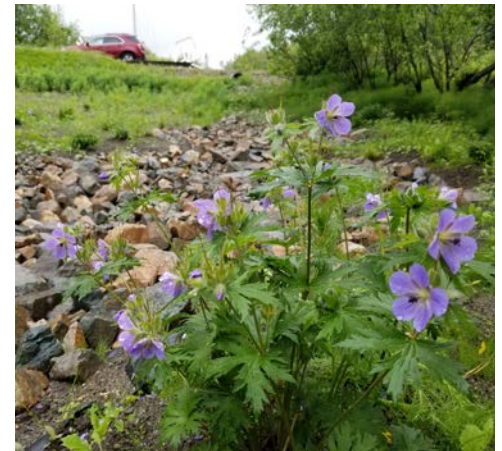
Plantings in Phase 2 were predominately native shrubs, ground covers, grasses and perennials. These elements served to enhance and unify the natural landscape, stabilize soils, filter sediment and contaminants. In this Phase, specific plants were chosen to tolerate flooding, deposition, and pollutants while capable to withstanding high velocity flows. The infiltration soils provide natural drainage with a high water-holding capacity. Trees or large shrubs in conflict with overhead utilities were removed or relocated outside of the utility zones.

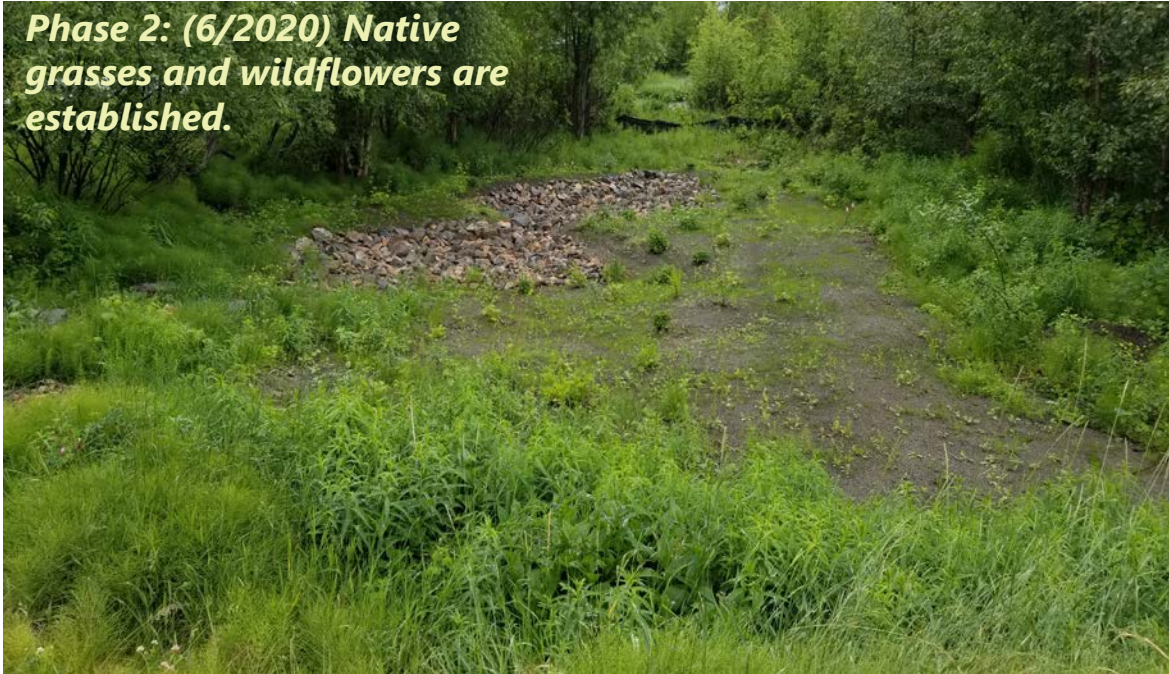
Phase 2: (6/2020) Native grasses and wildflowers are established.

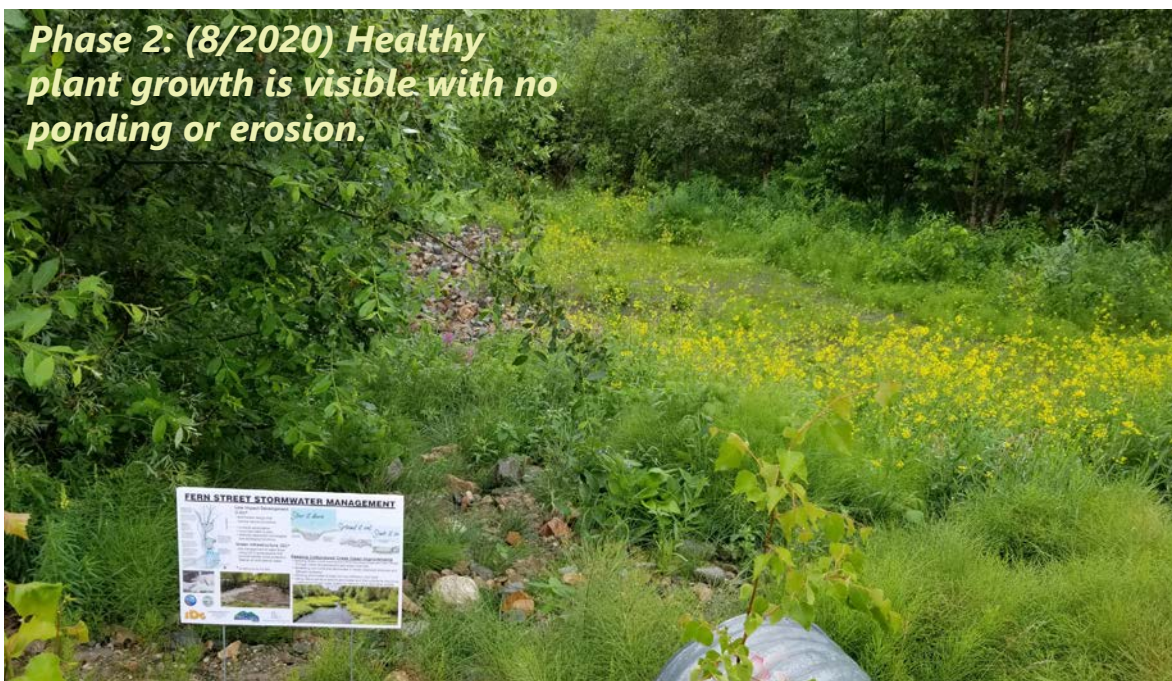
Phase 2: (8/2020) Healthy plant growth is visible with no ponding or erosion.
