ALASKA DEPARTMENT OF ENVIRONMENTAL CONSERVATION
Division of Spill Prevention and Response
Prevention Preparedness and Response Program
SITUATION REPORT (SITREP)

Tug *Francis Snow* **Sinking Steamboat Slough**

SITREP #: 1 and Final

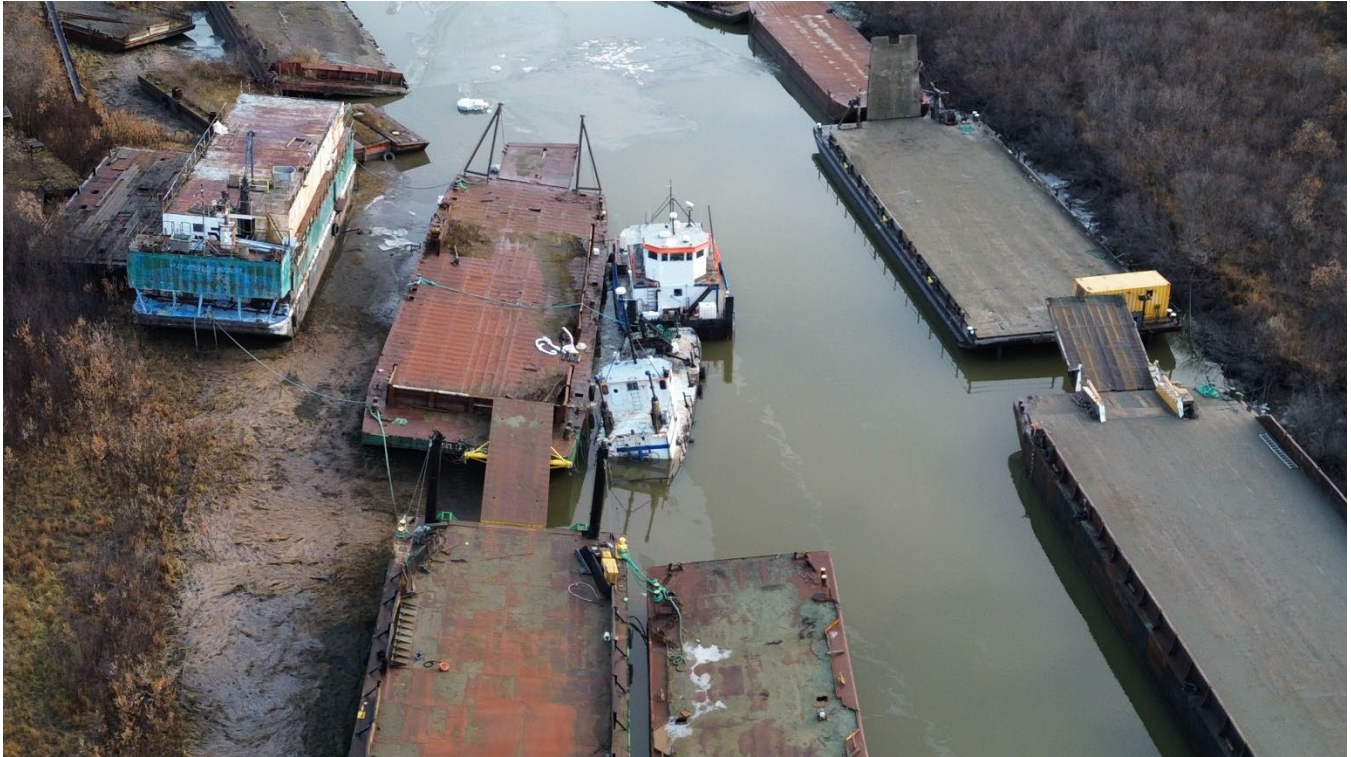
CAUSE OF SPILL: The 61.6 ft. tug vessel, *Francis Snow*, was moored alongside a grounded barge in the Steamboat Slough. Following discovery of the oil sheen, the *Francis Snow* was found to be partially sunken, with the stern of the boat beneath the water. The cause of the vessel sinking was reported by Vitus to be a 1.5-inch crack in the hull at frame 1 starboard side.

Figure 1. Tug *Francis Snow* in Steamboat Slough on October 31, 2023. Photo provided by Charles Guest with Bethel Search and Rescue.

SOURCE CONTROL: The source has been controlled. Vitus crew used dewatering pumps to refloat the vessel at approximately 6:00 p.m. on Tuesday evening, October 31st. Additionally, the crack in the hull was partially plugged, using a soft patch and plywood, to keep the vessel afloat.

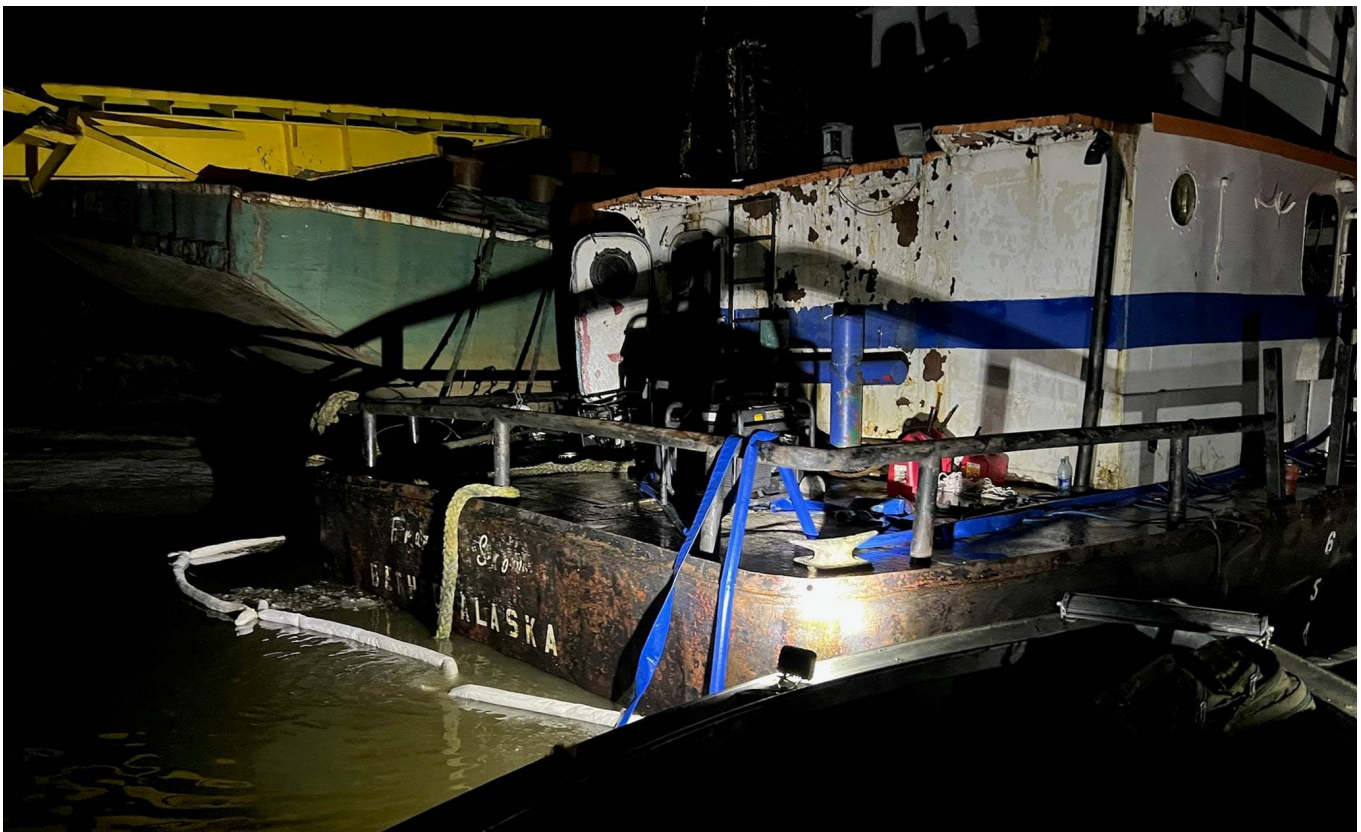
Figure 2. Tug *Francis Snow* floated on October 31, 2023. Photo provided by Vitus Energy LLC.
