ALASKA DEPARTMENT OF ENVIRONMENTAL CONSERVATION
Division of Spill Prevention and Response
Prevention Preparedness and Response Program
SITUATION REPORT (SITREP)

2025 Red Dog Mine Process Water Release

SITREP #: 2 and Final

SPILL #: 25389913401

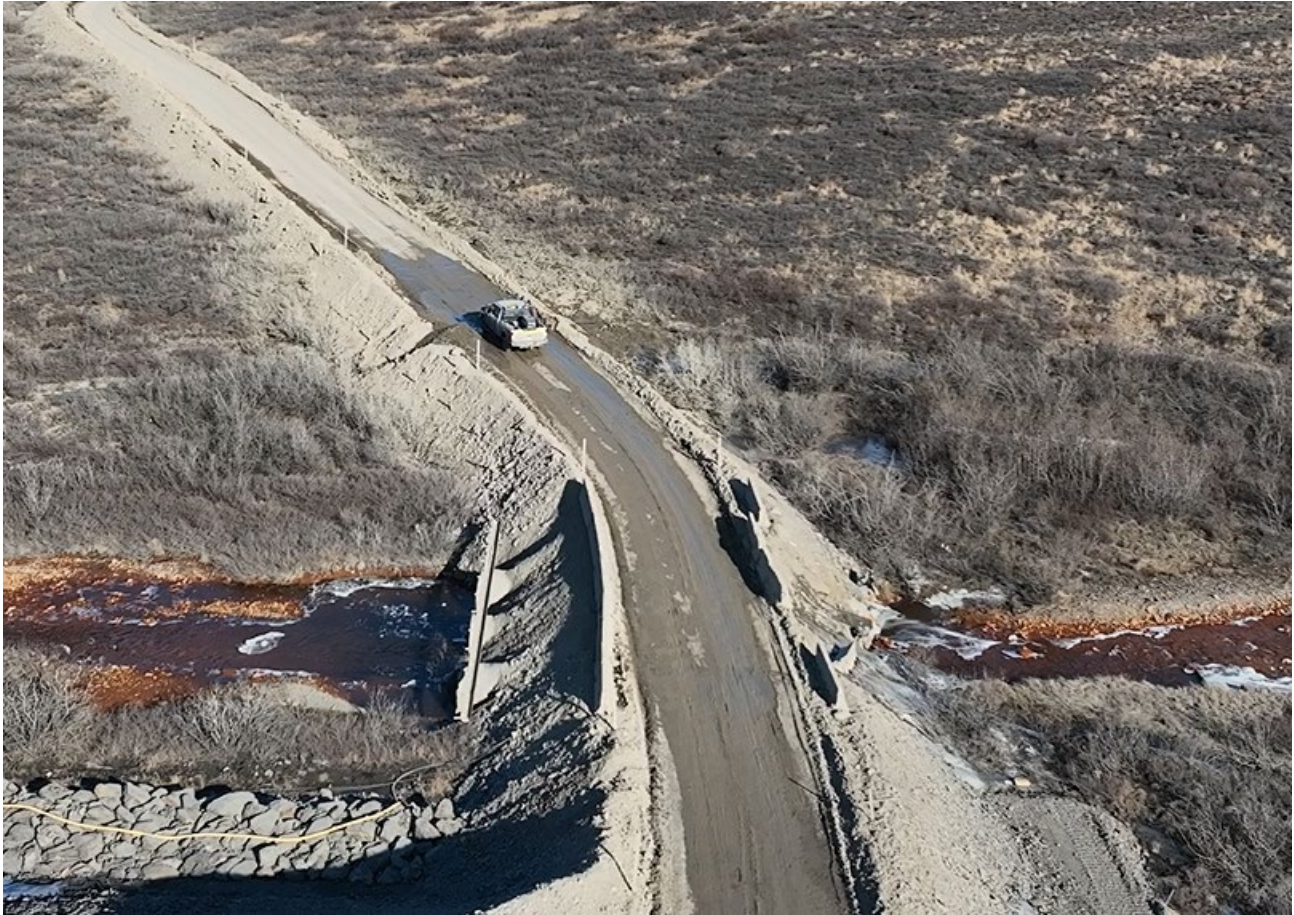
Figure 1: Image showing extent of the release along the road at the Red Dog Creek crossing. The area where the release breached the berm is to the left of the truck. Photo taken by Teck on May 14, 2025.

RESPONSE ACTION: A trench was created across the road to divert the spill into a lined containment area. Berms were created to keep the spilled process water on the gravel infrastructure. Vacuum trucks collected approximately 9,700 gallons of process water. The majority of solids in the process water naturally deposited on the gravel infrastructure. The area of release has been well delineated. Crews collected 870 cubic yards of surface material from the gravel infrastructure. Repairs and modifications were made to the road and existing snow berms to direct future runoff into secondary containment and away from sensitive areas.
