Annual Report to Alaska Department of Environmental Conservation

Commitment to Corrosion Monitoring Year 2006

Corrosion, Inspection and Chemicals (CIC) Group
BP Exploration (Alaska), Inc.

March 2007

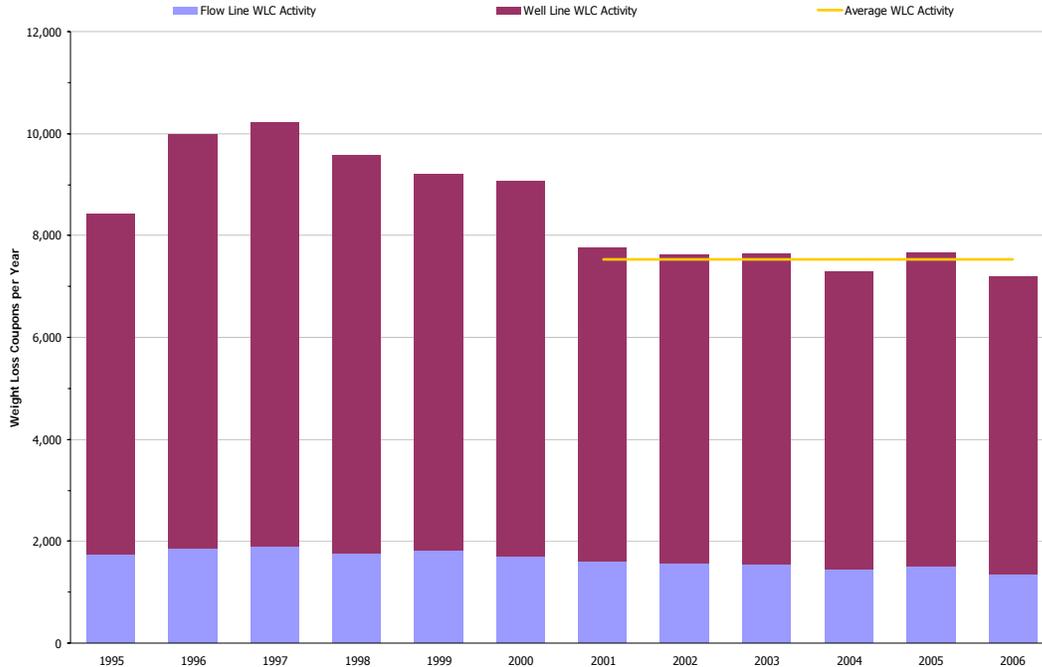
GPB Figure C.1 Corrosion Monitoring Activity Statistics by Equipment

As discussed in prior reports, there has been a gradual reduction in the number of weight loss coupons being evaluated, which reflects the on-going effort to optimize the program. Following the rationalization in 2000/01, the level of WLC activity has stabilized at ~7,500 coupons per year. The number of weight loss coupons reported for 2006 does not reflect the inventory of coupons that are installed in the system at year-end and still to be 'processed.' The reduction in 2006 coupon numbers therefore represents a timing effect and not a reduction in the program scope or activity level.

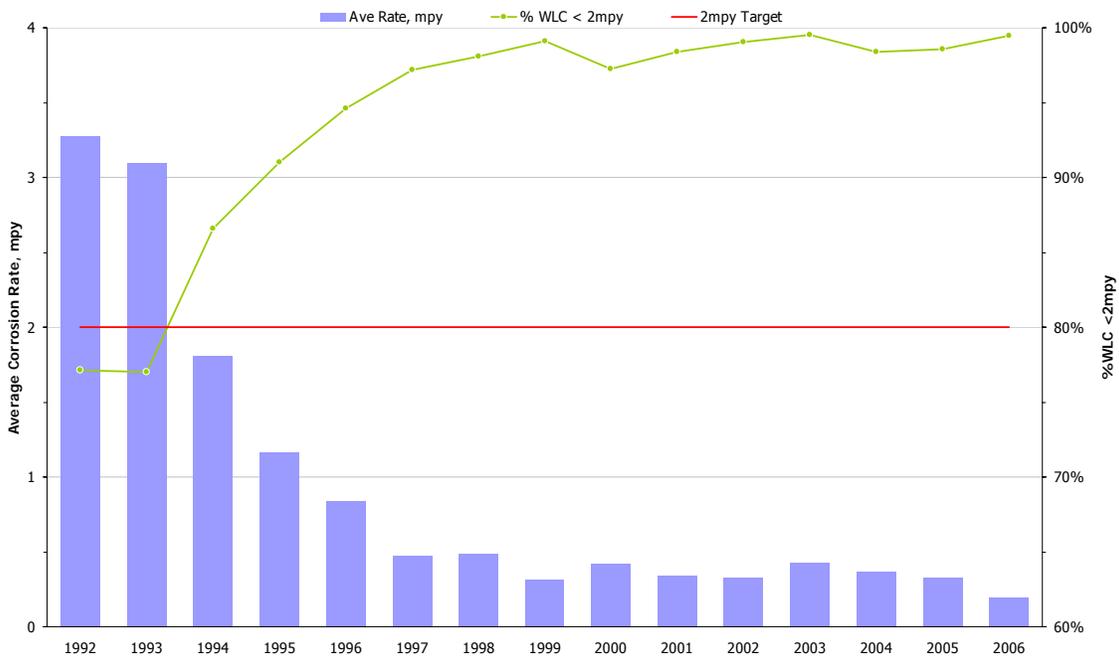
GPB Figure C.2 Flow Line Oil Service Corrosion Rate Trend

Conversely, the average corrosion rate has the advantage of showing the overall performance trend that would otherwise be lost when only looking at the exceptions >2 mpy. Hence, it is necessary to review both metrics in order to gain an overall understanding of the performance of the program.

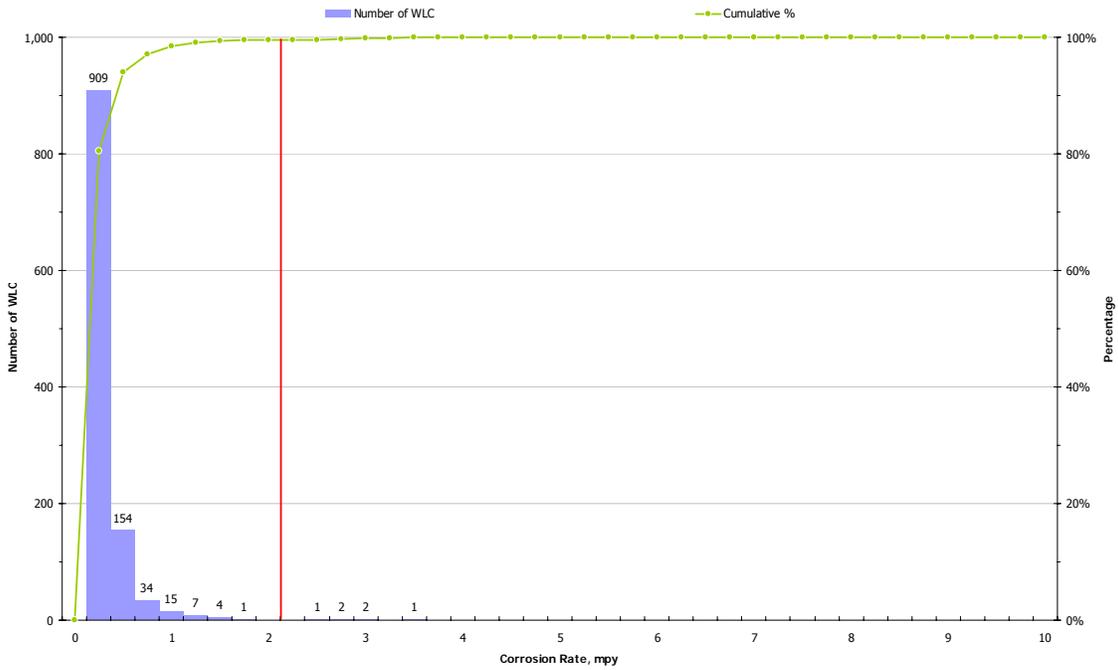
GPB Figure C.4 Flow Line Oil Service WLC Histogram

GPB Figure C.4 shows a distribution of corrosion rate for WLC in flow line oil service. There were 6 WLC greater than the 2 mpy target. Refer to Section H.1.5 for details and corrective actions.

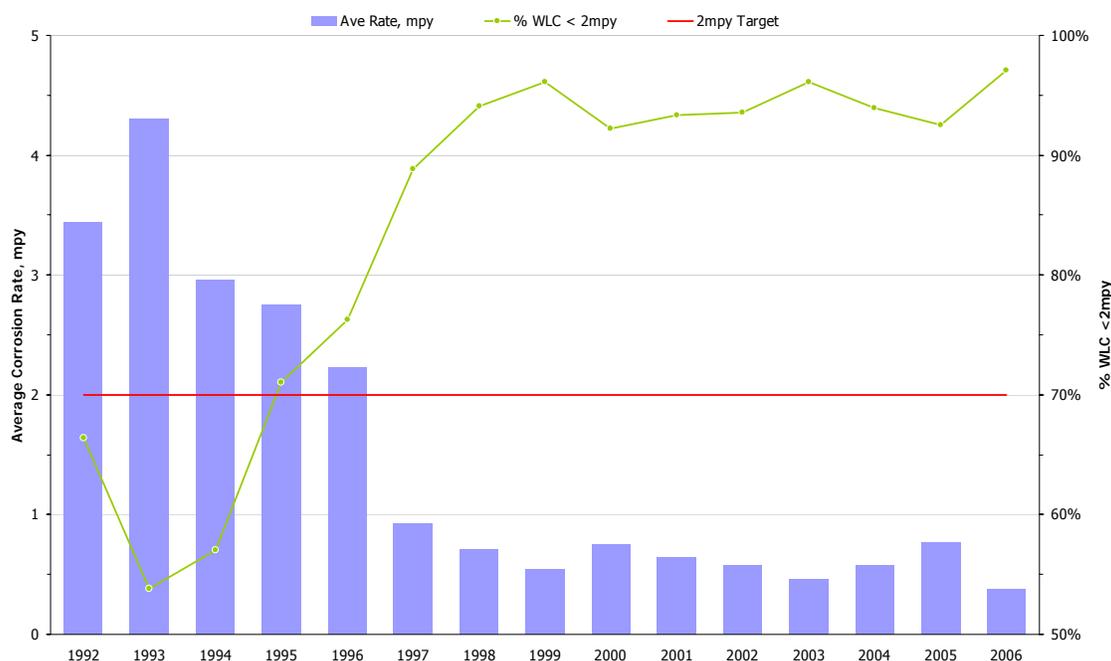
GPB Figure C.5 Well Line Oil Service Corrosion Rate Trend

GPB Figure C.5 shows the average corrosion rate and percentage of WLC ≤ 2 mpy since 1992. The trends are very similar to those seen in the cross-country 3-phase oil flow lines, showing a long-term improvement in the level of control from early 1990's to the present day with a slight decrease in performance from 2003 to 2005. This decrease in performance was largely due to chemical deployment problems discussed in previous reports. 2006 results demonstrate best ever performance.

The long term corrosion control improvement in the well lines is of the same magnitude as that seen in the flow lines with corrosion rates being reduced from an average >4 mpy in 1993 down to an average of 0.5 to 0.8 mpy over the past six years.

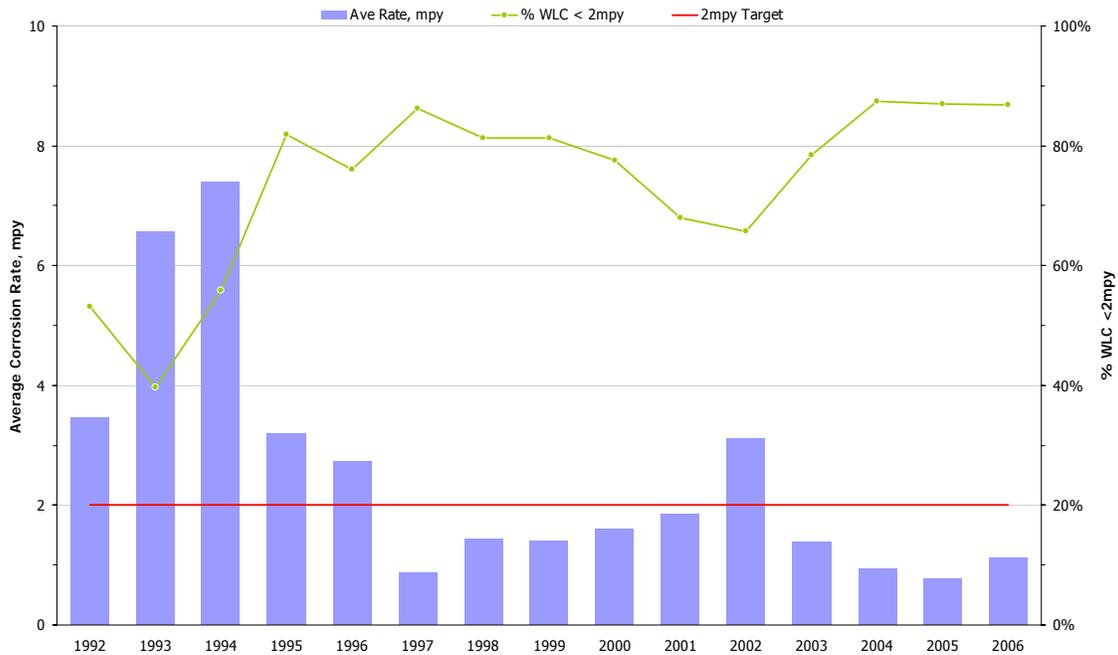
GPB Figure C.6 Flow Line PW/SW Service Corrosion Rate Trend

GPB Figure C.6 is a summary of aggregate data for produced water and seawater flow lines. The data show the 2006 WLC corrosion rates show a decrease in performance over last year, but comparable to the last three years.

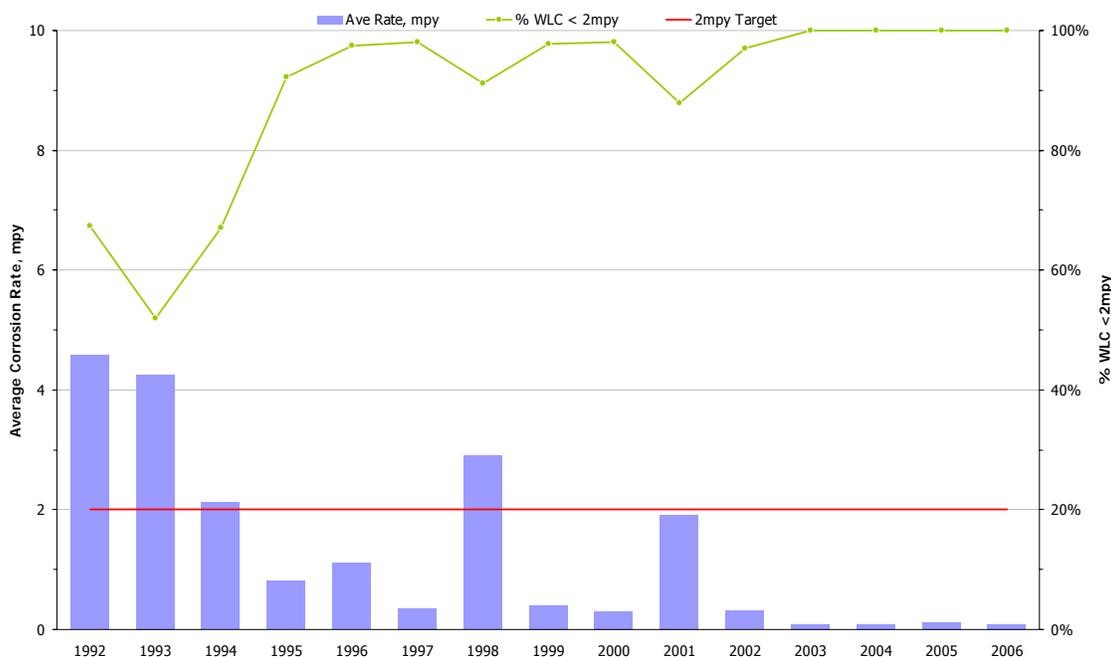
GPB Figure C.7 Corrosion Rates for 100% PW System

GPB Figure C.7 and GPB Figure C.8 summarizes the historical corrosion rate data for produced water well lines. The data show general corrosion rates in the produced water system have fallen as the level of inhibition in the 3-phase system was increased and supplemental produced water corrosion inhibitor injection was initiated.

GPB Figure C.7 shows the performance for 100% produced water service. The 2006 levels maintained average corrosion rates at ~ 0.1 mpy and $\sim 100\%$ WLC ≤ 2 mpy.

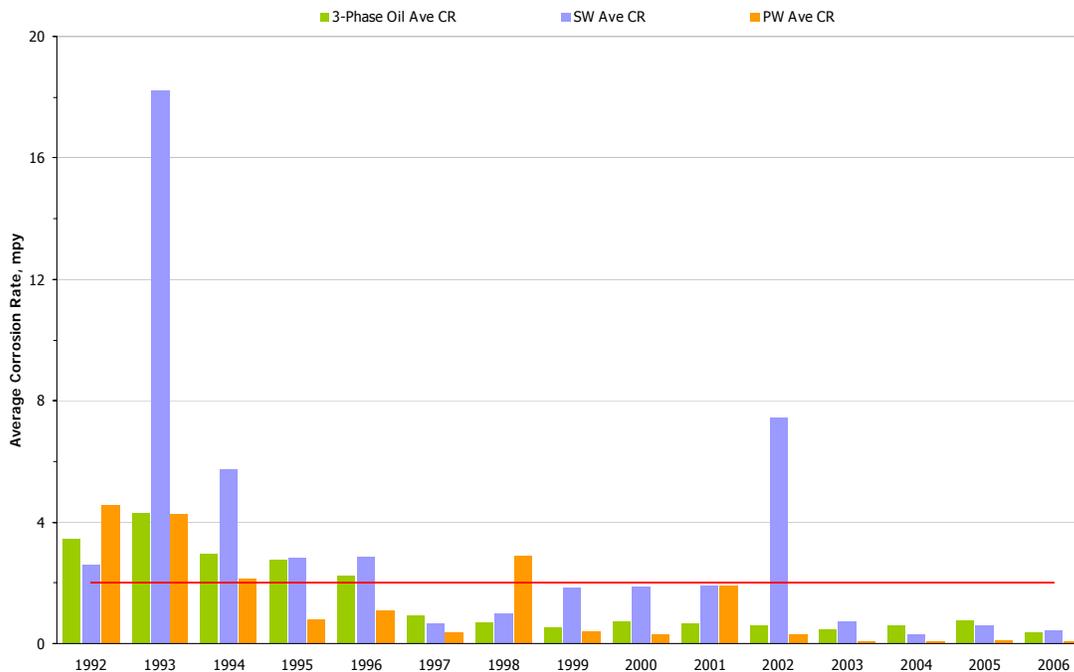
GPB Figure C.12 Well Line Average Corrosion Rate Summary by Equipment and Service

GPB Figure C.12 shows the corrosion rate and GPB Figure C.13 shows WLC corrosion conformance for well lines. The well line 3-phase system performance has remained essentially unchanged since 2000. The produced water and seawater well lines corrosion performance has remained essentially consistent since 2002.

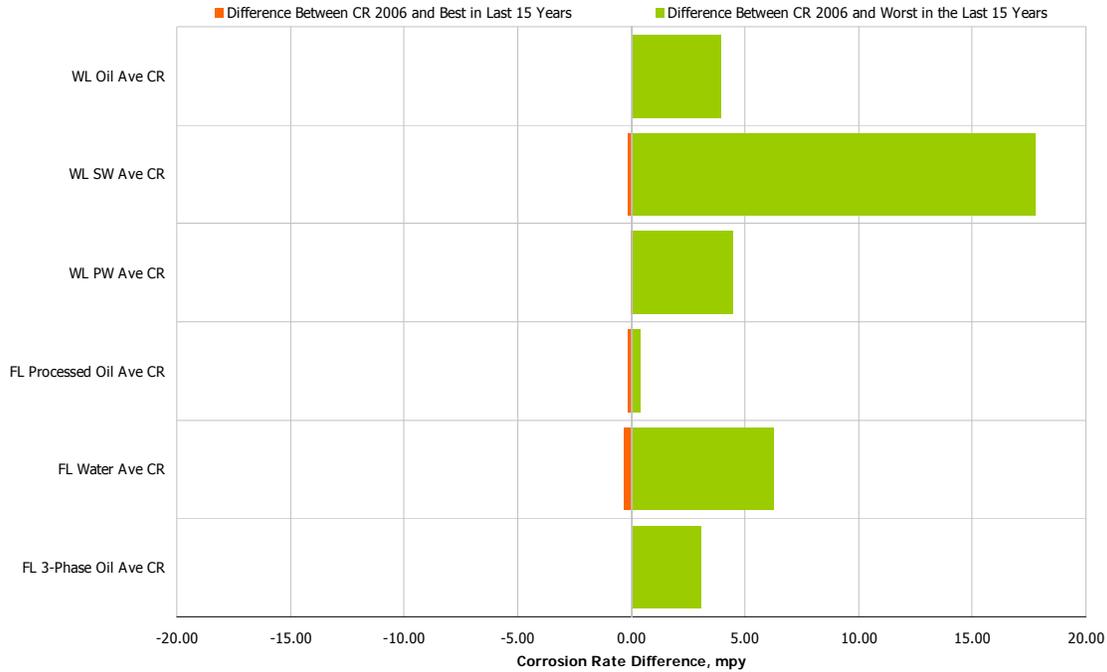
GPB Figure C.14 WLC Corrosion Rate Difference by Service and Type

each of the systems and the best, or lowest, WLC corrosion rate and the worst, or highest, WLC corrosion rate observed since 1992. This is an approximate measure of the successes and/or shortcomings of the program today versus the ~13-year history and highlights areas for attention.

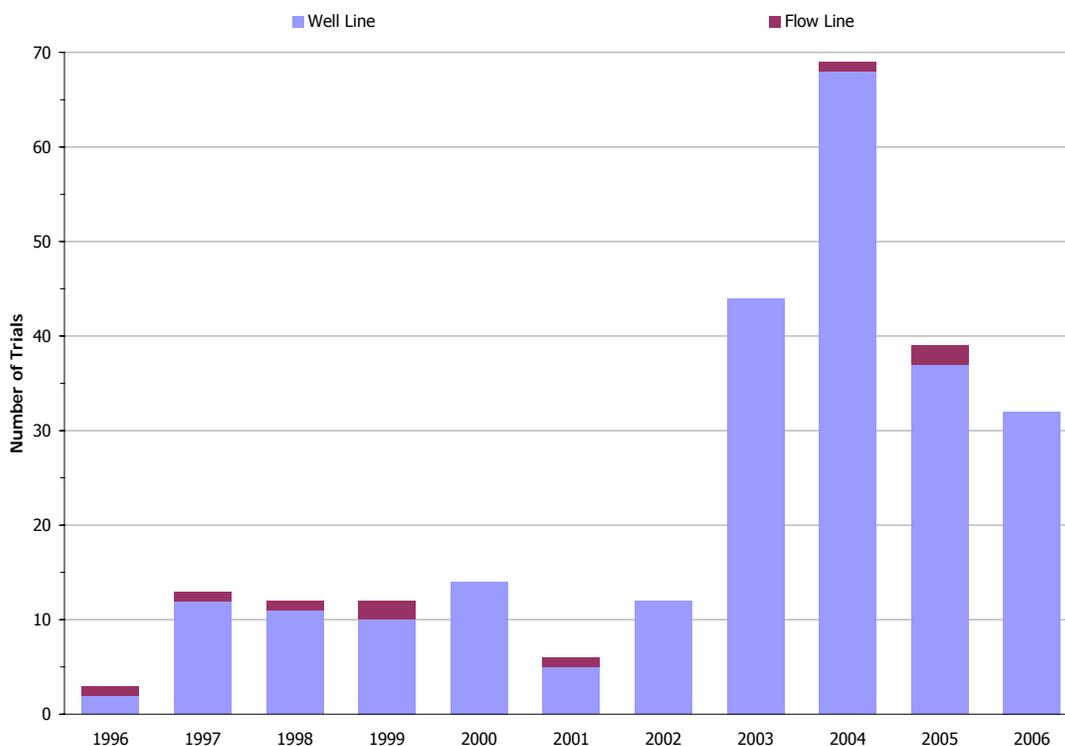
GPB Figure D.1 Number of Well Line and Flow line Tests

GPB Figure D.1 summarizes the number of well line and flow line tests which have been completed since 1996. The level of well line test activity increased beginning in 2003 due to a change in the screening protocol, which reduced the time required per test. The combined number of well line and flow line tests has increased from ~10-14 per year⁷ to more than 32 during 2006. This level of activity represents a substantial investment of resources towards the development of new and more effective corrosion inhibitors.

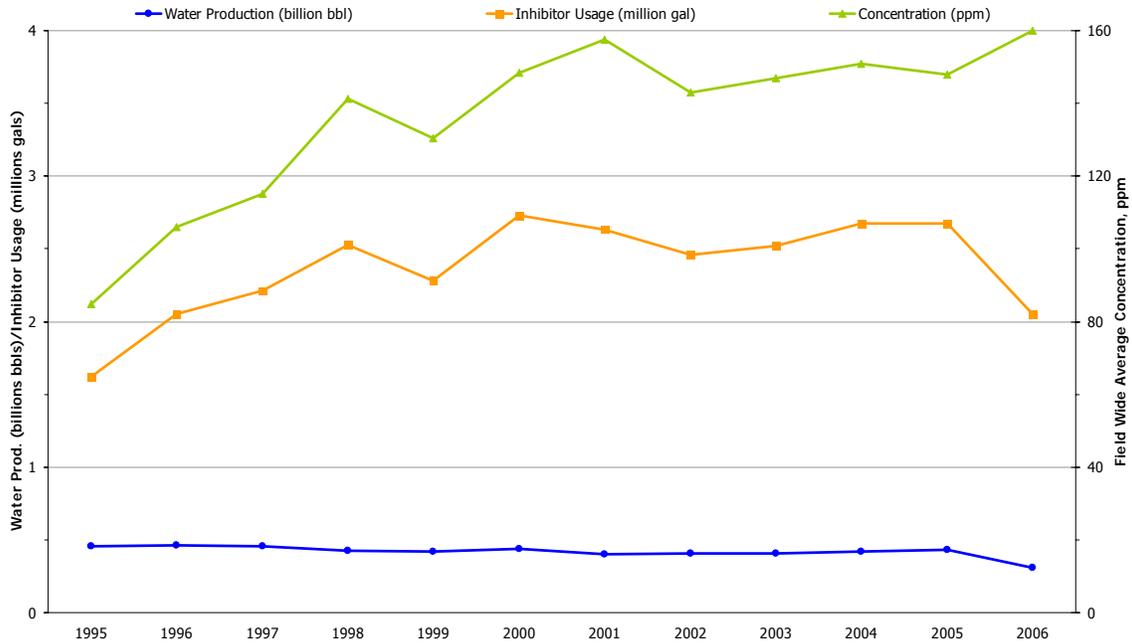
GPB Figure D.2 Field Wide Chemical Usage

The metrics in GPB Figure D.2 deal with chemical usage at the field level but much of the chemical optimization activity focuses on injecting the correct amount of corrosion inhibitor to each piece of equipment. The inhibitor requirement is driven by factors such as water cut, water volume, flow regime, and condition of the equipment and varies over a wide range, from a few parts per million (ppm) to several hundred ppm. For 2006 the target chemical usage was 2.06 million gallons as compared to actual usage of 2.05 million gallons; or 99.3% of the target volume.

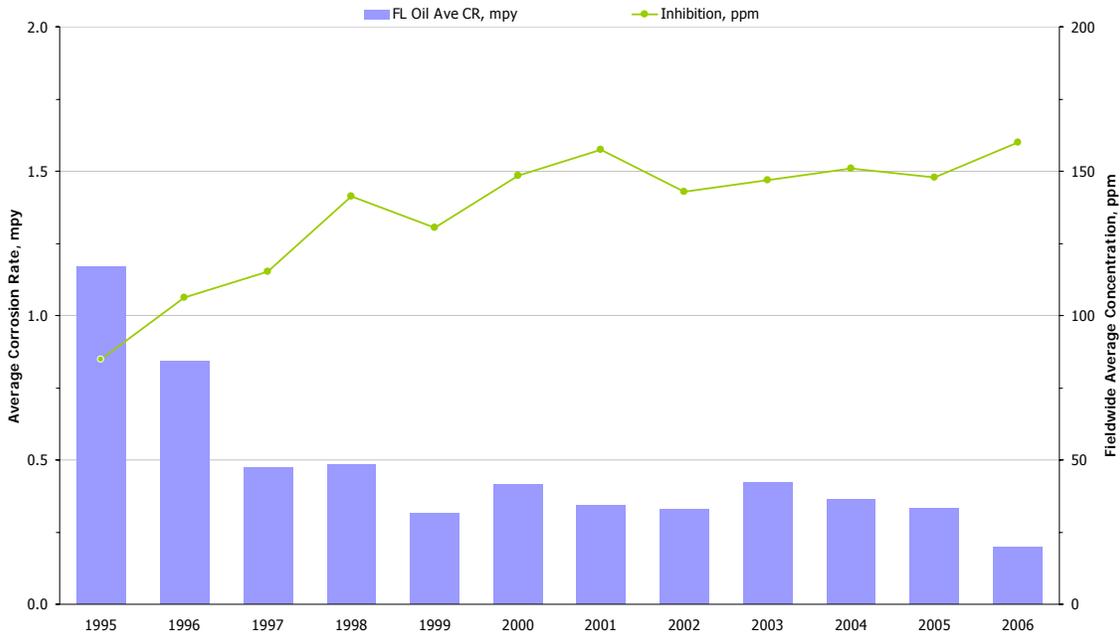
GPB Figure D.3 Average Corrosion Rate versus Inhibitor Concentration

GPB Figure D.3 shows the correlation between the increased level of corrosion inhibitor and the reduction in average corrosion rate from 1995. As might be expected, the decline in average corrosion rate correlates with the increase in corrosion inhibition levels over time.

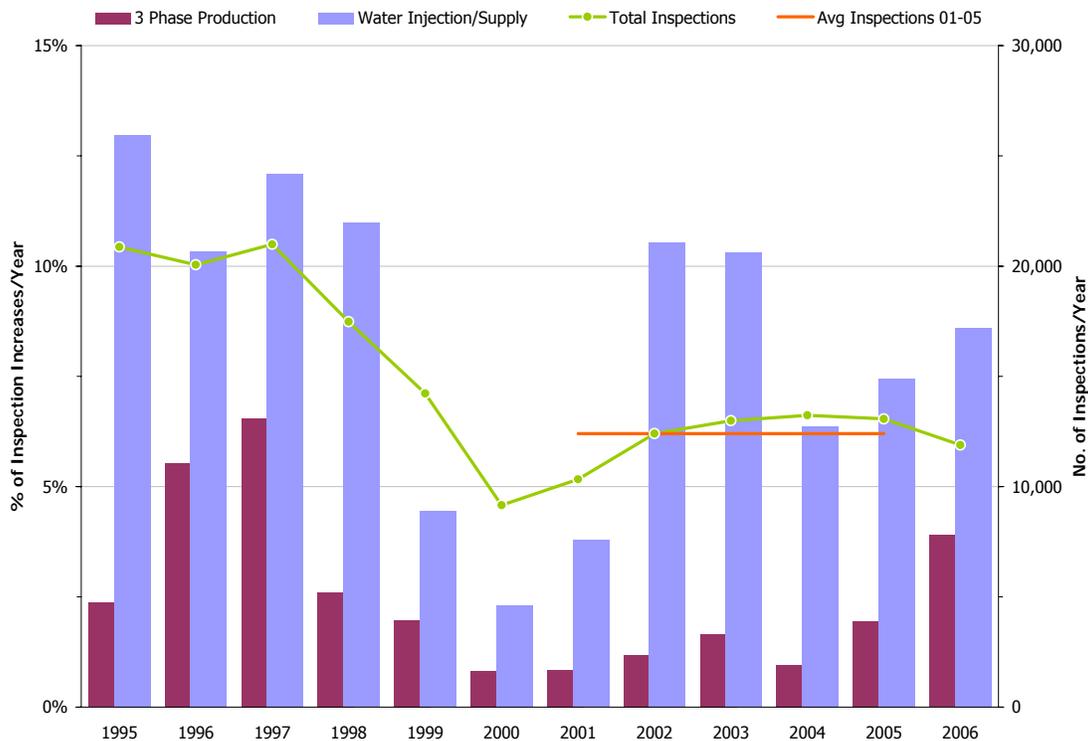
GPB Figure E.2 Flow Line Internal Inspection Increase by Service

GPB Figure E.2 shows the percentage of inspection increases (%I's) and the number of inspections per year for the flow lines segregated by 3-phase production and water injection (seawater and produced water) service. The total number of inspections in 2006 is slightly below the 5 year average between 2001 and 2005.

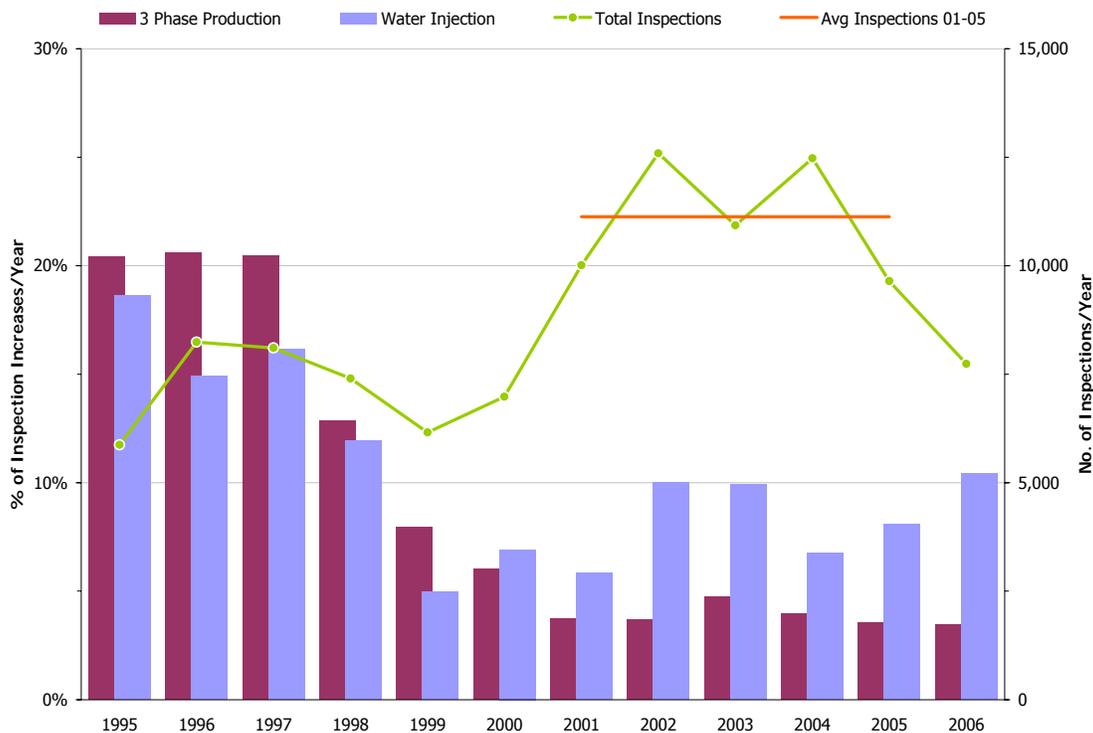
GPB Figure E.3 Well Line Internal Inspection Increase by Service

For the water system, the trends for well lines are similar to flow lines. As with the flow lines, improvements in the chemical mitigation program are expected to add to the level of corrosion control and show a reduction in the percent of increases in coming years.

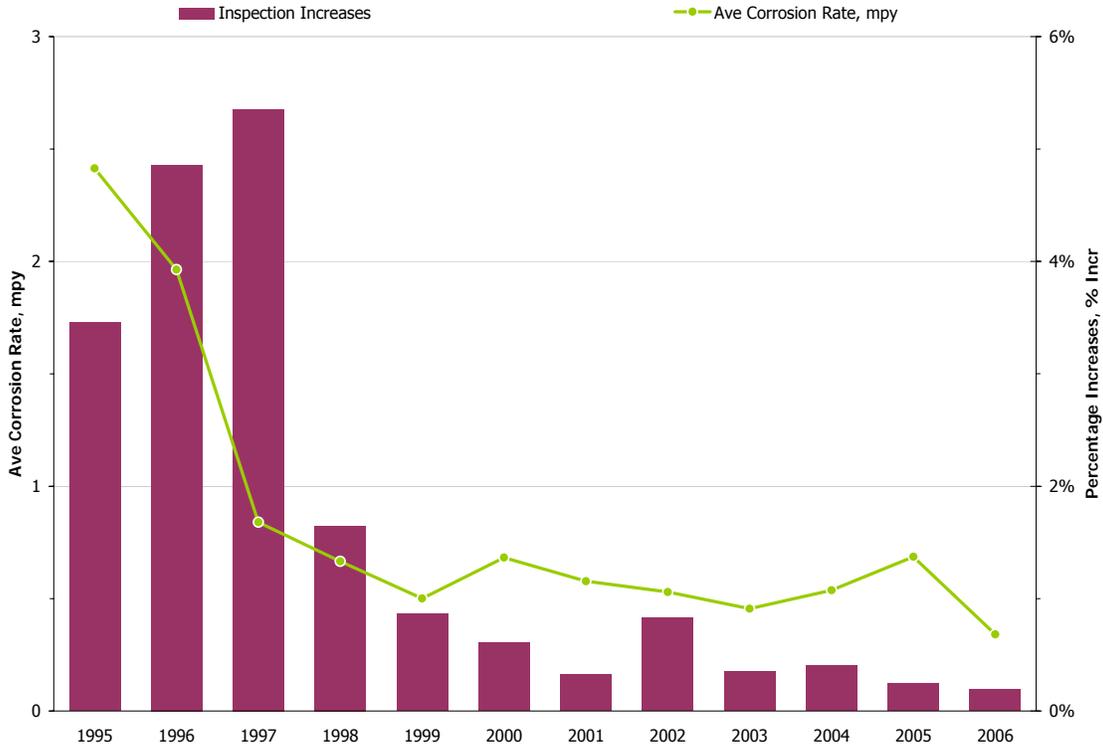
GPB Figure E.4 Correlation of Corrosion Rate and %Increases, 3-phase Production

- Because of the lower sensitivity of the techniques used in the inspection program, the corrosion rates in the 3-phase flow lines are below the detection limits for inspection; therefore corrosion rate monitoring becomes a function of the coupon program leaving inspection as a confirmation and integrity assessment tool.

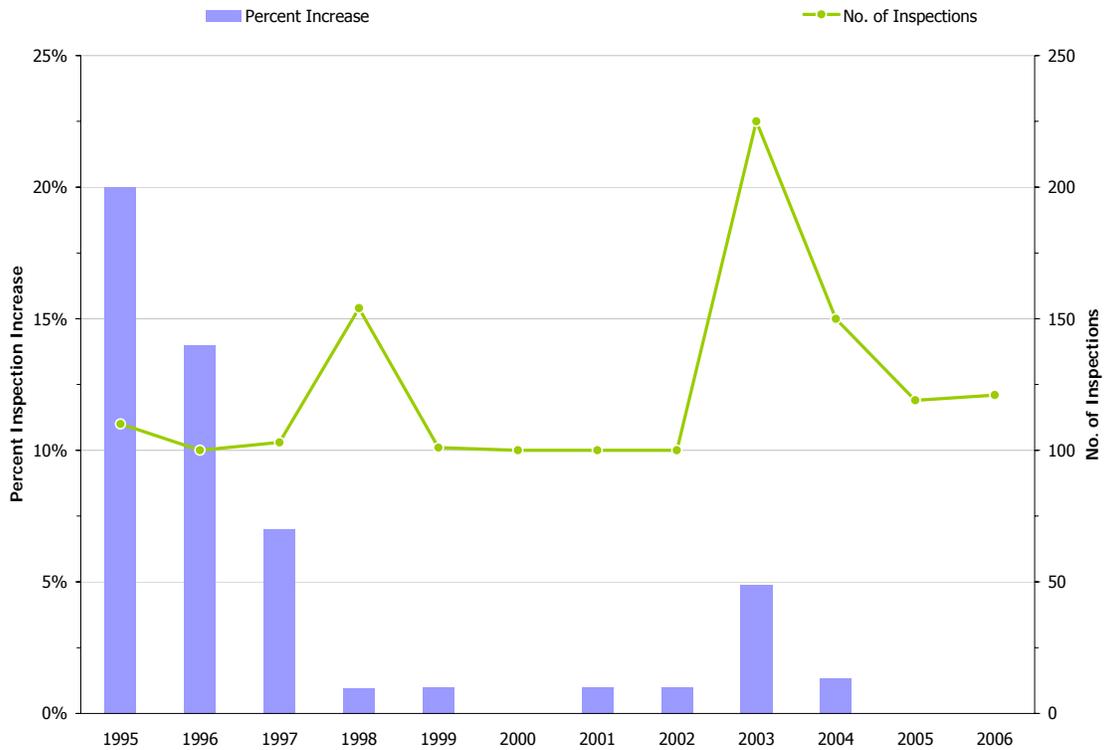
ACT Figure D.1 Endicott IIWL UT Readings

ACT Figure D.1 shows the percent inspection increases and the number of inspections since 1995 for the IIWL. No inspection increases were identified in 2006, the second year in a row. This is the result of the optimization program begun in October, 2004 whereby the corrosion inhibitor concentration was increased from 20 to 30 ppm and biocide program was rebalanced. Additionally, the 2006 maintenance pigging program was fairly successful with seven runs completed out of a total nine runs scheduled (78%).

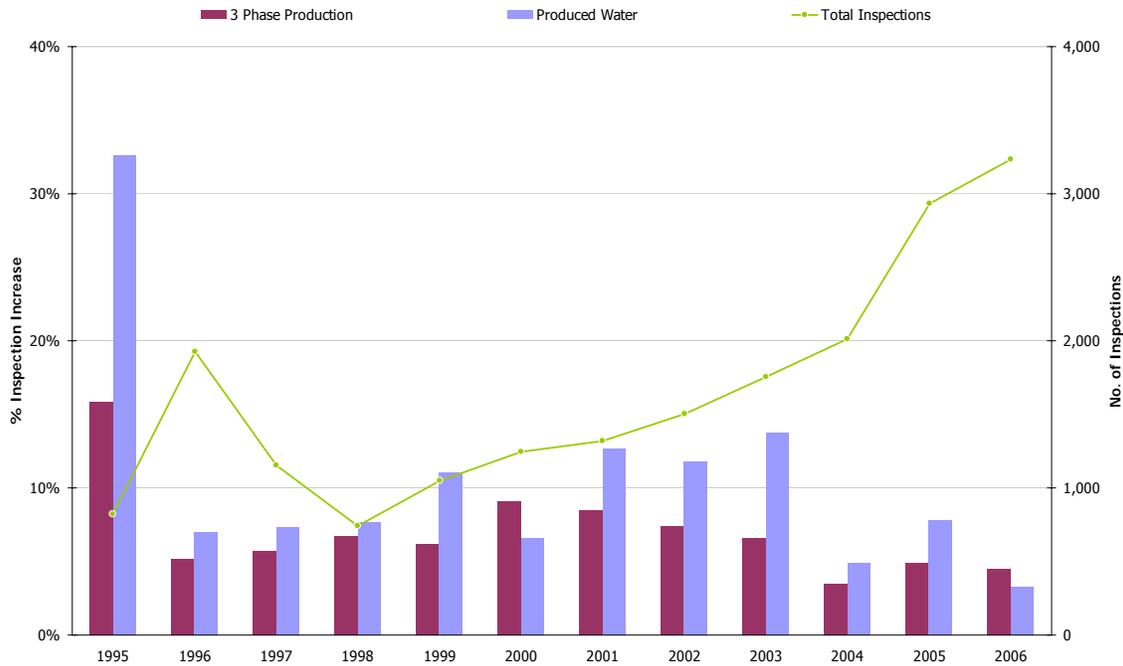
ACT Figure E.1 Endicott Well Line Internal Inspection Increases

Corrosion activity in the water injection well lines had been increasing since 2000 and was addressed by increasing the corrosion inhibitor concentration by ~18% in 2003 and then by another 50%, to 30 ppm, in late 2004. The additional corrosion inhibitor reversed the increasing trend in 2004; however there was an increase in 2005 and a reduction in 2006. The majority of these increases are slight, whereas the increases during 2001-2003 were more significant. This trend is being monitored to determine what additional changes might be required to the PW inhibition program.

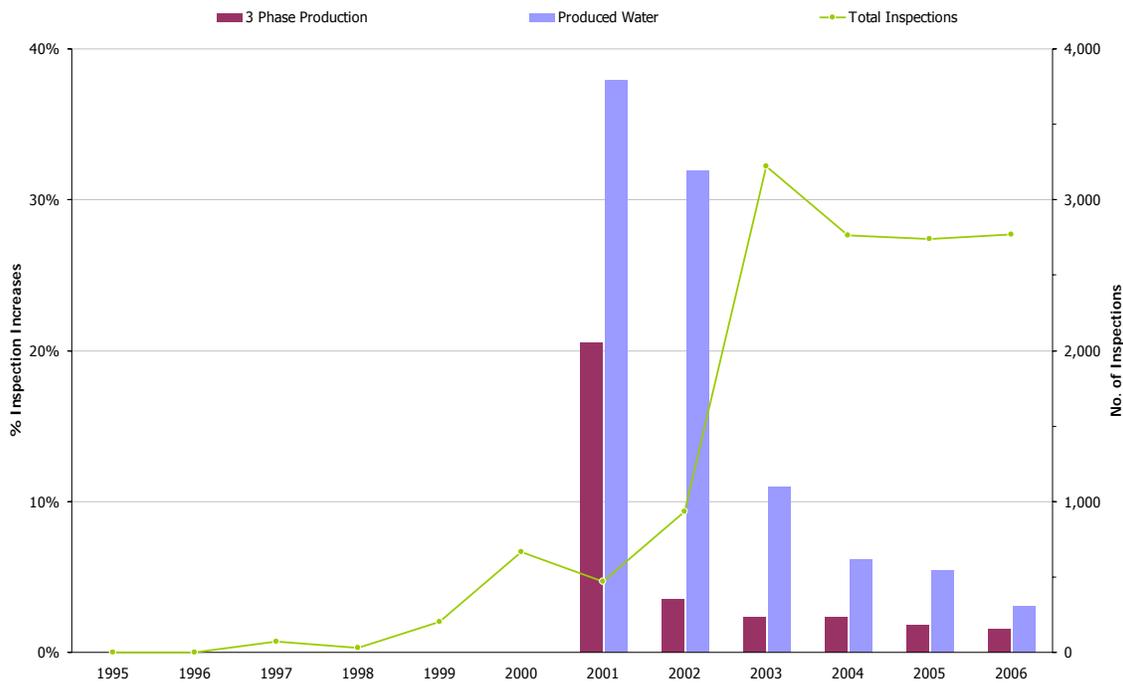
ACT Figure E.4 MPU Well Line Internal Inspection Increases

The three phase well lines damage rate has remained essentially level over the past two years at about 2% of repeat locations showing an increase in corrosion activity. There is currently no corrosion inhibition program for the production well lines.

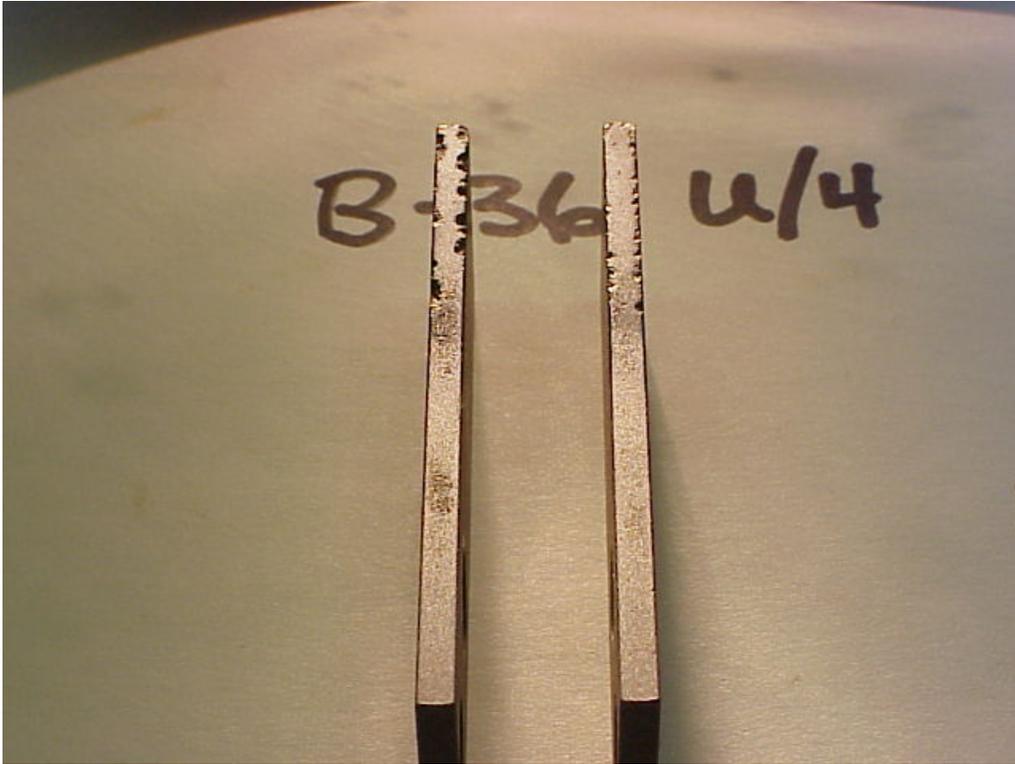
Figure 4 Corrosion coupons pulled after an 'unsuccessful' chemical trial

A second example, utilizes the output from the weight loss coupon program. This example from a test performed in 2001, demonstrates the need/value of multiple monitoring techniques when evaluating corrosion inhibitor performance. The trial product was tested for a 90-day period with no negative response observed by the ER probes. However, after the 90-day test period the corrosion coupons were pulled and showed relatively high general corrosion and pitting rates - see Figure 4. The product evaluated was a failure and the incumbent product was re-instated based on the coupon results. Corrosion inhibitor tests use all the monitoring tools available such as corrosion probes, coupons, and inspection data to determine corrosion control performance. In addition, the corrosion inhibitor is evaluated for plant production performance to show compatibility with the separation process.

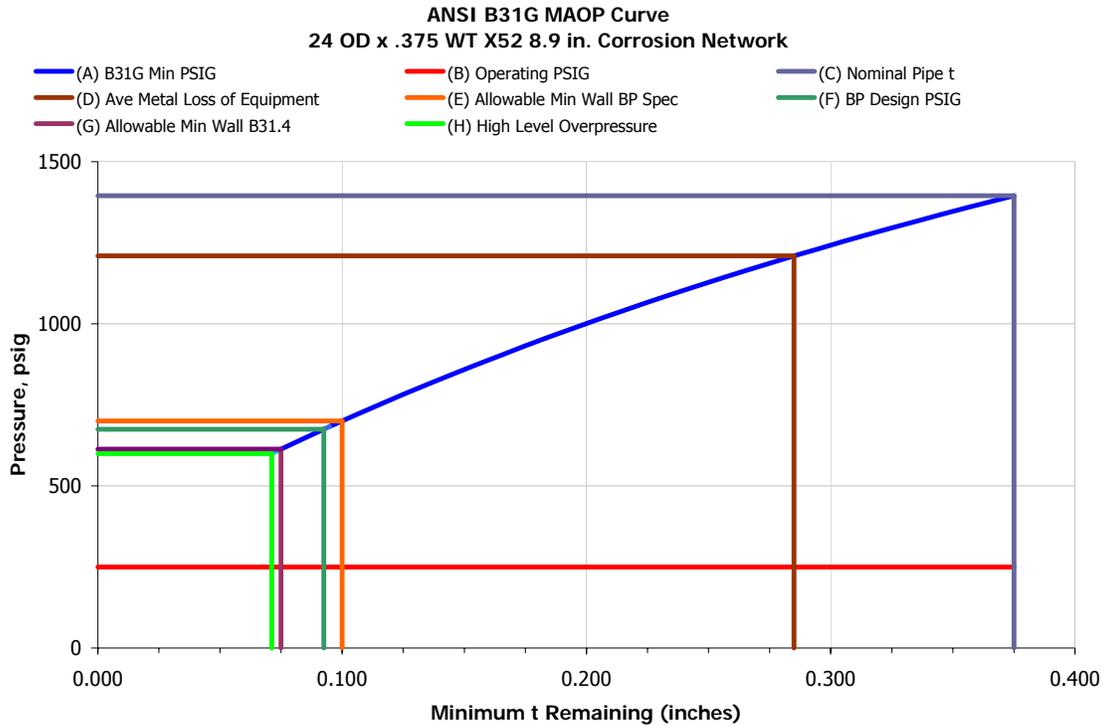
Evaluation of Corroded Pipe The evaluation of corroded pipe involves determining the remaining strength and safe operating pressure on the basis of the overall axial length, circumferential extent, and maximum depth of the corroded area.

Legend	Description/Comments
(A) B31G Min PSIG	The relationship between maximum allowable operating pressure, MAOP, as given by B31G and the remaining wall thickness

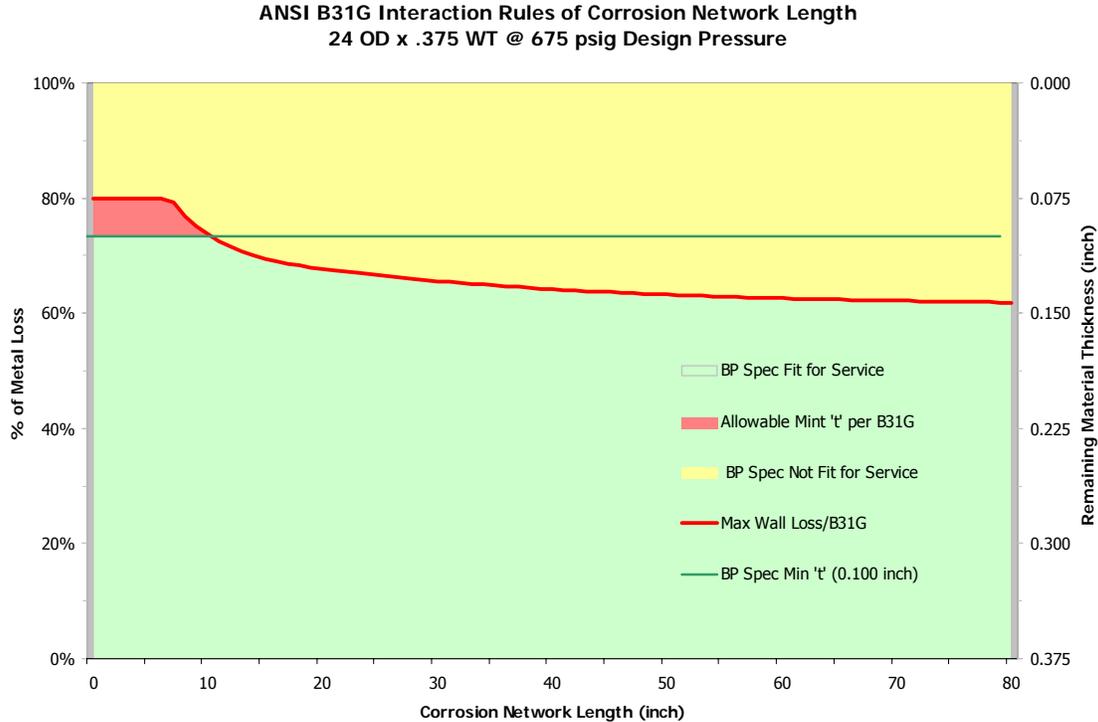
Figure 6 Fitness-for-Service Envelope Based on BP SPC-PP-00090

Figure 6 illustrates the FFS envelop for a combination of depth and length of defect as defined in BP Specification SPC-PP-00090. As can be seen from the curve, the criteria for allowable operating service condition is more conservative than the industry standard at the low end of the remaining wall thickness. This conservatism reflects two issues, (a) the need to provide a margin for error in the determination of wall thickness and corrosion rate, and hence remaining life, and (b) the decreased accuracy of the NDE techniques in use at a wall thickness of less 100 mils.
