Brownfield Assessment

Summary of Environmental Research:

Noyes Slough Reclamation Evaluation
Fairbanks, Alaska

By:
OASIS Environmental, Inc.
January 28, 2008

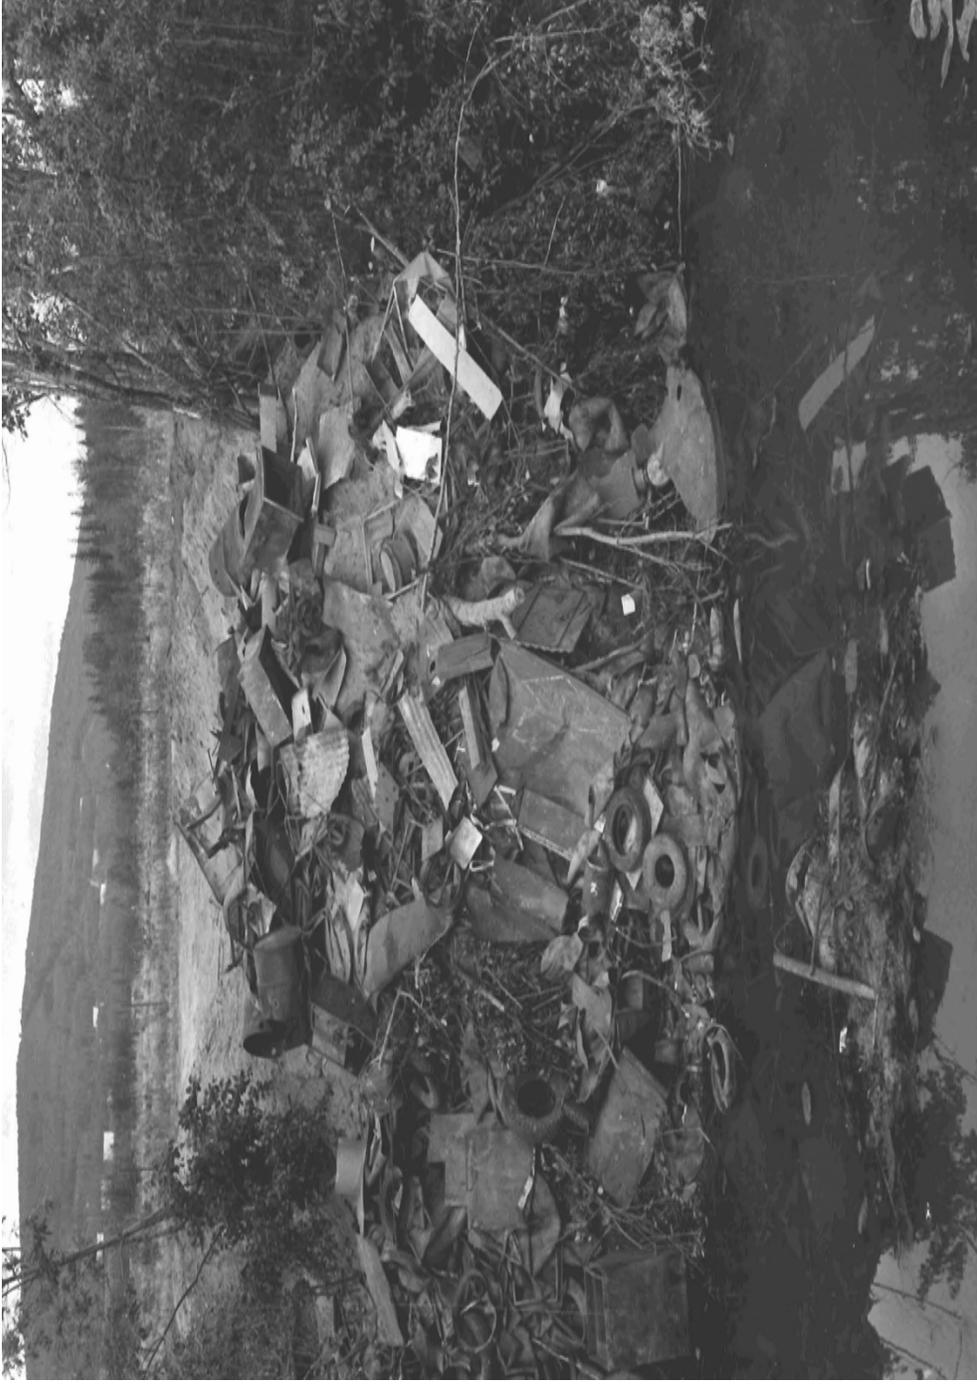
**Figure 1. Dumping into Noyes Slough behind Bentley-Miller Salvage Yard.
This view is across the slough from the intersection of Noyes and Ina Streets, June 1974.**

3. Bentley-Miller Salvage Yard (102.15.004): The salvage yard is a potential source of contamination because of documented complaints to the DEC as noted in Table 12 and illustrated in Figure 1. The salvage yard existed in 1959, as shown in Figure 4. An apparent drum stockpile is evident in an aerial photograph taken in 1965 (Figure 7). No available information links this site to contamination identified in past investigations of the slough.

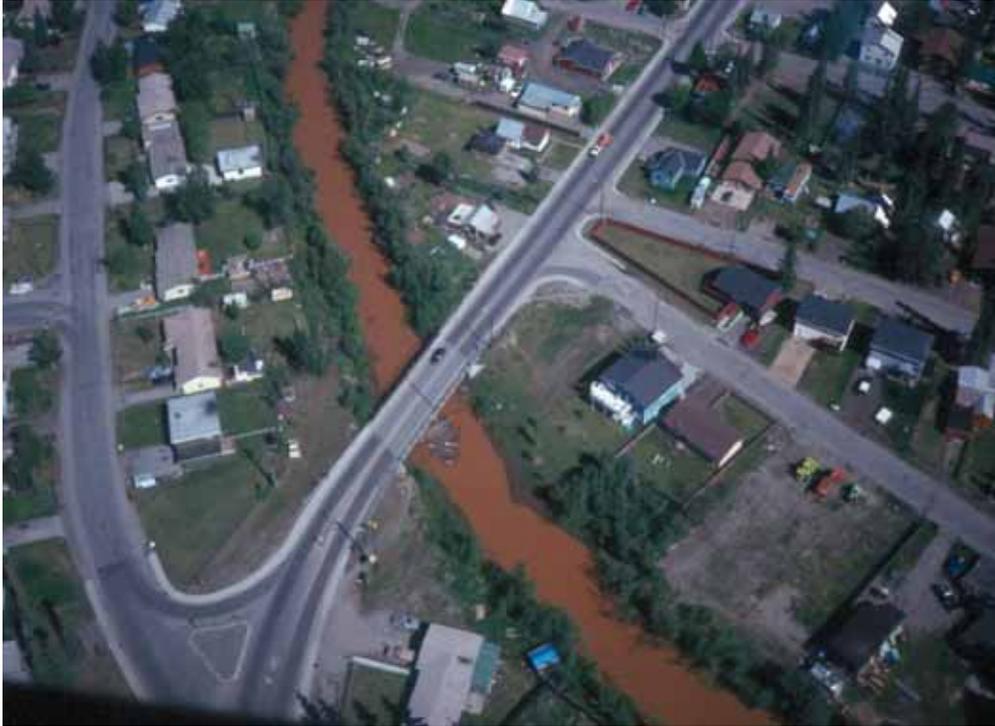
Figure 2. Results of dewatering activity at the Bentley-Miller gravel pits. Noyes Slough at Aurora Drive, June 1991.

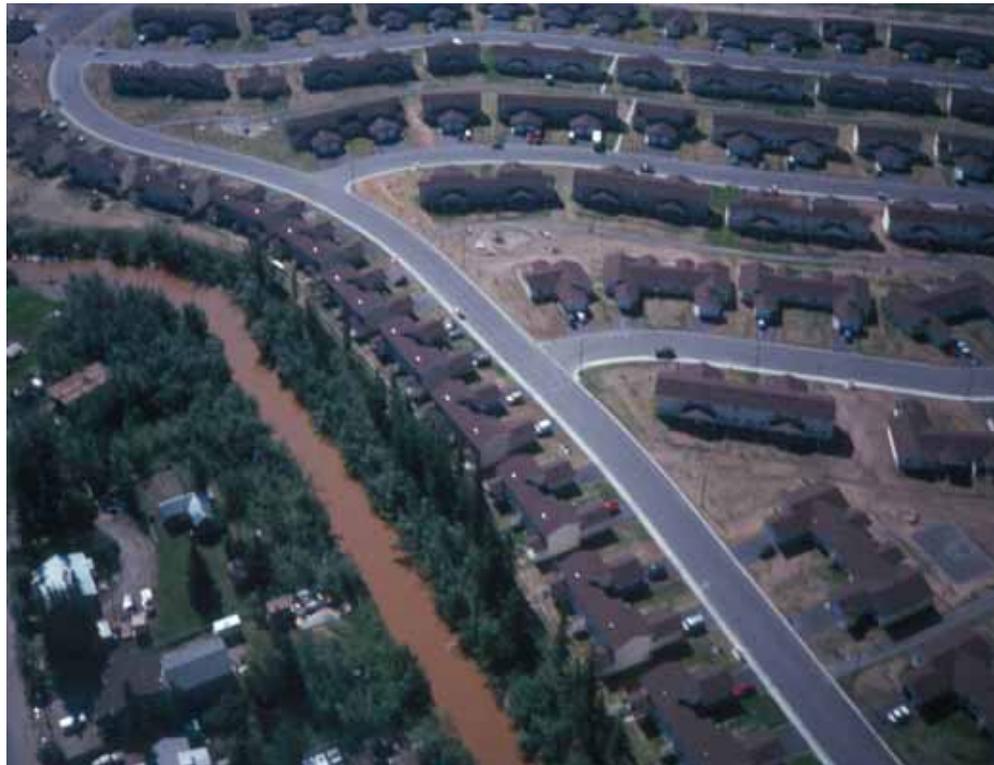
Figure 3. Dewatering activity at the Bentley-Miller gravel pits discolors the slough. Near Walden Pond and military housing on Hampstead Avenue, June 1991.

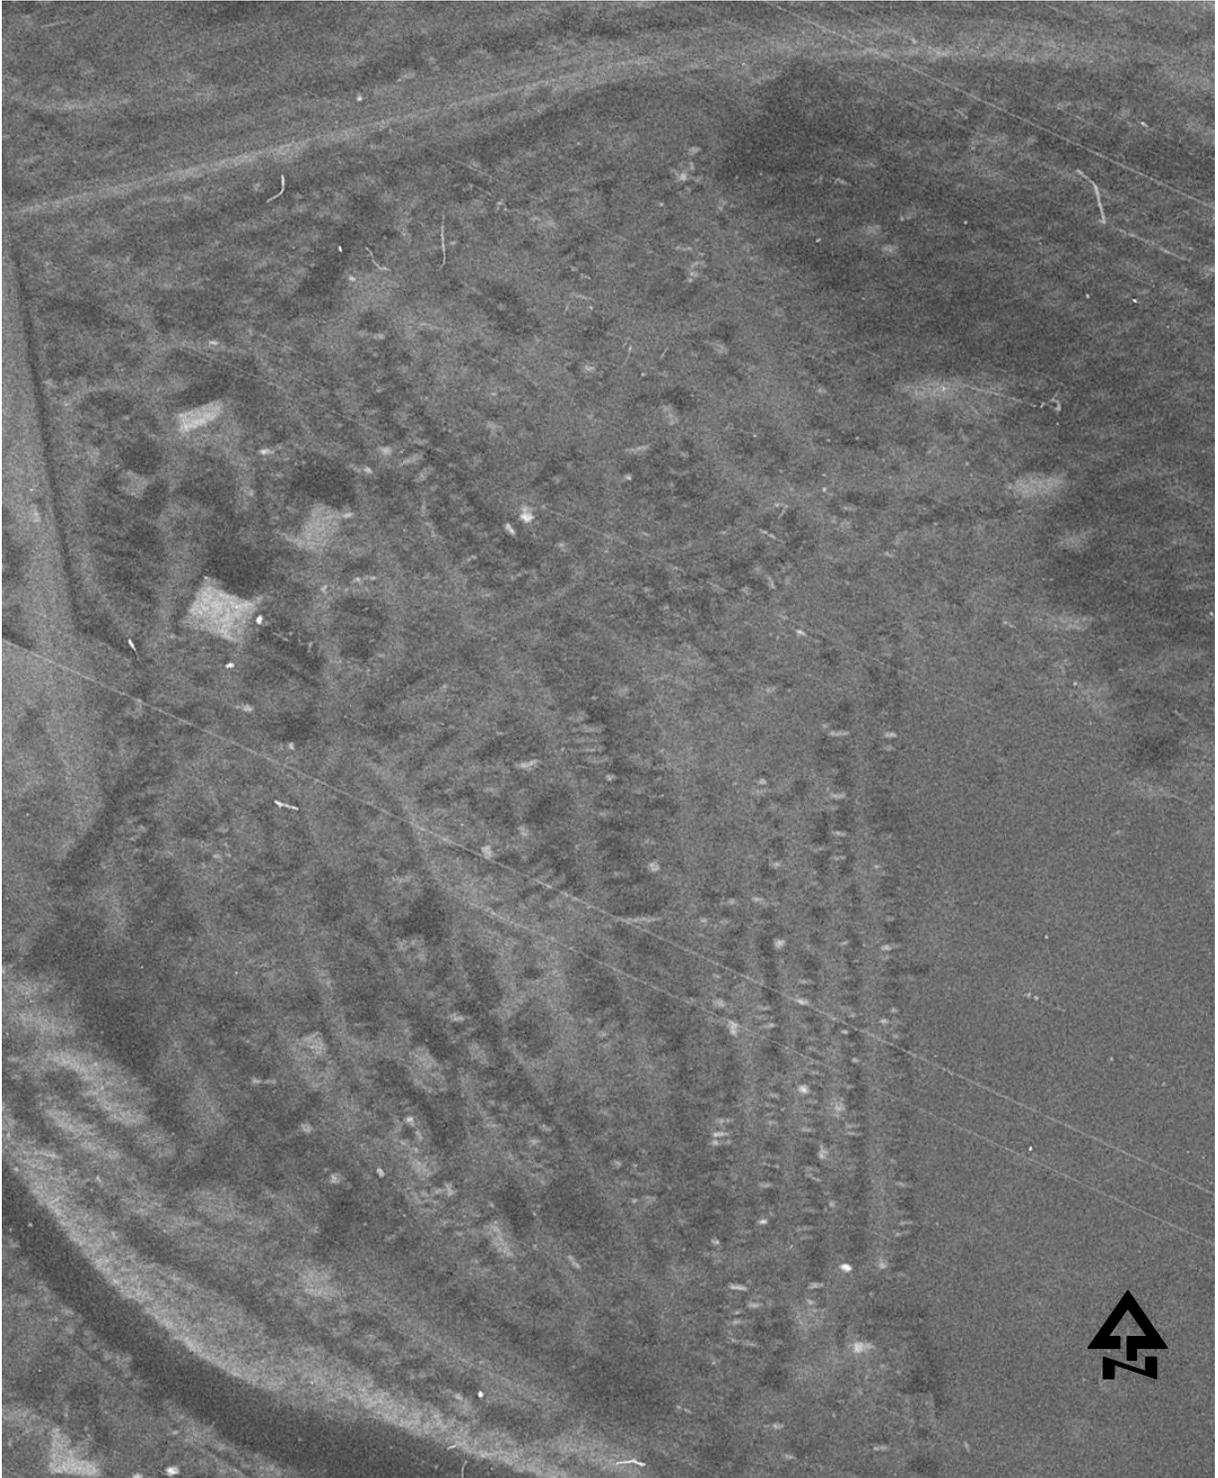
Figure 4. 1959 aerial photograph of the Former Bentley-Miller Salvage yard.
The salvage yard is bounded by College Road to the west and the Alaska Railroad tracks to the north. Refer to Figure B2 for the location of this figure.

lot encompasses a large expanse (154 acres) of land south of the Johansen Expressway, east of College Road and north of Old Steese Highway (see also Figure 4). The site has a long history of industrial land use dating back to the 1940s. Former land users include the U.S. Army (barracks), Great Western Chemical, and Snoopy (auto) Repair Shop (Figure 5). The heaviest activity occurred during the Trans-Alaska Pipeline construction of the 1970s, when the land was used for Alyeska pipe storage and a pipe double-jointing and coating facility (Figure 5). Businesses and storage yards related to pipeline construction were abandoned in the early 1980s, and the site was essentially vacant until 2004 (DEC, 2006). The site has been used commercially by various businesses since then. A 2006 aerial photograph (Figure 6) of the area identifies the current businesses in Tax Lot 201 and also shows the lot to the north containing the Bentley-Miller gravel pits, Tax Lot 203.

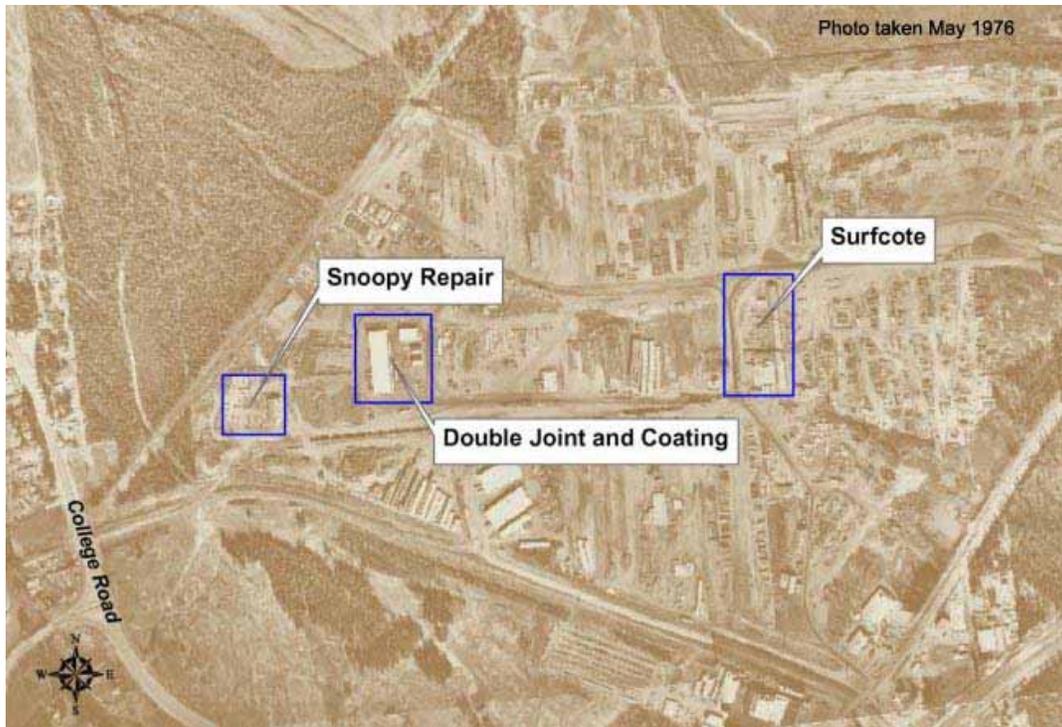
Figure 5. 1976 aerial photograph of Bentley Trust Property Tax Lot 201. Businesses considered potential sources of solvent contamination are identified (DEC, 2006).

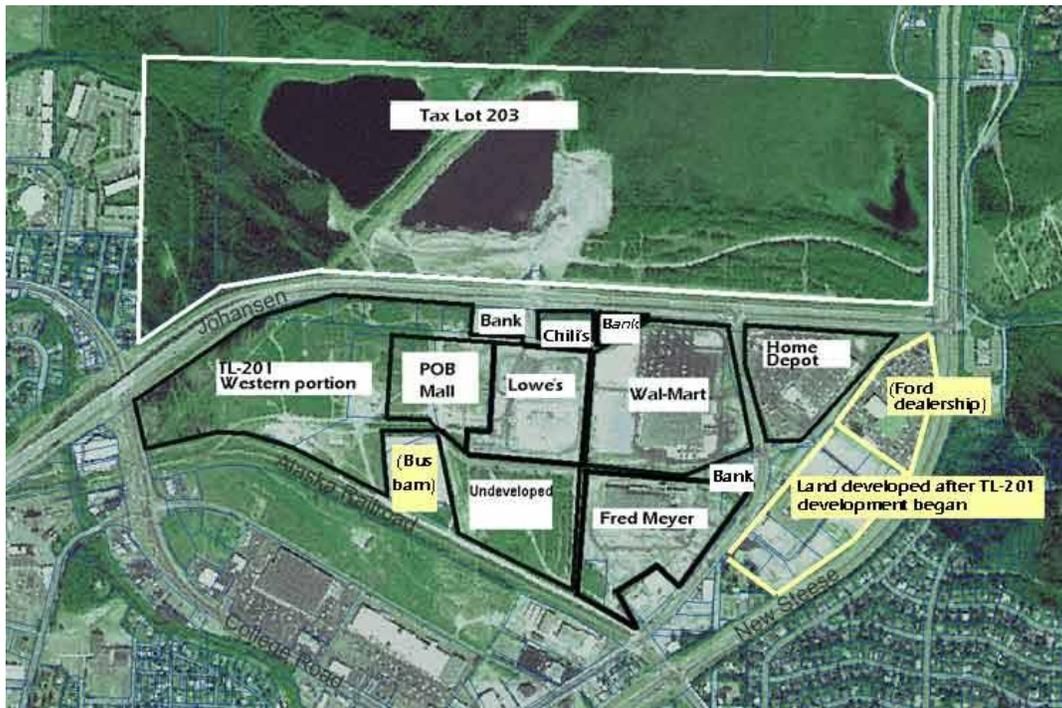
Figure 6. 2006 aerial photograph of Bentley Trust Property Tax Lots 201 and 203. Current commercial business operations on Tax Lot 201 are identified (DEC, 2006).

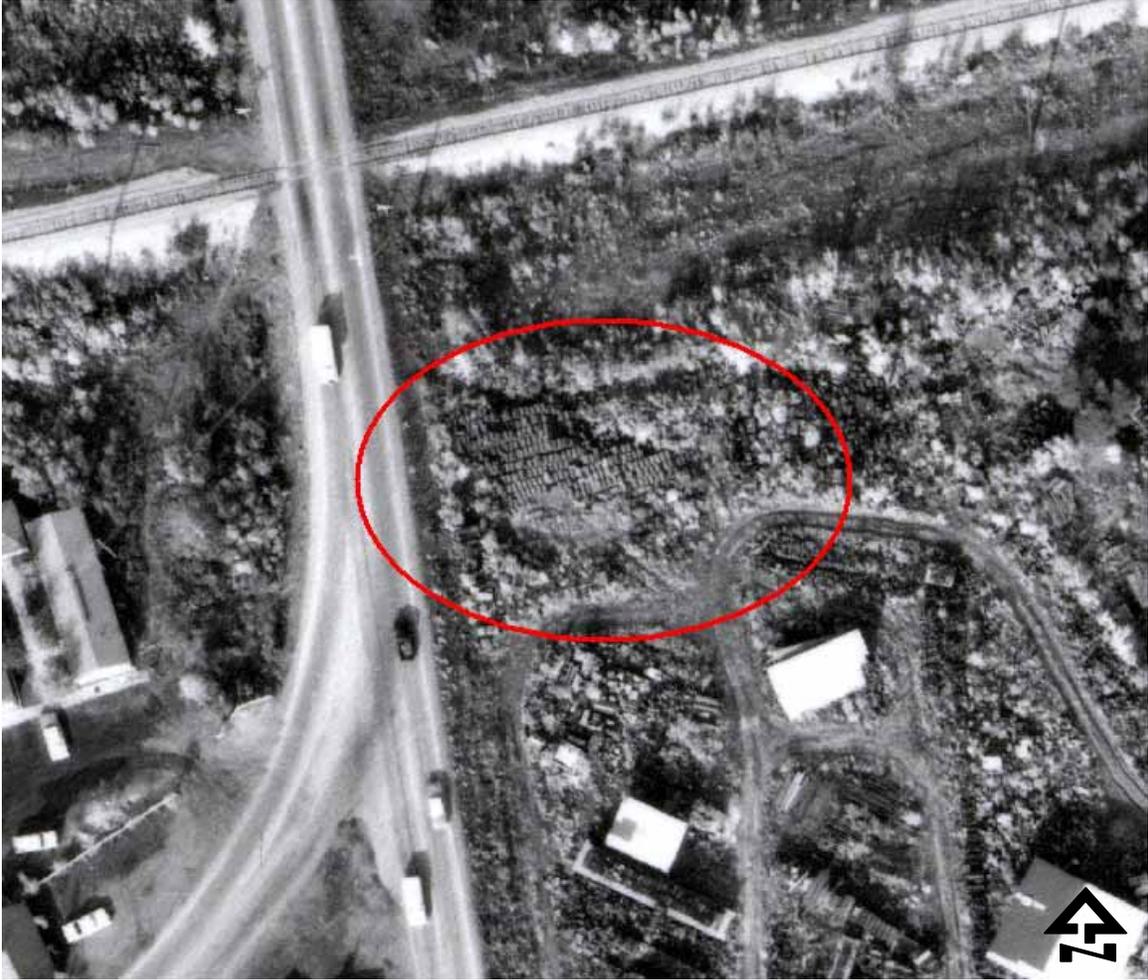
Figure 7. 1965 aerial photograph of the former Bentley-Miller Salvage Yard. A cache of drums appears inside the red circle. College Road at the entrance of Illinois Street is shown to the left.

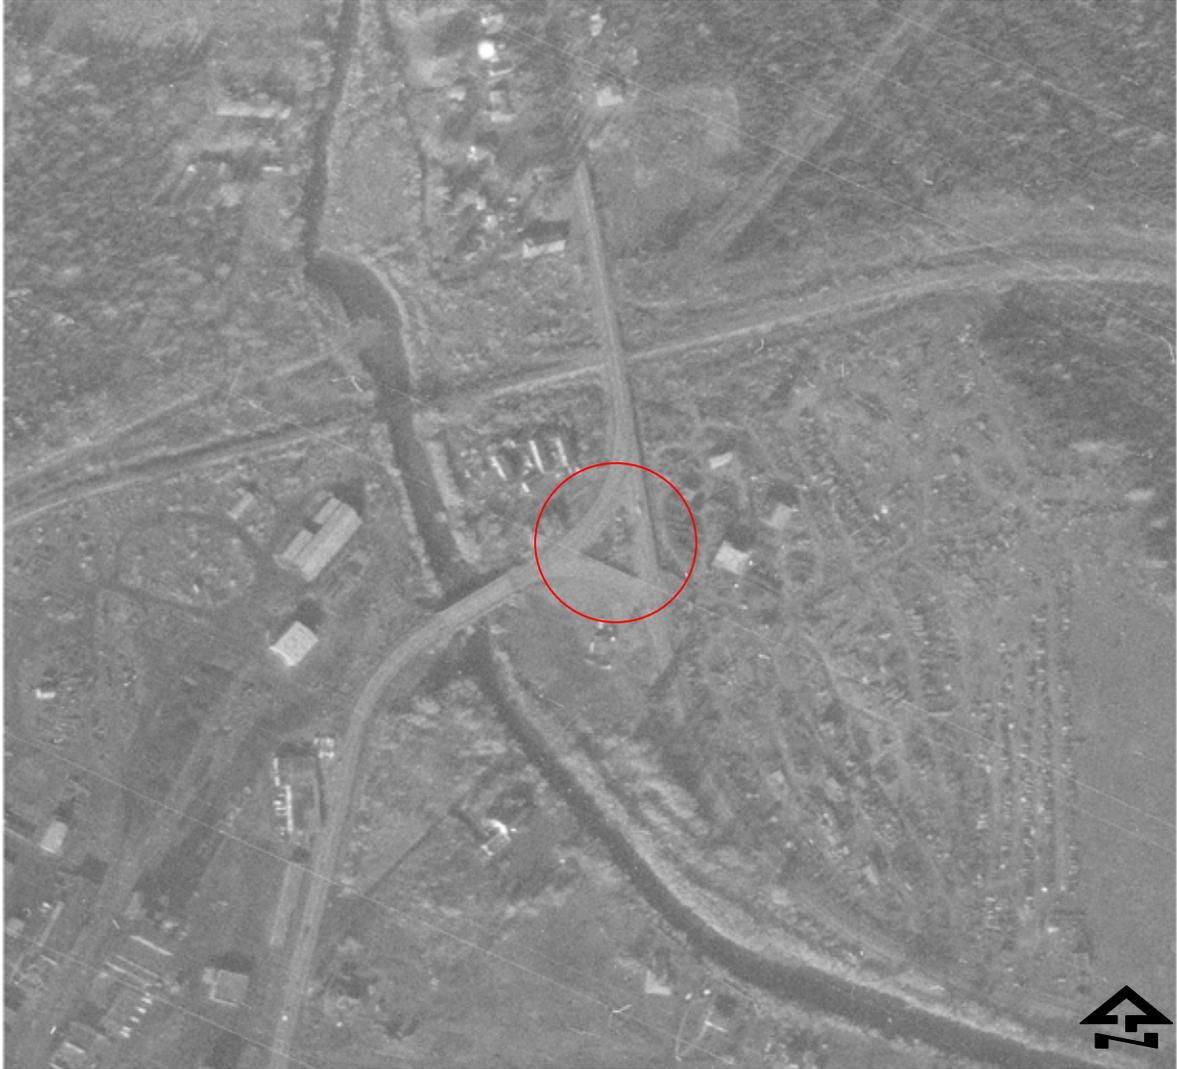
Figure 8. 1959 aerial photograph showing the former location of the Triangle Service Station. Location is at the junction of College Road and Illinois Street. Refer to Figure B2 for the location of this figure.

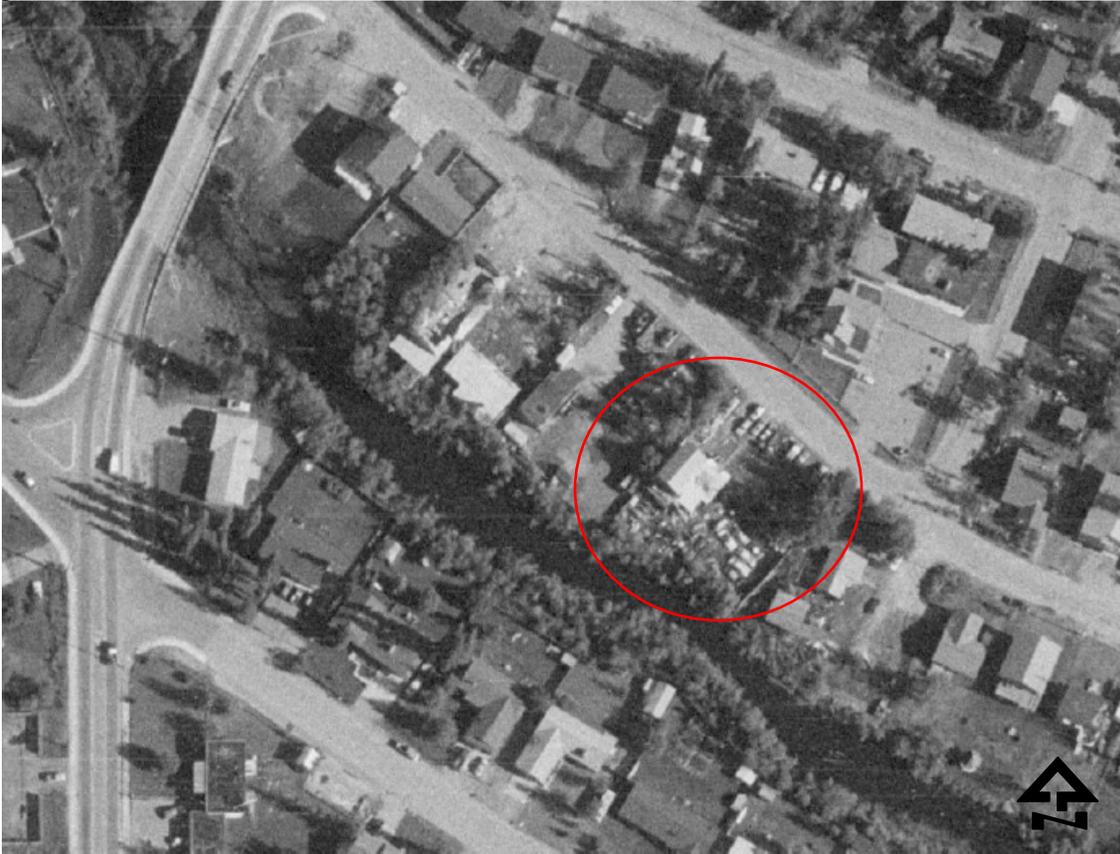
Figure 9. 1987 aerial photograph of Doogan's Tiffany Auto Rebuild. Noyes Slough flows from right to left. Note restricted flow of slough near the Aurora Drive bridge, upper left part of photograph (bridge also shown in Figures 2 and 13). USGS sample SED13 was collected just upstream from the bridge and yielded high levels of metals and semi-volatile compounds associated with activities using urethane, coal tar, tire tar, and petroleum products.

The results of past sampling events and historical uses in the area of the slough near the Aurora Drive Bridge (Tiles 3 and 4) indicate additional investigation is warranted. An automobile repair shop, Doogan's Tiffany Auto Rebuild, was included on the EPA's list of businesses with injection wells found during the source-water protection study of 2001. This property is shown in Figure 9 as it existed in 1987. This is a potential source of contamination found in slough sediment samples collected downstream from the shop (See SED13 and SED14 sample results, Appendix C). In addition to the automobile repair business, a long-term resident provided anecdotal information to the USGS involving a small engine and firearms shop that was historically active on a property near Aurora Drive that routinely dumped waste into the slough through a sump drain located inside the shop building (Ben Kennedy, personal communication, 2007).

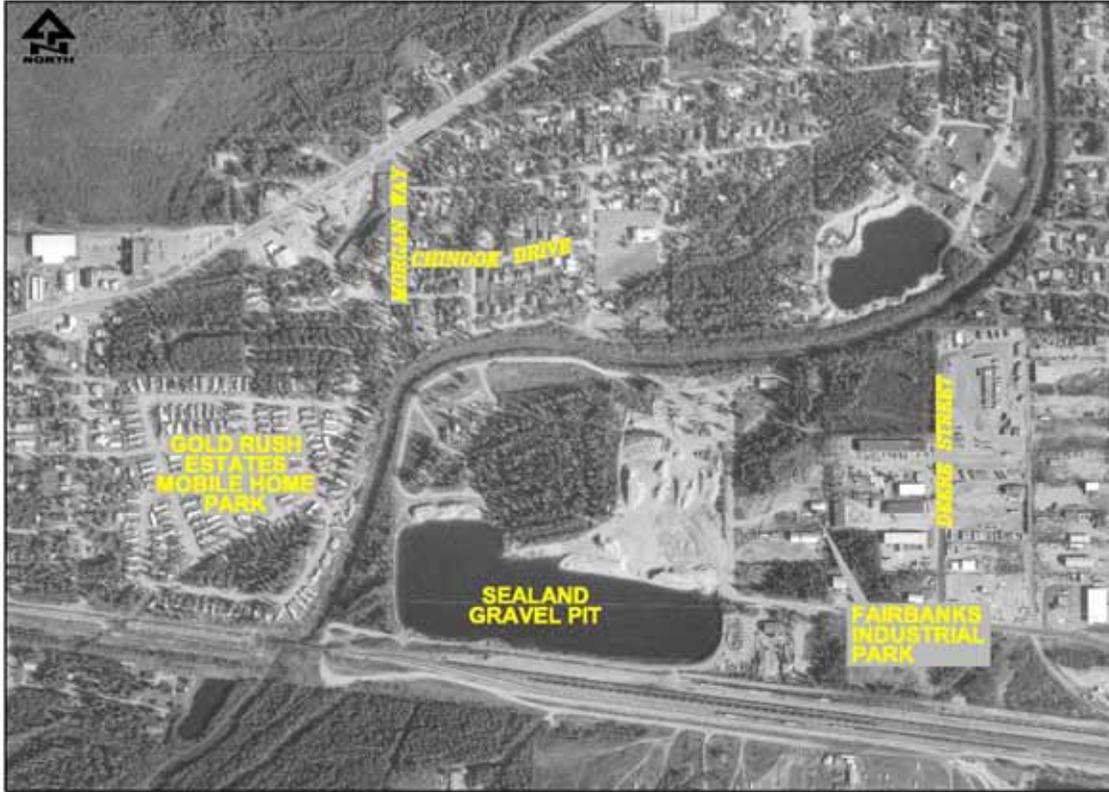
Figure 10. 1987 aerial photograph (Appendix B) showing industrial areas on and around Deere Street.

Several businesses and reported incidents in this area are considered potential sources of contamination to the slough (see Tables 12 and 13). The streets and areas associated with these businesses and incidents are highlighted with yellow text. Refer to Figure B4 for the location of this figure.

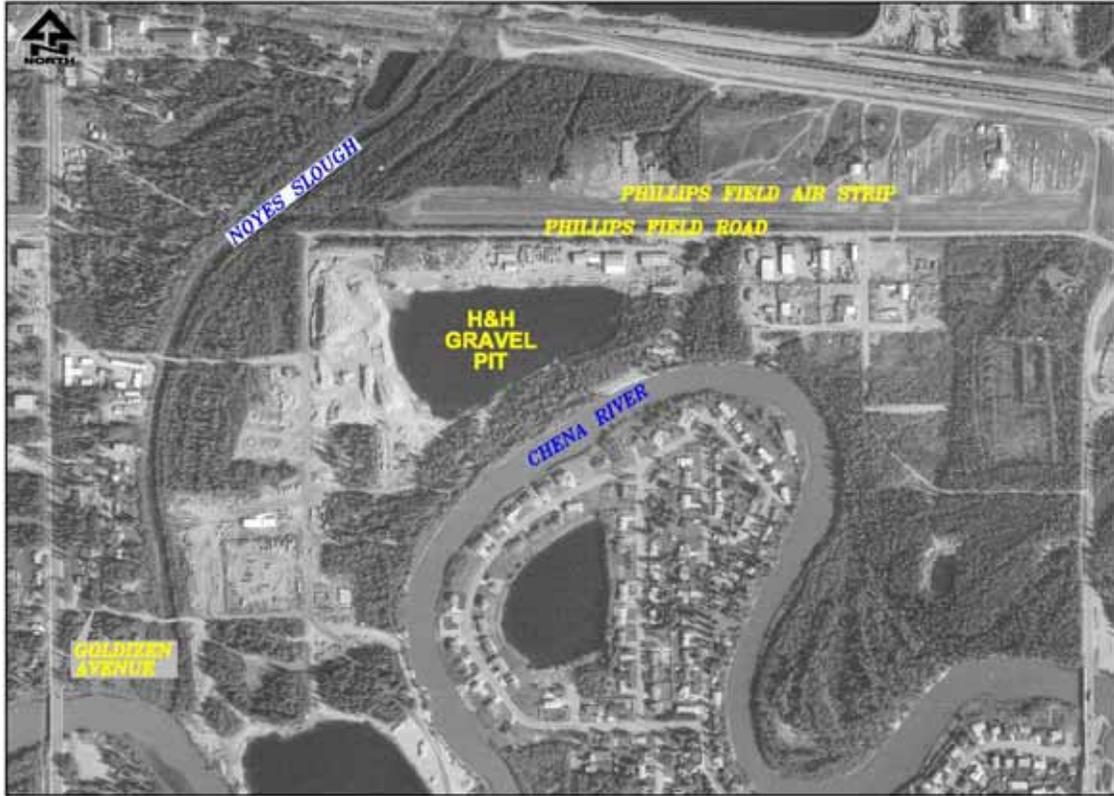
Figure 11. 1987 aerial photograph (Appendix B) showing the Phillips Field industrial area. Several businesses and reported incidents in this area are considered potential sources of contamination to the slough (see Tables 12 and 13). The streets and areas associated with these businesses and incidents are highlighted with yellow text. Refer to Figure B4 for the location of this figure.

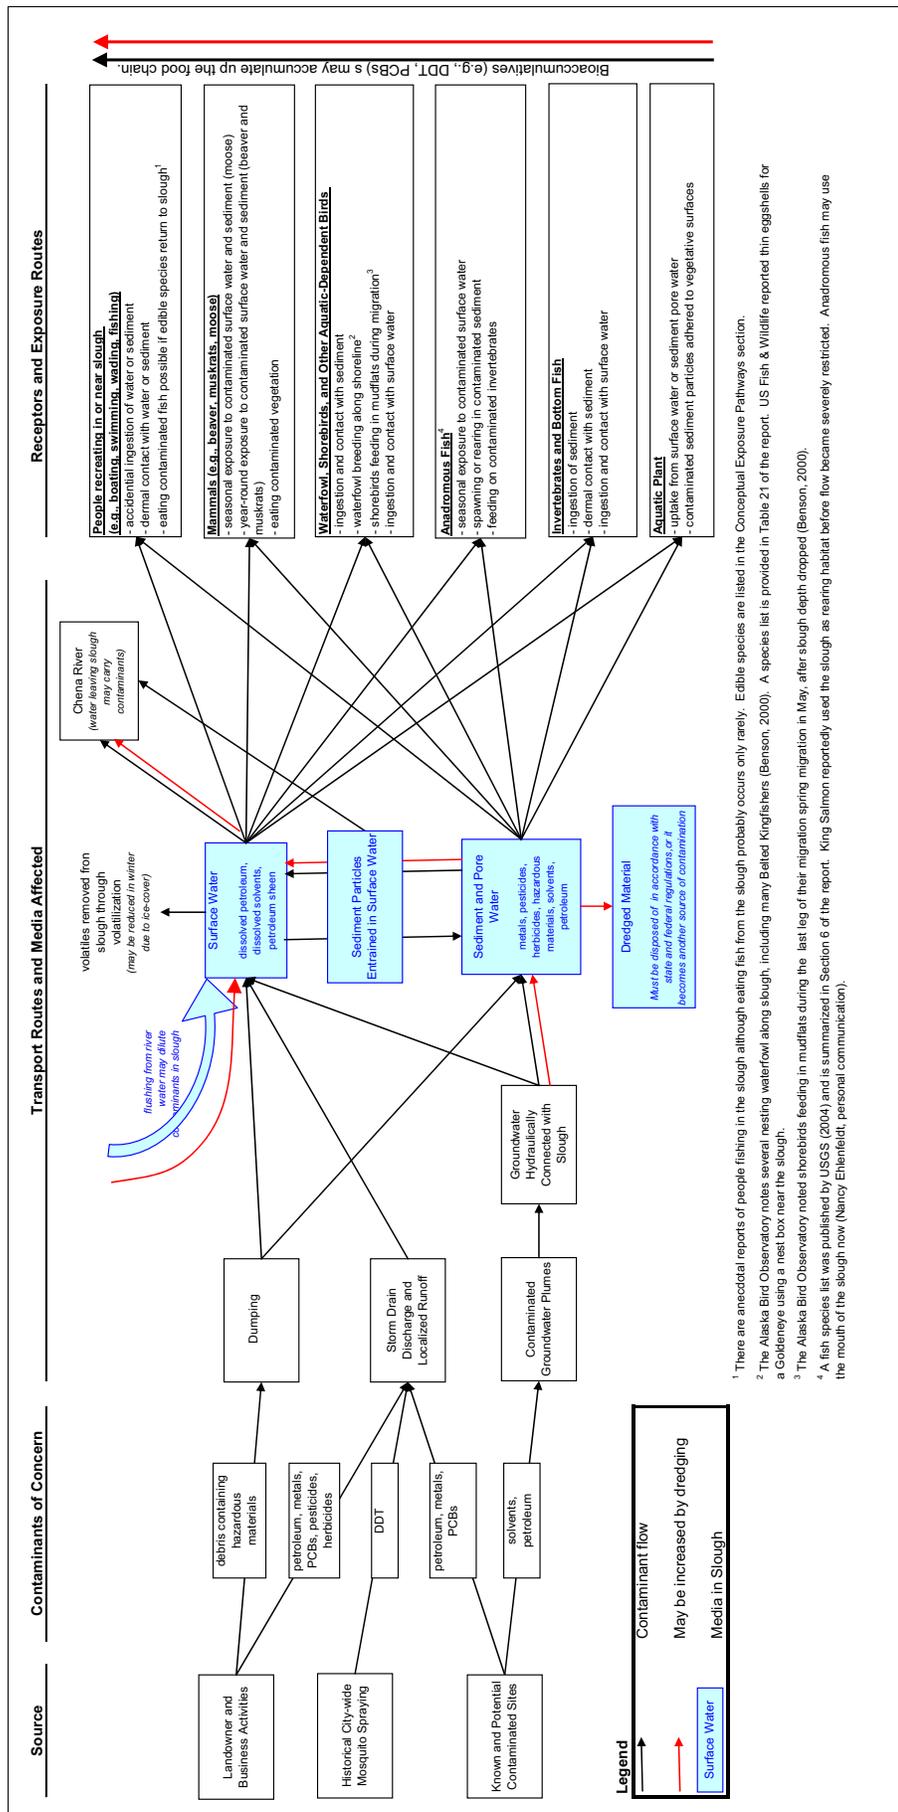
Figure 12. Conceptual exposure pathway model for Noyes Slough, showing possible effects of dredging.

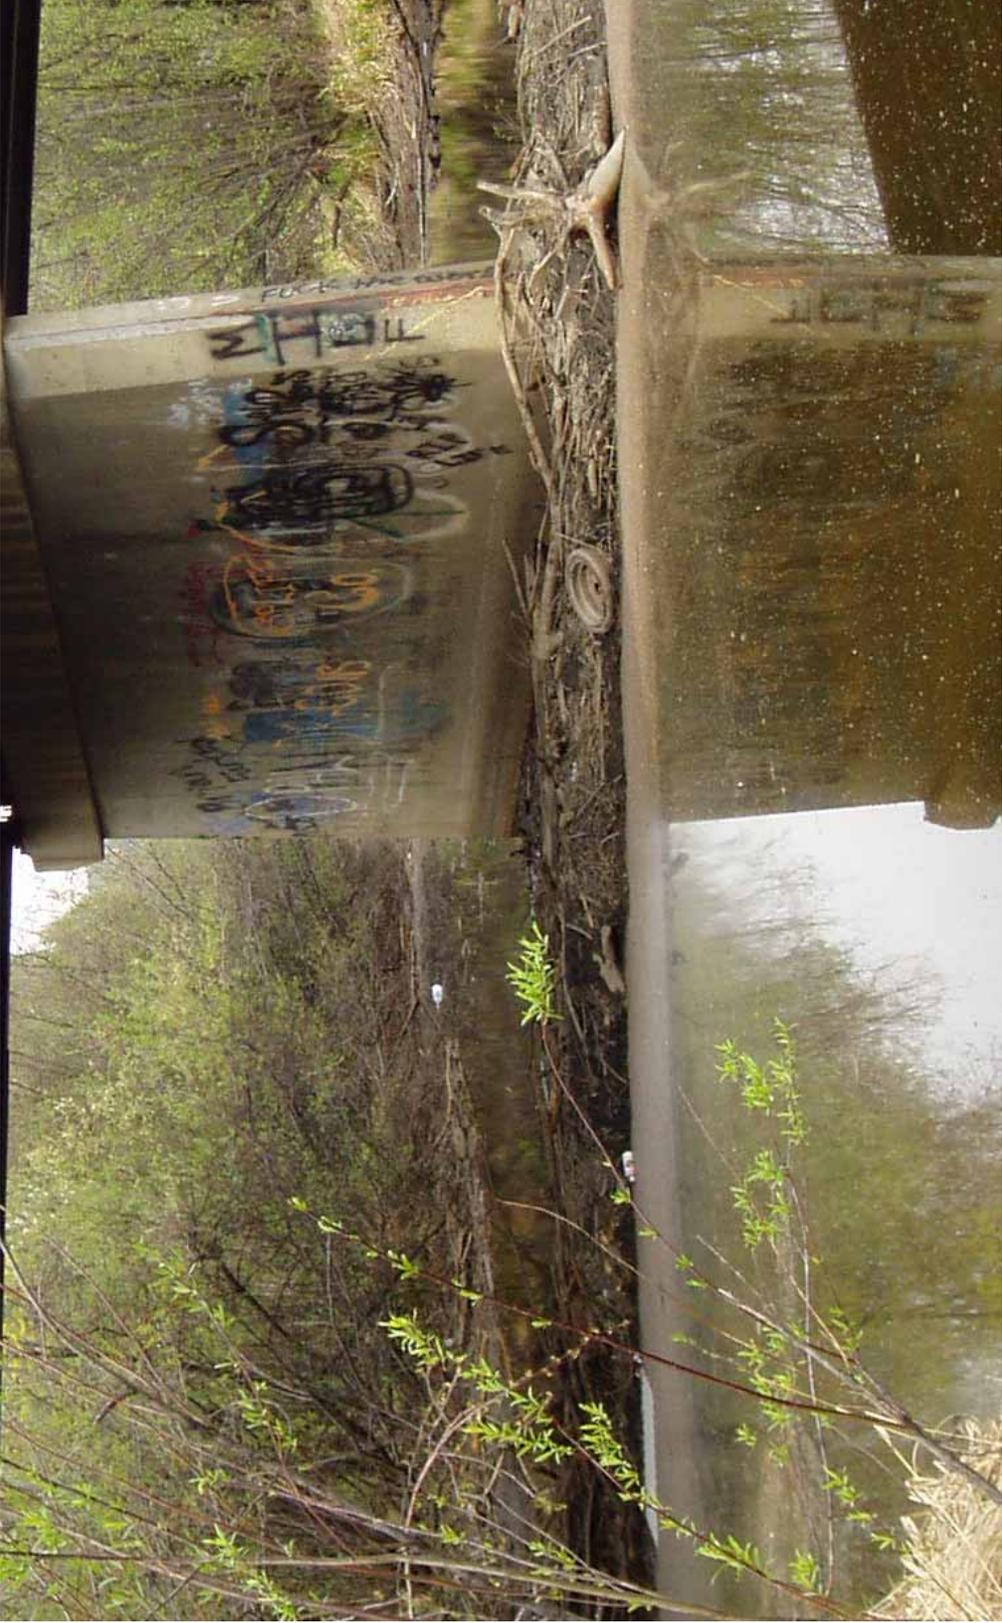
Figure 13. Noyes Slough and beaver dam with debris below Aurora Drive bridge. May 22, 2007. This bridge also appears in Figures 2 and 9.

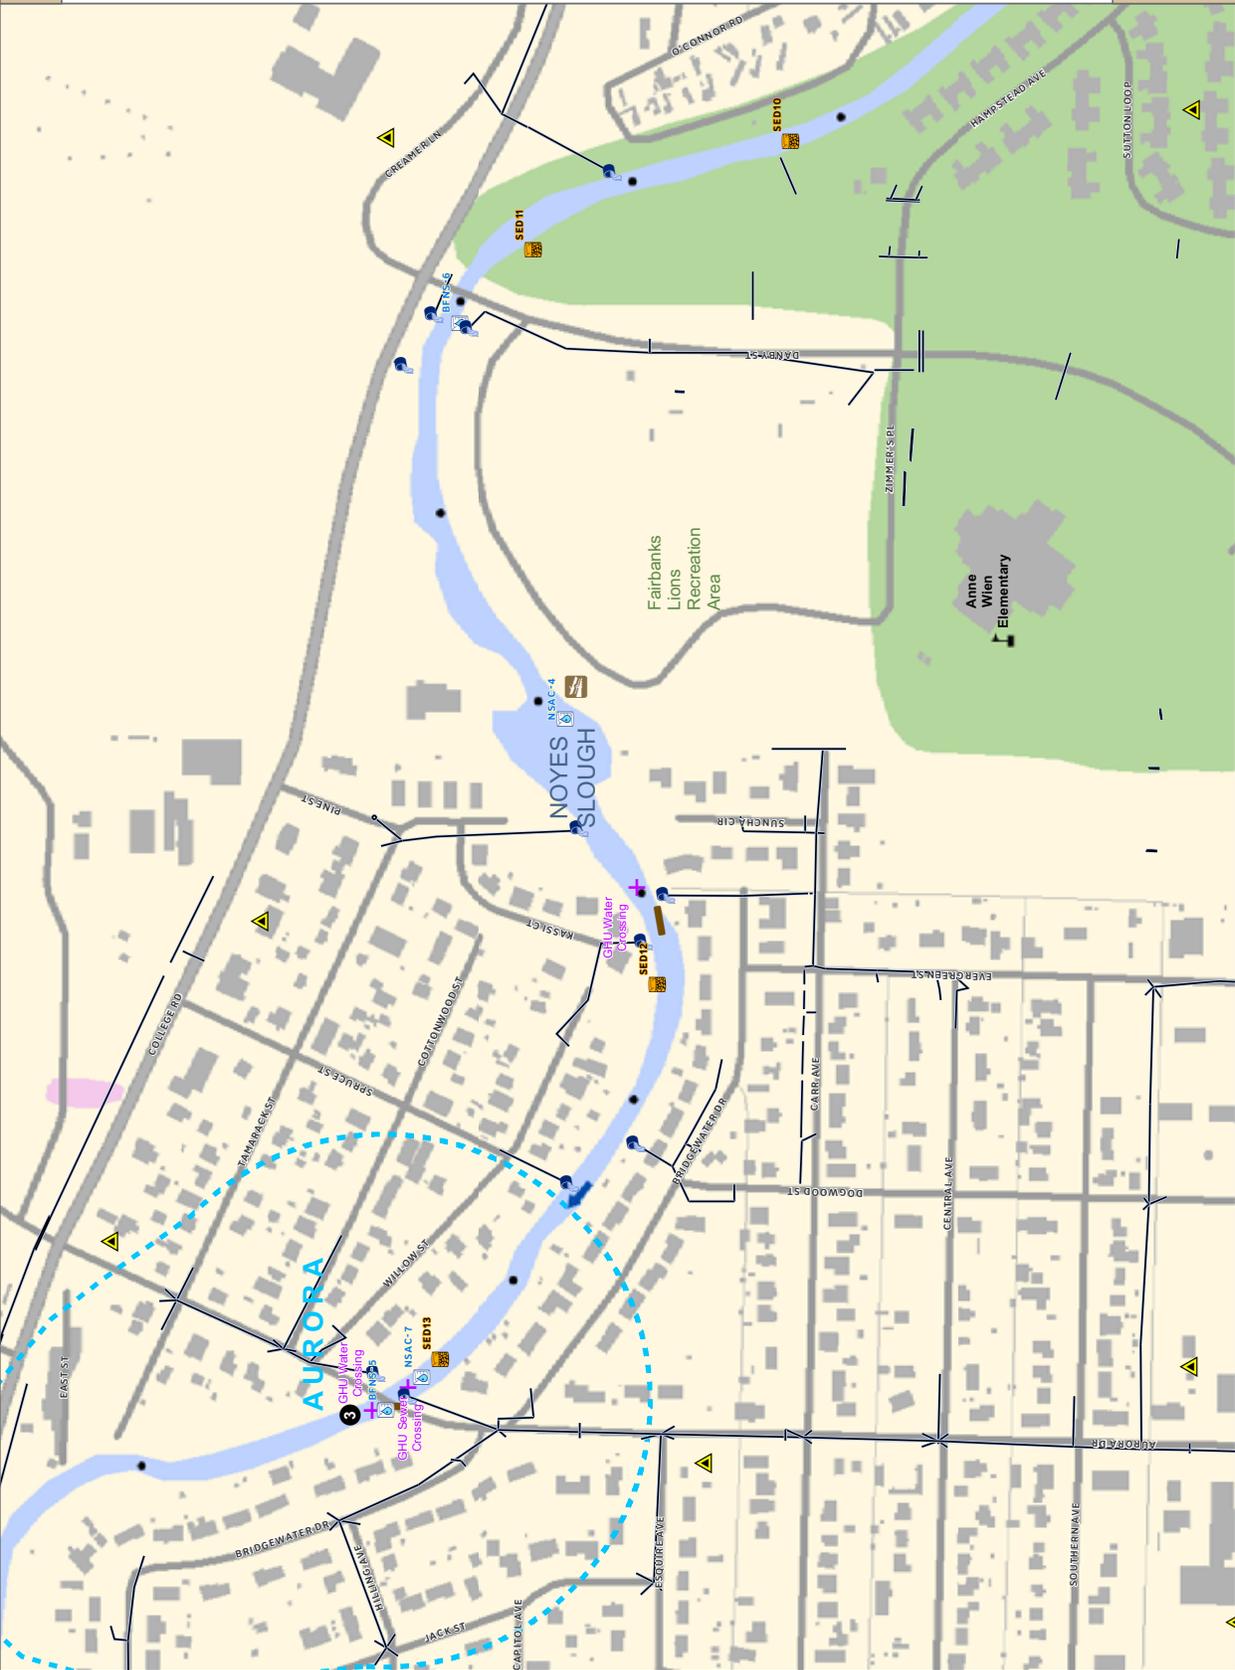
Tile 4 Noyes Slough

- ## Guide to Sampling
- Pen Water: BM-NS-XX - Bentley Mail East Satellite Building - Diffusion Bag Study
 - Groundwater: NS-XX - Alaska Railroad Wells; BM-AM-XX - Bentley Mail East Satellite Building; 201 MHW-XX - Bentley Mail East, July 2011; FAIR-MW-XX - Fairbanks Area-wide Industrial Reclamation project; FAIR-X - FAIR temporary wellpoints; L-S-W-X - Letter Shop Wells; US-MW-X - US Travel Wells
 - Surface Water: NS-AC-X - Noyes Slough Action Committee; SL-X - AGRU Earth and Environmental; BF-NS-X - DEC Biomfield Program
 - Sediment: SED-XX - USGS WRRR 03-4238; NS-AC-X - Noyes Slough Action Committee

A legend is found along the right side of each of the maps. The legend defines all of the features and symbols on the map. Physical features include water bodies, stormwater piping and outfalls, beaver dams, and municipal roads and building outlines.

Lastly, the map shows contamination features. These include DEC Contaminated Sites, which are represented by yellow and red triangles; potential sources of contamination, such as businesses that use significant amounts of petroleum products or hazardous substances; estimated delineations of contaminant “plumes” in groundwater, mapped on the basis of sampling results (color-coded by type of contaminant); and other areas of concern, where contamination has either been detected or historical uses indicate the potential for environmental problems.
