**Preliminary Hazardous Waste
Site Evaluation
Proposed Minnie Street Connector
Fairbanks, Alaska**

May 1989
SHANNON & WILSON, INC.

X-0176

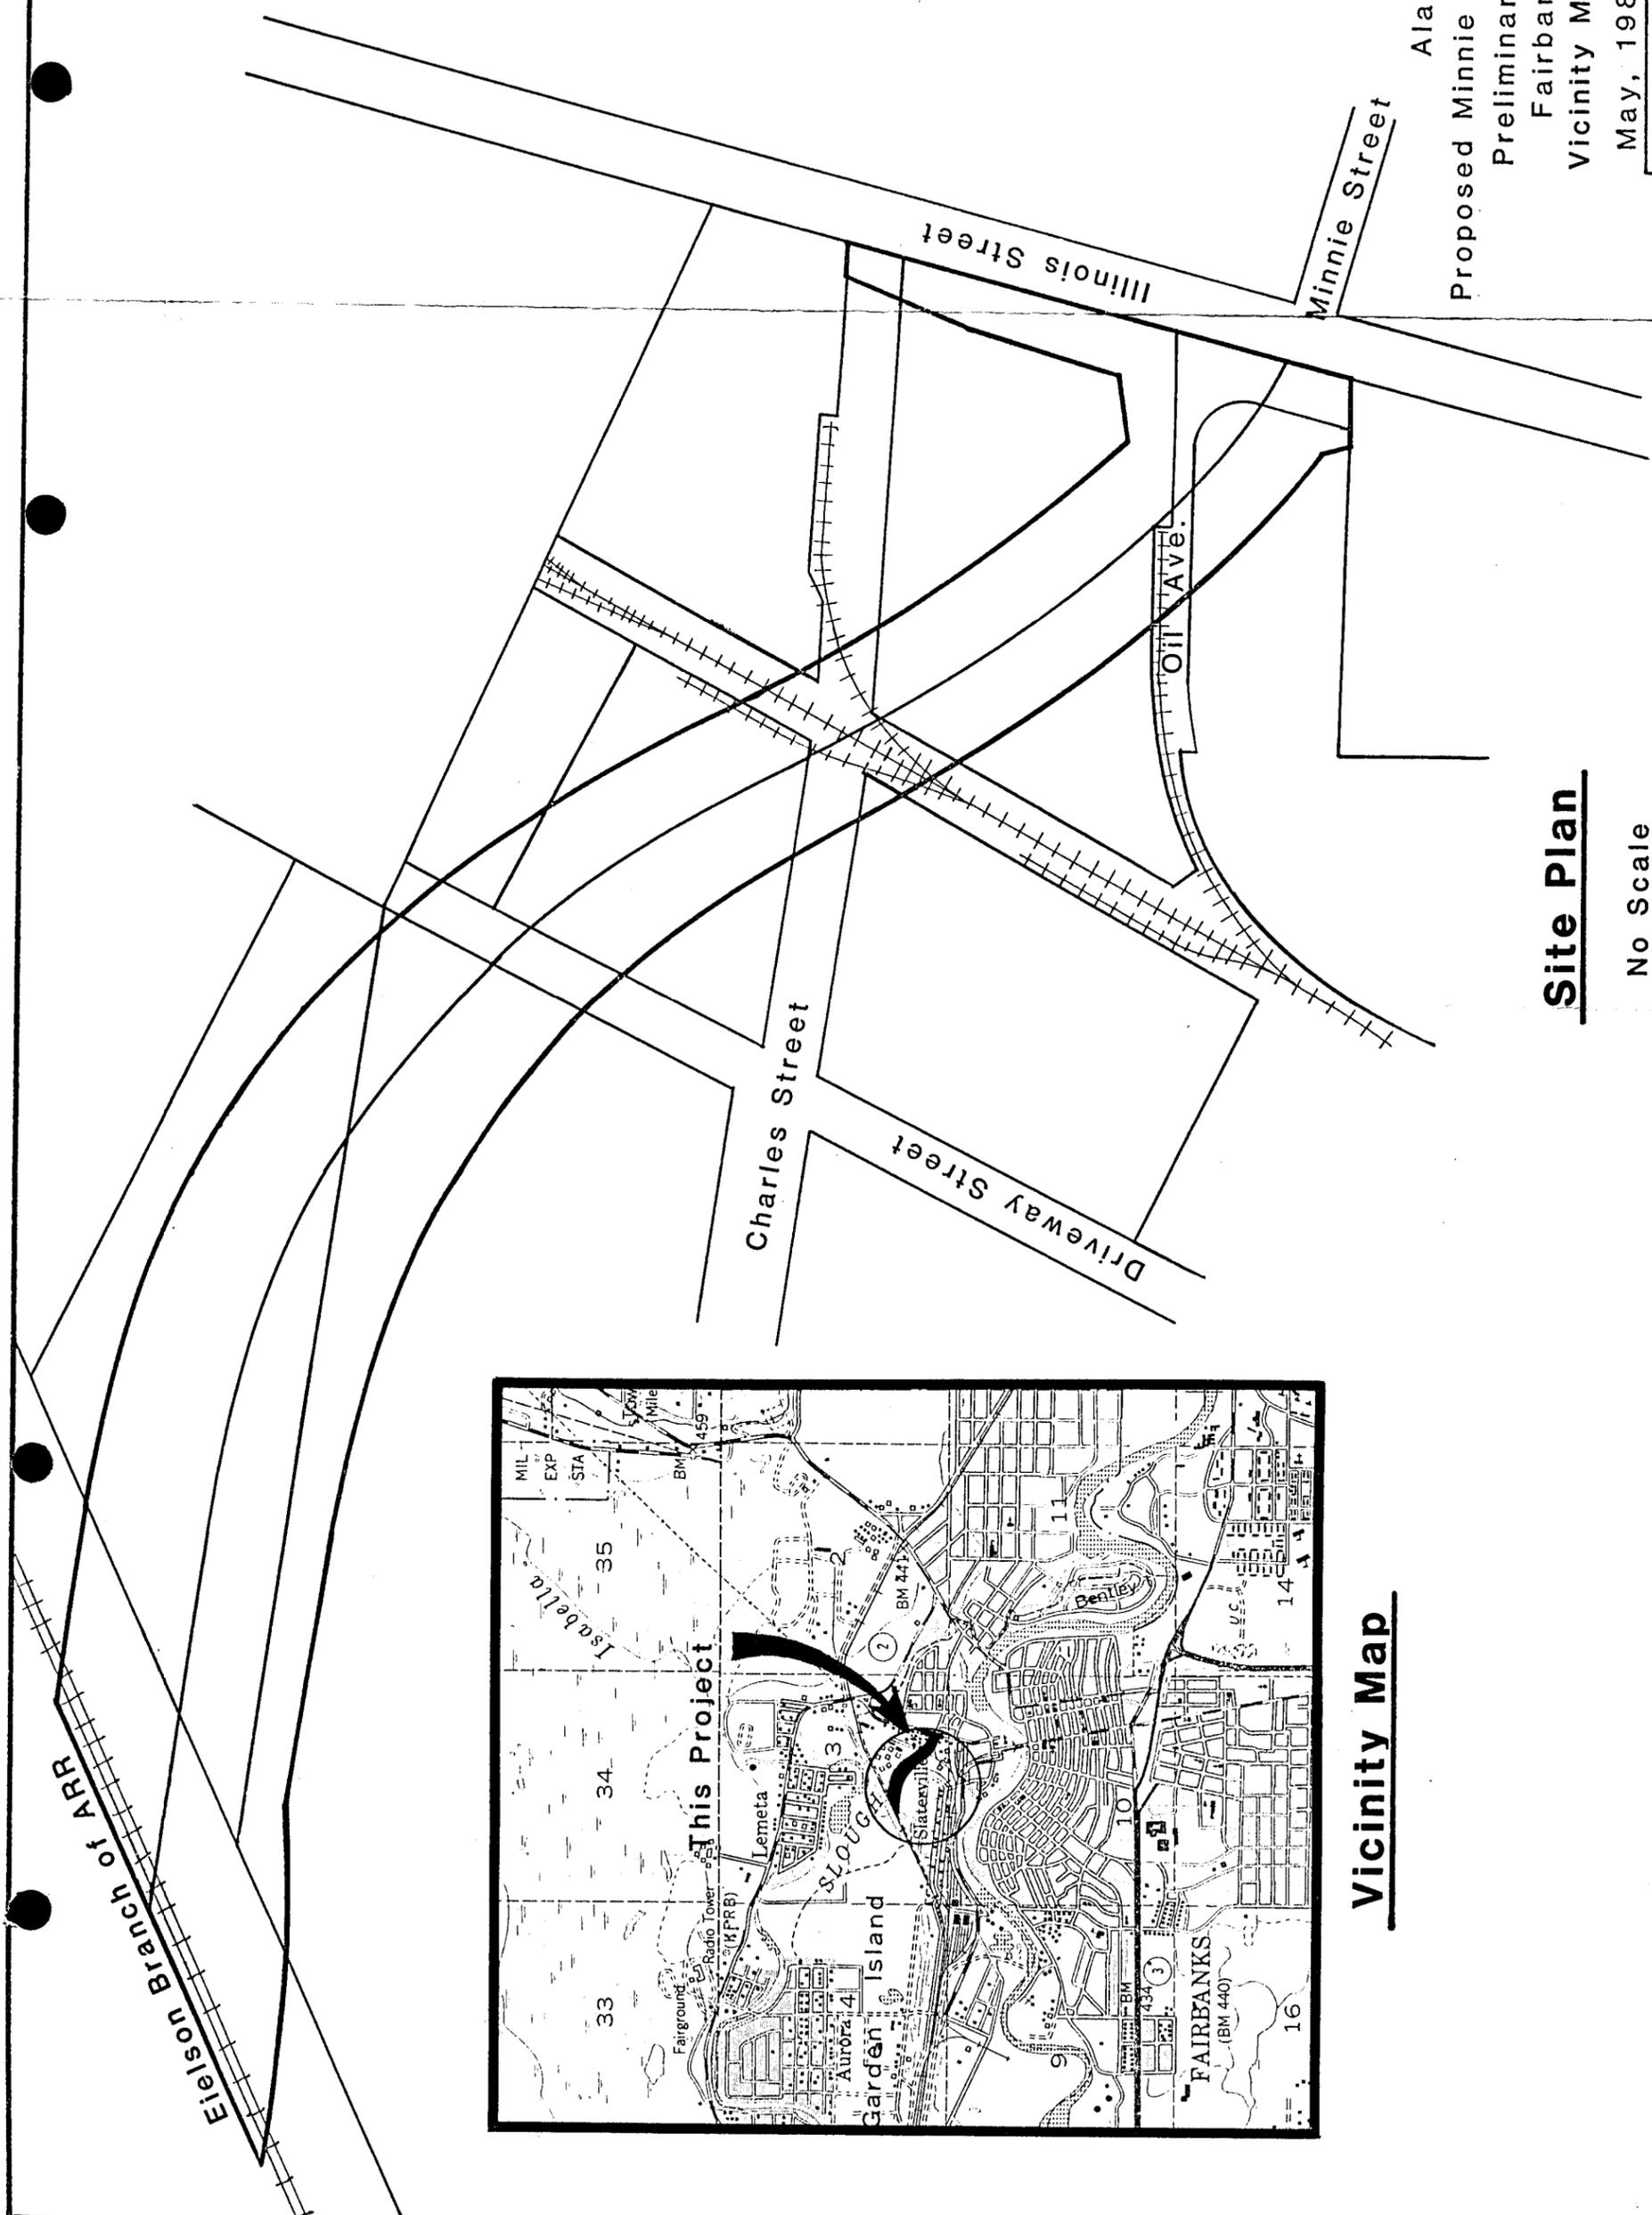
FIG. 1

Vicinity Map

Site Plan

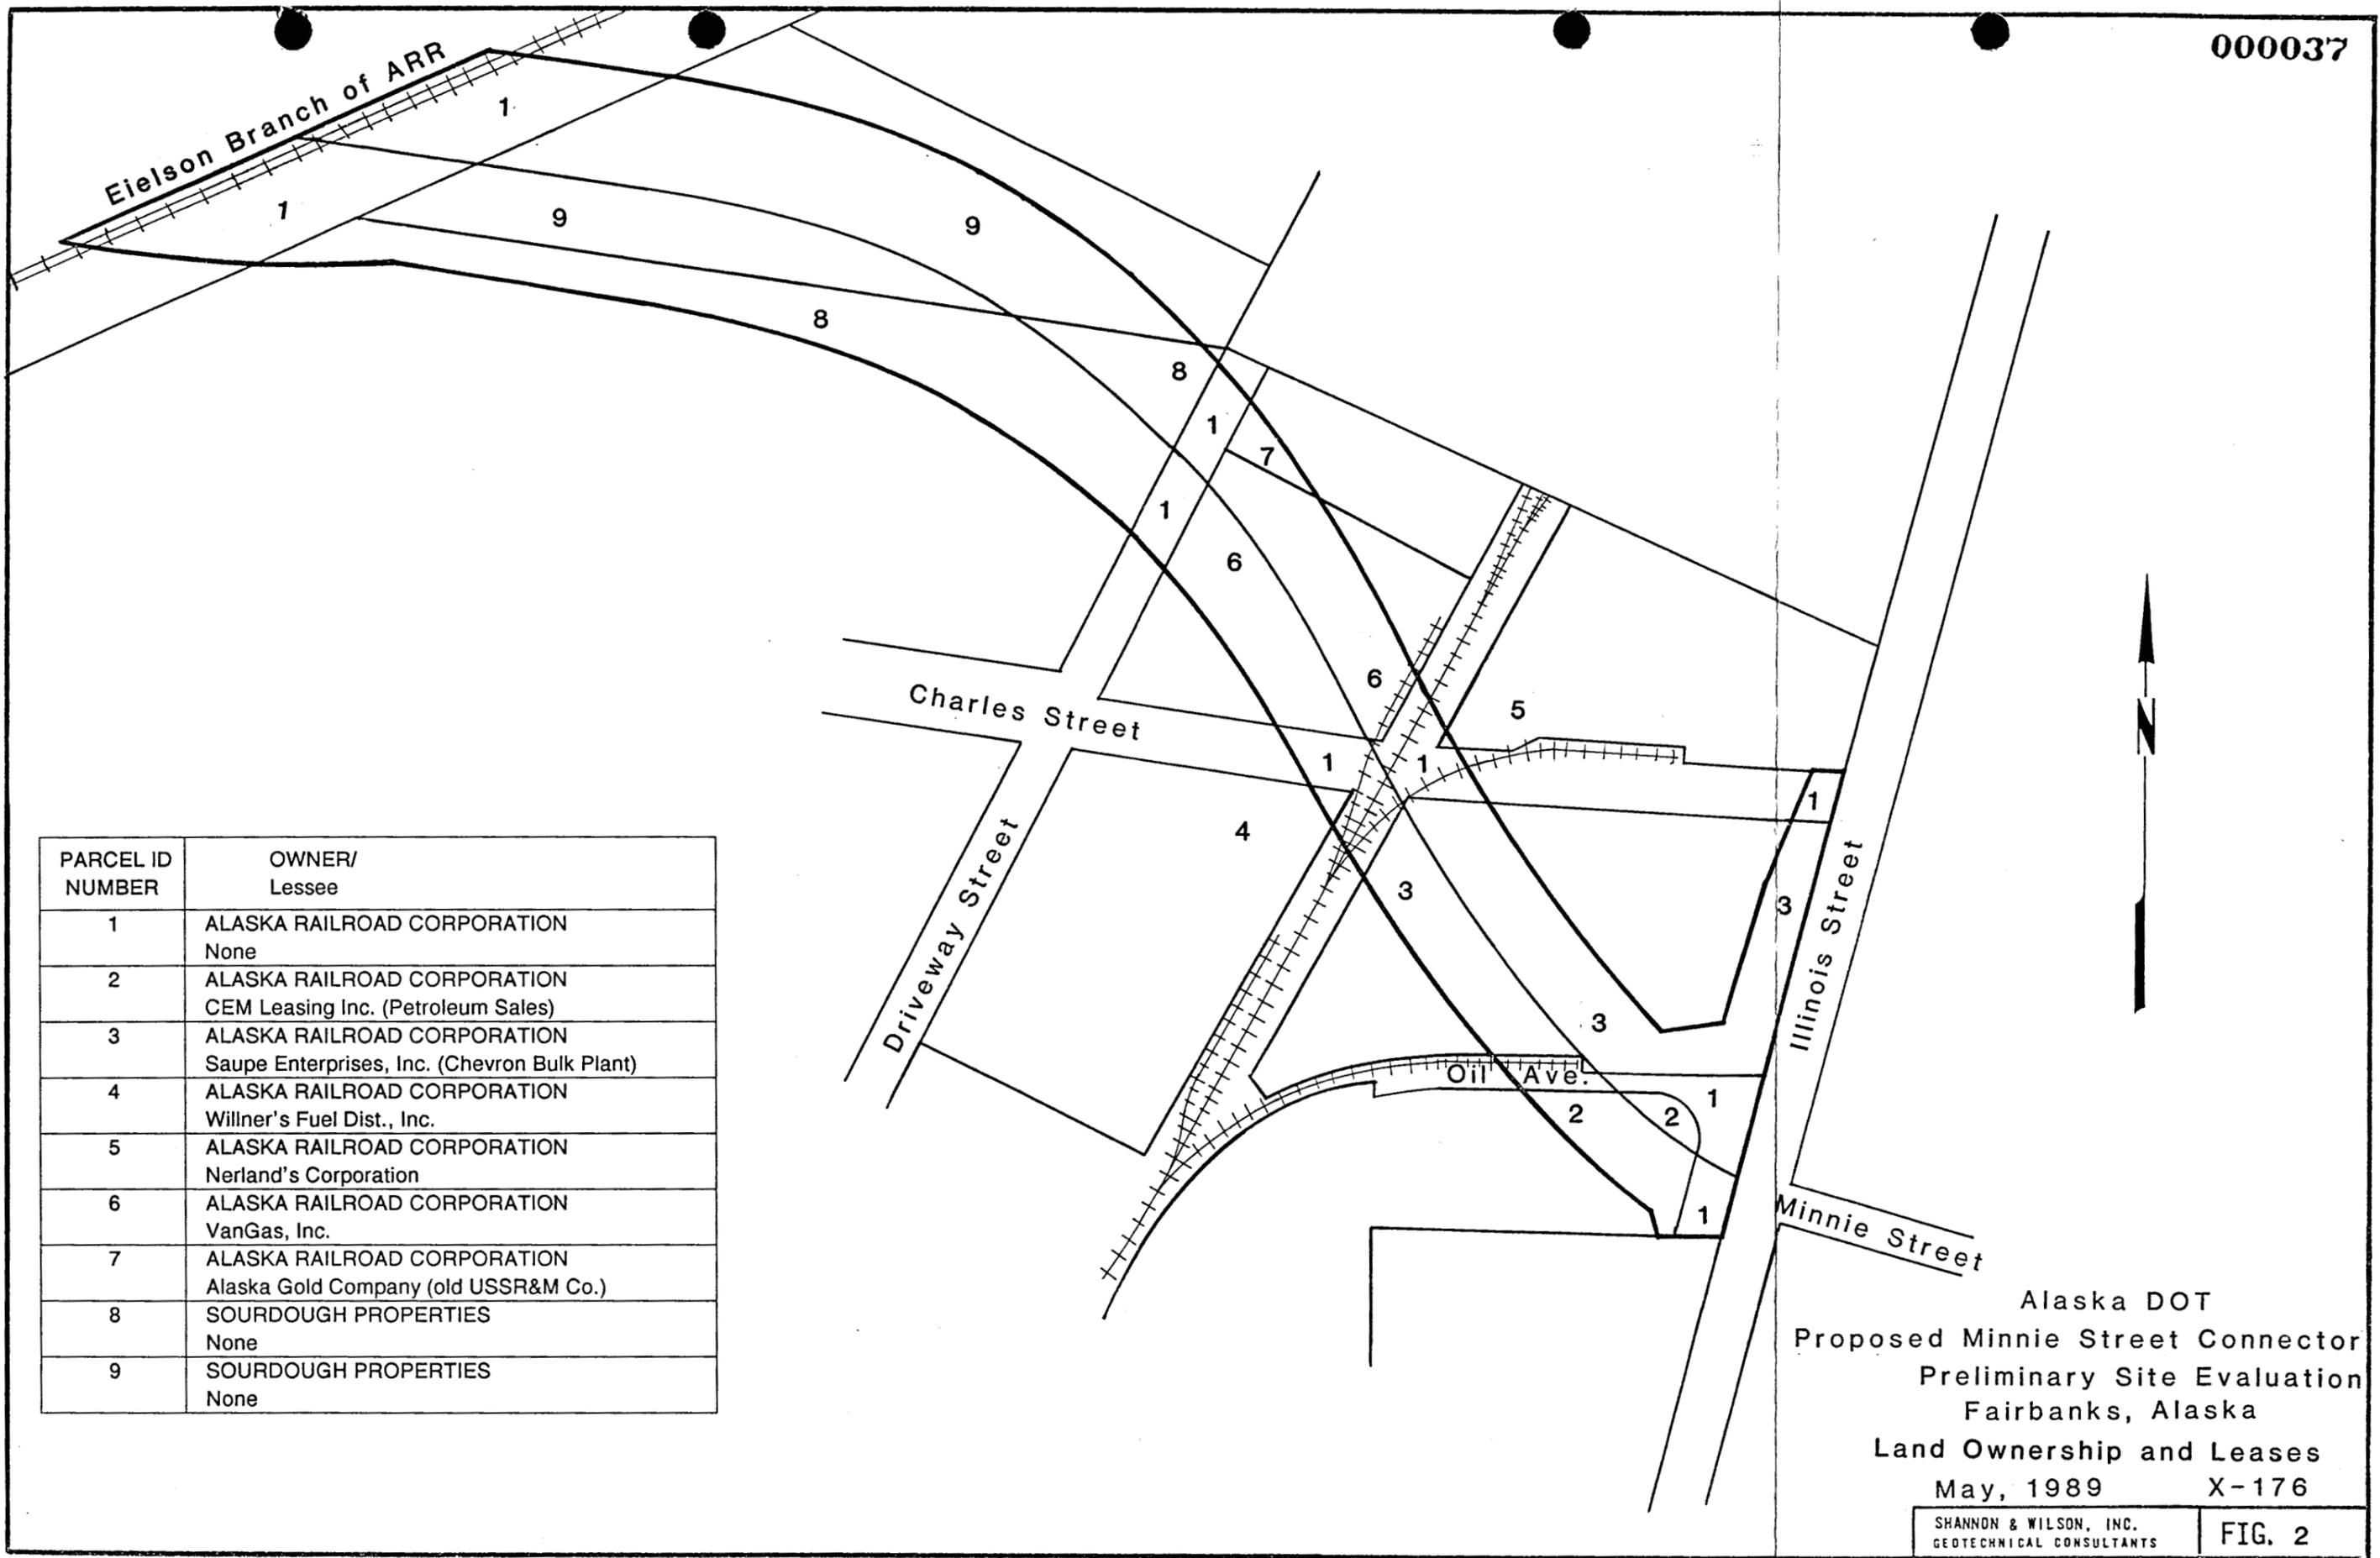
FIG. 2

PARCEL ID NUMBER	OWNER/ Lessee
1	ALASKA RAILROAD CORPORATION None
2	ALASKA RAILROAD CORPORATION CEM Leasing Inc. (Petroleum Sales)
3	ALASKA RAILROAD CORPORATION Saupé Enterprises, Inc. (Chevron Bulk Plant)
4	ALASKA RAILROAD CORPORATION Willner's Fuel Dist., Inc.
5	ALASKA RAILROAD CORPORATION Nerland's Corporation
6	ALASKA RAILROAD CORPORATION VanGas, Inc.
7	ALASKA RAILROAD CORPORATION Alaska Gold Company (old USSR&M Co.)
8	SOURDOUGH PROPERTIES None
9	SOURDOUGH PROPERTIES None

Alaska DOT
 Proposed Minnie Street Connector
 Preliminary Site Evaluation
 Fairbanks, Alaska
 Land Ownership and Leases
 May, 1989 X-176

Figure 2 gives the location of the businesses and parcels listed above and impacted by the proposed project. Also, this figure shows the footprint of the road project on the existing land.

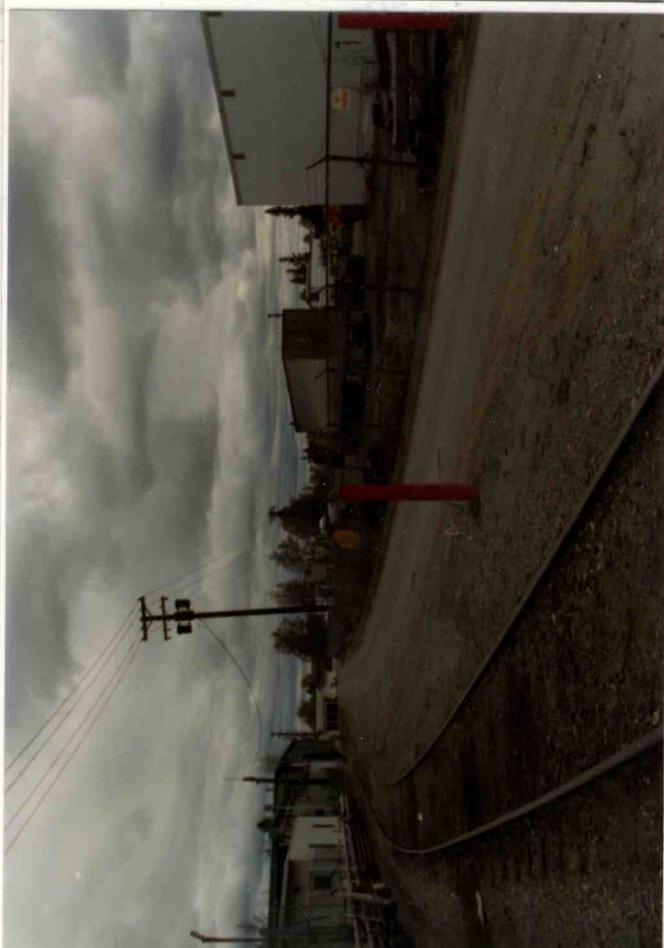
Photo #: 1

Location: Rail spur serving Saube Enterprises. Looking east along Oil Avenue.

Description: Surface contamination resulting from unloading rail tanker cars.

A site survey of these properties revealed two areas of accumulated petroleum releases; the rail spurs at VanGas and at Saupe Enterprises. Photographs #1 through #4 show petroleum-stained ground. Another observation during the site survey was ongoing discharges from a stack of 55 gallon drums located outside the western lease boundary of VanGas and within the 50 foot right-of-way of Driveway Street (Photographs #5 and #6). Philip Wood, district manager for Suburban Propane (VanGas), indicates that the drums belong to Fred Schikora, past owner of Northern Gas and Oil (pre-VanGas). Mr. Wood is not sure, but thinks the drums may contain tar.

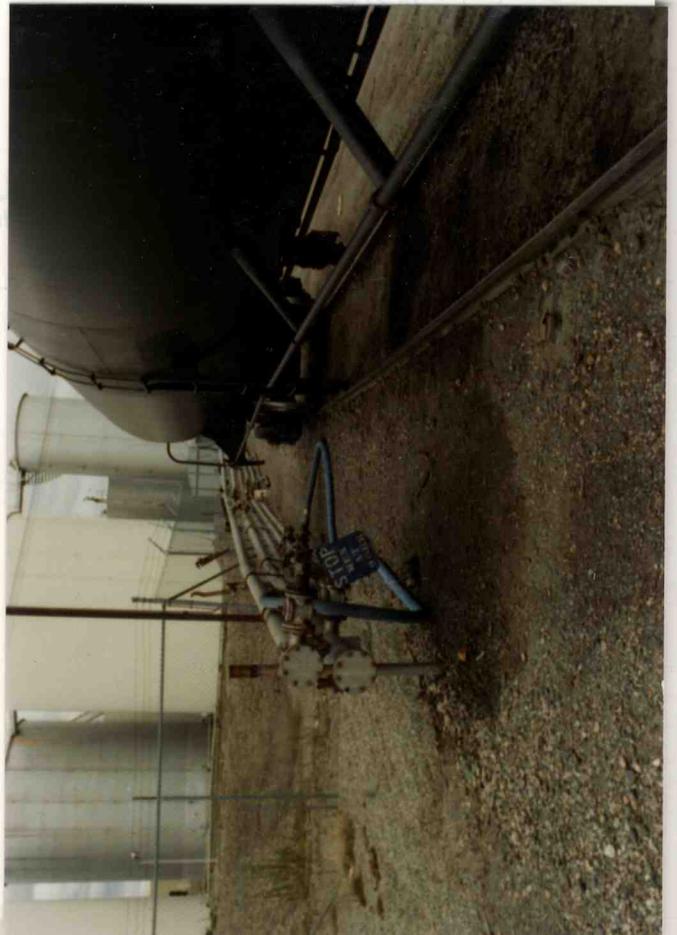
Photo #: 2

Location: Rail spur serving Saube Enterprises. Looking east along Oil Avenue.

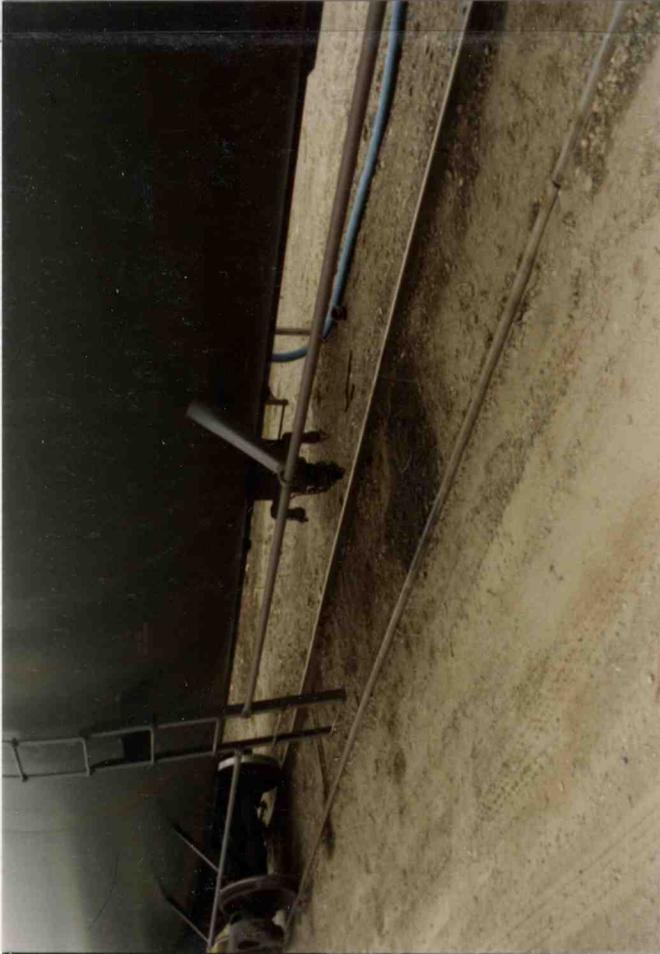
Photo #: 3

Location: Rail spur serving Saupe Enterprises along Oil Avenue.

Description: Surface contamination from railroad tanker cars.

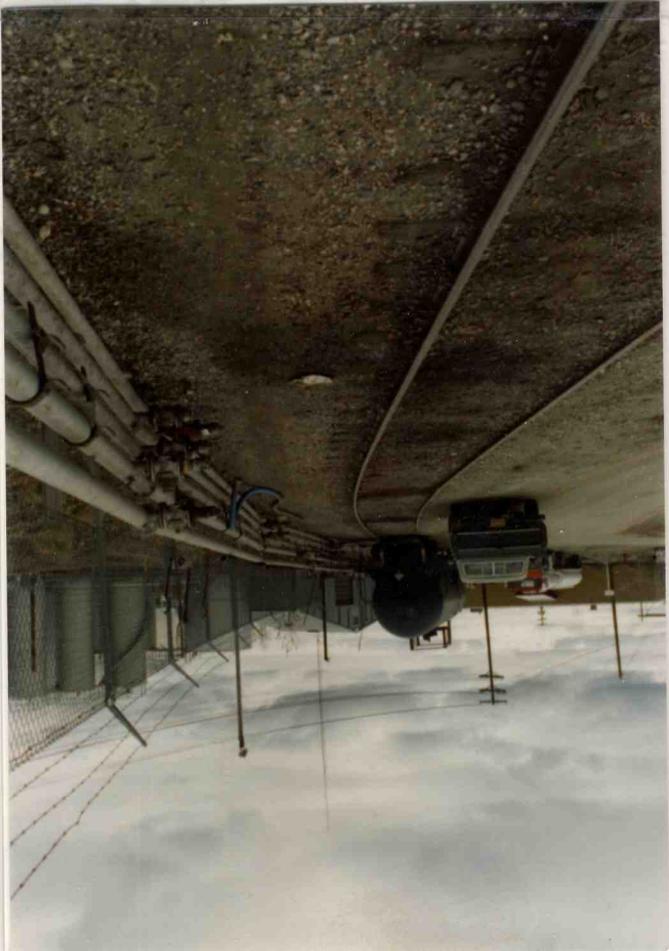
Photo #: 4

Location: Rail spur at Saupe Enterprises. Looking west along Oil Avenue.

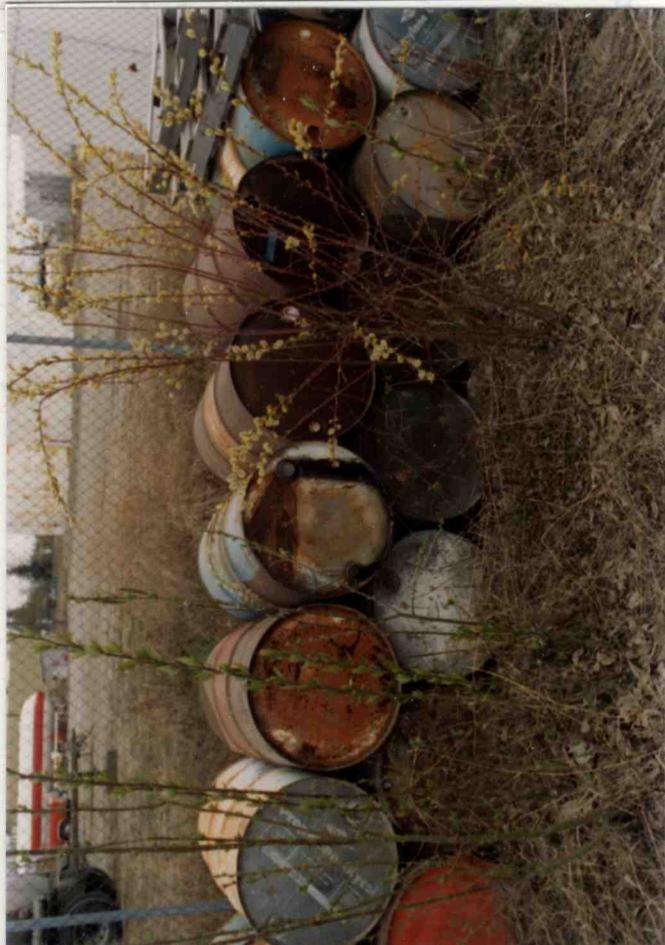
Photo #: 5

Location: On Driveway Street looking east towards VanGas properties.

Description: 55 gallon drums stockpiled outside VanGas property fence; some are actively leaking. Exact origin and contents are unknown.

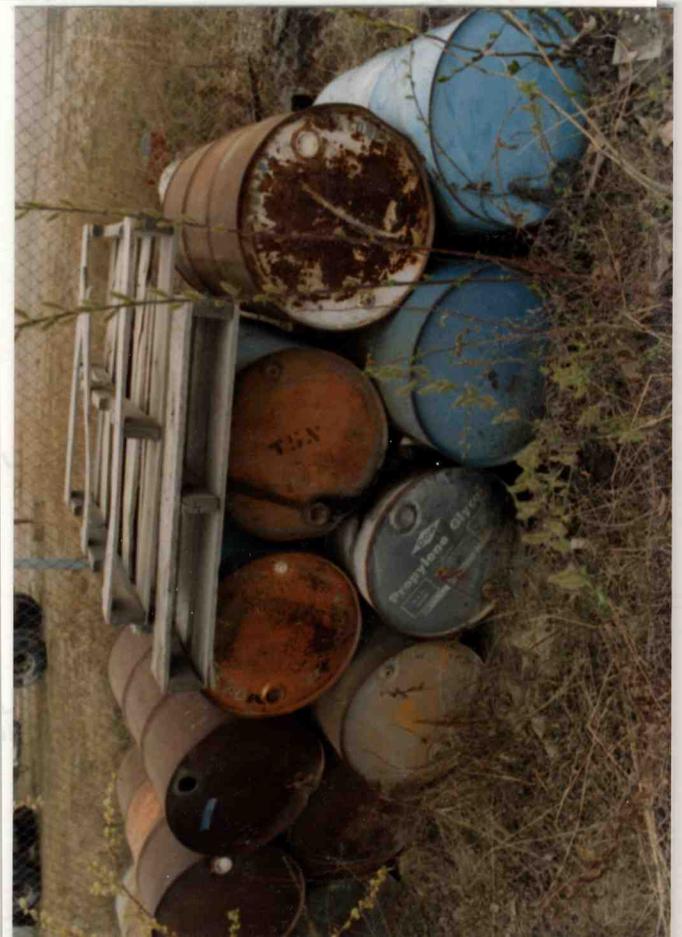
Photo #: 6

Location: On Driveway Street looking east towards VanGas properties.

Description: 55 gallon drums stockpiled outside VanGas property fence; some are actively leaking. Exact origin and contents are unknown.

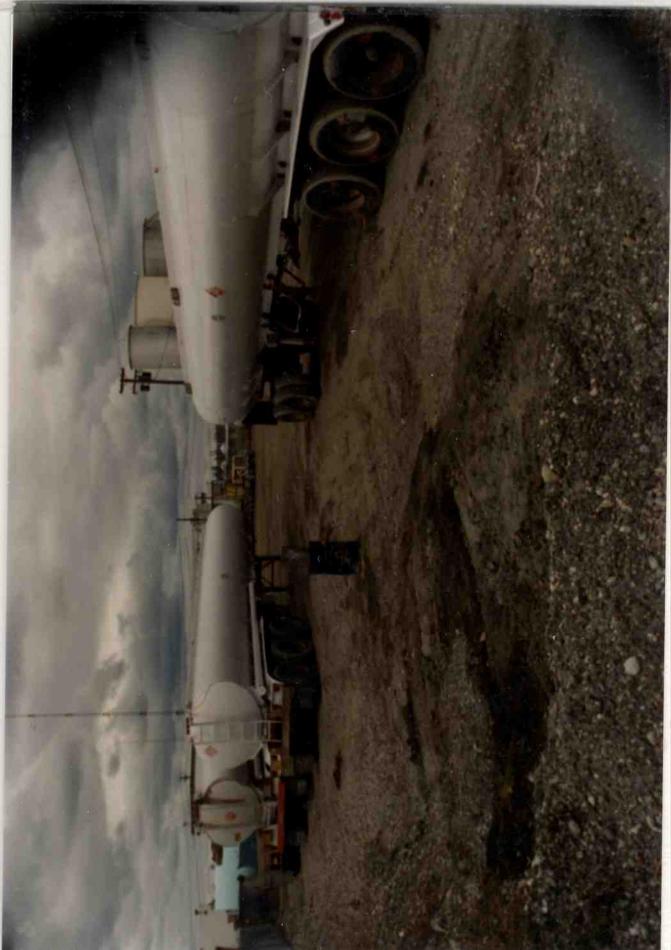
Photo #: 9

Photograph #9 shows Saupe Enterprises from atop a large AST looking in an easterly direction. This photograph shows the large warehouse to the right which is used to store the packaged products. To the left shows the tank truck loading rack (post late 1960s) for bulk deliveries. Photograph #10 shows the location of the old tanker truck loading platform (pre late 1960s). Photograph #11 shows the underground piping system going to the existing tank truck loading rack. Photograph #12 is a view of the load rack and ASTs from the Charles Street and Illinois Street intersection.

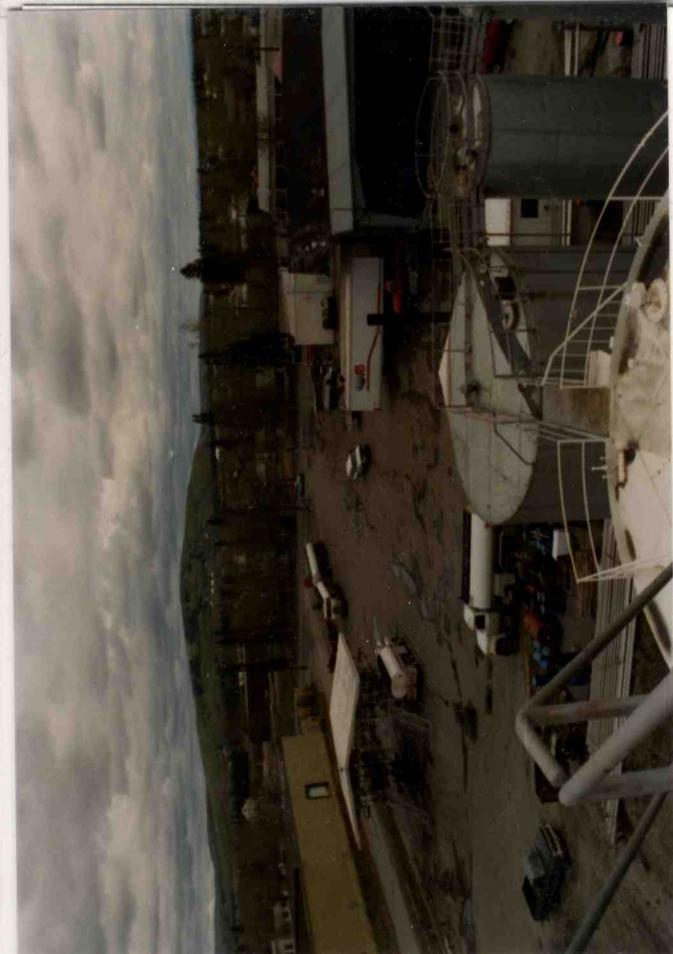
Location: Looking northeast from atop bulk tank located at Saupe Enterprises.

Description: Photo shows current use of land.

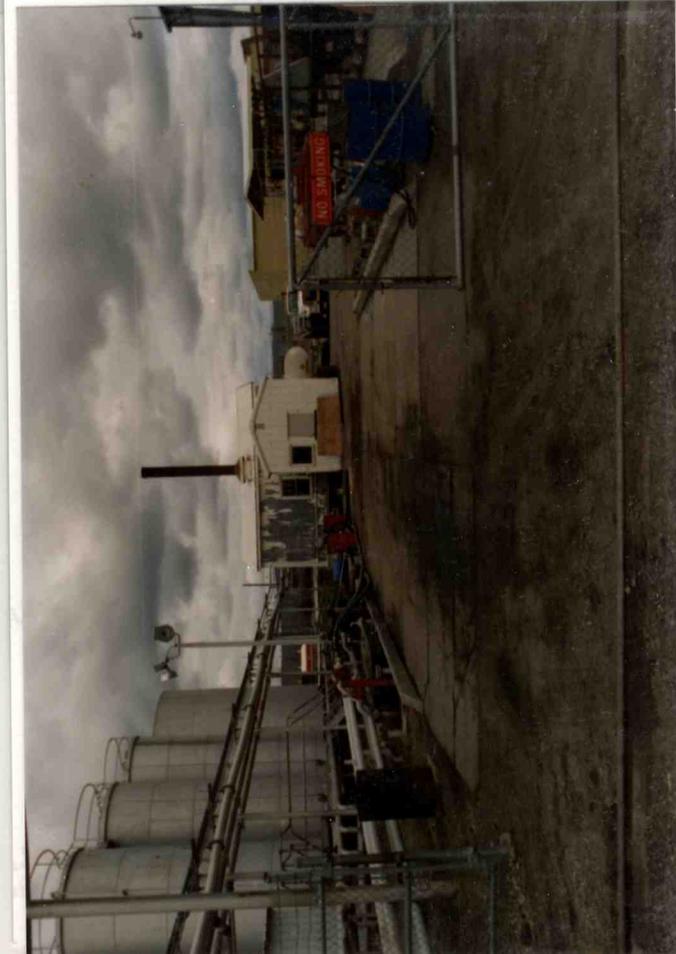
Photo #: 10

Location: Looking north from Oil Avenue through gate onto Saupe Enterprises' property.

Description: Photo shows location of old truck loading facility used until late 1960's. Petroleum stained surface evident.

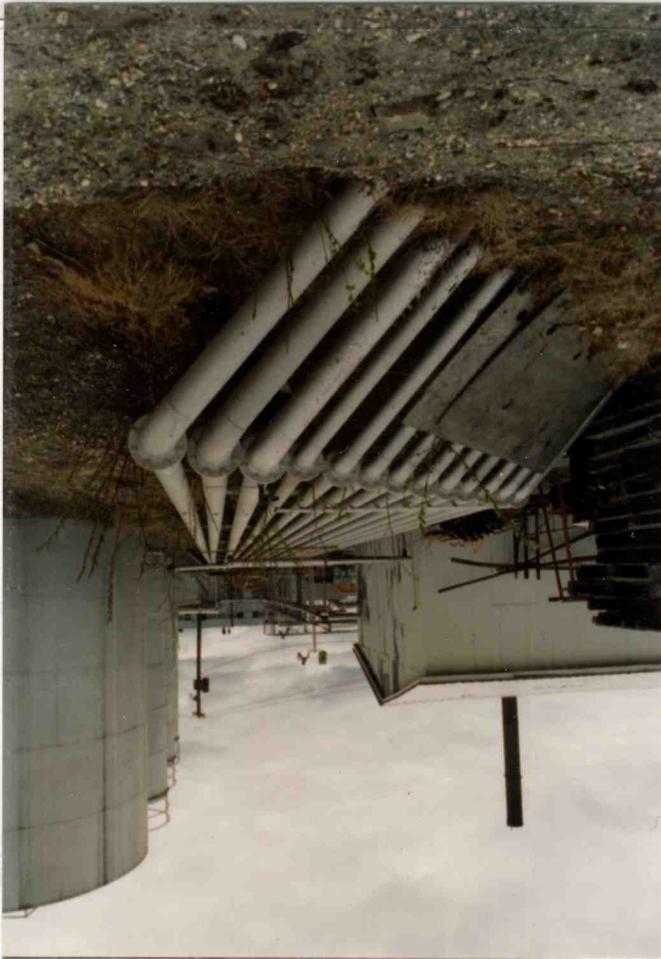
Photo #: 11

Location: Looking south on Saupe Enterprises' property.

Description: Photo shows petroleum product piping partially above ground, going underground to tank truck load rack.

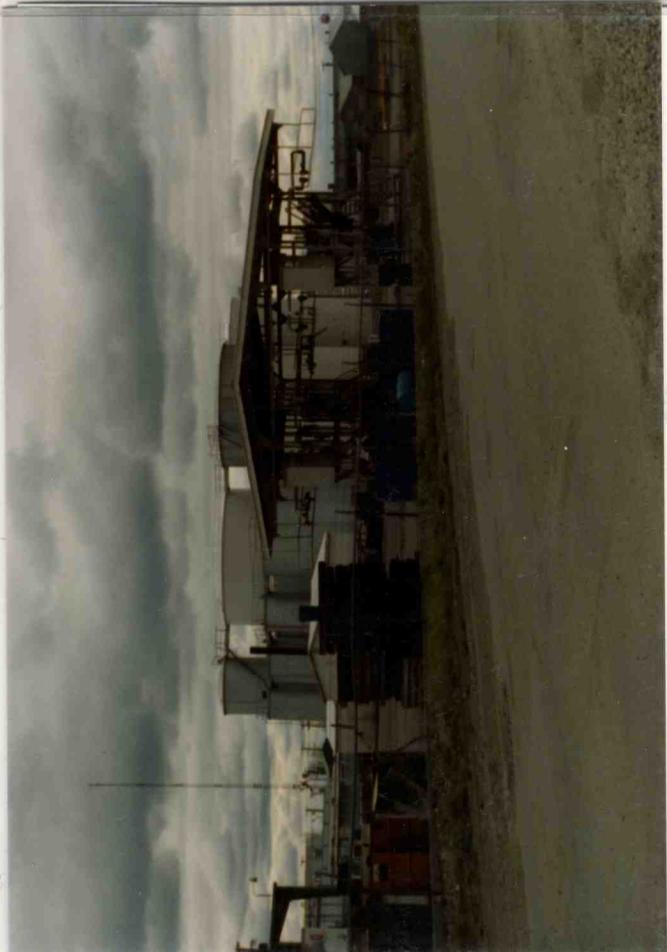
Photo #: 12

Location: Looking southwest towards Saupe Enterprises from Charles-Illinois Street intersection.

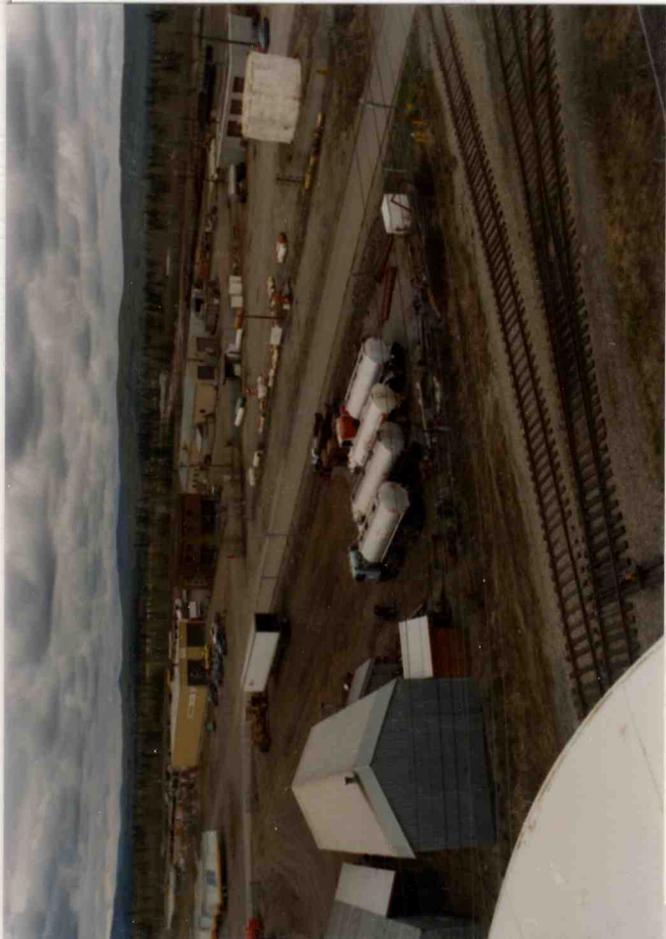
Photo #: 13

Location: Looking northwest from atop bulk tank located at Saube Enterprises.

Description: Photo shows the northeast corner of Willner's Texaco property next to Charles Street and the railroad corridor.

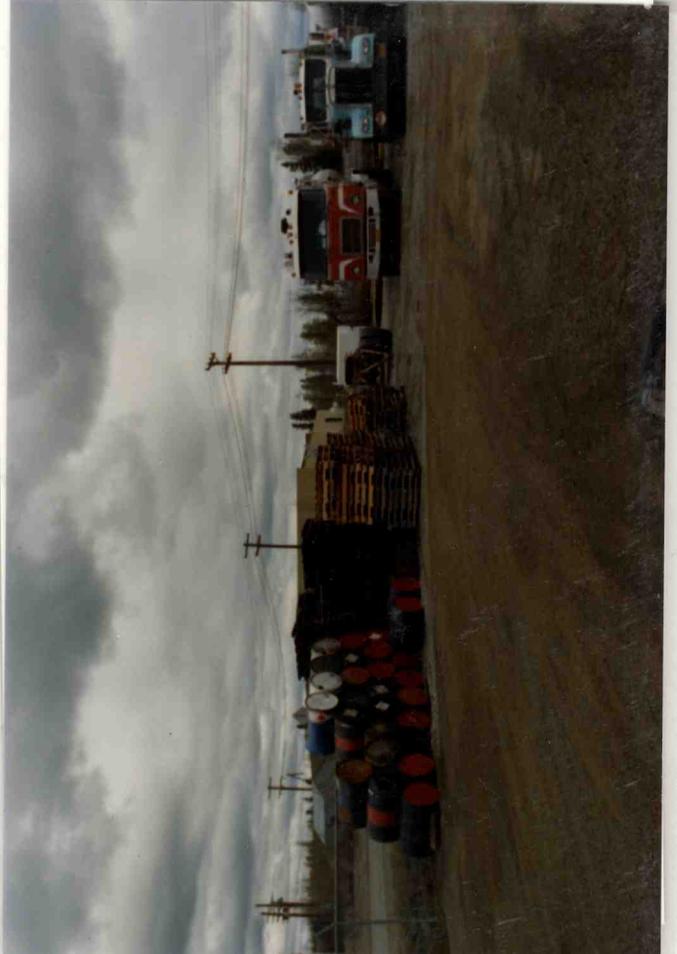
Photo #: 14

Location: Looking east on Willner's Texaco property.

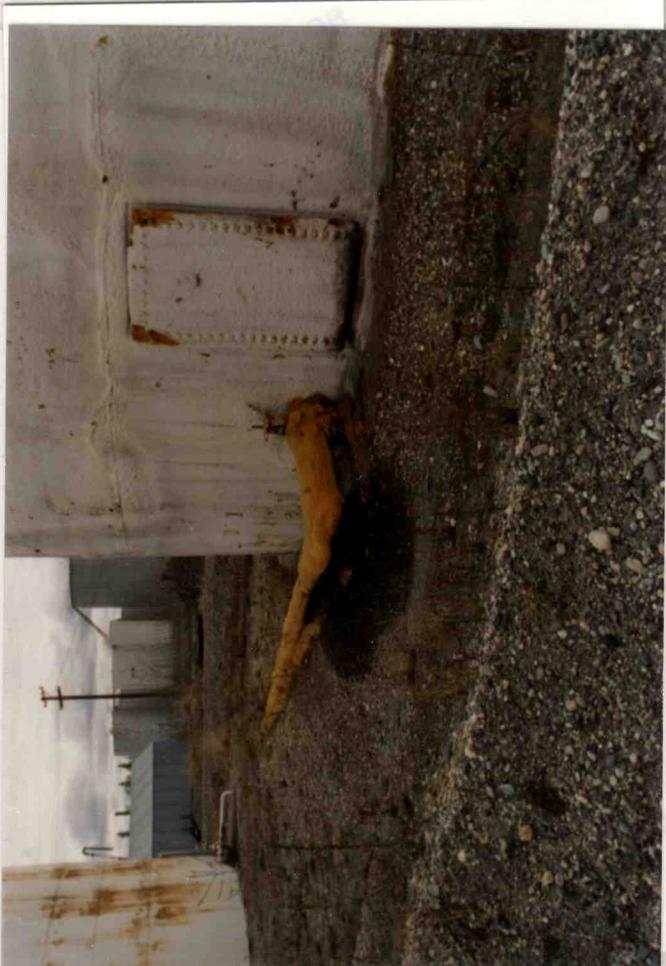
Photo #: 17

Location: Looking southeast at northwest AST on VanGas property.

Description: Photo shows petroleum stained ground from AST piping and connection.

Photograph #16 shows the VanGas facility looking northwest from atop bulk tank located at Saupe Enterprises. Photographs #17 and #18 show that petroleum releases have occurred from both ASTs. Photograph #19 shows contaminated ground at the tanker truck loading facility and area used for unloading rail cars. The fill pipe used for filling tanker trucks was actively leaking during our site visit. Photographs #20 and #21 show contaminated ground near a diesel pump located on the southern boundary of VanGas adjacent to Charles Street. Photograph #22 is a view of the front of the vehicle maintenance building. Photo #23 is a view of the east side of the vehicle maintenance building.

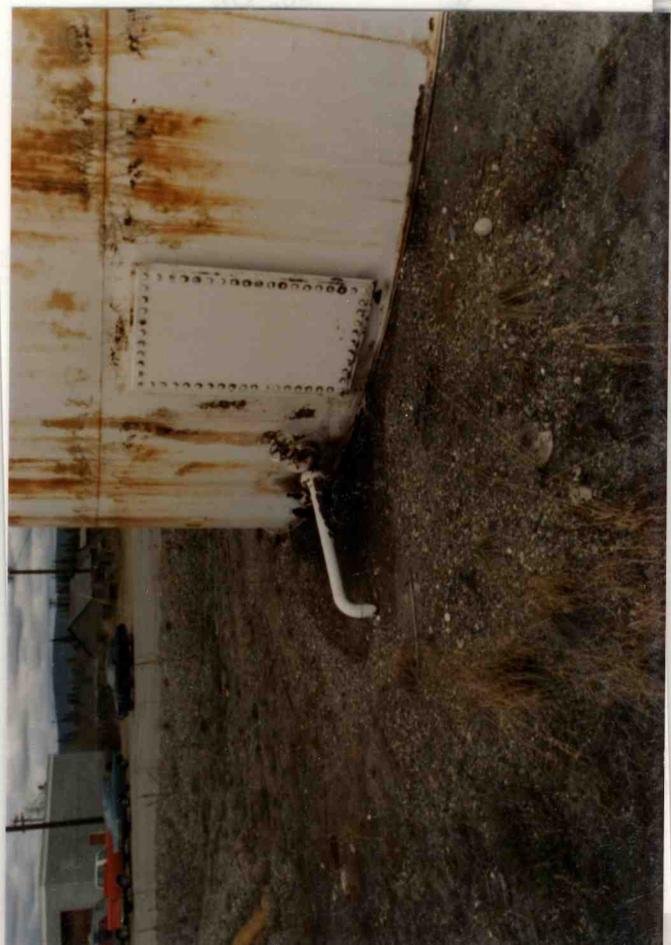
Photo #: 18

Location: Looking northwest at southeast AST on VanGas property.

Description: Photo shows petroleum stained ground from AST piping and connection.

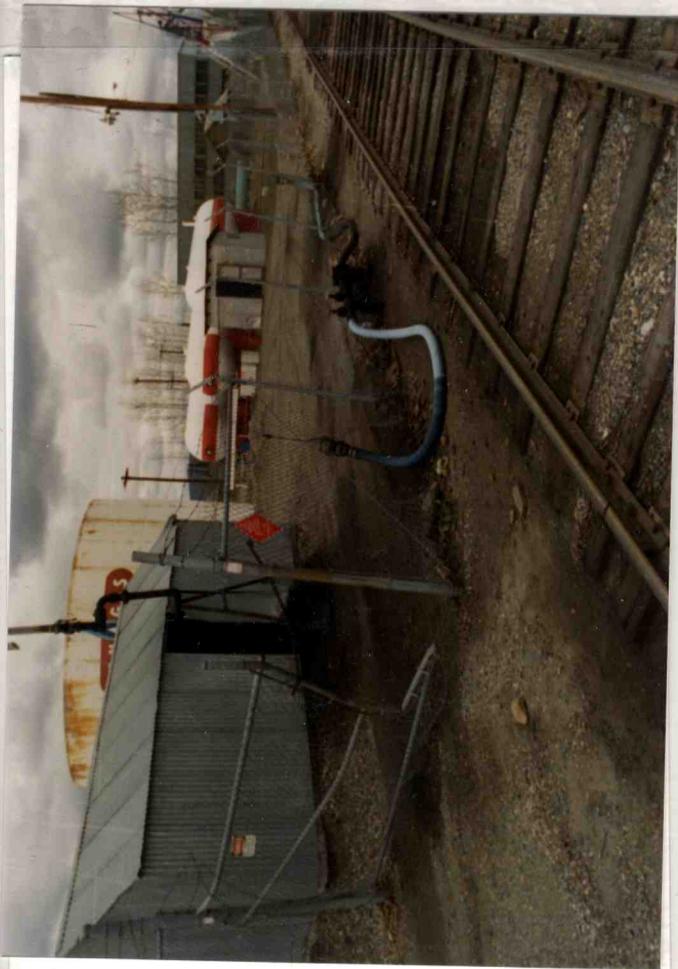
Photo #: 20

Location: Looking north from Charles Street towards VanGas property.

Description: Photo shows a diesel pump on the southern edge of VanGas property which is contaminated with petroleum (diesel).

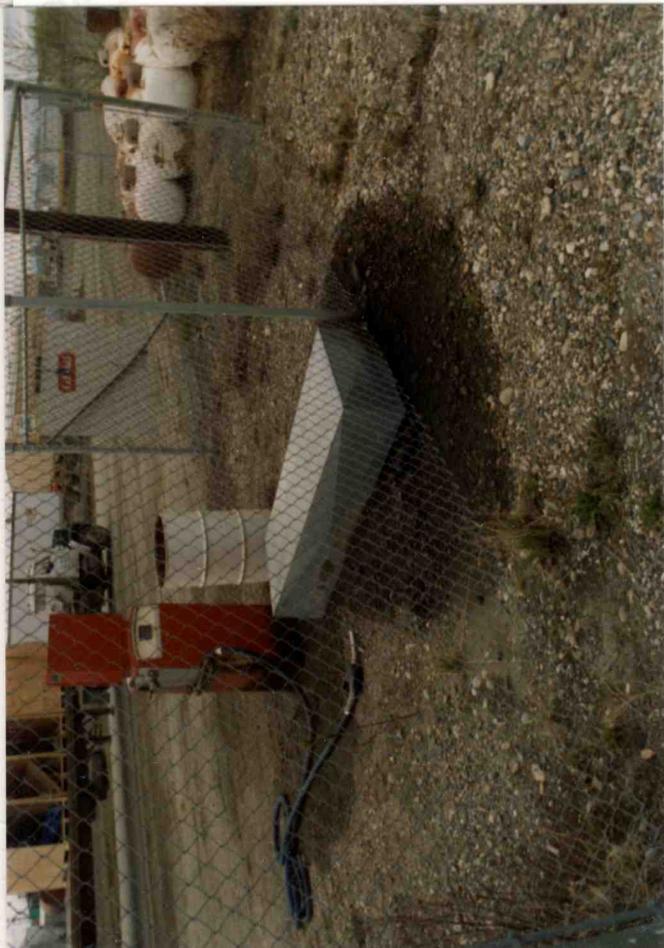
Photo #: 21

Location: Looking southeast at VanGas diesel pump.

Description: Photo shows petroleum stained ground around diesel pump.

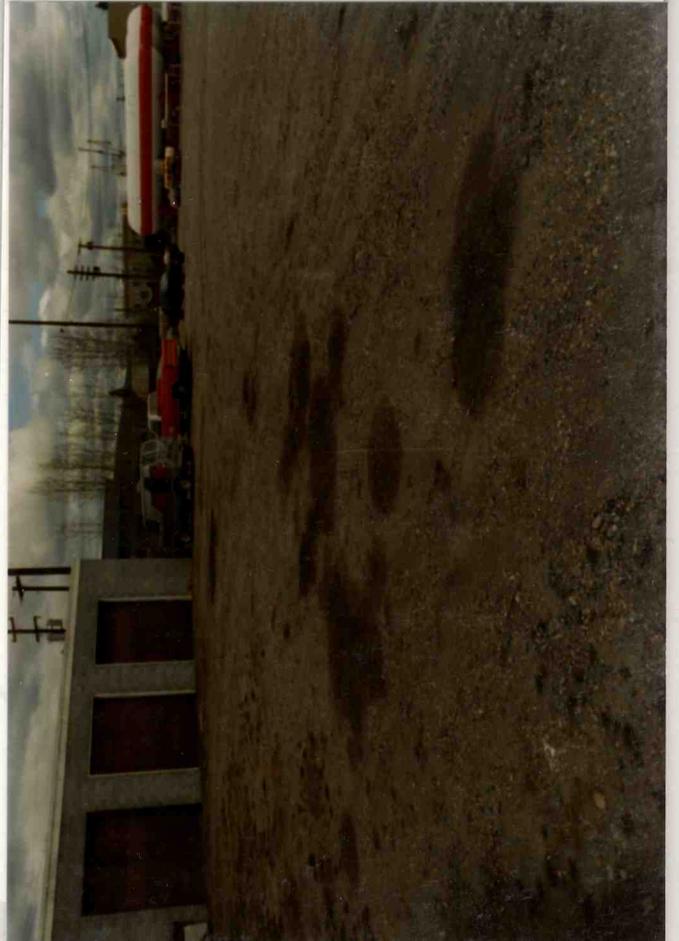
Photo #: 22

Location: Looking north-northeast at garage located on VanGas property.

Description: Photo shows petroleum stained ground.

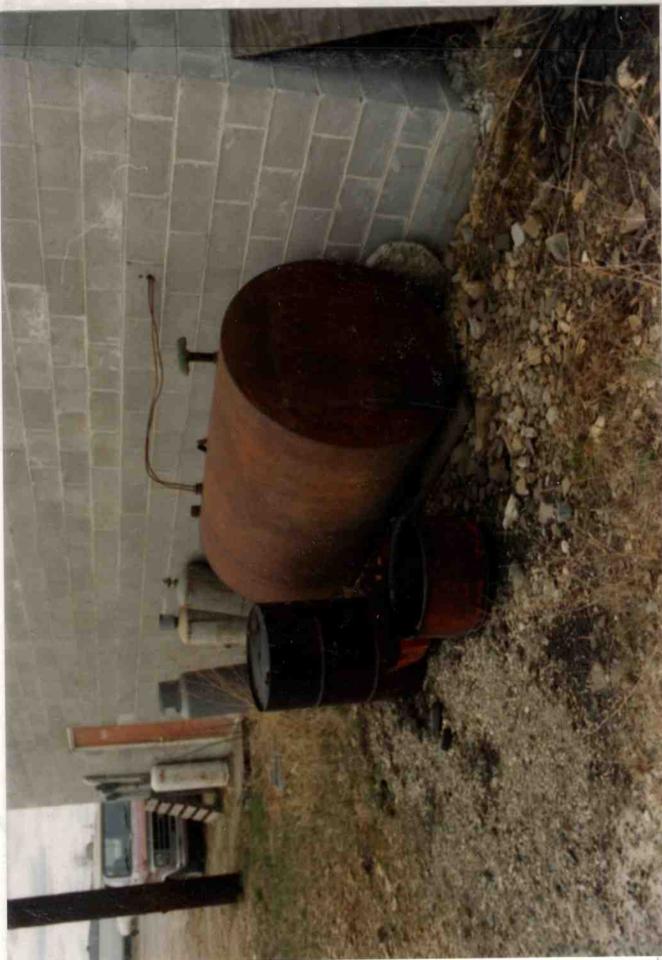
Photo #: 24

Location: Looking south-southeast at southwest corner of Alaska Gold Company (USSR&M) property.

Description: Photo shows that the land is currently being used to park and store equipment and materials.

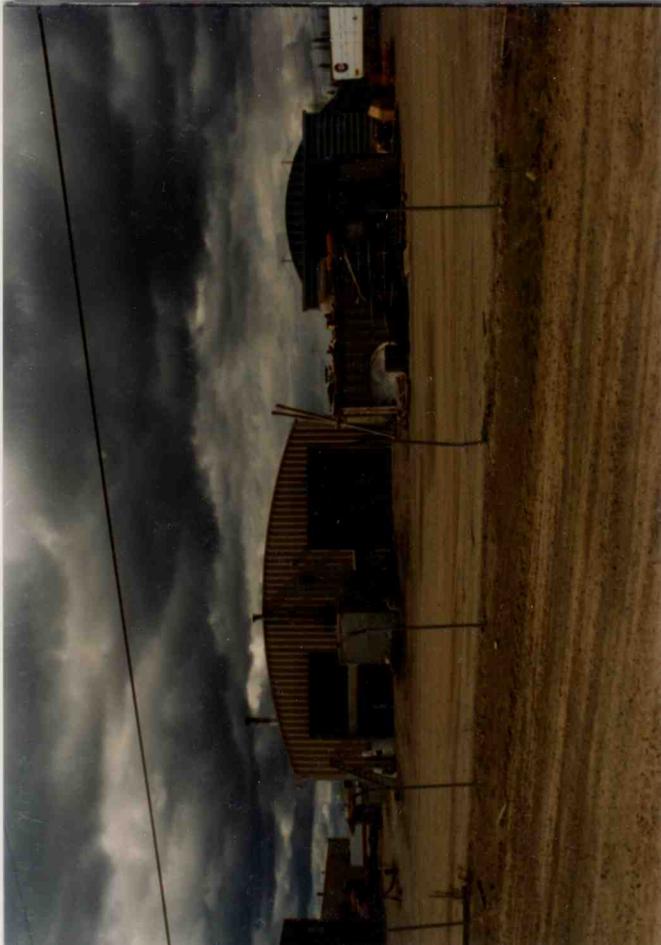
Photo #: 25

Location: Looking west from Driveway Street.

Description: Sourdough Express truck maintenance shop and warehouse located within the proposed right-of-way.

Two large buildings (vehicle maintenance shop and warehouse) are situated within the proposed right-of-way (Photograph #25). Photographs #26 through #28 show the various materials and objects stored in the backyard of Sourdough Express. Photograph #29 shows the north property line and other various equipment parked in back yard. Small accumulations of 55 gallons drums were noted at several locations.

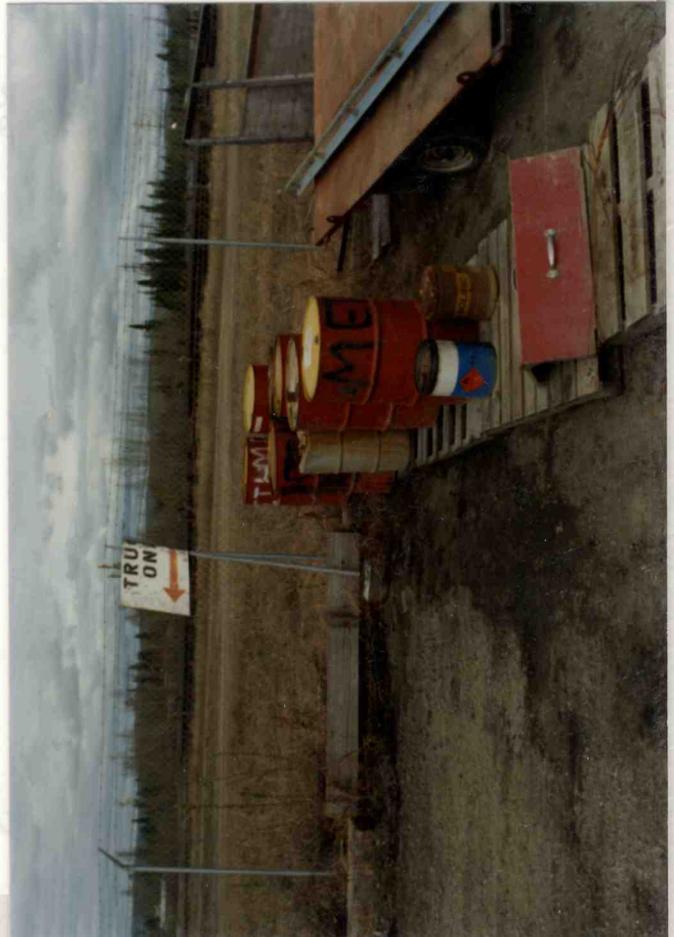
Photo #: 26

Location: Looking north towards north property fence of Sourdough Express storage yard.

Description: Photo shows petroleum stained ground and barrels of methanol being stored along north property fence.
