**Preliminary Hazardous Waste
Site Evaluation
Proposed Minnie Street Connector
Fairbanks, Alaska**

May 1989
SHANNON & WILSON, INC.

X-0176

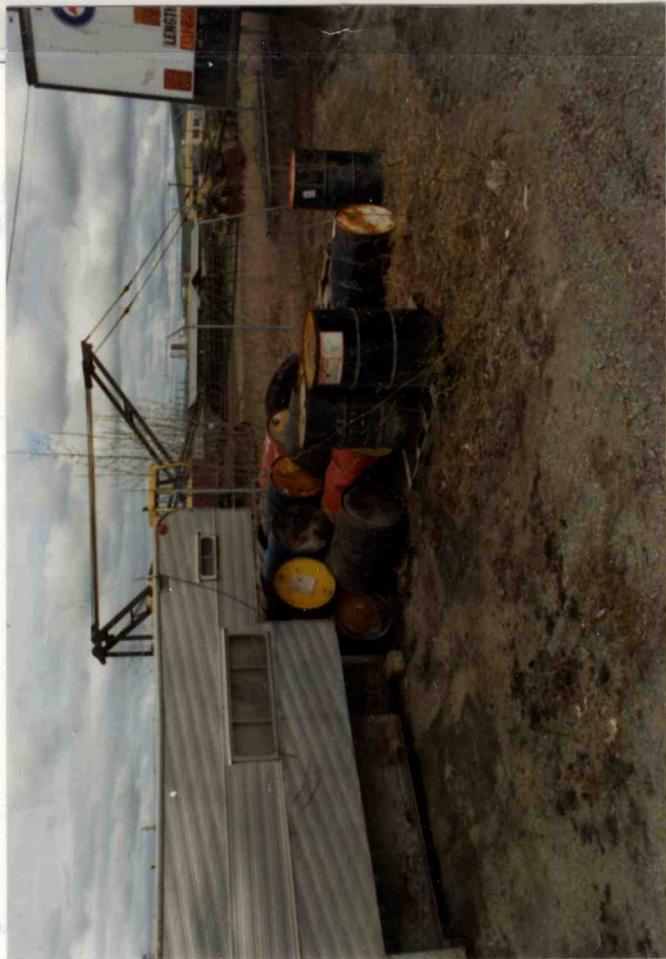
Photo #: 27

Location: Looking northeast towards north property fence of Sourdough Express storage yard.

Description: Photo shows 55 gallon barrels stockpiled along north property fence. Some barrels full. Contents unknown.

Two large buildings (vehicle maintenance shop and warehouse) are situated within the proposed right-of-way (Photograph #25). Photographs #26 through #28 show the various materials and objects stored in the backyard of Sourdough Express. Photograph #29 shows the north property line and other various equipment parked in back yard. Small accumulations of 55 gallons drums were noted at several locations.

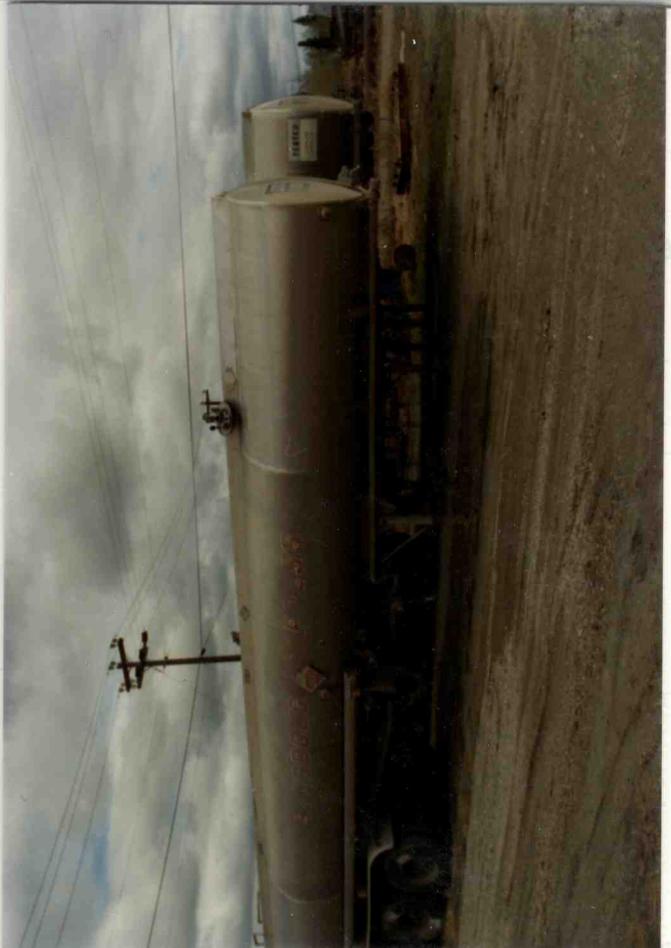
Photo #: 28

Location: Looking east-northeast from Sourdough Express storage yard.

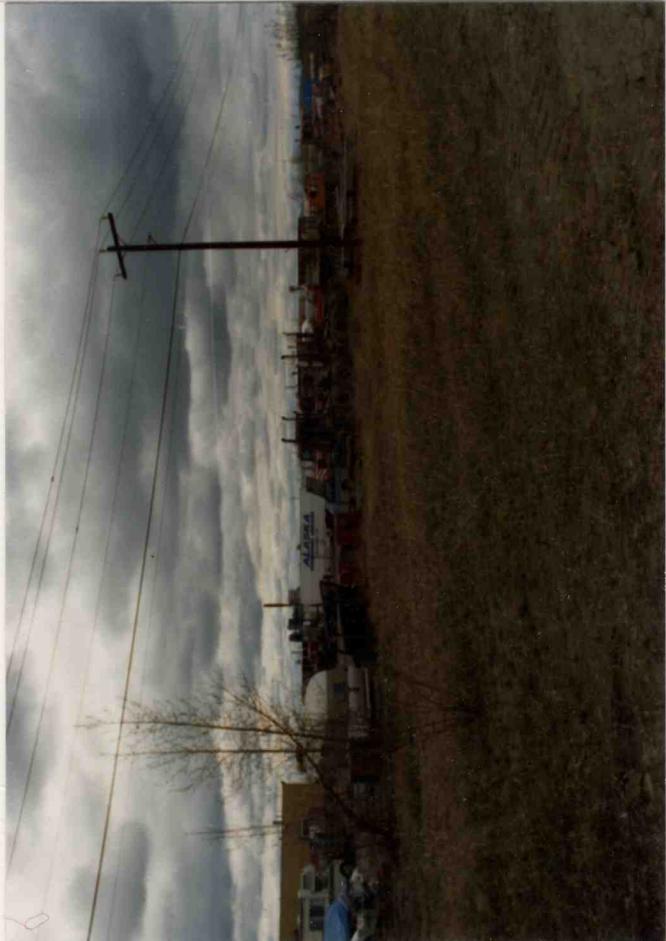
Photo #: 29

Location: Looking southwest from northeast corner of Sourdough Properties' north vacant lot.

Description: Photo shows the north property fence of Sourdough Express storage yard. Vacant lot north of fence is Sourdough Properties' north lot.

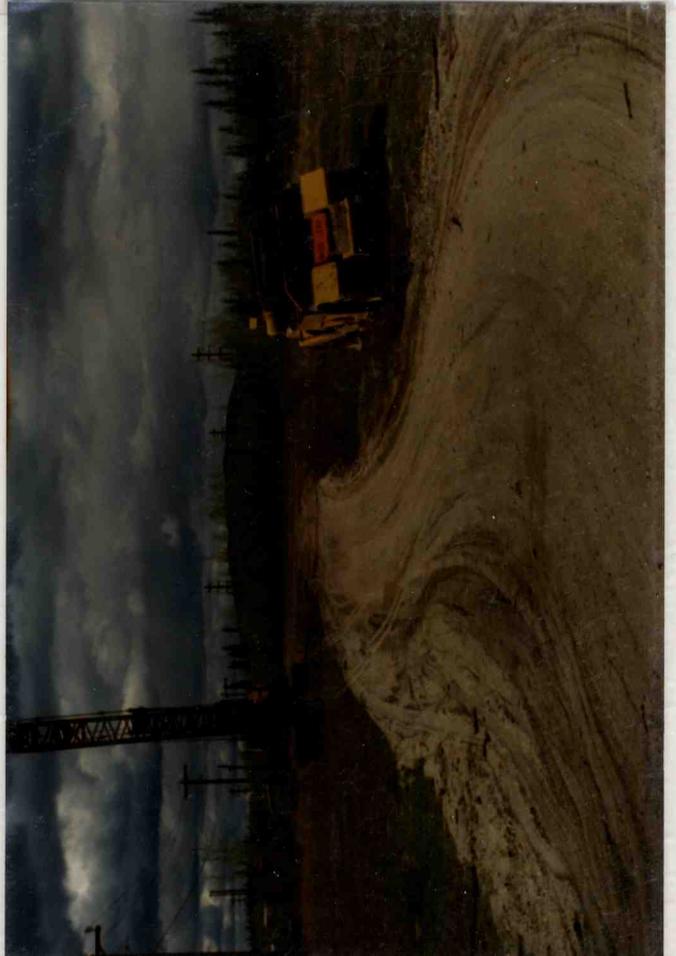
Photo #: 30

Location: Looking west across Sourdough Properties' north vacant lot from Driveway Street.
