# Alaska Department of Environmental Conservation Spill Prevention and Response

## SALT CHUCK MINE, MILL AREA

Database Name: USFS Salt Chuck Mine

Location: Prince of Wales Island, Alaska

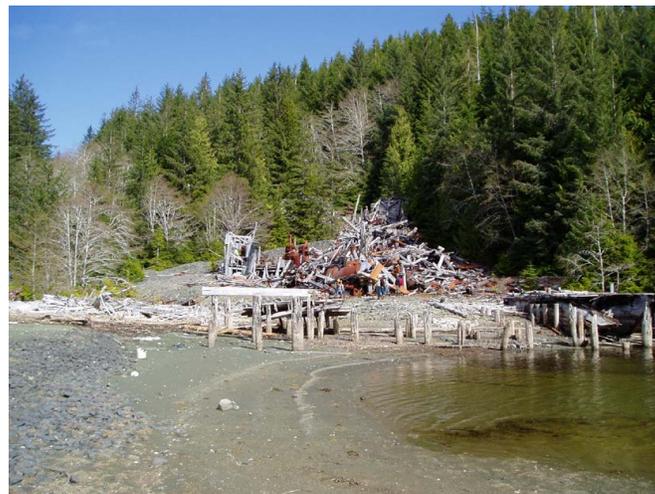
The mill area is shown in May 2009 (above). The mine openings are about a half mile uphill from the mill area. The contaminants from the Salt Chuck Mine include polychlorinated biphenyls (PCBs), copper, lead, mercury, selenium, vanadium, nickel, arsenic, petroleum and polycyclic aromatic hydrocarbons. (DEC photo)

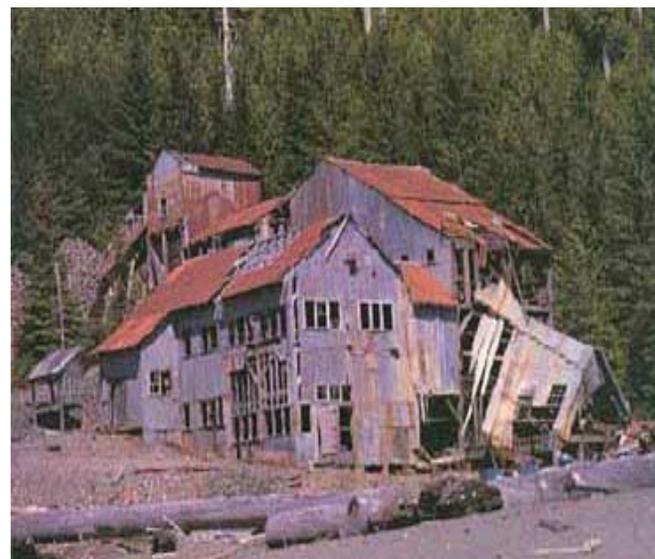
The mill at the Salt Chuck Mine is shown in a photo taken in the mid-1970s (above). (Photo by Patricia Roppel, courtesy of the U.S. Forest Service)

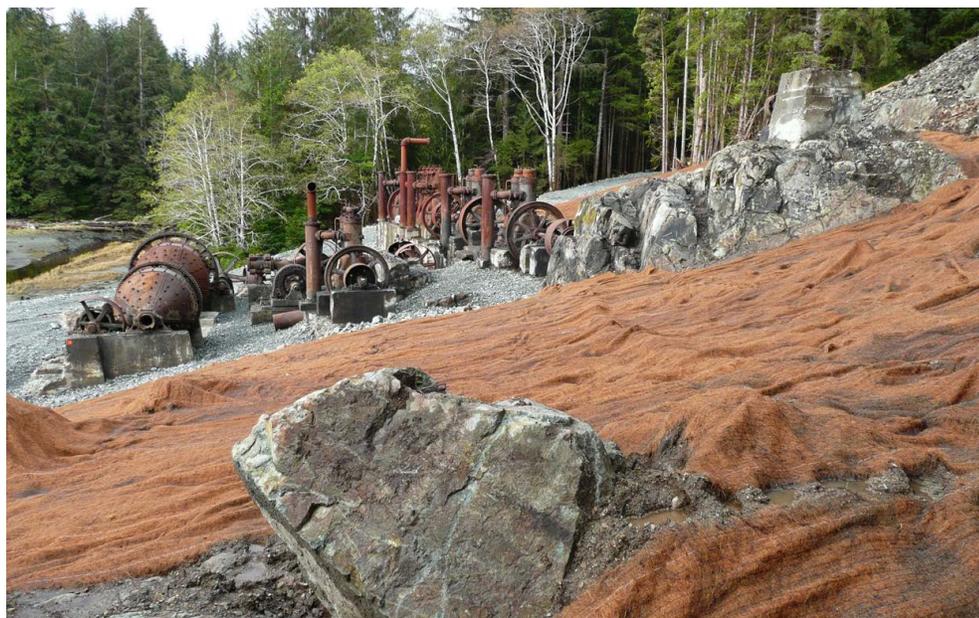
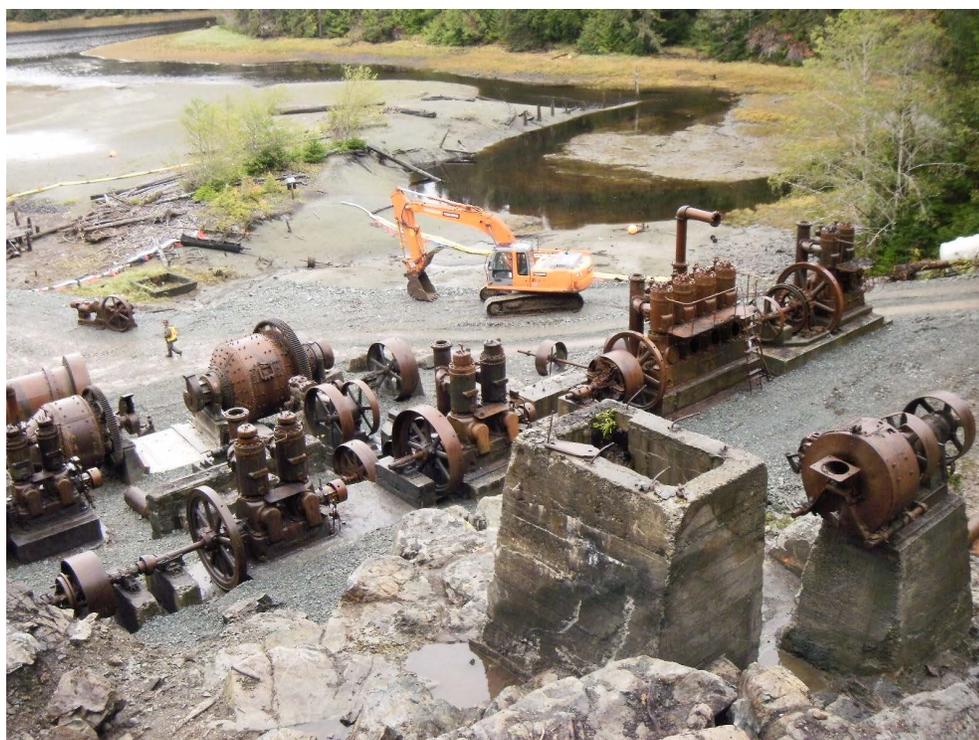
The U.S. Forest Service built a short road to provide access to the site in 2011, removed building debris, drums and tanks, excavated roughly 5,400 cubic yards of petroleum-contaminated soil and metals-contaminated tailings – 8,400 tons of contaminated material, which filled 300 containers averaging 28 tons per load. The material will go to a permitted landfill out of state. The agency set aside the site's historical mining equipment during the excavation, then grouped it in one area, as shown in the photos taken in October 2011 photos (top and bottom). (Photos courtesy of the U.S. Forest Service)

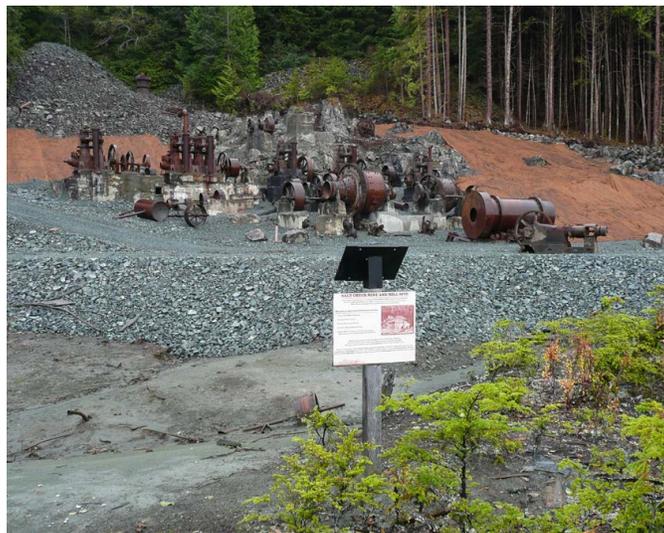
The site's historical mining equipment is now collected in one area, as shown in this October 2011 photo (above). (Photo courtesy of the U.S. Forest Service)

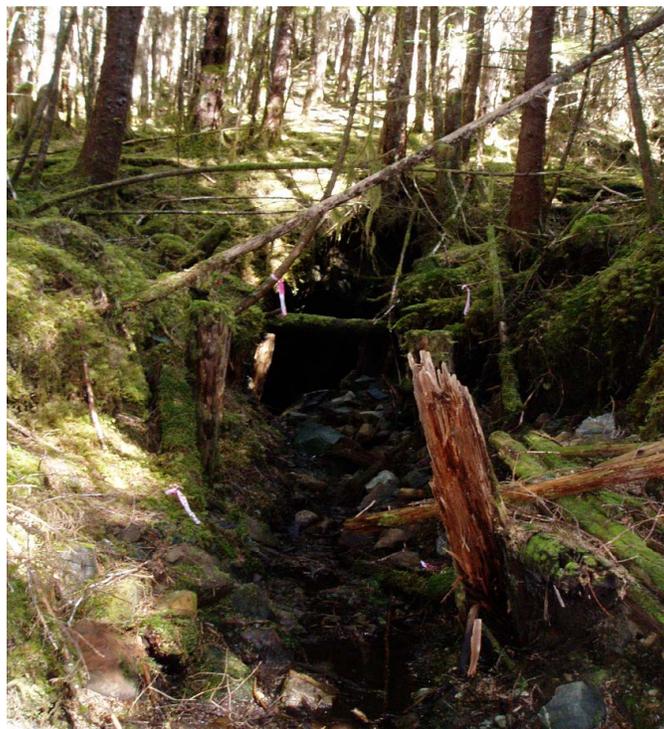
One of the main adits to the mine is shown in this May 2009 photo (above); the adit looked similar in the summer of 2011. An adit is a nearly horizontal passage from the surface to a mine. (DEC photo)

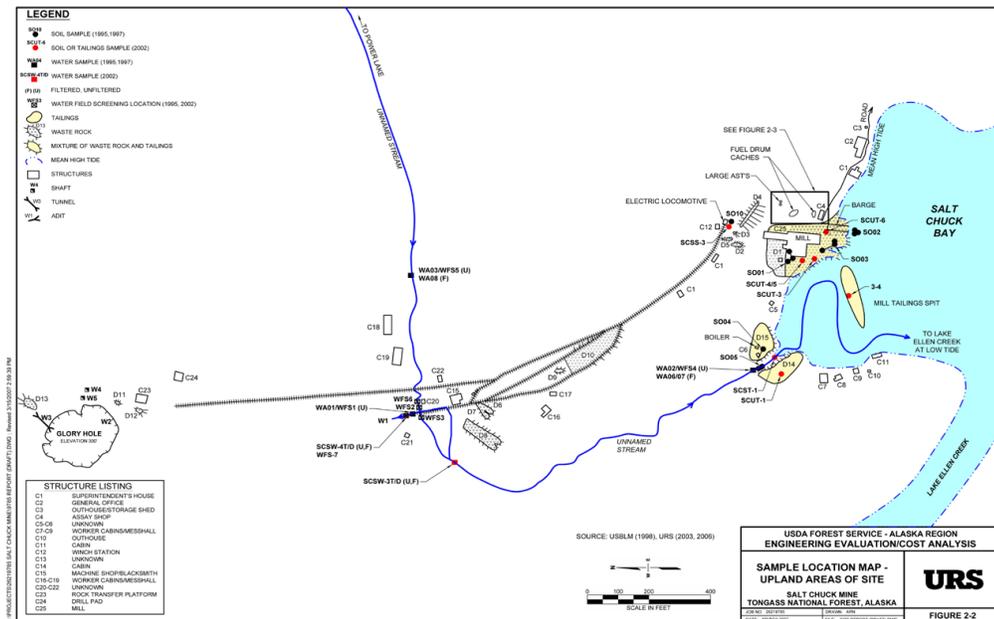
The layout of the Salt Chuck Mine is shown on this March 2007 map. (Map courtesy of the U.S. Forest Service)

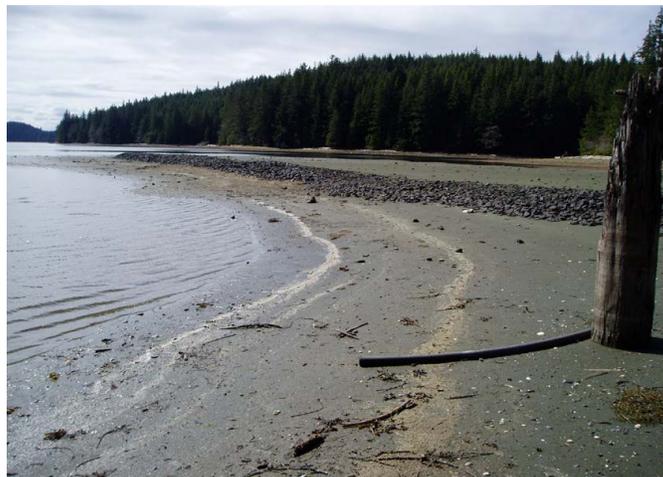
The line of brown rocks and all the sediment on the nearby beach (above) are metals-contaminated tailings. The beach is near the mill area, on Salt Chuck Bay, and the photo was taken in May 2009. The main contaminants of concern in the intertidal area are copper, arsenic and vanadium. (DEC photo)

In May and August, the EPA also conducted a treatability study in the inter-tidal area to determine if certain actions would be effective in reducing erosion. Some tailings were removed to straighten out the small creek to prevent more erosion, and rock was placed to armor the stream bank where it was eroding. Different plants were transplanted at different elevations on the tailings to see if the plants would grow and hold onto the tailings. The EPA will evaluate the progress of the treatability study in 2014.
